BETA LAB NO.M10198, REV. 1 - Tesoro E6600 HEAT EXCHANGER "E". SUMMARY OF THE RESULTS PART: 6600-E HEAT EXCHANGER "E", ALL PARTS DAMAGE DEPTH, AND PART 17 MOUNTS	TESORO REFINING AND MARKETING COMPANY ANACORTES REFINERY 10200 W. MARCH POINT ROAD T91WA4428 ANACORTES, WA 98221	CUSTOMER P.O. No.: 4501667904
		DATE: 3/7/2011
		PAGE 1 OF 70

LABORATORY REPORT

SAMPLE DESCRIPTION: The heat exchanger, labeled E6600 "E" (Echo), failed and a test protocol was developed for the failure analysis of the component. This test protocol and its addendum, as of this date and contained in Attachment 1, were developed and signed by Tesoro Companies, Division of Occupational Safety and Health and U.S. Chemical Safety Board. FirstEnergy BETA Laboratory was selected as the referee test laboratory to perform the testing requirements of the test protocol. The test protocol was not specific as to the test samples to be removed from the heat exchanger or the test locations/test parameters for each specific test within the test sample. Therefore it was agreed

This report is the eleventh in a series of the reports on the failed parts ("E") of the 6600E heat exchanger "E". The LS# and CS# refer to longitudinal

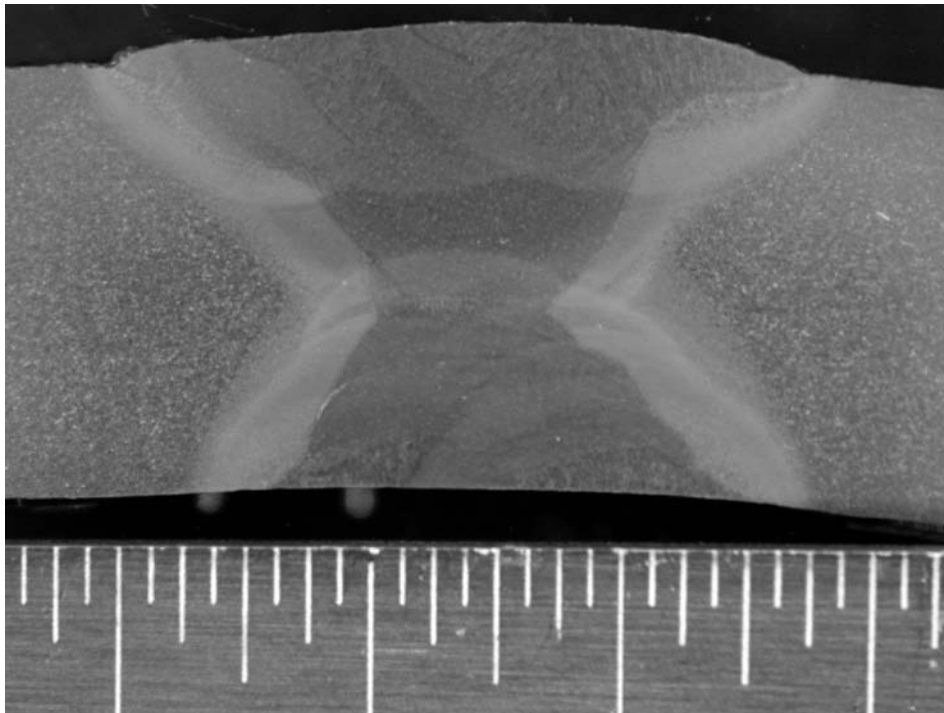
LS1

Figure 3, OD is on top and ID on bottom

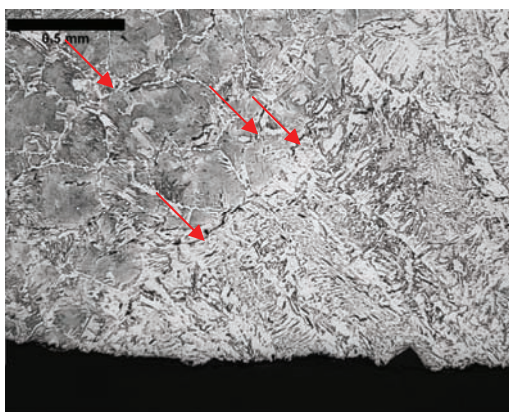
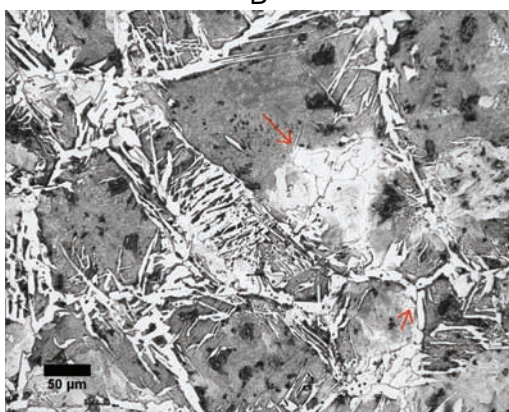
Figure 9. Definitions of the damage locations (devised by others) used in Table 11 and in the text. The locations in the base metal (BM) or in the weld metal (WM) are self-explanatory.

When the observed damage is located at the fusion line (FL) or at the 1st or 2nd grain of the CG HAZ (Coarse Grain of the Heat Affected Zone, CG everywhere in this report), it is marked as **"FL"**

It is typical to find damage beyond the FL and the 2nd grain of the CG, as it shown on the micrographs at left. The arrows at the microphotograph [B] show a spot indicative of the damage well deep in the CG, away from the FL. On microphotograph [C] the damage is in the 21st – 22nd grain inside the CG.

If this is observed, the location of the damage is defined as **"CG"**.

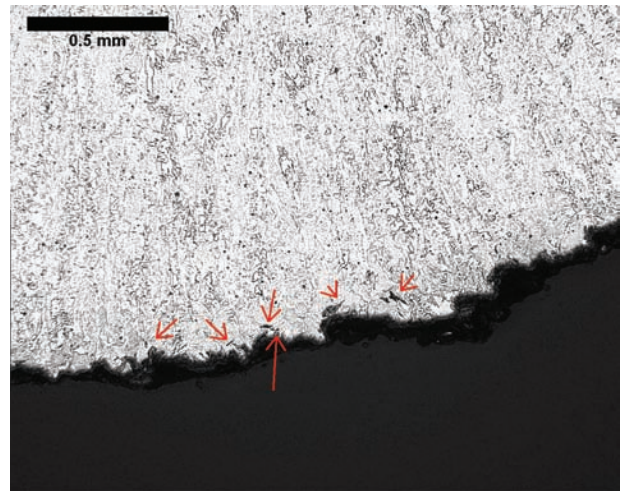
Un-etched- right side of weld

Etched- right side of weld

Damage Depth, mm	
Left of Weld	Right of Weld
0 (Clad)	17.73

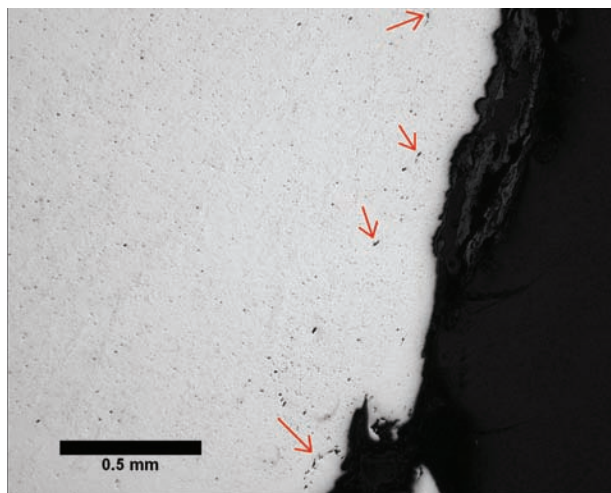
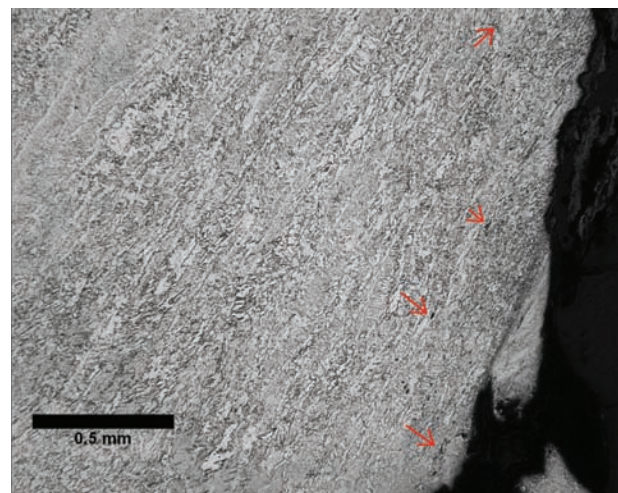
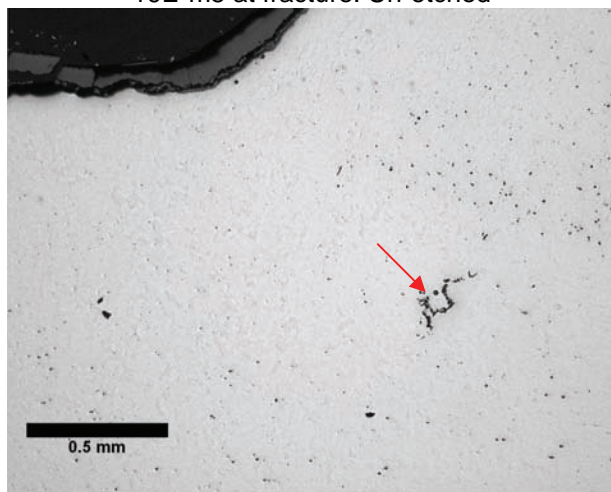
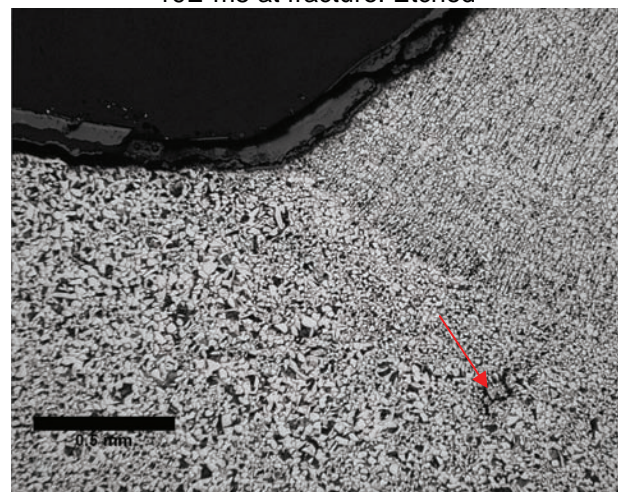
14M5

19E-m5 at fracture. Un-etched

19E-m5 at fracture. Etched

14-m5 at O.D. Un-etched.

14-m5 at O.D. Etched

Damage Depth, mm	
Left of Weld	Right of Weld
0 (Clad)	21.8

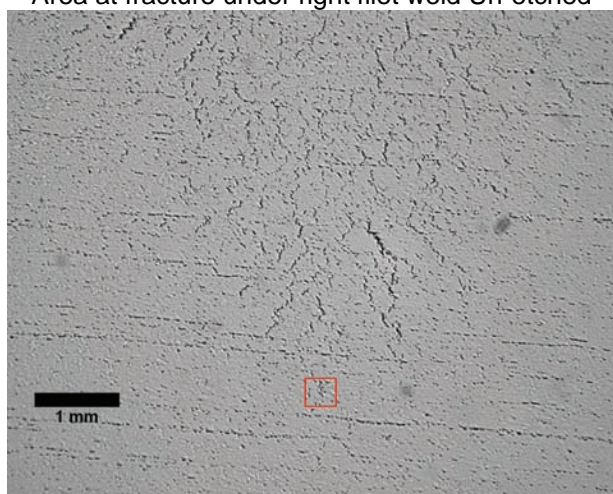
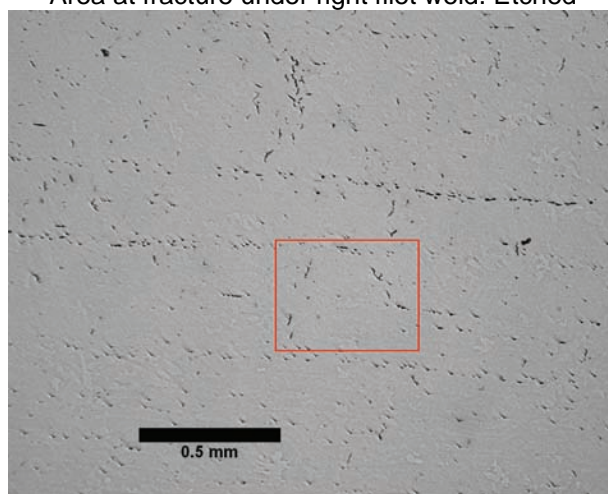
CS4 WELD, SAMPLE 18-M2

Area at fracture under right fillet weld Un-etched

Area at fracture under right fillet weld. Etched

Area under left weld. Un-etched

Area under left weld enlarged. Un-etched

Damage Depth, mm	
Left of Weld	Right of Weld
9.32	9.86

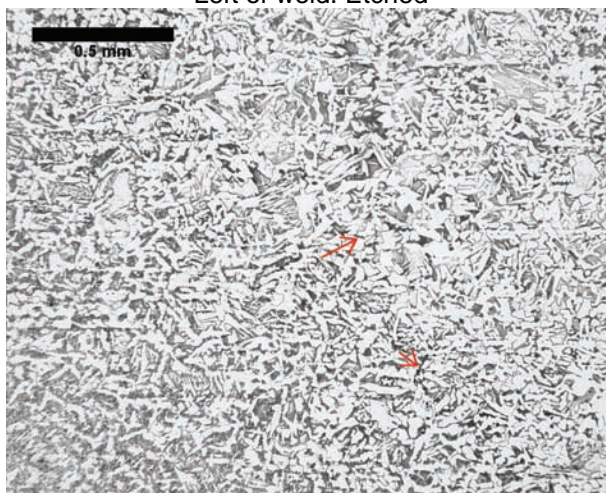
**LABORATORY REPORT
PART 16-1. LS2 WELD, SAMPLE T-2L**

Left of weld. Un-etched

Right of weld. Un-etched

Right of weld. Etched

Damage Depth	
Left of Weld	Right of Weld
5.85	7.45

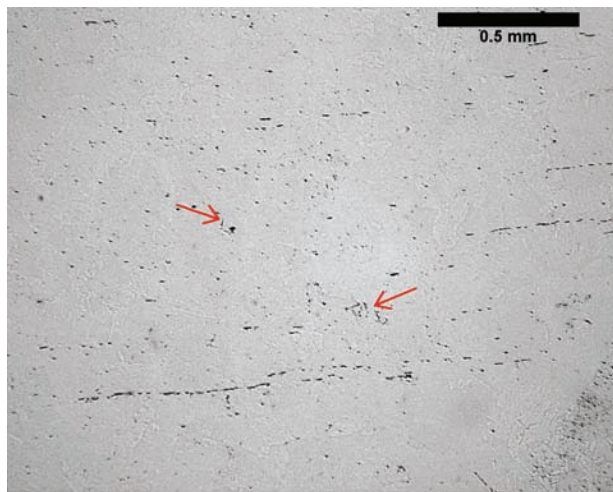
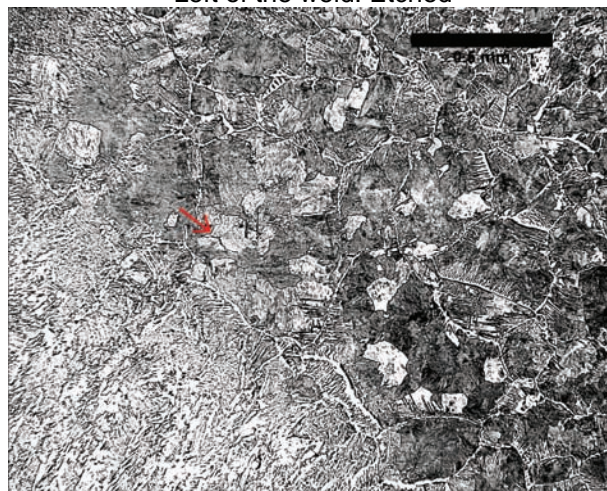
**LABORATORY REPORT
PART 16-2. LS2 WELD, SAMPLE 22" FROM CS3**

Left of the weld. Un-etched

Right of the weld. Un-etched

Right of the weld. Etched

Damage Depth, mm	
Left of Weld	Right of Weld
3.04	5.37

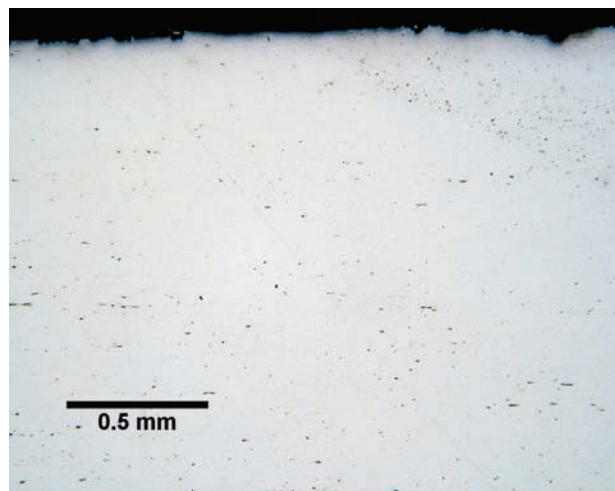
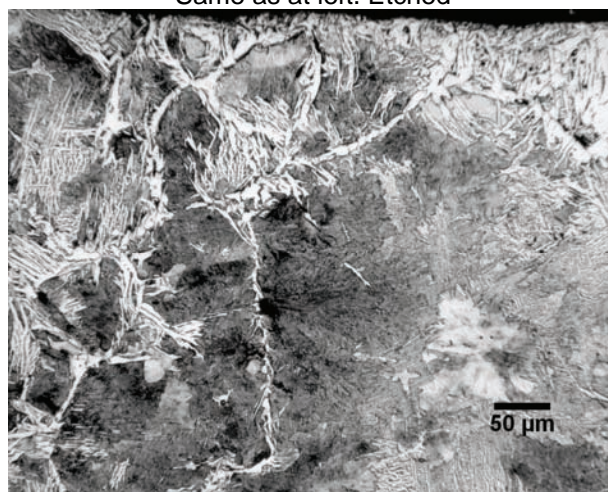
**LABORATORY REPORT
PART 17, Weld LS1, SAMPLE LS1**

Left of the weld. Un-etched

Same as above at higher magnification. Un-etched

Same as at left. Etched

Damage Depth, mm	
Left of Weld	Right of Weld
0	0

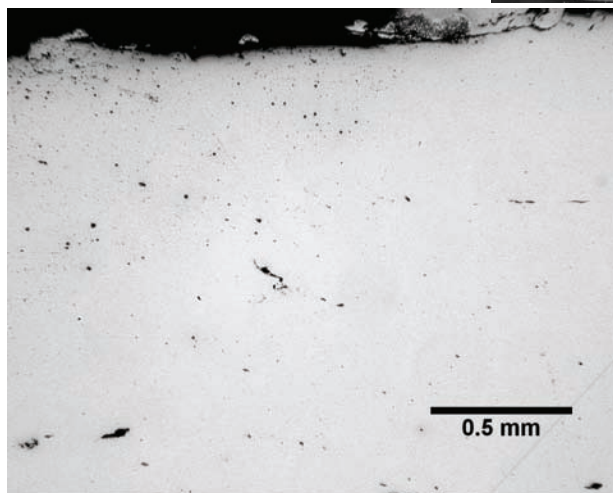
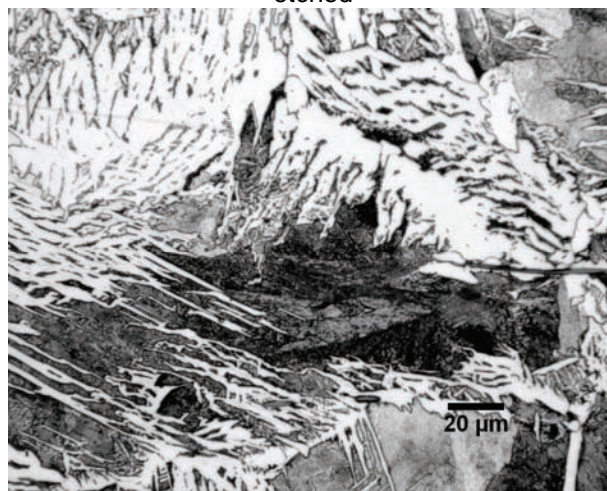
**LABORATORY REPORT
PART 17, Weld LS1, SAMPLE LS1**

Right of the weld. Un-etched

Right of the weld farther from ID. Un-etched

Right toe area at ID. Etched

Damage Depth, mm	
Left of Weld	Right of Weld
0	0

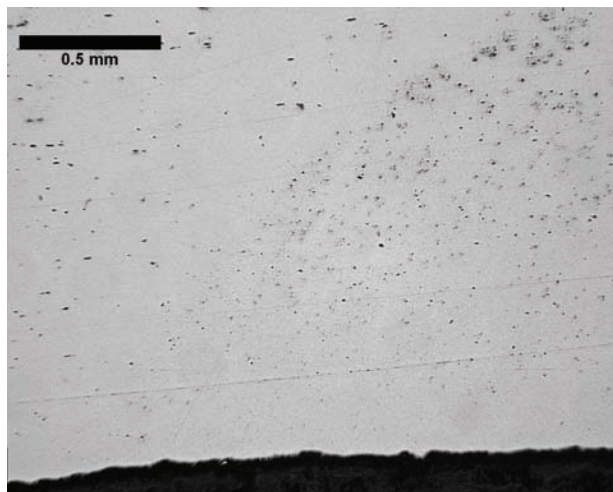
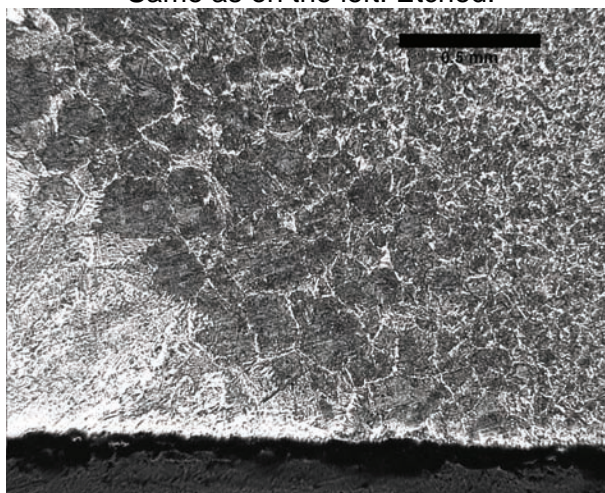
**LABORATORY REPORT
PART 17, Weld LS1, SAMPLE 17-LS1**

Left toe at the ID. Un-etched

Right toe at the ID. Un-etched

Same as on the left. Etched.

Damage Depth, mm	
Left of Weld	Right of Weld
0	0
