CASE STUDY

Mixing and Heating a Flammable Liquid in an Open Top Tank

Universal Form Clamp, Inc.
Bellwood, Illinois
June 14, 2006

Investigation No. 2006-08-I-IL
April 2007

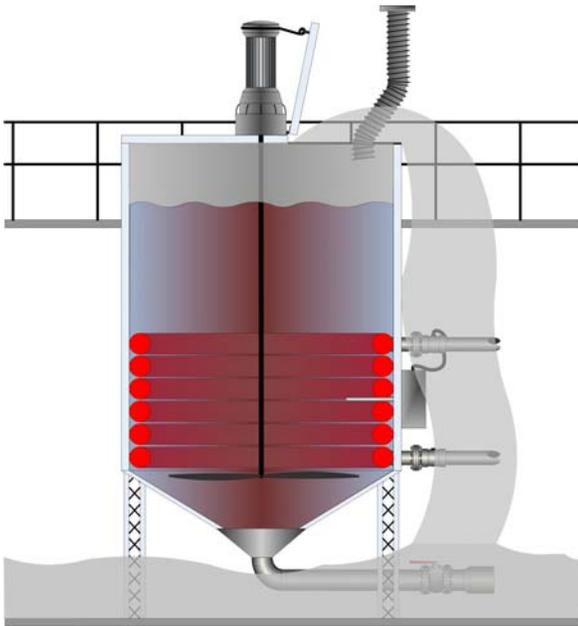
As the operator was adding an ingredient to the batch, he observed a “dense fog” accumulating on the floor below the tank (Figure 1).

Figure 1. Vapor spilling from top of mixing tank

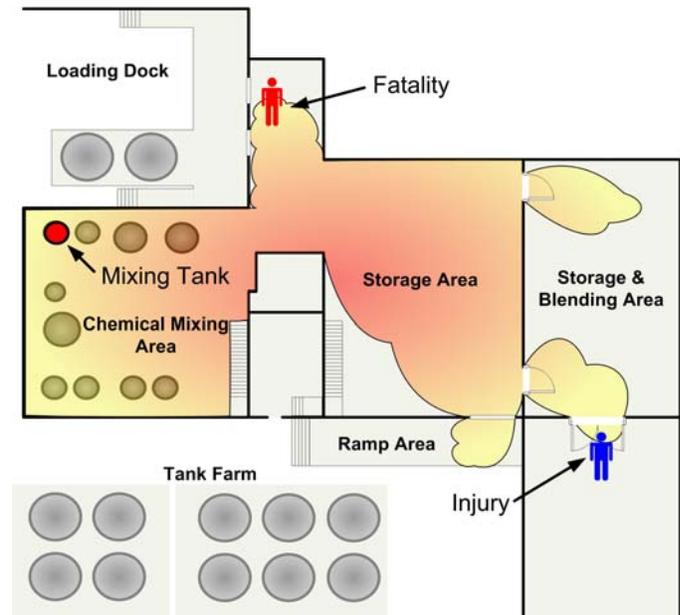
As the vapor cloud spread throughout the mixing area and surrounding workspaces, other employees exited the building (Figure 2).

Figure 2. Vapor cloud propagation

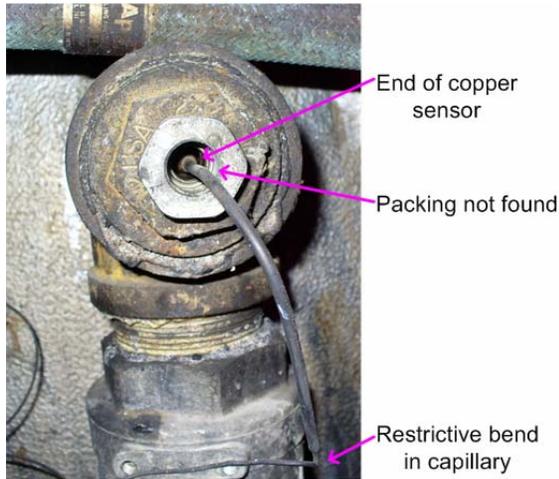
- The temperature-sensing bulb and thermometer well housing (thermowell) did not conform to the manufacturer's specifications.
 - The thermowell, designed to be filled with thermal conductive fluid, was dry, and parts designed to hold the bulb in place were missing (Figure 3).
 - The bulb was not fully inserted into the well (Figure 4).

Both of these conditions may have contributed to inaccurate temperature sensing or a delayed response, and may have caused the steam valves to remain open long enough to boil the mixture.

Figure 3. Temperature sensor well

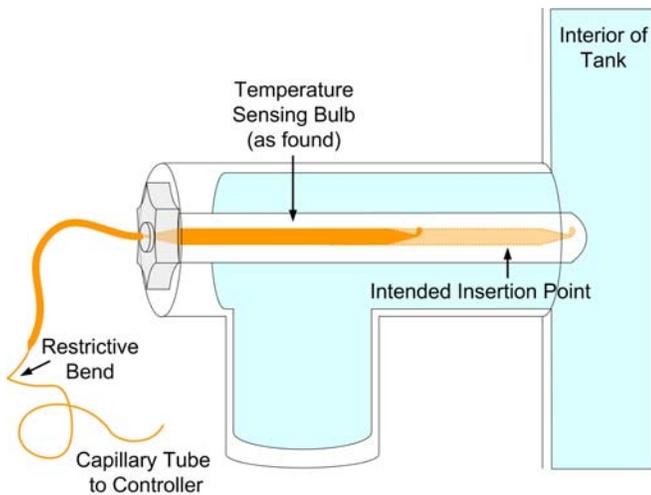
- There was a restrictive bend in the liquid-filled capillary tube connecting the sensing bulb to the temperature controller (Figure 4). Fluid inside the bulb must be able to expand and move freely through the capillary tube for the controller to operate properly. This bend may have caused the controller to perform sluggishly or to malfunction.

Figure 4. Intended sensor location

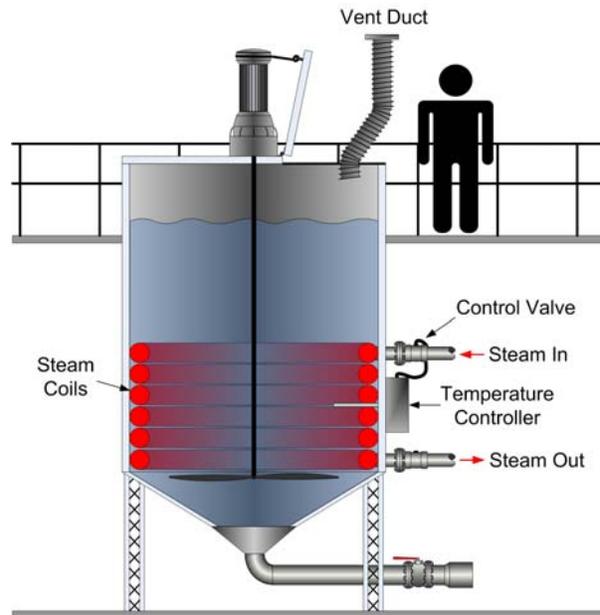
Figure 5. Mixing tank mechanical systems

The local exhaust system included two exhaust fans connected to a main duct with flexible ducts extending into the tops of the mixing tanks (Figure 5). This system was incapable of controlling vapors released from the tank because

- both exhaust fan drive belts were broken before the incident, and
- it was not designed to capture and remove a high volume of vapors from an open top tank.
