**Client: United States Chemical Safety Board**

**Report Title: Didion Milling Explosion Assessment**

***Incident: May 31, 2017***

**Final Report R0**

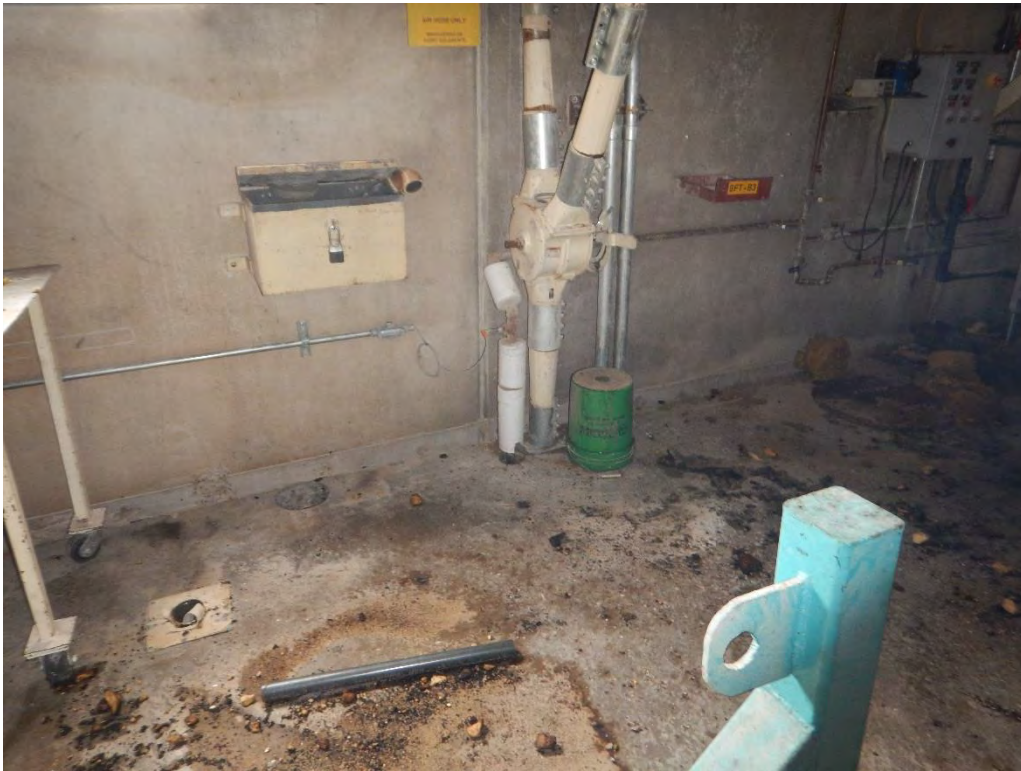
**Figure 2-3. Mill B Wall Panel to Level 2 Slab Connection Failure Perspective**

Failure of the connections between the Mill B precast wall panels and the Mill B floor slabs were observed after the Didion explosion. A perspective of the failure at level 2 of Mill B is provided in Figure 2-3 and shown in detail in Figure 2-4. Provided drawings show the precast wall panel connection to be an embedded #4 reinforcing bar dowel secured with adhesive at each floor slab at various spacing

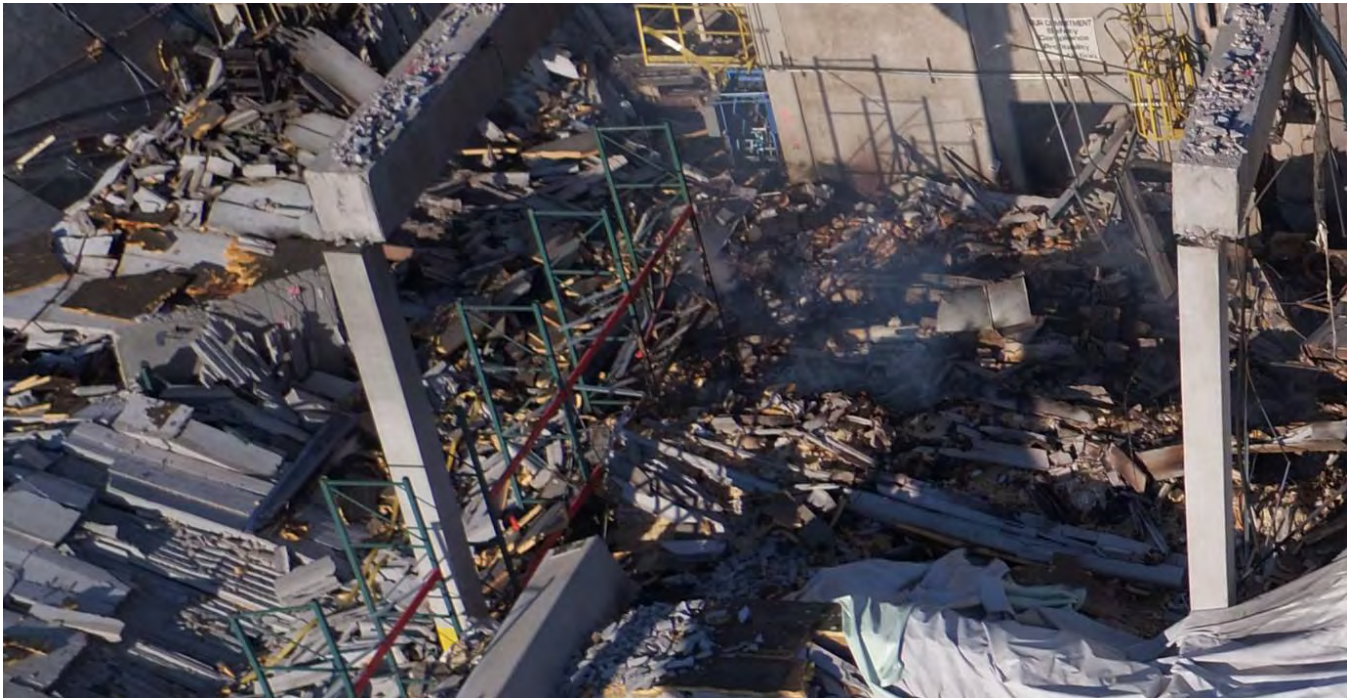
**Figure 2-14. Failed Multipurpose Building Beam to Column Joint**

The beam to column connections were simple bearing connections as shown in Figure 2-14. In a typical precast beam to column connection, the precast beam sits on a bearing pad on top of the column. The beam is dropped over a dowel that extends out of the top of the column. The dowel goes into a vertical tube placed through the depth of the beam. Once the beam is set in place, this tube is grouted solid to prevent the beam from shifting off the column. (See the attached Spancrete typical detail BC-8 in Figure 2-15.)

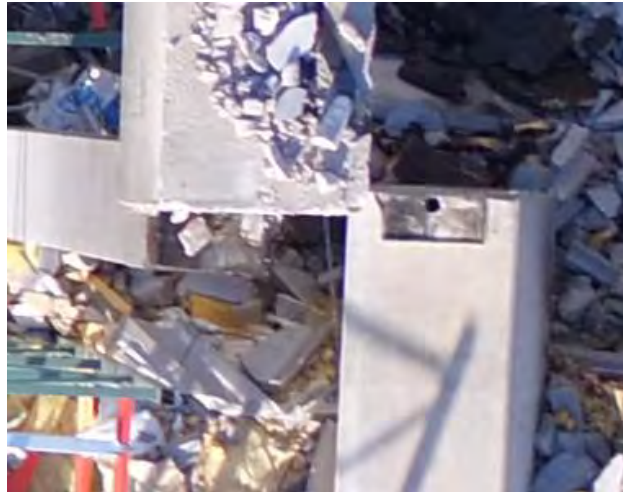
**Figure 2-16. Multipurpose Building Beam Grout Hole**

In the few bays in which the beam was dislodged from the columns, the grout hole in the bottom of the beam is observable in the overhead drone photos shown in Figure 2-16. It is noted that there does not appear to be grout visible in the holes. Dowels extending from the top of the columns are visible in the photographs, including the example in Figure 2-17. However, the grout holes in the beams appear to be ungrouted when viewed from the underside of the beam. Therefore, it is concluded that the beams were resting on top of the columns with little to no physical connection between elements other than an ungrouted dowel.

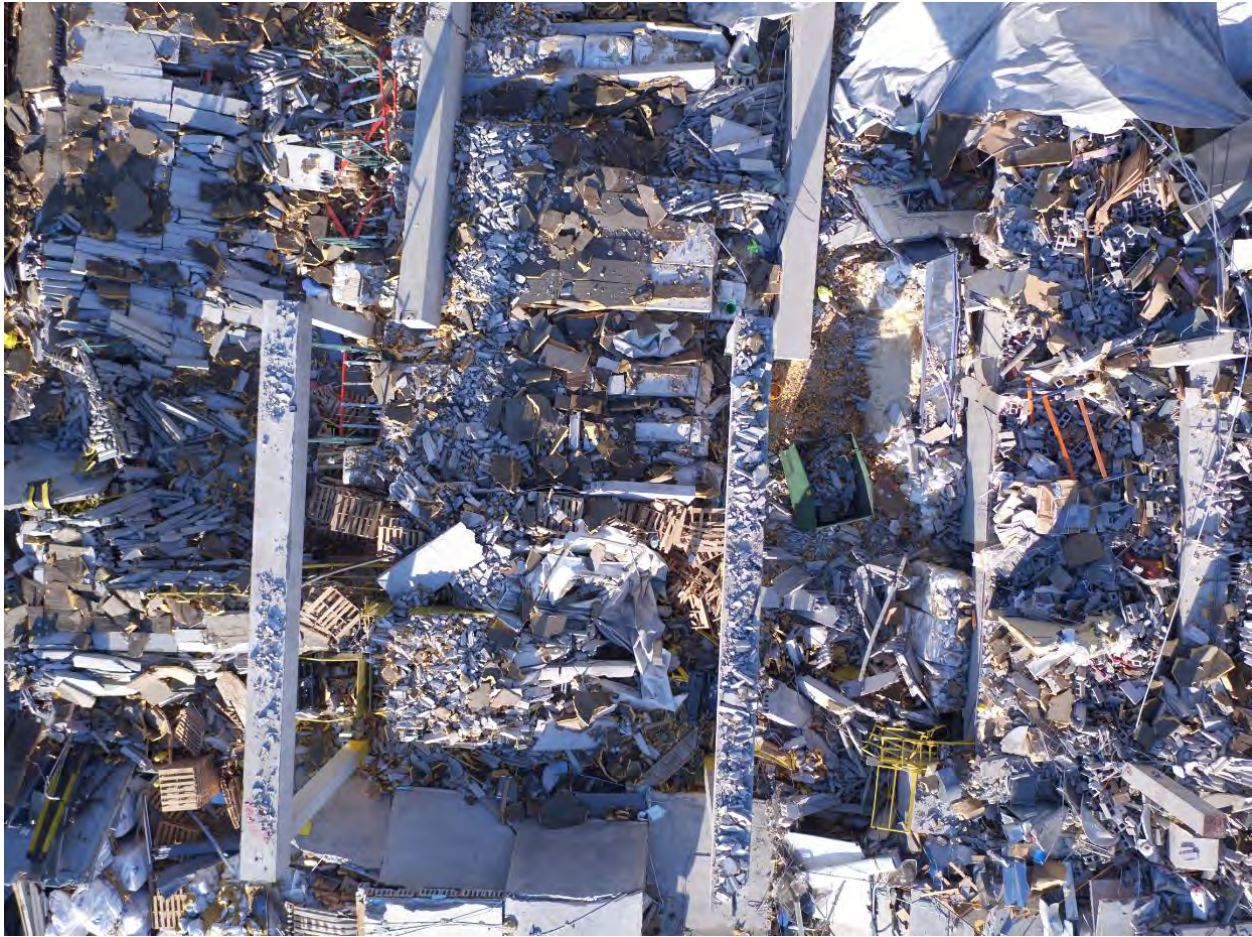
**Figure 2-19. Top of Multipurpose Building Beams**

In a number of overhead aerial photographs, including the one provided in Figure 2-19, it is evident that the top of the exposed concrete beams are smooth and free from any extended dowels (or spalled concrete suggesting the presence of dowels). There are also no embedded corner angles to which the underside of the hollow core slabs could have been welded. Therefore, it is concluded that the hollow core slabs were simply resting on top of the precast beams with no physical connection between elements.

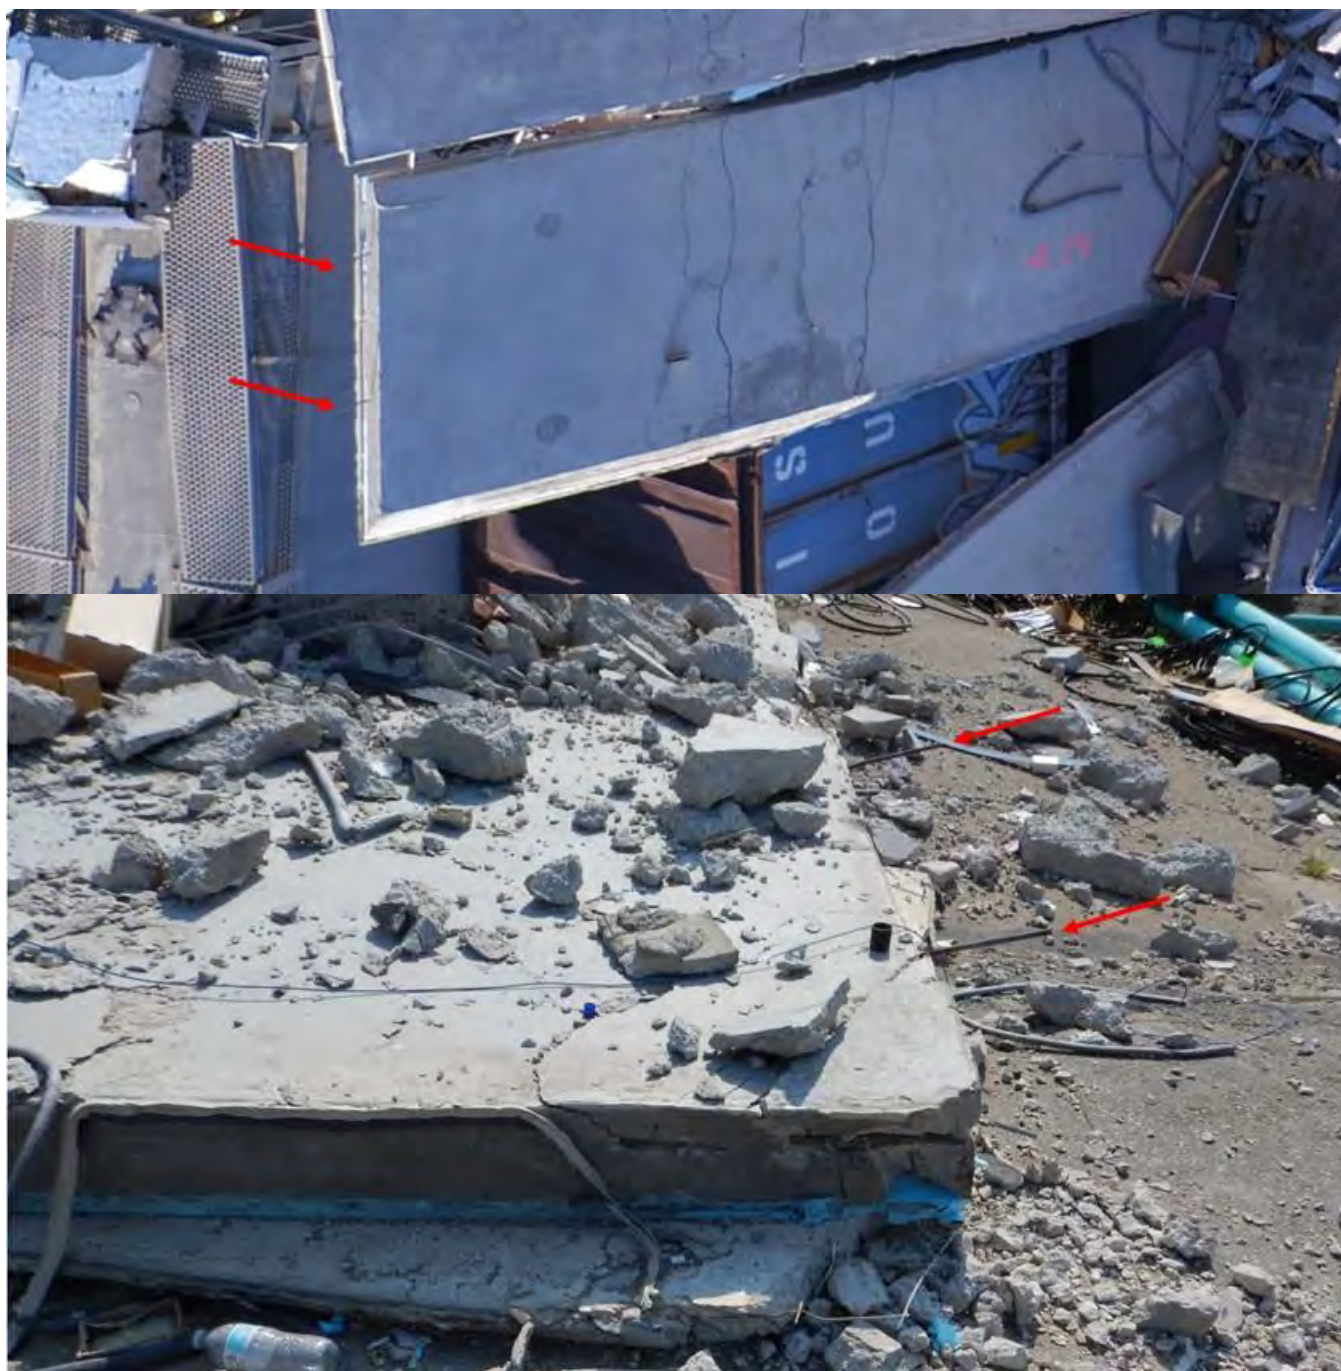
Figure 2-21. Multipurpose Building Load Bearing Wall Dowels into Hollow Core Planks

In a few photographs, as shown in Figure 2-21, small rebar dowels sticking out of the top of the exposed concrete walls can be seen. These bars were likely used to tie the wall to the slabs for out-of-plane wall loads. The bars appear to be #3 or #4 bars at approximately 4 ft. on center (which matches the width of the hollow core slab panels). Therefore, it is concluded that each hollow core slab plank was connected to the walls by extending the rebar dowel through the slab into the top of the walls as shown in Spancrete typical detail H-6 in Figure 2-22. It is unclear whether any grout was placed around the dowel inside the hollow core slab cavity.

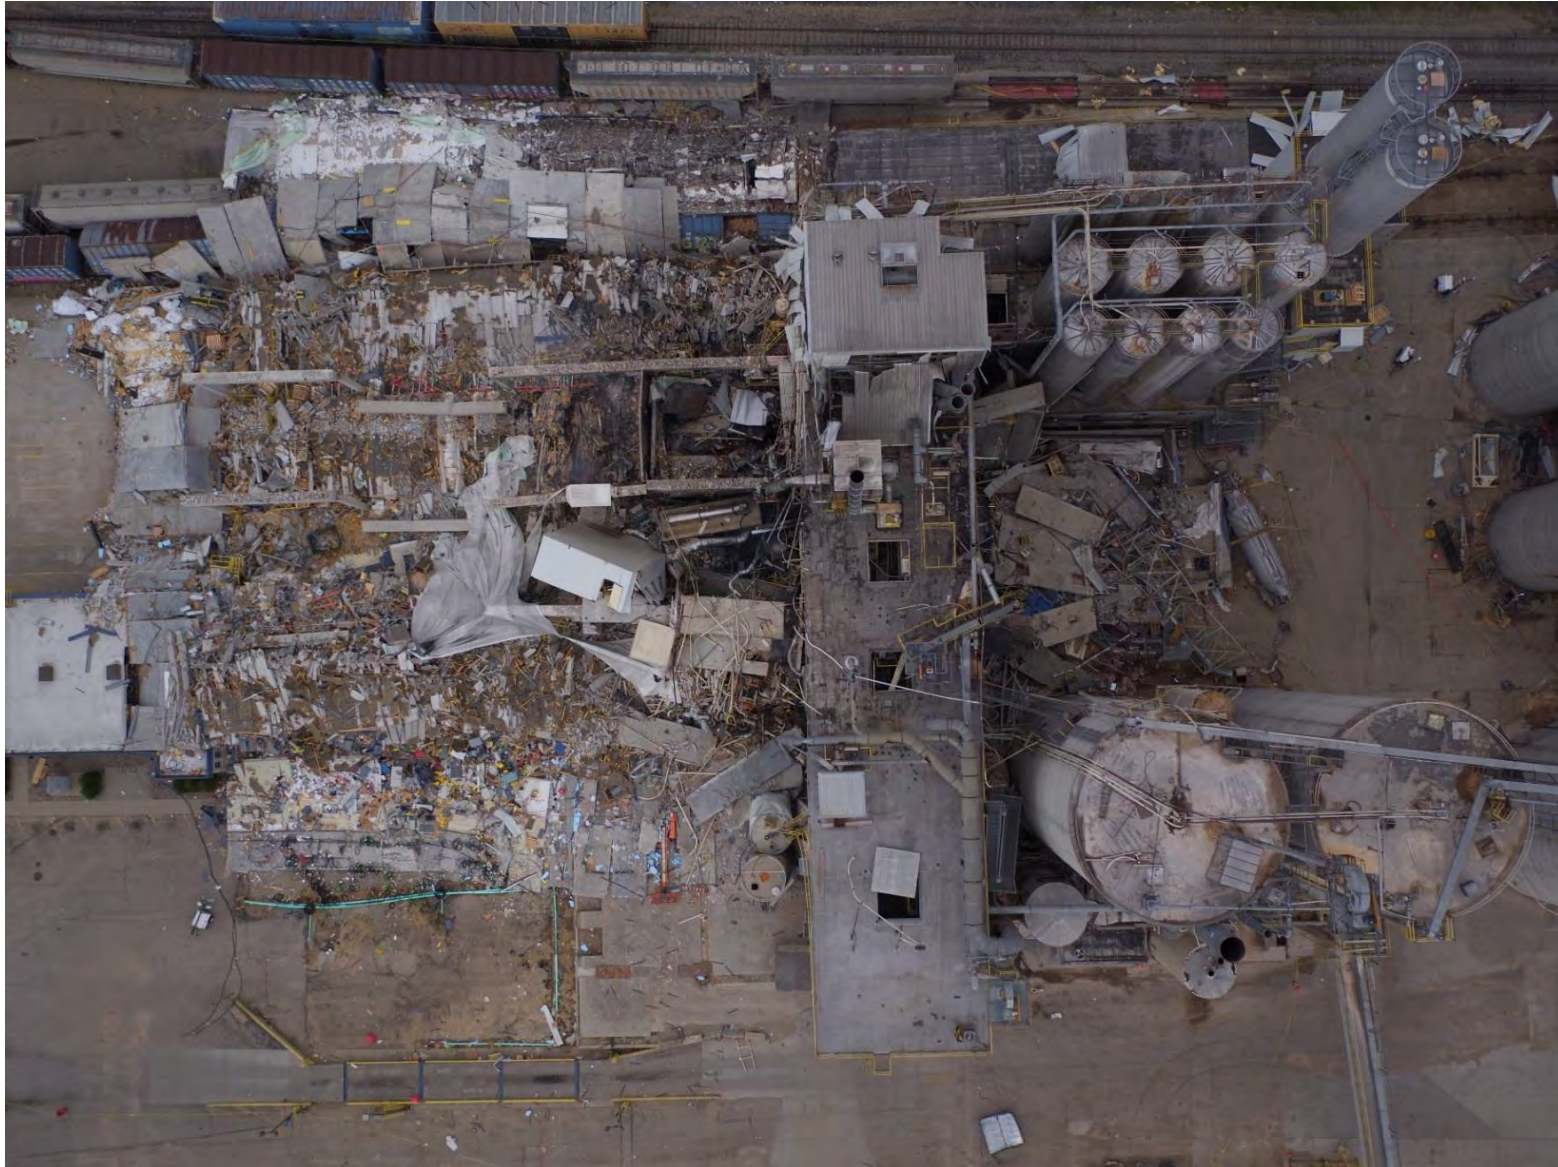
**Figure 3-1. Overhead Photo of Didion Milling Complex Collapse**

Propagation of the explosion resulted in the complete collapse of the overhead concrete roof of the Multipurpose Building, Mill F, and the Boiler Room. Precast walls of Mill B collapsed above the 3<sup>rd</sup> level and were failed at the south end of Mill B on both the west and east facades. Mill D precast panel connections failed and the wall panels were deflected at the 2<sup>nd</sup> level. Mill D was determined (by others) to be too unstable for entry and demolition of this mill was planned. An overhead view of the milling complex damage and collapse is shown in Figure 3-1. Damage to the west façade is shown in Figure 3-2, and the east façade in Figure 3-3.

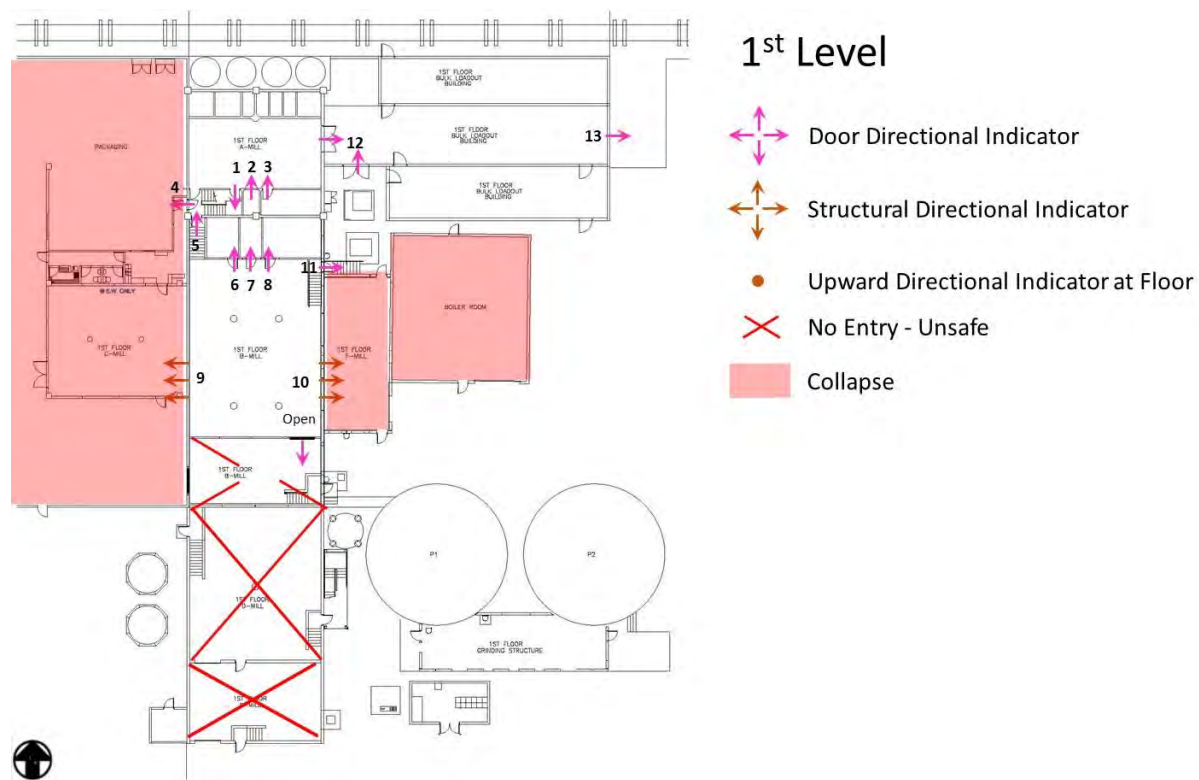
Figure 3-5. Level 1 of Mill A & B Directional Indicators

Directional indicators for the first level of Mill A and Mill B as well as the truck bulk loading are presented in Figure 3-5 and identified in Table 3-1 below. Exemplar indicators provided in Figure 3-6 indicate that overpressure which initiated in Level 1 of Mill B entered the vertical air shaft and exited the air shaft into Level 1 of Mill A. In addition, fire damage to the piping to the exterior of the Level 1 Mill B air shaft opening, highlighted in Figure 3-7, is consistent with a flame traveling from Mill B into the air shaft. The piping was also charred on the mill side of the pipe highlighted in Figure 3-7. The directional indicators are consistent with an explosion occurring in Level 1 of Mill B.

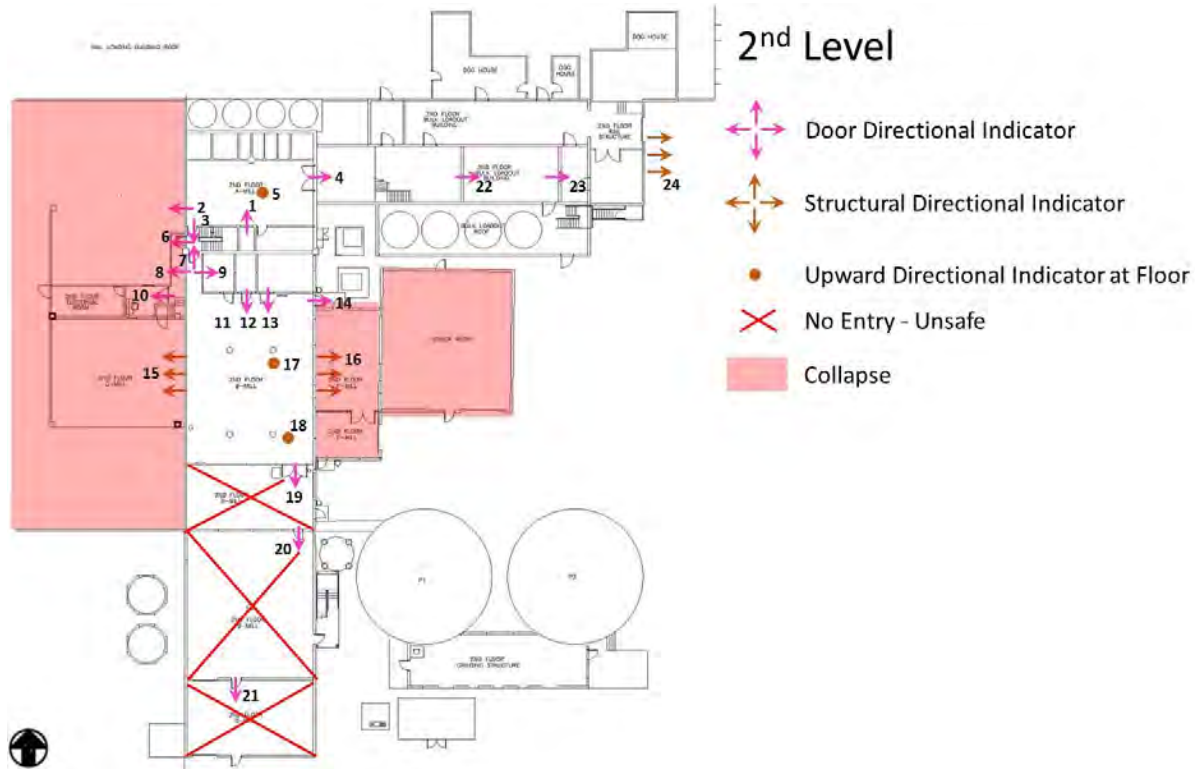
Figure 3-8. Level 2 of Mill A & B Directional Indicators

Directional indicators for the second level of Mill A and Mill B as well as the truck bulk loading are presented in Figure 3-8 and identified in Table 3-2 below. Exemplar indicators provided in Figure 3-9 indicate that overpressure entered Level 2 of Mill A and Mill B from the vertical air shaft. The door between Level 2 of Mill B and the stairwell is indicative of overpressure in Level 2 of Mill B. The air shaft on the Mill B side at Level 2 clearly indicates fire travelling vertically in the air shaft upward from the first to second levels as indicated by the fire damage to the underside of the horizontal piping which is shown in Figure 3-10. The air shaft opening at Level 2 of Mill A is shown in Figure 3-11 and the opening between the air shaft and Mill B is shown in Figure 3-12. Both air shaft openings clearly show indications of heat travelling from the air shaft into Mill A and Mill B at the second level of the mill. The directional indicators are consistent with an explosion propagating into Level 2 of Mill A and B from the vertical air shaft.

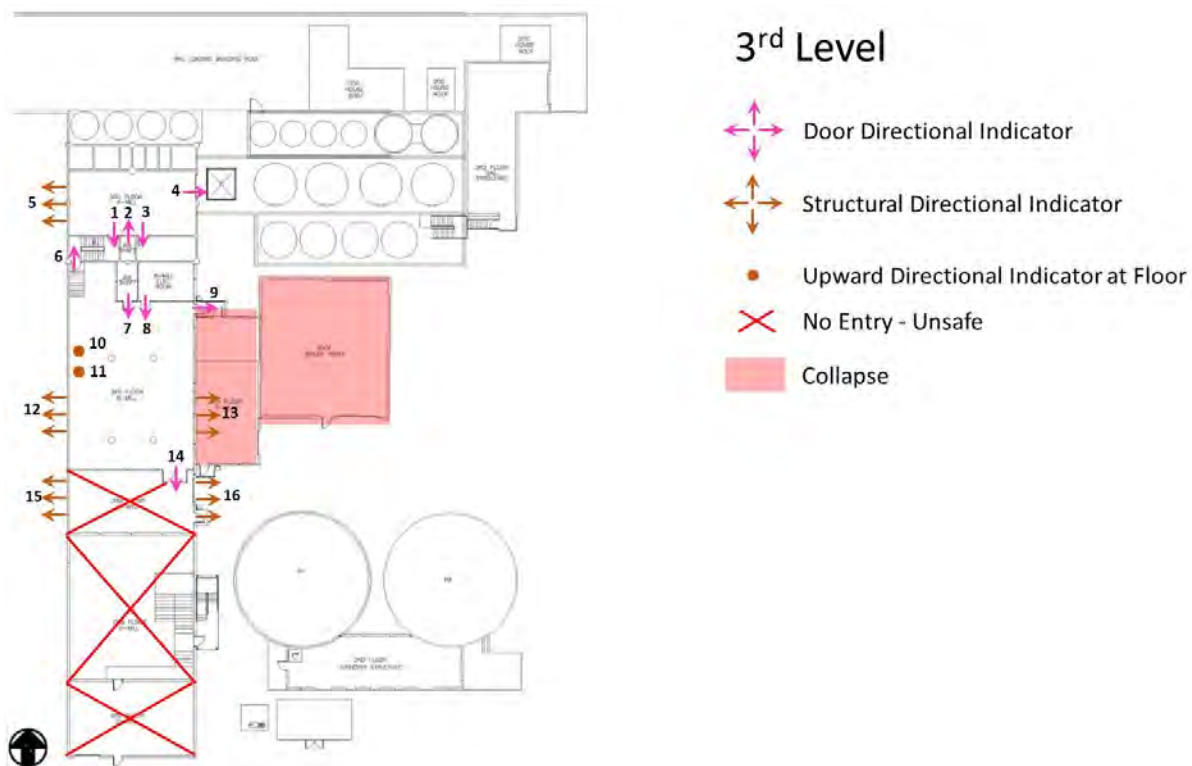
Figure 3-13. Level 3 of Mill A & B Directional Indicators

Directional indicators for the third level of Mill A and Mill B are presented in Figure 3-13 and identified in Table 3-3 below. Examples of the directional indicators are shown in Figure 3-14. Fire exiting the vertical air shaft into both Mill A and Mill B at the third level was indicated by melting of pipe coverings and scorching as shown in Figure 3-15 and Figure 3-16, respectively. These directional indicators are consistent with an explosion propagating into Level 3 of Mill A and Mill B from the vertical air shaft.

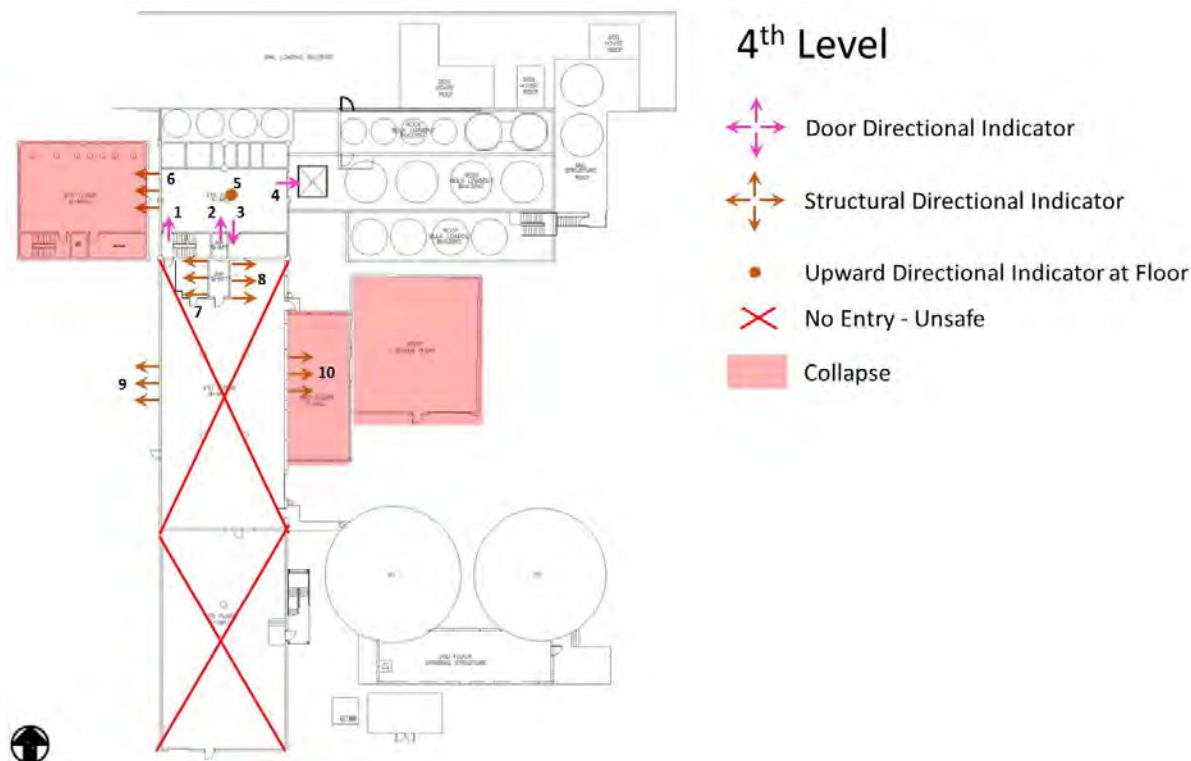
Figure 3-17. Level 4 of Mill A & B Directional Indicators

Level 4 of Mill B could not be accessed safely due to the collapsed side walls and unprotected fall hazards. Drone photos were reviewed in lieu of access. Directional indicators for the fourth level of Mill A and Mill B are presented in Figure 3-17 and identified in Table 3-4 below and examples are provided in Figure 3-18. The exemplar directional indicators show overpressure in the air shaft pushing out of the air shaft into Mill B and overpressure in Mill A that forced the west Wall of Mill A away from the slab. Fire exiting the air shaft into the fourth level of Mill A is evident as shown in Figure 3-19; however, the drone photographs of the fourth level Mill B opening, provided in Figure 3-20, were inconclusive for fire indicators due to the range from which the photographs were taken. The directional indicators are consistent with an explosion propagating into Level 4 of Mill A and Mill B from the vertical air shaft.

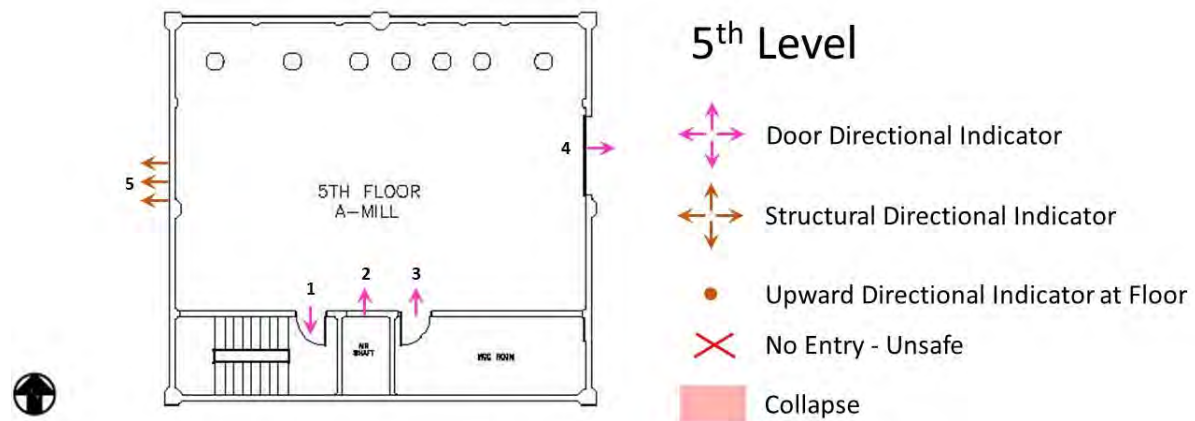
Figure 3-21. Level 5 of Mill A & B Directional Indicators

Directional indicators for the fifth level of Mill A are presented in Figure 3-21 and identified in Table 3-5 below. Examples of the observed directional indicators on level 5 of Mill A indicate overpressure proceeding from the vertical air shaft into Mill A as shown in Figure 3-23. The directional indicators are consistent with an explosion propagating into Level 5 of Mill A from the vertical air shaft.

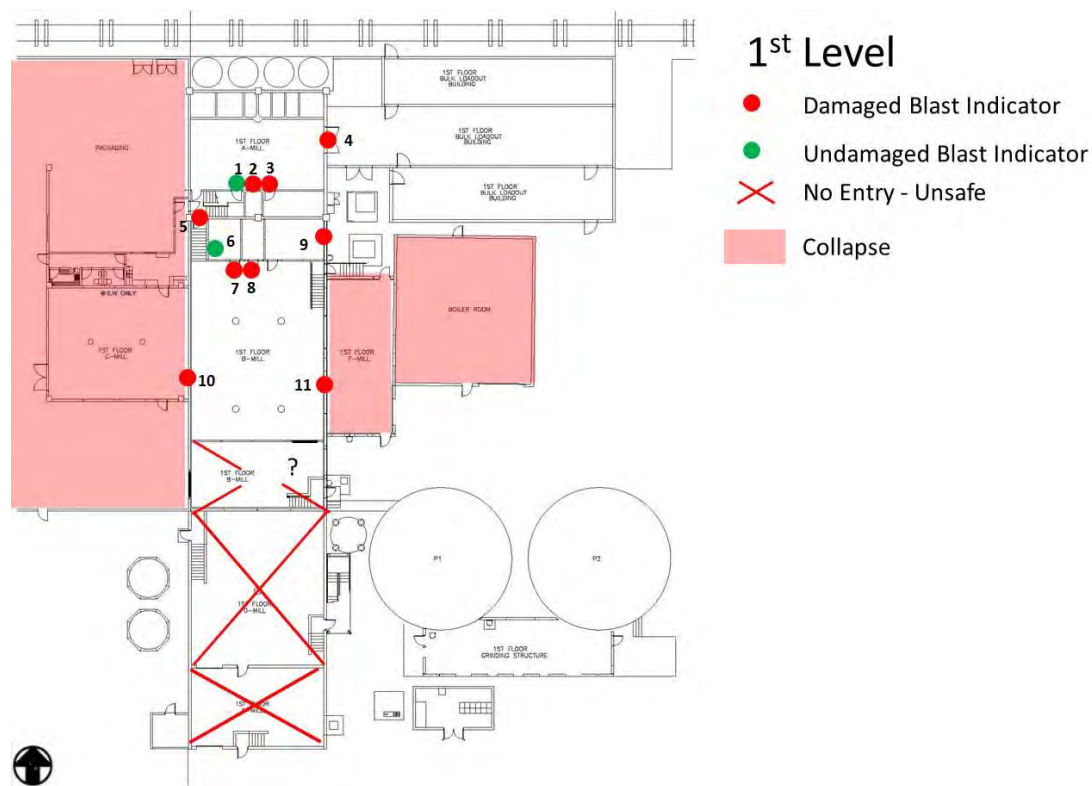
Figure 3-25. Level 1 of Mill A & B Blast Damage Indicators

Blast indicators for the first level of Mill A and Mill B are presented in Figure 3-25 and identified in Table 3-6 below. Examples of indicators provided in Figure 3-26 indicate that an explosion in Level 1 of Mill B was severe enough to cause significant damage to the stairwell door as well as the doors to the air shaft and electrical rooms. Overpressure in Level 1 of Mill B damaged the double door between Mill A and the bulk loading. In addition, a significant overpressure event occurred in the east electrical room attached to Mill A.

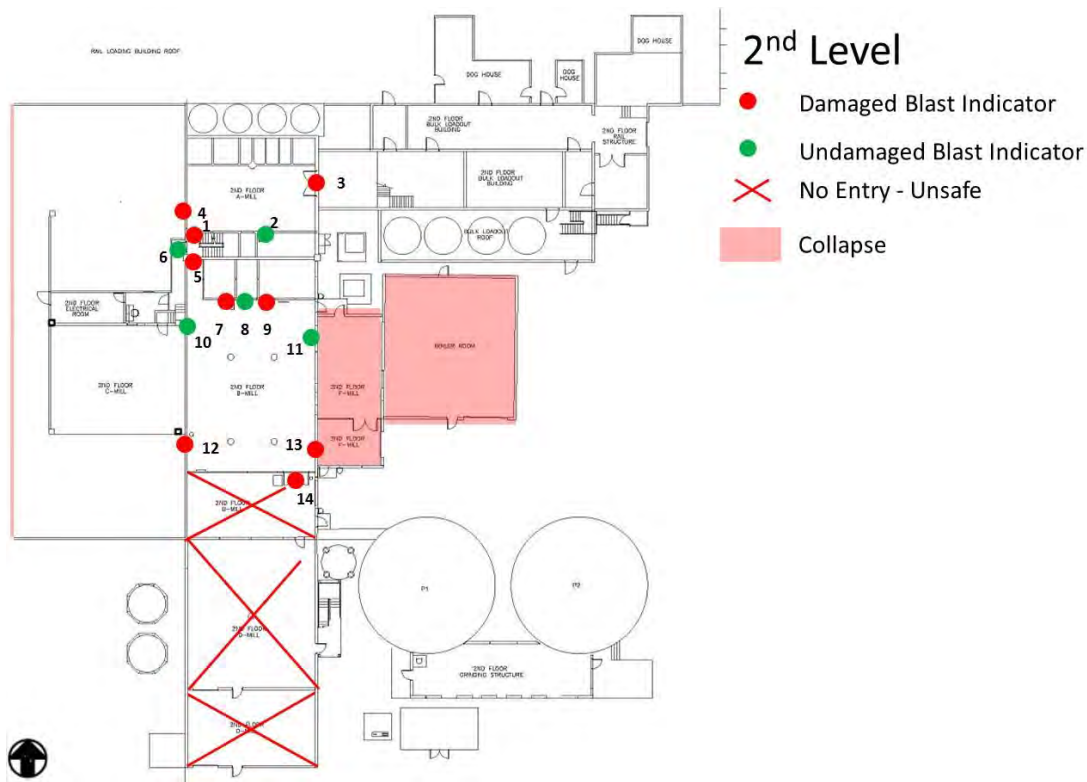
Figure 3-27. Level 2 of Mill A & B Blast Damage Indicators

Blast indicators for the second level of Mill A and B are presented in Figure 3-27 and identified in Table 3-7 below. Examples of indicators provided in Figure 3-28 indicate that overpressure in level two of Mill B was substantial enough to force the entry door through the frame into the stairwell but did not result in permanent deformation to the undamaged electrical boxes. In addition, the west precast wall of Mill B was separated from the 2<sup>nd</sup> level slab. Overpressure in Level 2 of Mill A unseated the entry door with sufficient energy for the door to strike the jamb at the stairway landing that led to the corridor and the control room. Not shown in Figure 3-28 is the roll up door on the west face of Mill A that was pushed through the tracks into the packaging area of the Multipurpose Building.

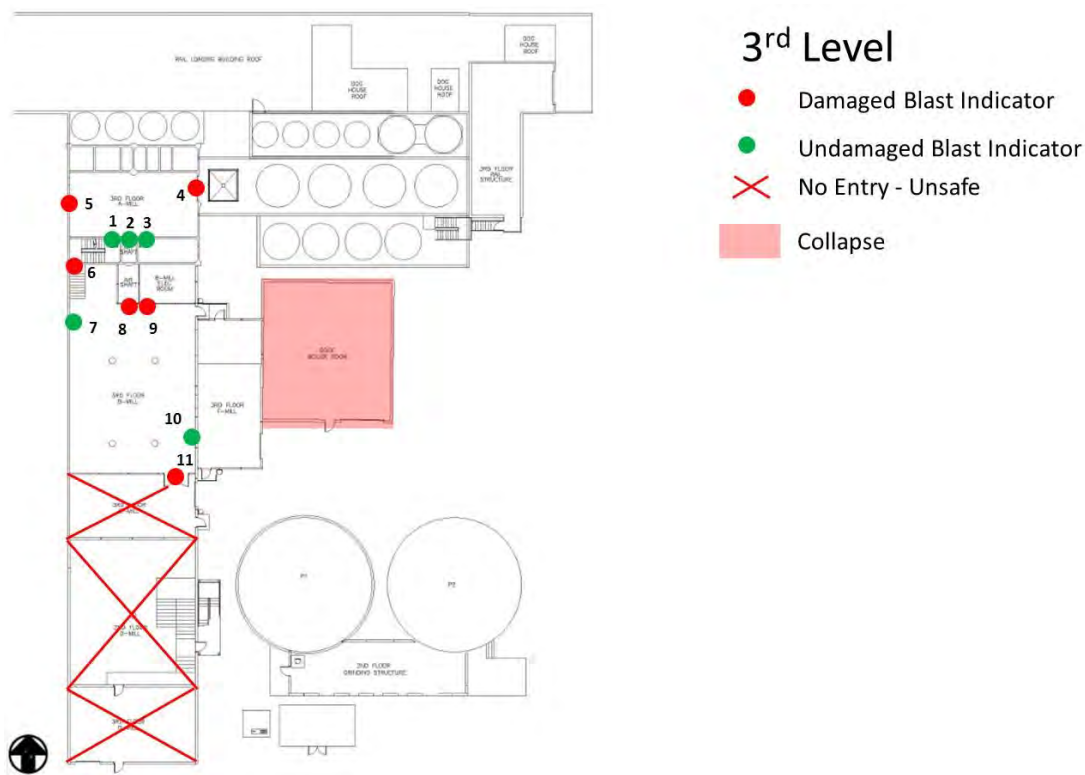
Figure 3-29. Level 3 of Mill A & B Blast Damage Indicators

Blast indicators for the third level of Mill A and Mill B are presented in Figure 3-29 and identified in Table 3-8 below. Exemplars of the directional indicators are shown in Figure 3-30. Overpressure in Mill B pushed the stairwell entry door through the frame with such force that the entry door separated from the hinges and came to rest on the landing between levels 3 and 2 of the stairwell. The electrical boxes in Mill B were undamaged by the overpressure. The overpressure in Mill A at the third level was sufficient to damage the third level west wall at the ceiling (4<sup>th</sup> level slab) and fail the double doors on the east face.

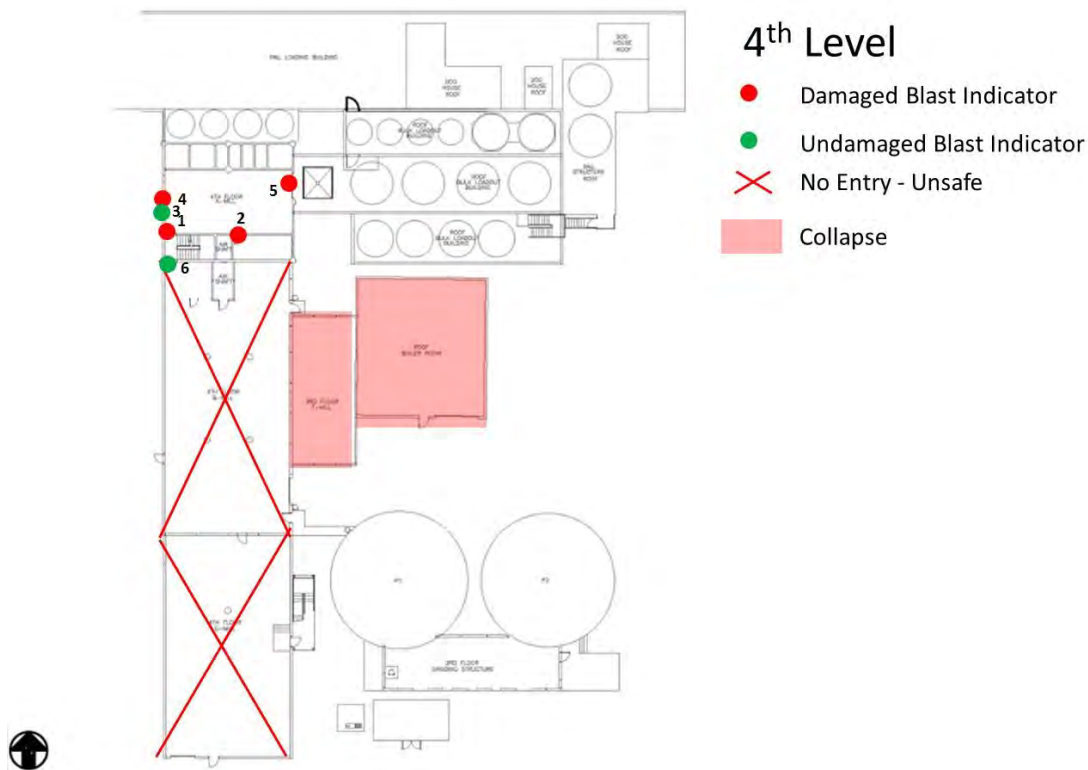
Figure 3-31. Level 4 of Mill A & B Blast Damage Indicators

Level 4 of Mill B could not be accessed safely due to the collapsed side walls and unprotected fall hazards. Drone photos were reviewed in lieu of access. Blast indicators for the fourth level of Mill A and Mill B are presented in Figure 3-31 and identified in Table 3-9 below and examples are provided in Figure 3-32. The exemplar blast indicators show that overpressure the 4<sup>th</sup> level of Mill B was insufficient to damage the stairwell entry door and only slightly damage the HVAC ducting above the mechanical rooms. Overpressure in Mill A at the 4<sup>th</sup> level separated the west concrete wall from the 4<sup>th</sup> level floor slab, pushed the electrical room double doors through the opening into the electrical room, but did not damage the electrical box on the west wall.

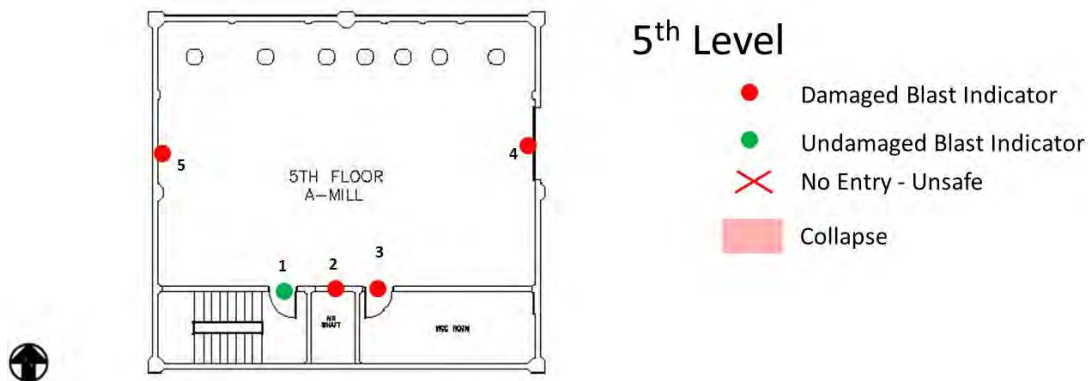
Figure 3-33. Level 5 of Mill A & B Blast Damage Indicators

Blast indicators for the fifth level of Mill A are presented in Figure 3-33 and identified in Table 3-10 below. Examples of the observed blast indicators on level 5 of Mill A again indicate overpressure separated the west wall from the Mill A slab, this time at the 5<sup>th</sup> level. The overpressure failed the east view windows and door as shown in Figure 3-34 and damaged the air shaft door between Mill A and the air shaft.

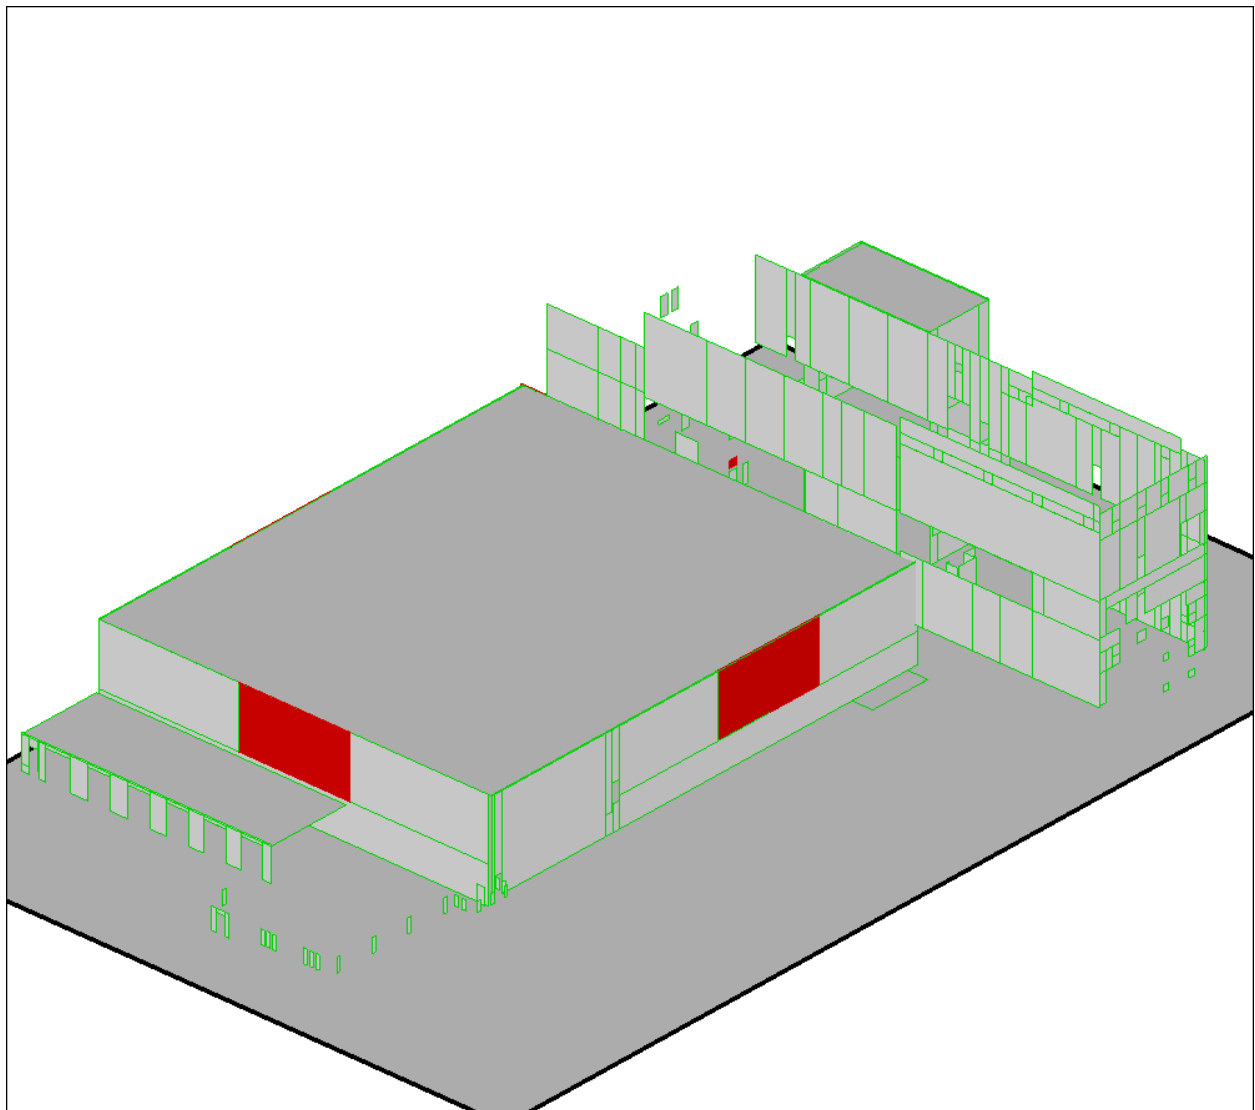
Figure 5-7. Vented Multipurpose Building Failure Patterns (in Red)

The minimum volume of a combustible dust cloud in the Multipurpose Building necessary to generate the onset of structural instability and failure was determined to be approximately 70 m<sup>3</sup> at a concentration of 500 gm/ m<sup>3</sup>. This equates to 35 kg, or roughly 80 lbs. of dust. The precast elements of the Multipurpose Building were not designed nor connected together in a manner to resist the internal pressure loading in a ductile manner.

Venting of the Multipurpose Building to protect the precast construction would have required approximately 20% of the wall surface area, or 250 m<sup>2</sup> of total vent area, on the north, south, and west walls to protect the precast construction. Proper engineering of vents in the Multipurpose Building in conjunction with additional continuity of the structure could have reduced or eliminated the structural failures.
