DuPont La Porte, Texas Chemical Facility Toxic Chemical Release

Interim Recommendations

Investigation: 2015-01-I-TX
Incident Date: November 15, 2014
Issue Date: September 30, 2015

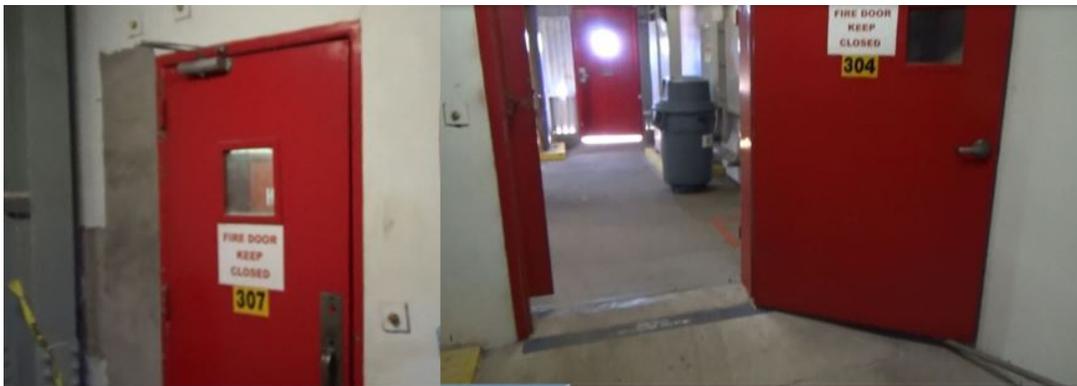
7. The main portion of the manufacturing building is separated on each floor by an internal wall. The east side of the wall is where liquids processing equipment is located and is referred to as the “wet end.” The west side of the wall is where liquids are removed via damp and dry processing equipment and is referred to as the “dry end.” The Vydate® product is a liquid, while the Lannate® products are powders.
8. Inside the manufacturing building, the internal wall that separates the east and west sides is equipped with fire doors that allow worker access between the wet and dry ends, as shown in Figure 3. By design, these doors are intended to be closed, but at times the doors were left propped open. In addition to adversely affecting the fire protection design, opening the doors provides a path for released chemicals on one side of the room to infiltrate to the other side.

Figure 3. Doors within the manufacturing building on the 3rd floor that separate the east (wet end) and west (dry end) sides. Although intended by design to remain closed, these doors were propped open at times, as shown in the photograph of door 304 on the right.

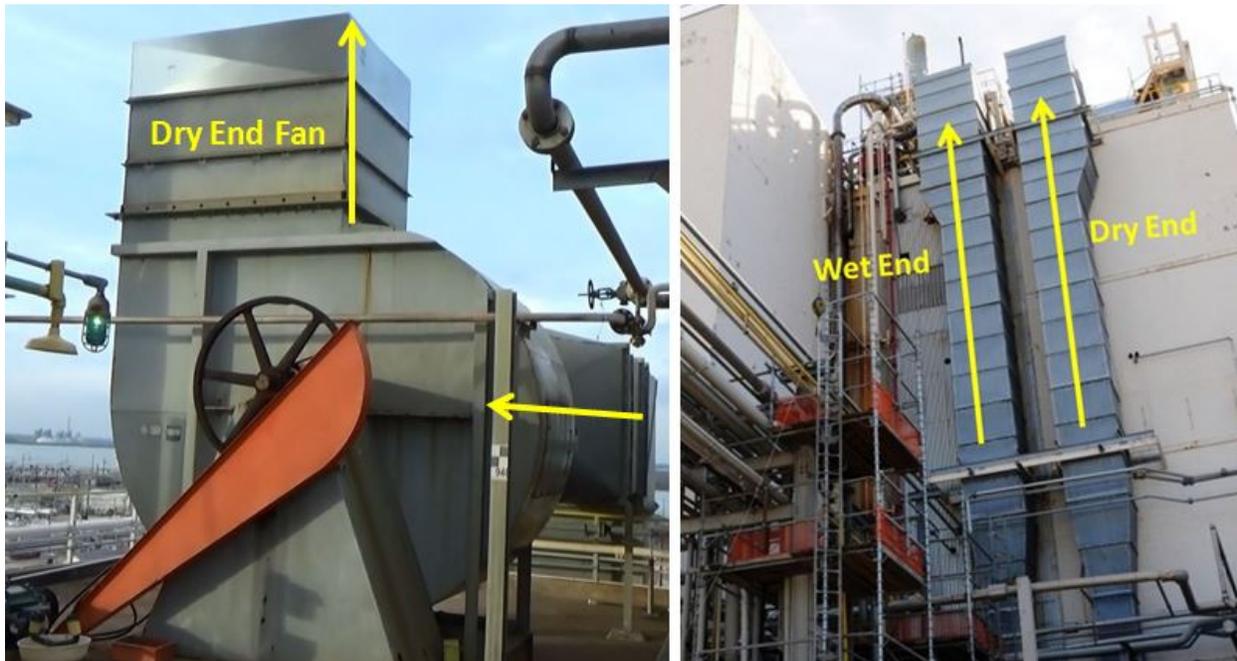
Figure 8. The dry end fan (left photo) and the exhaust air duct work (right photo). The exhaust air ducts from each floor are connected on the north side of the manufacturing building and air is pulled up through the fans and exhausted to atmosphere. Note – the dry end fan was not operational at the time this photo was taken.

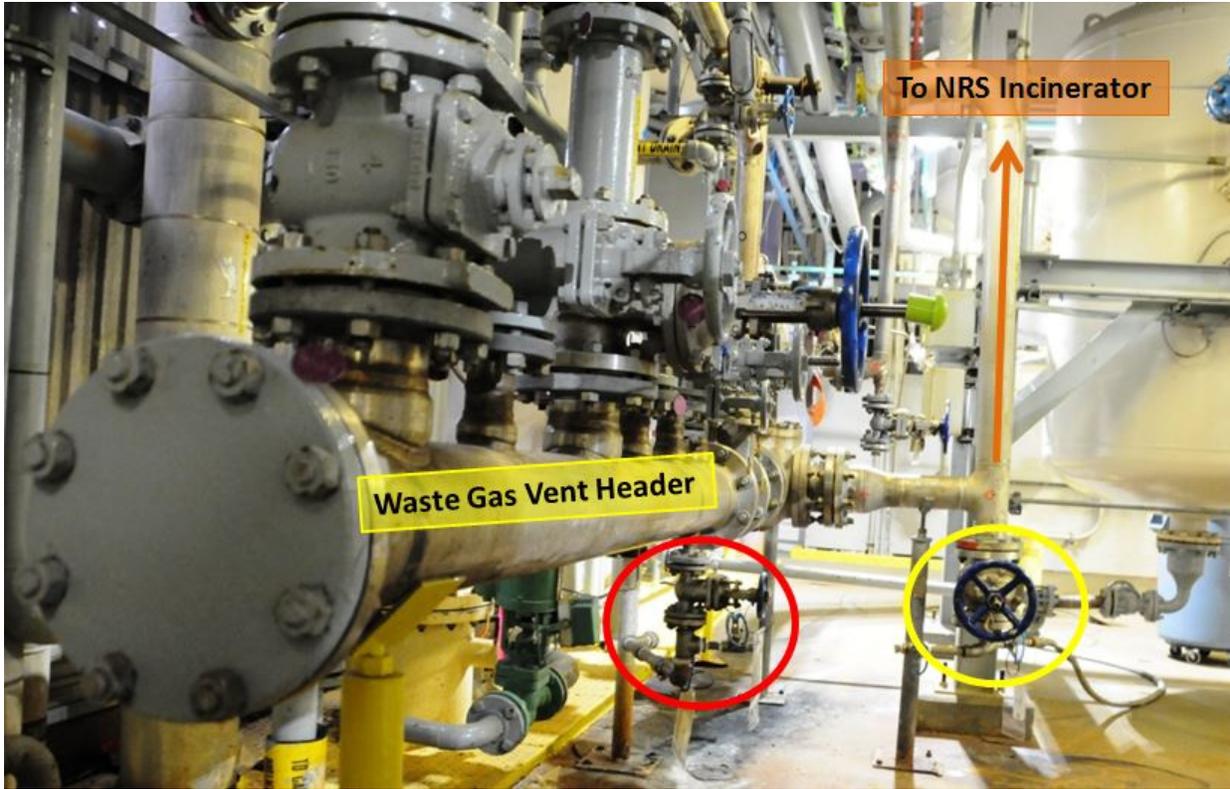
Figure 10. Waste gas vent header piping on the third floor of the manufacturing building. This portion, where several waste gas sources come together, is referred to as the waste gas vent header. Waste gas from this portion of the vent header travels up to reach the NRS Incinerator, a piping configuration that creates a low spot where liquid accumulates. To remove the liquid during waste gas vent header piping high pressure events, operators were instructed to open valves (yellow circle) and drain the system through a hose routed to a floor drain located near a safety shower. The floor drain is connected an open trench-type sump on the first floor. At the time of the incident, a second set of drain valves (red circle) were also opened directly to the floor inside the manufacturing building. This photo was taken while facing south. See Figure 11 for a view of the equipment while facing north.

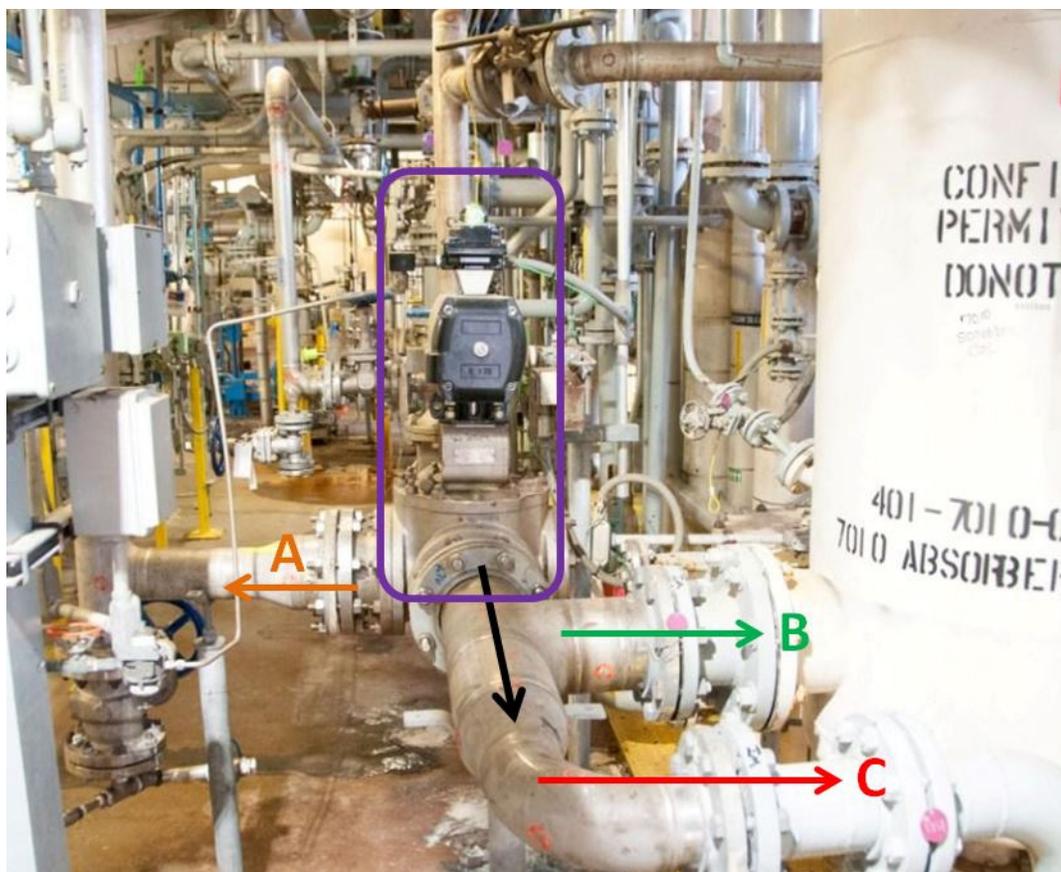
Figure 11. Waste gas vent header piping on the 3rd floor of the manufacturing building. This photograph was taken while facing north. Figure 10 shows the same waste gas vent header piping but taken while facing south. A 3-way valve (purple) is controlled to send the waste gas to either the NRS incinerator labeled “A” (orange) or a caustic scrubber labeled “B” (green). The caustic scrubber is designed with a vapor equalization line labeled “C” (red) that connects to the vapor space of the caustic receiver on the floor below (2nd floor). Prior to the installation of the NRS Incinerator, the 3-way valve did not exist and liquid that might accumulate in the waste gas vent header piping could freely drain into the caustic scrubber system.

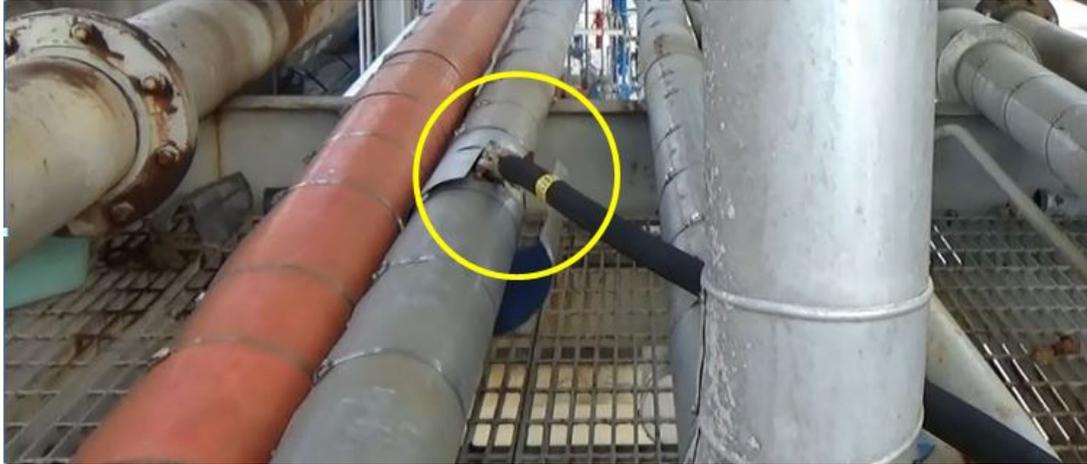
Figure 14. Hot water hose positioned on the liquid methyl mercaptan feed piping to flow hot water between the piping and the insulation in an effort to heat the piping and dissociate the solid hydrate that formed after water inadvertently entered the mercaptan storage tank.

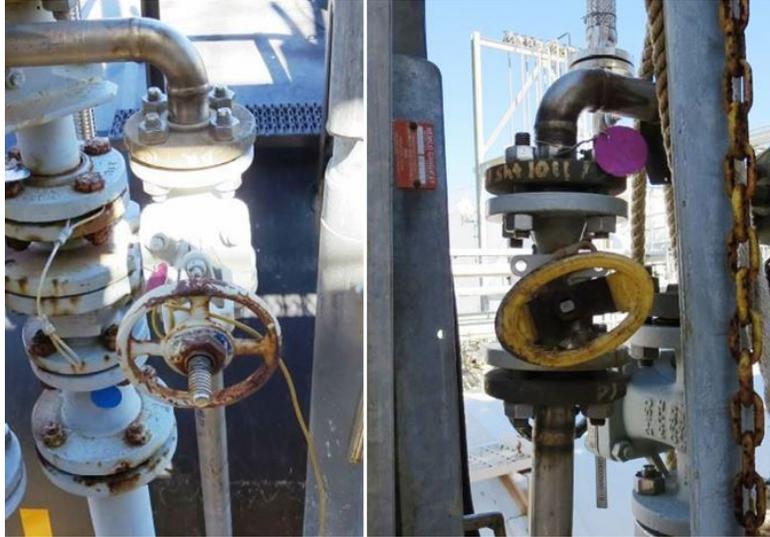
Figure 17. The fully open valve (left photo) and the cracked open valve (right photo) between the methyl mercaptan feed line and the waste gas vent header. These post-incident photos show the valve positions at the time of the incident.

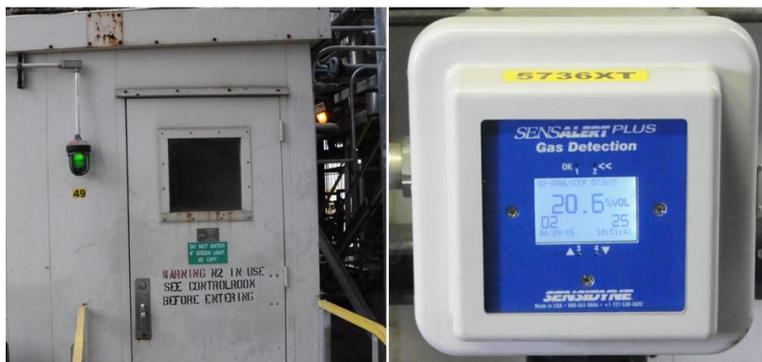
49. Analyzer houses in the MIC process area outside of the manufacturing building are equipped with oxygen analyzers and lights that warn potential entrants if the internal atmosphere is low in oxygen concentration and not safe to enter (Figure 23). However, the manufacturing building has no similar oxygen atmosphere monitoring or warning system despite having significantly larger inventories of hazardous chemicals and unventilated areas.

Figure 23. Unlike the manufacturing building this DuPont analyzer house shown in the left photo is equipped with safeguards to ensure entrant safety. The oxygen analyzer shown in the right photo is inside the analyzer house continuously monitoring the analyzer house atmosphere. If a nitrogen leak occurs inside the analyzer house sufficient enough to cause the atmosphere inside to approach dangerous levels, an alarm sounds and the green light outside the door turns off to indicate it is not safe to enter. The manufacturing building lacks similar safeguards. The CSB has not been able to determine why DuPont applied more rigorous safeguards to the infrequently entered analyzer house than for the normally occupied manufacturing building.

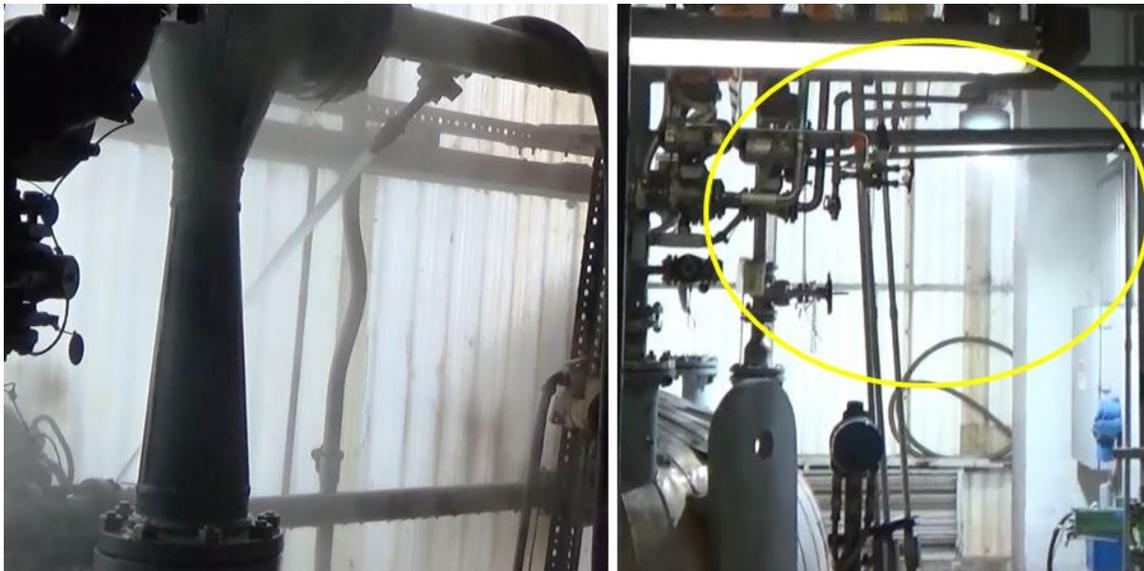
51. The ventilation design is adversely affected by the DuPont operational practice of leaving external doors to the manufacturing building open,⁷¹ resulting in short circuiting of designed air flow patterns. As shown in Figure 24, the ventilation system at times is not even able to remove water vapor from the manufacturing building. The ventilation system performance with higher molecular weight gases such as chlorine and methyl mercaptan would likely be worse as these higher molecular weight gases need more dilution air velocity⁷² to sweep them up from the floor and into the exhaust air duct along the ceiling.

Figure 24. Ineffective ventilation on the second floor of the manufacturing building. These photos document an operational activity taking place on January 9, 2015. Operations had directed a hot water hose on a flow meter on the north east side of the second floor as seen in the photo on the left. The photo on the right shows the steam nearly motionless (yellow circle) on the south east side of the building also on the second floor. Although the wet end fan was running at the time, an open door (Figure 25) provided a less restrictive path for air to enter the building and thus very little dilution air ventilation was taking place to sweep potentially hazardous gases out of the south east corner of the room. Note – these photos are snippets from a video recording. The video recording does a much better job of demonstrating the poor ventilation within the yellow circle.

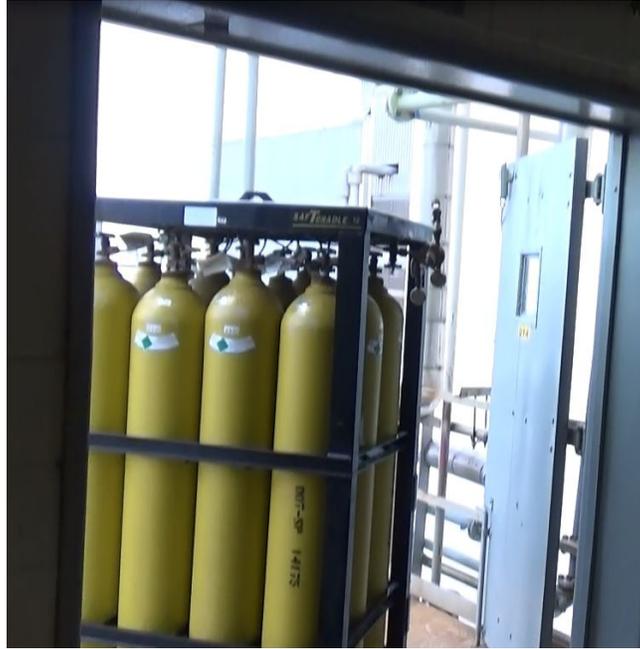
Figure 25. Photo of the open door on the south side of the second floor adversely impacting the dilution air ventilation flow across process equipment described in Figure 24.

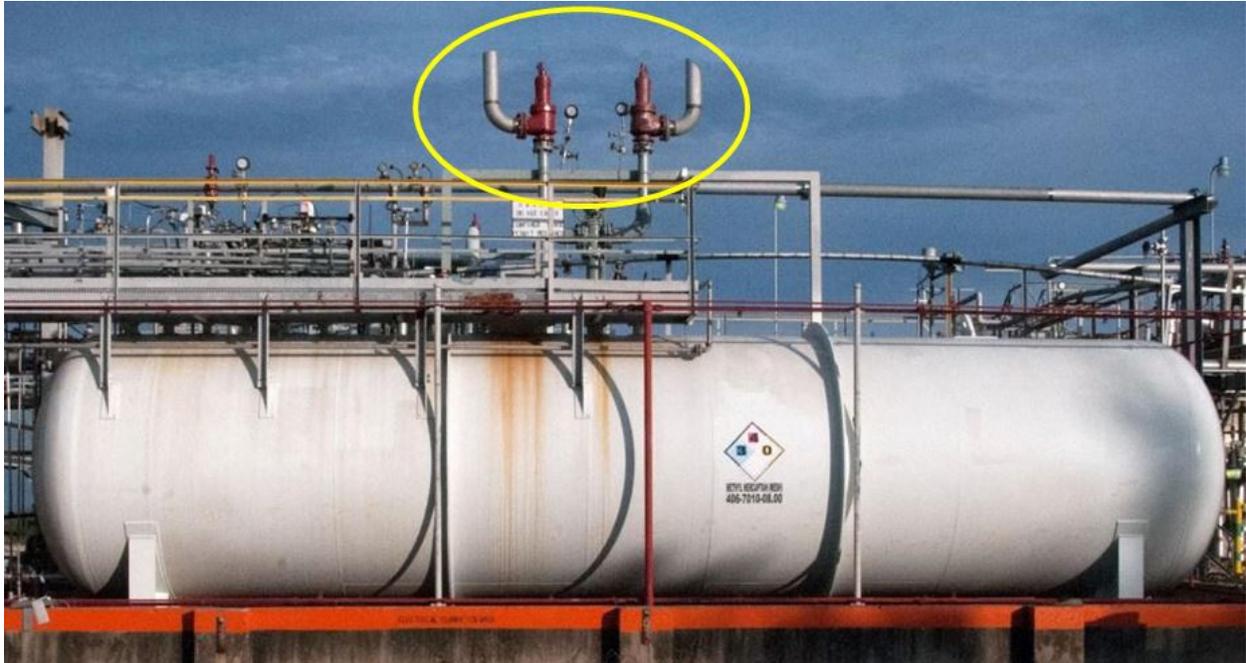
⁸⁷ A 2005 document indicates that the insulation installed on the methyl mercaptan storage tank in 2002 resulted in corrosion to the methyl mercaptan storage tank and further implied that the insulation would be repaired. There was no indication that simply removing the insulation was an option.

Figure 26. Methyl mercaptan storage tank showing atmospheric relief valves (yellow circle). At present, the storage tank is not insulated and there does not appear to be any mitigation to prevent off-site ERPG-3 concentrations as required by American Petroleum Institute and DuPont standards.

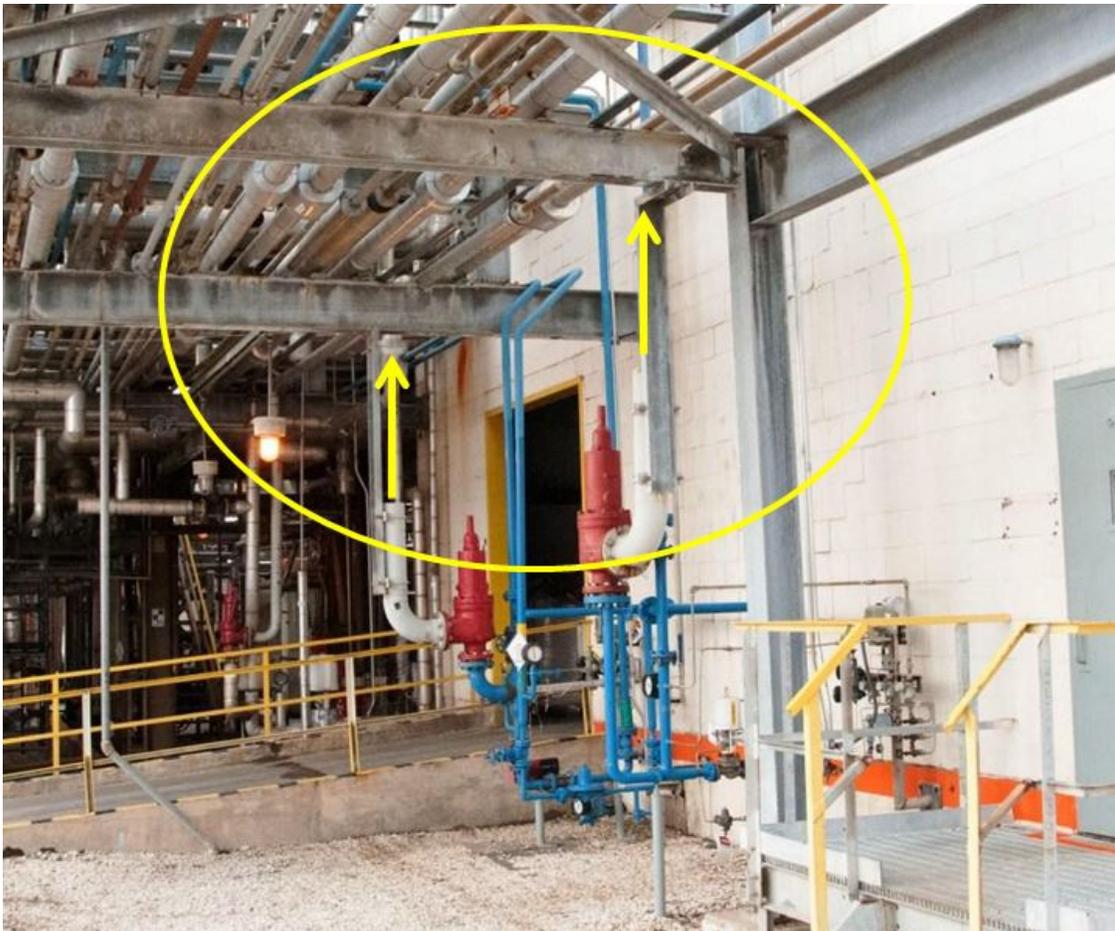
Figure 27. Nitrogen relief valves near south entrance of the manufacturing building. Dispersion from these atmospheric nitrogen relief valves is obstructed by an overhead pipe rack. This obstruction could result in a dangerous atmosphere to workers as they enter or exit from the manufacturing building.

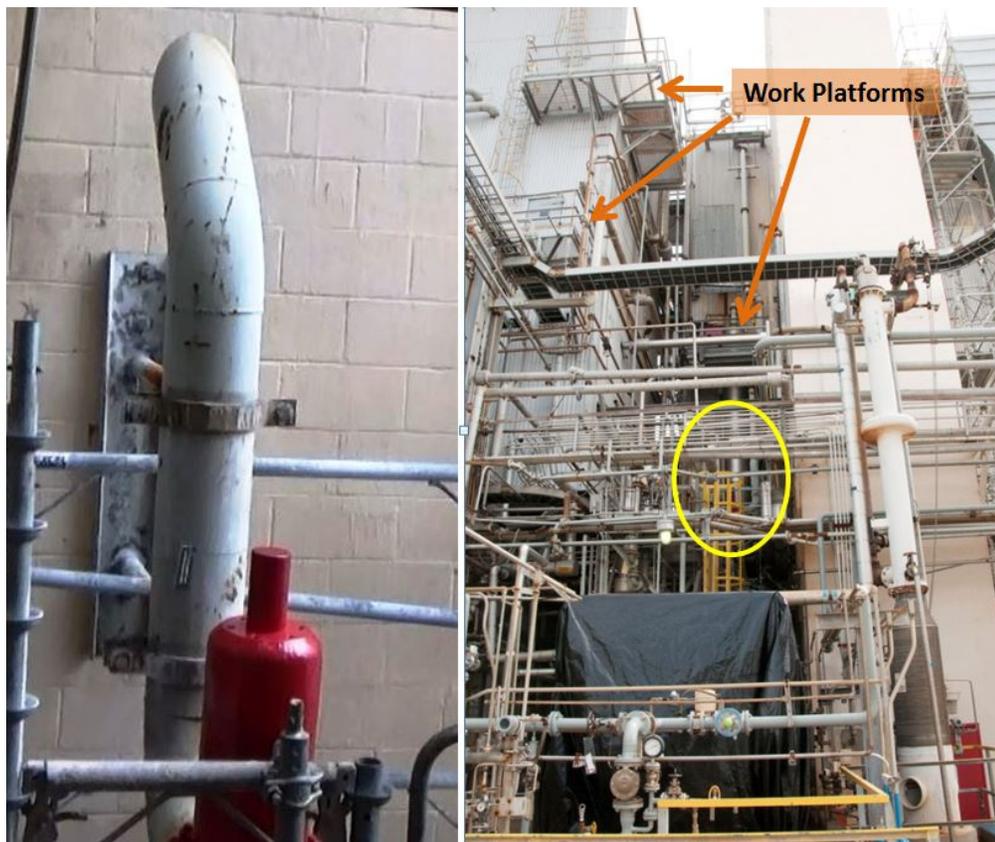
64. On December 16, 2014, highly toxic chlorine was released from a caustic scrubber relief valve (Figure 28 left photo) during an operation to vent and disconnect a chlorine railcar from the process. DuPont documentation indicates that the relief valve discharge piping is 10 feet above the work platform. This 10-foot value is used to help ensure relief valves discharge to a safe location.⁸⁸ However, an evaluation of the relief valve in the field indicates that while this 10-foot vertical safety margin exists for the immediate work platform, there are several other adjacent work platforms above the relief valve discharge piping as shown in Figure 28 (right photo). As a result, these adjacent work platforms are not safe locations for workers because highly toxic gas could be discharged towards them. The design of the relief valve discharge location should be thoroughly evaluated for safety.

Figure 28. Caustic scrubber pressure relief device location. The photo on the left shows the relief valve within the yellow circle in the photo on the right. This caustic scrubber relief valve is located in a congested area on the north side of the manufacturing building. Although DuPont documentation indicates the discharge piping of this relief valve is 10 feet above the work platform, the analysis failed to consider the other work platforms above this relief valve that can clearly be seen (orange arrows) in the photo on the right. On December 16, 2014, this relief valve was the source of a highly toxic chlorine release when a DuPont operations activity vented chlorine to the caustic scrubber in order to disconnect and relocate a chlorine railcar.

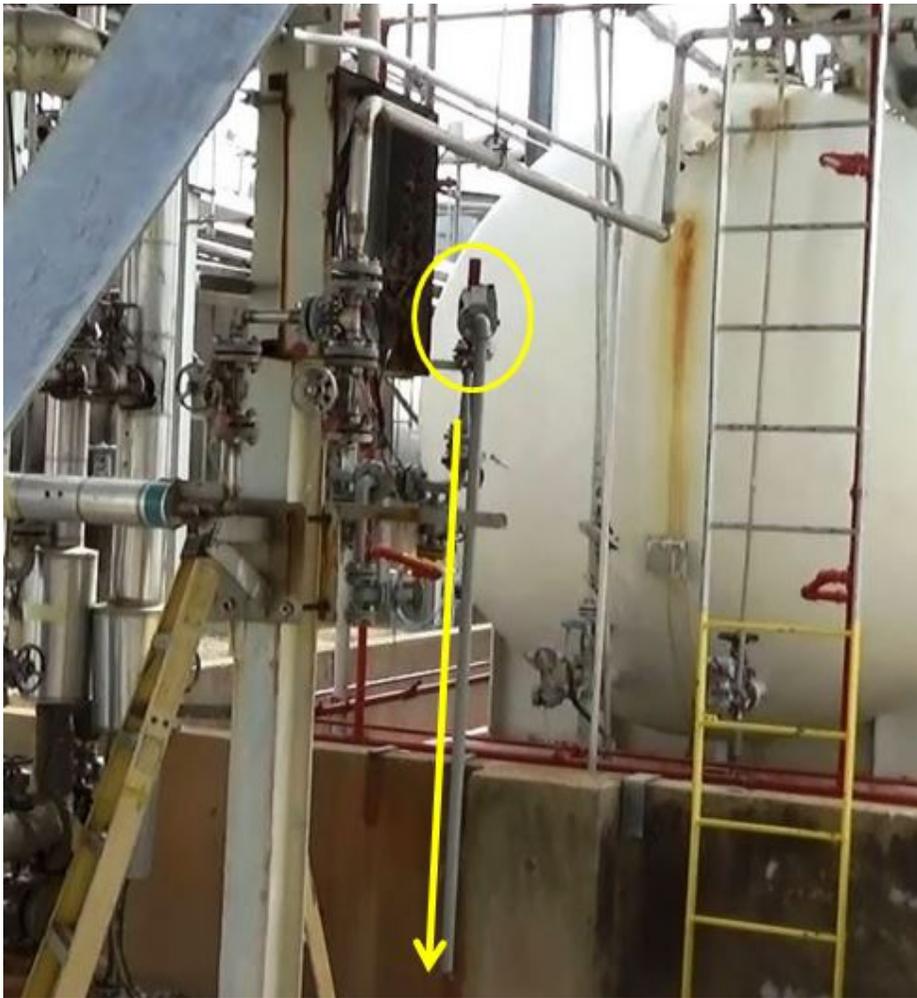
65. The methyl mercaptan pump that feeds the Lannate[®] process is equipped with relief valves designed such that they could discharge highly toxic, highly flammable liquid directly to the ground in the immediate vicinity of where an operator would be located when starting the pump (Figure 29). In the 1990s, DuPont eliminated a similar set of relief valves for the API process pump. Despite it being immediately adjacent and similarly designed, the Lannate[®] methyl mercaptan pump's relief valves remained. Furthermore, no PHA or engineering analysis has evaluated the Lannate[®] methyl mercaptan pump's relief valve discharge location to ensure worker safety.

Figure 29. Liquid methyl mercaptan relief valve on the discharge of the methyl mercaptan pumps is designed to discharge this highly toxic, highly flammable chemical to grade just north of the methyl mercaptan storage tank.

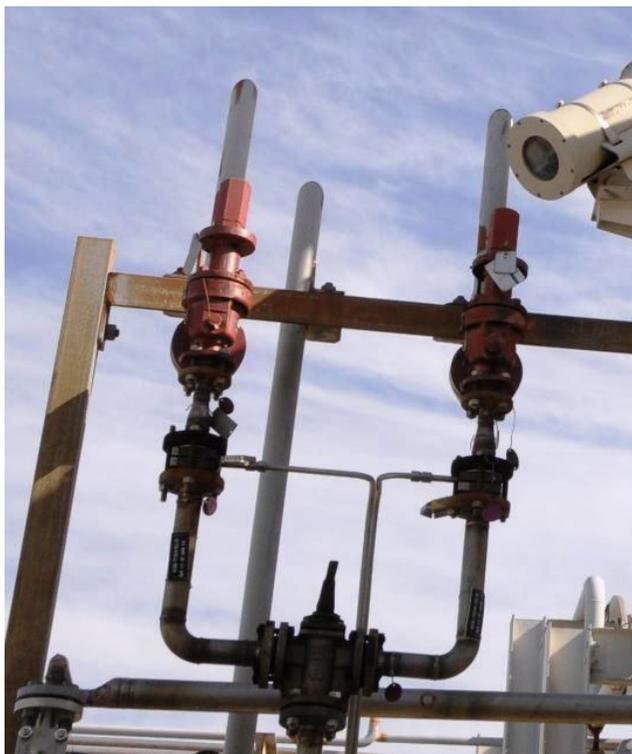
66. The design of the nitrogen relief valves at the railcar loading and unloading stations (Figure 30) did not consider a scenario where the relief valves could be lined up to the discharge of the methyl mercaptan pumps, as they were at the time of the incident. The methyl mercaptan pump discharge pressure (90 psig)⁸⁹ is higher than the set pressure (80 psig) of these nitrogen relief valves. Therefore, the methyl mercaptan pump will cause the relief valve to open and release the highly toxic and highly flammable chemical to the atmosphere. When tested post-incident, three of the four nitrogen rupture discs were ruptured and all four of the nitrogen relief valves leaked.⁹⁰ Because the rupture discs and relief valves would not hold pressure when tested, an atmospheric release of highly toxic and highly flammable liquid methyl mercaptan likely occurred during the incident through this relief system that was intended to release and disburse nitrogen vapor. This relief system is part of the 35% of systems that DuPont considers complete and in compliance with industry codes and standards. However, the alignment of block valves at the time of the incident revealed a highly toxic methyl mercaptan release scenario that DuPont's five-year relief system program never considered. Consequently, this program has not been fully effective.

Figure 30. This photograph shows the nitrogen relief valves at one of the two methyl mercaptan railcar unloading stations. The nitrogen relief systems for each of the two railcar unloading stations are nearly identical. DuPont PHAs and relief valve design documents never considered the possibility of the methyl mercaptan storage tank pumps being lined up to these relief valves – as it was at the time of the incident. As a result, liquid methyl mercaptan was discharged from a system designed for nitrogen vapor.
