U.S. Chemical Safety and Hazard Investigation Board

Fire During Hot Work at  
Evergreen Packaging Paper Mill

Canton, North Carolina

September 21, 2020

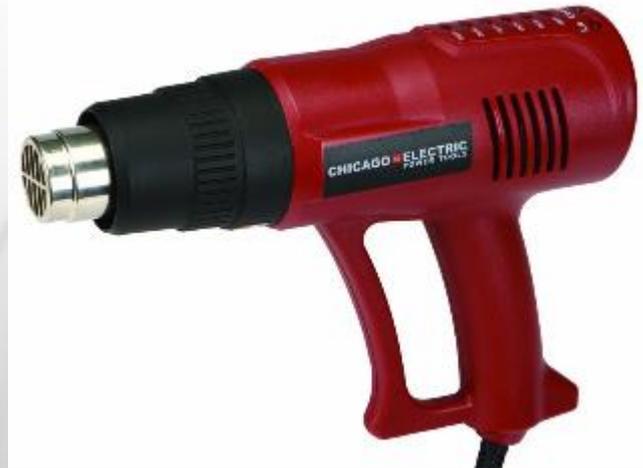
- Blastco workers attempted several methods of addressing the problem
- None were successful
- Two Blastco workers obtained an electric heat gun
- The workers used it inside the upflow tower to warm the resin
- This caused the resin to gel faster

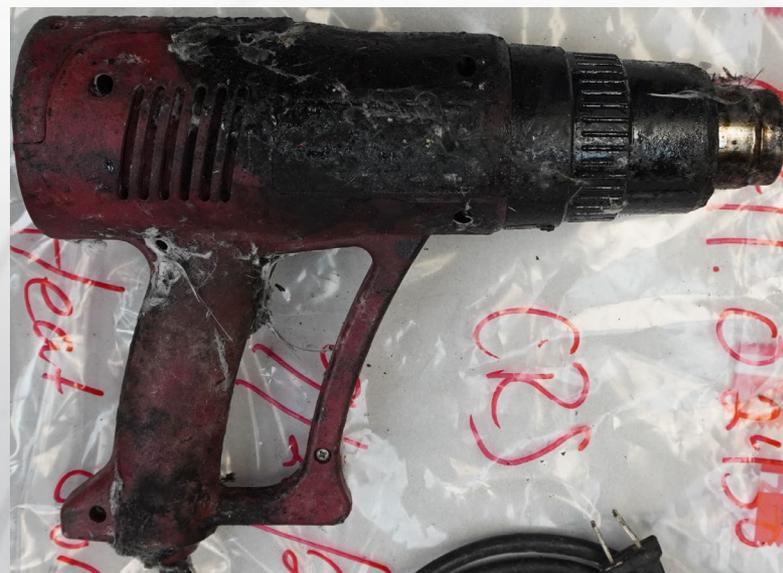
- Heat gun could produce temperatures in excess of resin flash point and autoignition temperatures
- Use of ignition sources in the presence of flammable liquids is a practice prohibited by OSHA
- Blastco did not warn Evergreen or Rimcor of its use of the heat gun in the presence of the resin

- Blastco did not recognize the ignition hazard presented by the heat gun
- Evergreen's internal policies and contractor orientation materials contained different definitions of hot work
- Staff proposes a recommendation each to Evergreen and Blastco

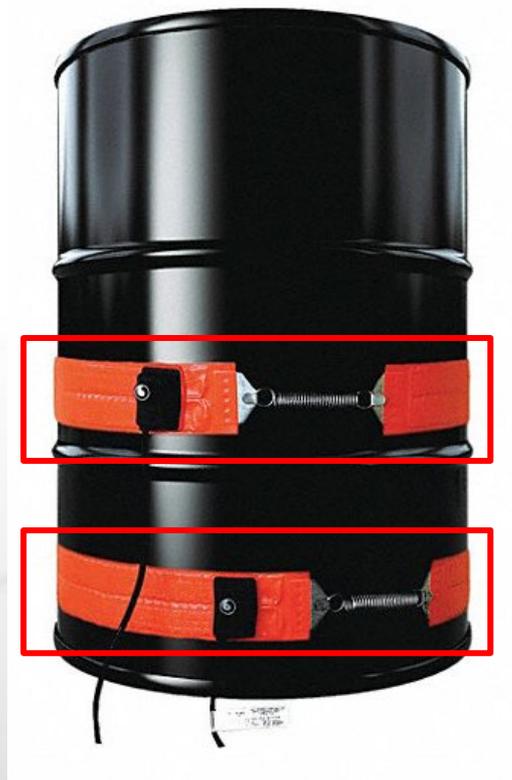
- Blastco had acceptable alternatives to using the heat gun to warm the resin inside the confined space
- When the Blastco workers obtained the heat gun, they first looked for drum heating bands but could not find them
- Temperatures during the day were in the mid-60s (degrees Fahrenheit)
- Blastco did not have standard operating procedures for addressing poor resin performance

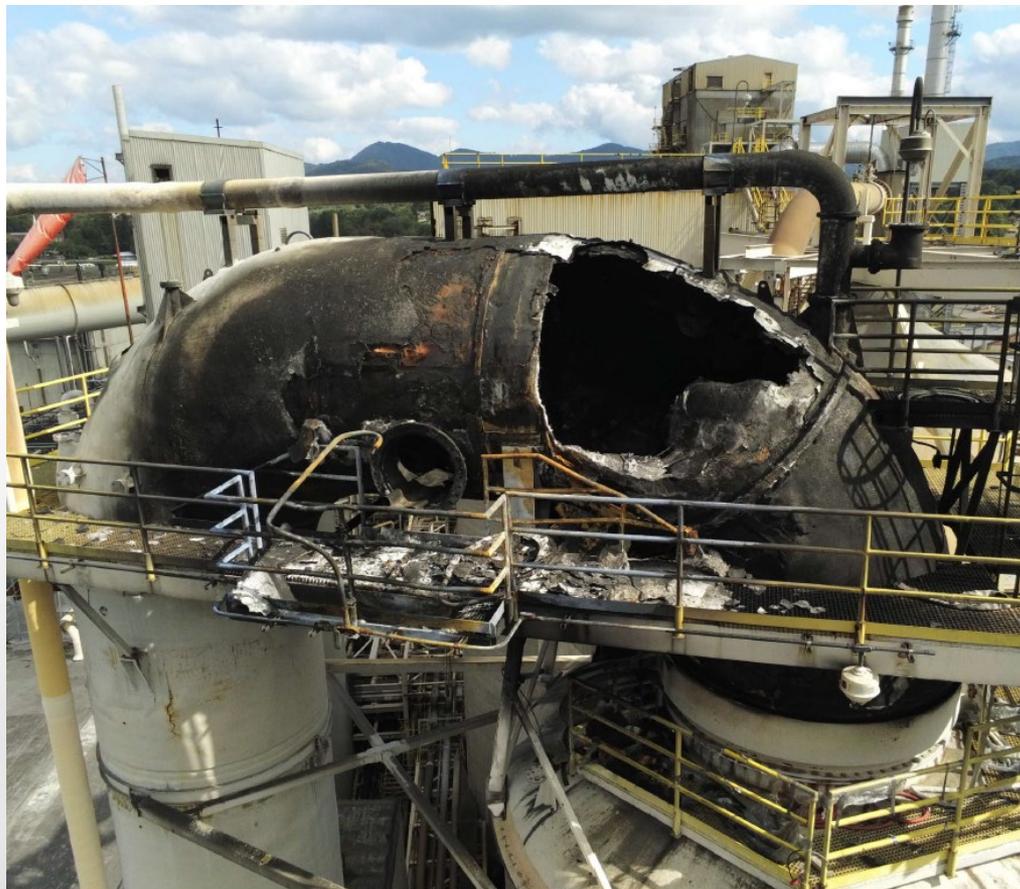
- FRP is combustible and will burn in the presence of a flame
- Upflow tower and crossover line constructed of FRP
- Evidence shows that inside surface of upflow tower burned
- This enabled the fire to rapidly spread to downflow tower
