U.S. Chemical Safety and Hazard Investigation Board

Carbide Industries, LLC, Louisville, KY Electric Arc Furnace Explosion

March 21, 2011
2 Killed, 2 Injured
No. 2011-05-I-KY

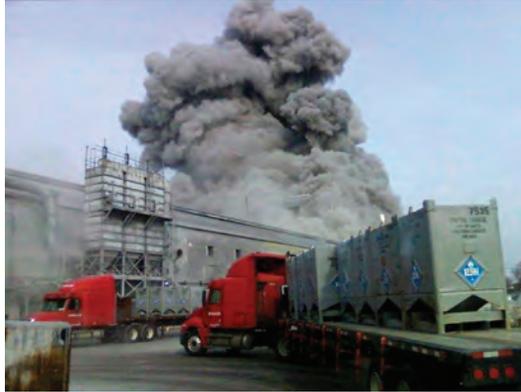
FIGURE 4 (LEFT)

At about 5:40 pm on Monday, March 21, 2011, the EAF at the Carbide Rubbertown facility violently overpressured, ejecting solid and powdered debris, hot gases, and molten calcium carbide at temperatures near 3800°F (2100°C). Witnesses reported an initial overpressure event from the furnace, a large explosion, and two to three more overpressure events. The cloud of debris and smoke traveled high enough to obscure the five-story furnace building (Figure 4).

Cloud of debris and smoke obscures the five-story furnace building (Photo courtesy Lake Dreamland FD)

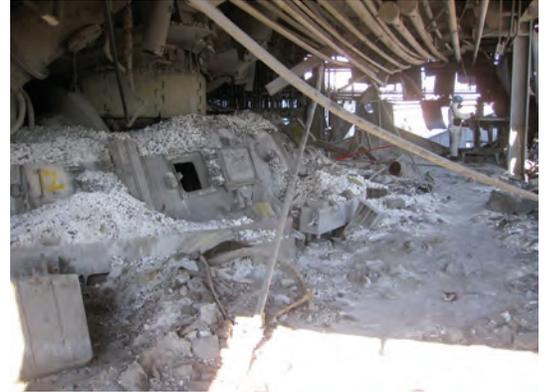
**FIGURE 5 (RIGHT)**

The hot gases and debris blown from the furnace broke through the double-pane reinforced glass window of the control room, severely burning the two workers inside; they died within 24 hours from their injuries.

Second floor of the EAF building after the explosion

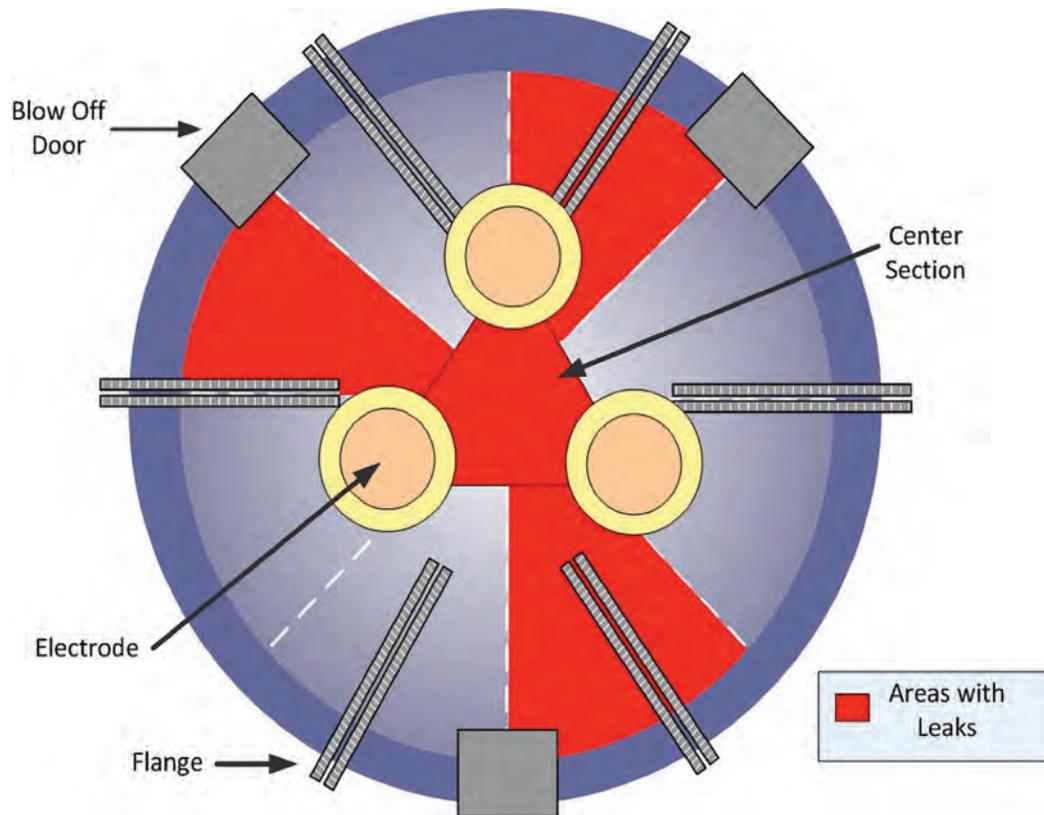
FIGURE 6

Diagram of the furnace cover showing areas of recent recurring water leaks

Examination of the underside of the furnace cover revealed that much of the refractory lining was worn and identified holes where cooling water had leaked into the furnace. Figure 6 is a diagram of the furnace cover showing recent recurring water leaks in water cooling zones.

Implement a mechanical integrity program for the electric arc furnace and cover, including preventive maintenance based on periodic inspections, and timely replacement of the furnace cover. At a minimum, the program should include factors such as leak detection and repair and refractory lining wear.

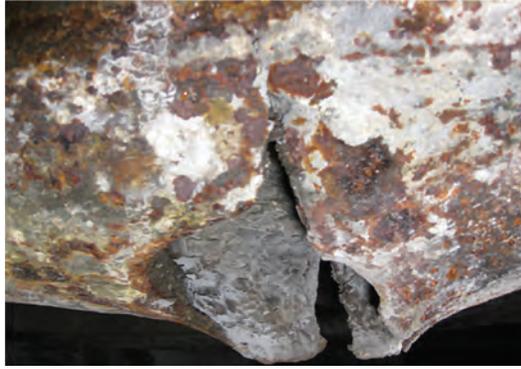
FIGURE 7 (LEFT)

The CSB considered several possible mechanisms that led to the tragic incident. Leaks begin due to thinning of the refractory lining, fouling,¹⁰ and the accumulation of solids inside the hollow chamber where water flows. Because the fouling insulates the metal on the underside of the furnace cover from the cooling water, the high temperature of the furnace softens the metal and the metal sags under its own weight (Figure 7). With continued exposure to the furnace temperatures, the sagging bulge cracks open, which led to the formation of a leak (Figures 7 and 8).

Crack in furnace cover formed due to fouling

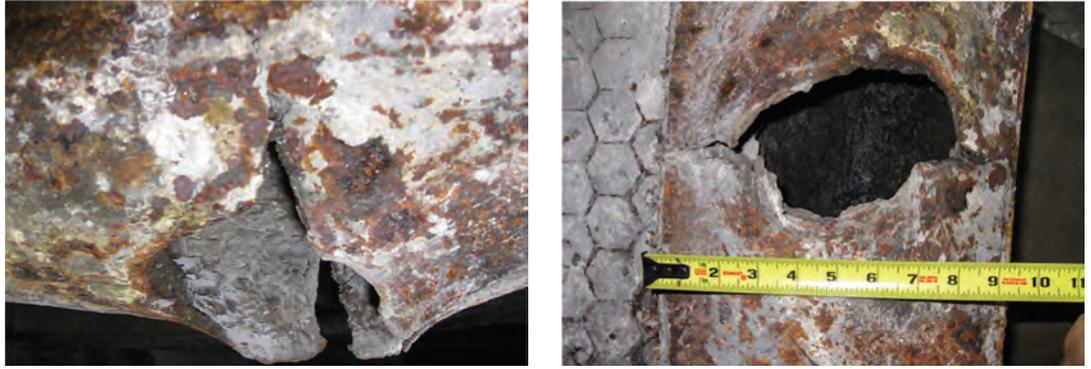
**FIGURE 8 (RIGHT)**

Cooling water leak in furnace cover with ceramic lining worn away

into the furnace, it leaves a lower layer of uncooled metal hanging beneath the now patched furnace cover. Maintenance records obtained by the CSB indicated 26 work orders to repair furnace cover water leaks in the four months prior to the March 2011 incident.
