U.S. CHEMICAL SAFETY AND HAZARD INVESTIGATION BOARD

INVESTIGATION REPORT

ALUMINUM DUST EXPLOSION

HAYES LEMMERZ INTERNATIONAL—HUNTINGTON, INC.

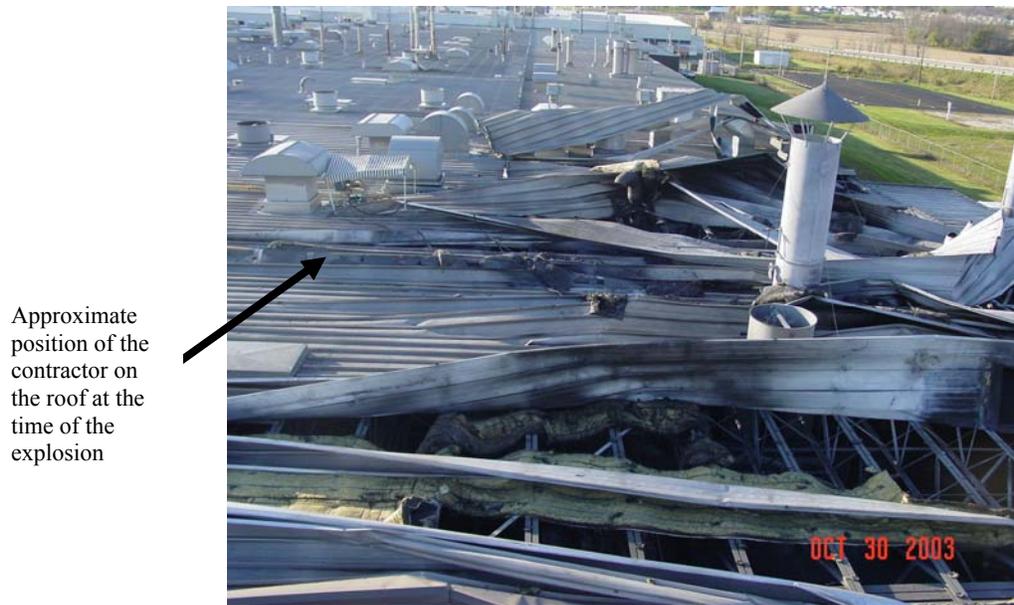
Figure 13. Damaged roof above furnace 5.

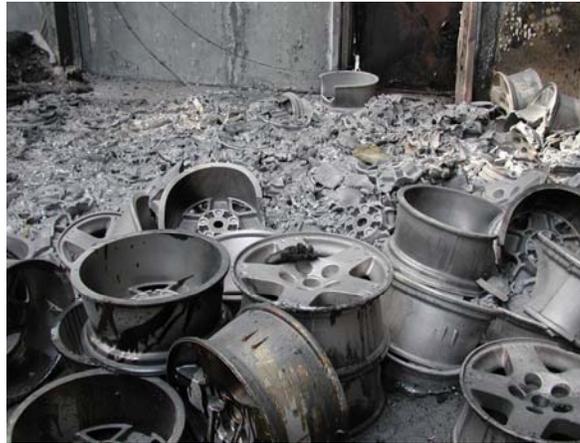
The fireball ignited roofing material and insulation, along with a small accumulation of combustible material stored behind the kiln dryer control panel. North-west of the furnace sidewall, plastic pallets containing rejected aluminum wheels waiting to be re-melted were also ignited, and some of those wheels eventually melted (Figure 14).

Figure 14. Melted wheels near furnace 5 after the fire.

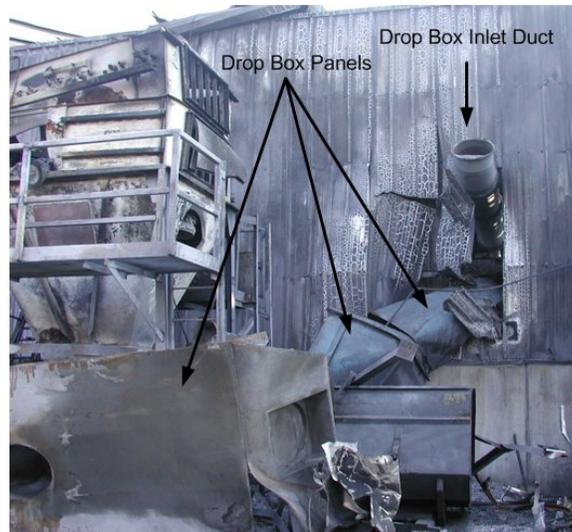
Figure 16. Dust collector (left) and drop box panels destroyed by aluminum dust explosion.

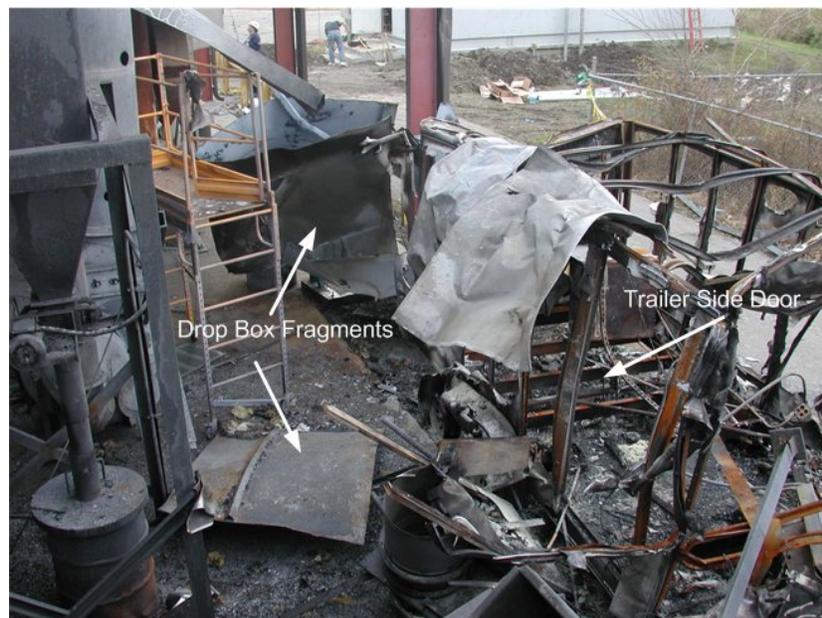
Outside the building, another stack emission-testing contractor was working in a mobile laboratory trailer parked near the drop box. He said he heard a “boom,” and was knocked down as the trailer lurched backward. The contractor looked out the trailer door to see the dust collector totally involved in a bright, hot fire. Something was lodged against the rear door of the trailer, making that exit impossible to use. He was forced to exit the side trailer door, which was closer to the fire than the rear door, but he also escaped serious injury.

Figure 17. Remains of stack testing contractor's trailer after fire.

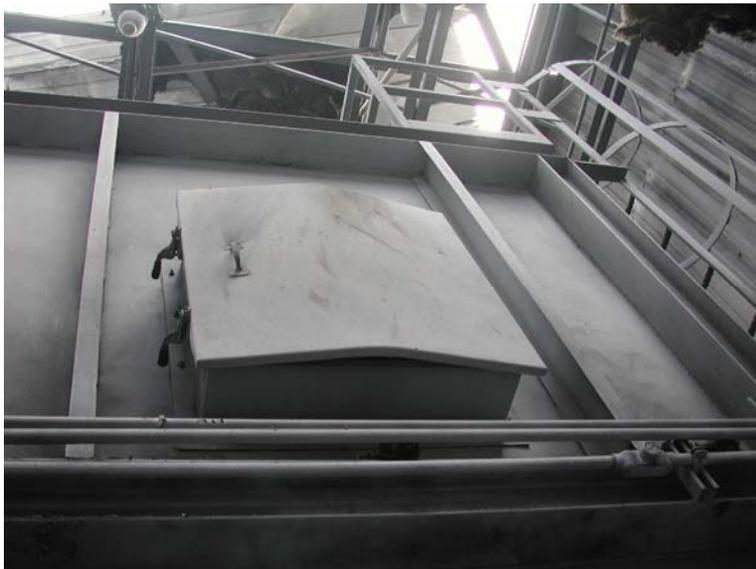
The fire damaged the chip system control console. Internal overpressure bulged the access doors on the side of the dry chip hopper and on the wet chip hopper inlet target box²¹ (Figure 18 and 19).

Figure 18. Bulged door on dry chip hopper.

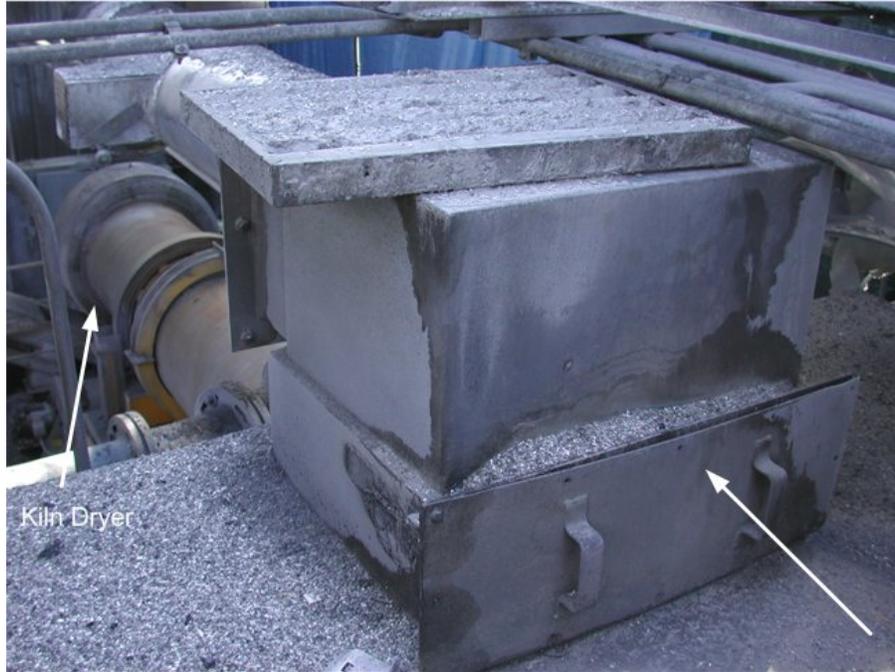
Figure 19. Wet chip hopper target box, with bulged access door (arrow).

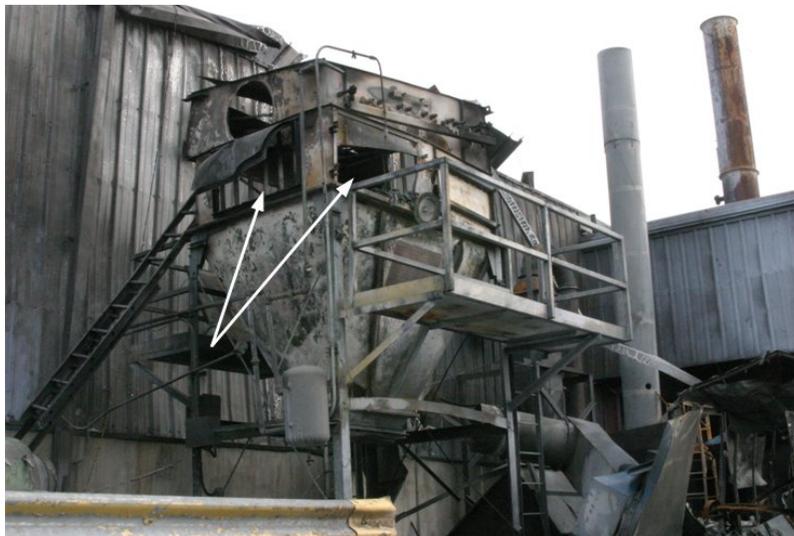
The explosion vent panels and maintenance doors (Figure 21) on the dust collector were blown out by the internal deflagration.

Figure 21. Explosion vent panel and maintenance door (arrows) blown out on dust collector.

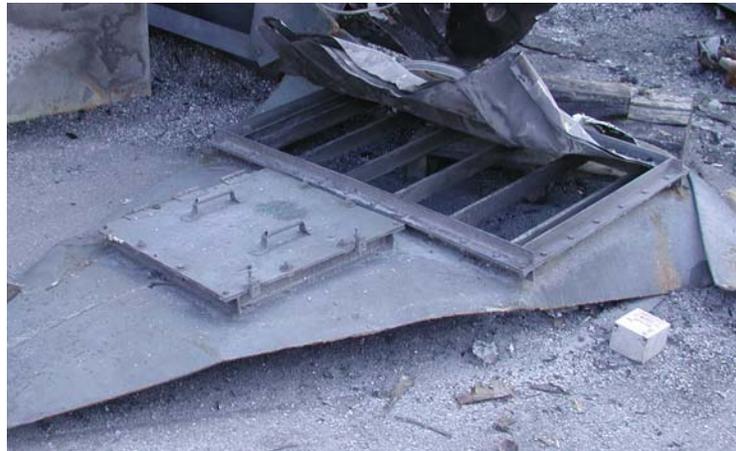
The drop box was pushed away from the dust collector, indicating that the pressure wave traveled into the drop box from the dust collector. The single explosion vent panel was blown and the drop box ruptured (Figure 22). The short duct connecting the drop box to the dust collector was pulled out and away from the dust collector (Figure 23), also indicating that the pressure wave traveled toward the drop box.

Figure 22. Drop box fragment, with blown explosion vent panel.

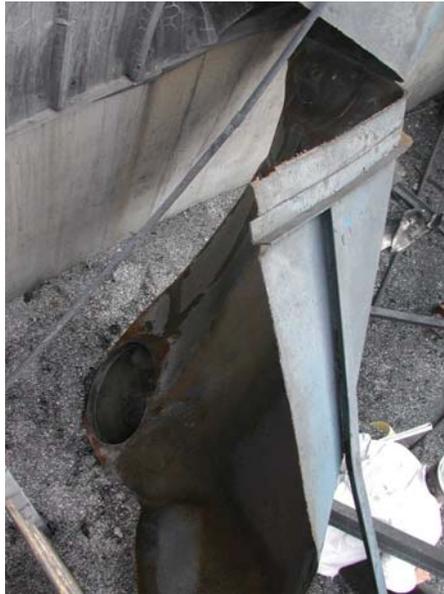
The drop box may have experienced significantly higher pressure than the dust collector, since an explosion propagating between two containers can result in a phenomenon referred to in literature as pressure piling.³² However, the drop box was a much weaker structure than the dust collector, lacking substantial framing and joined only by small corner welds, and it was relatively unprotected by explosion venting. The drop box failed mainly along the seams and fractured into several large pieces.³³ One of the larger fragments impacted the building wall and was found resting below the impact point (Figure 24). The impact slightly bent the vertical steel wall support beam inward (Figure 25).

Figure 24. Drop box fragment after impact with building wall

³³ CSB calculations indicate that the rupture pressure for the drop box was between 2 and 5 pounds per square inch gage.

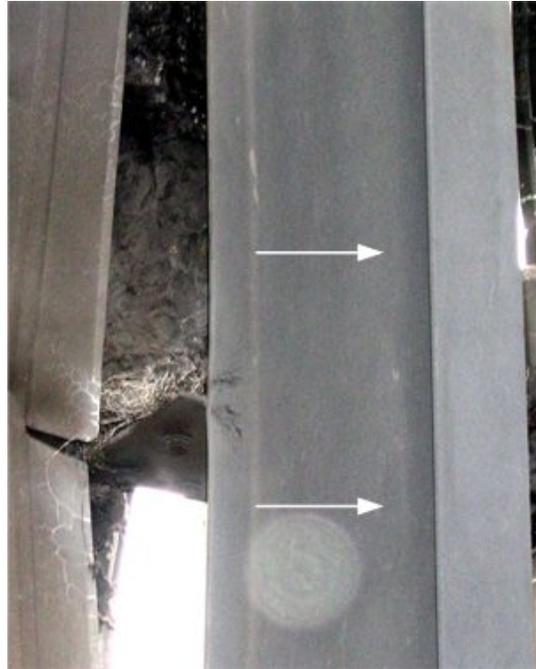
Figure 25 Beam slightly deflected by drop box impact. Arrows on either side of the point of impact show the direction of bending

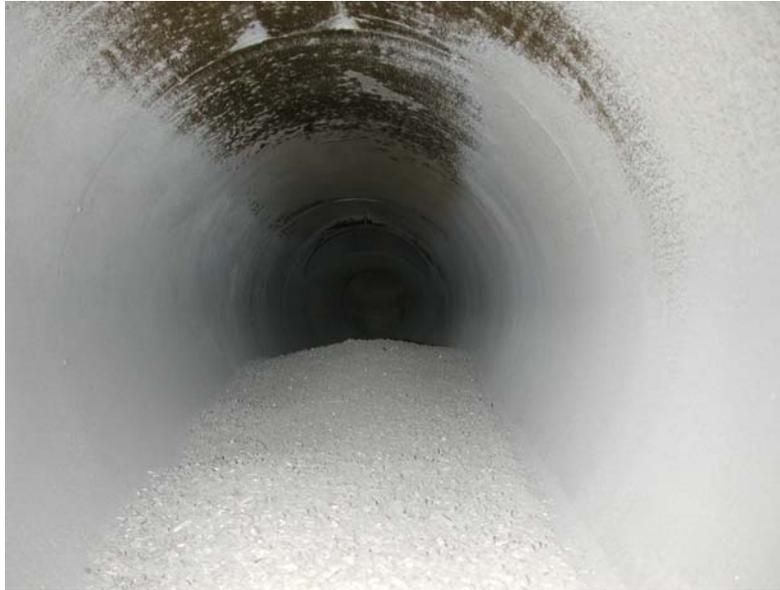
By lofting and igniting dust settled in the ducts (Figure 26), the deflagration also propagated upstream to the furnace 5 chip feed cyclone. CSB concluded that the deflagration traveled down the chip feed pipe and into the vortex box, causing the large fireball to erupt into the room. Witnesses recalled seeing the fireball exit the fume hood and wrap around the furnace. CSB also observed molten aluminum on the front of the victim's safety glasses and splashed onto nearby equipment—further indication that a pressure wave was directed into the vortex box and down into the sidewell.

Figure 26. Interior of main duct between the chip equipment and the drop box with significant dust and chip accumulation.

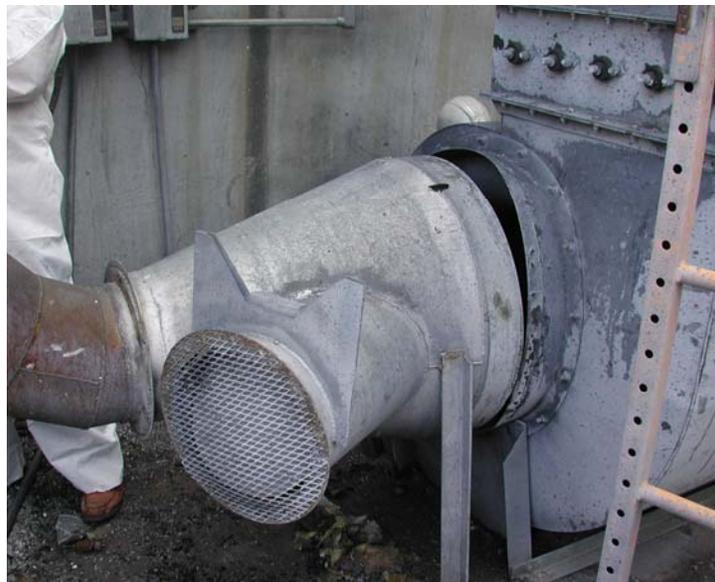
Figure 27. Fume hood exhaust fan cover damaged by overpressure.

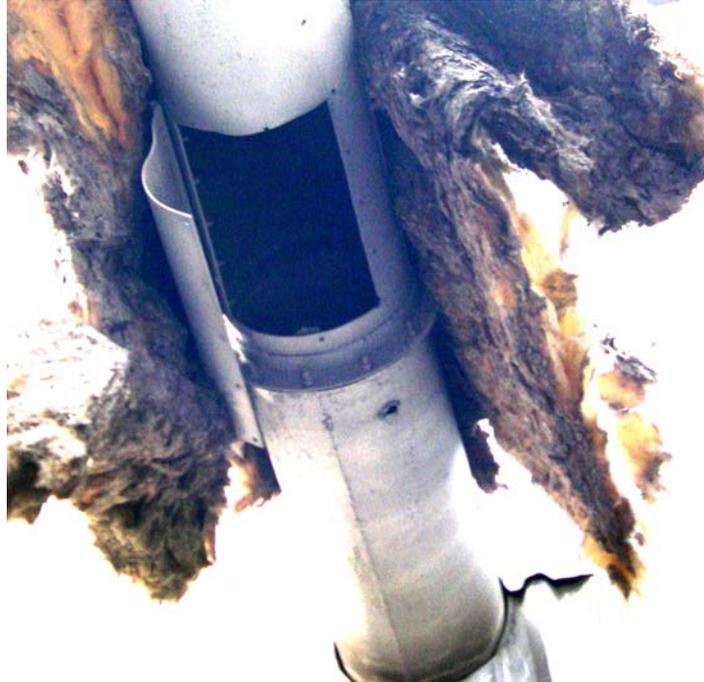
Figure 28. Cleanout door blown open on duct from furnace 5 fume hood to fume separator. Insulation from the roof rests on the duct (Figure 4 shows the location of this duct in the building).

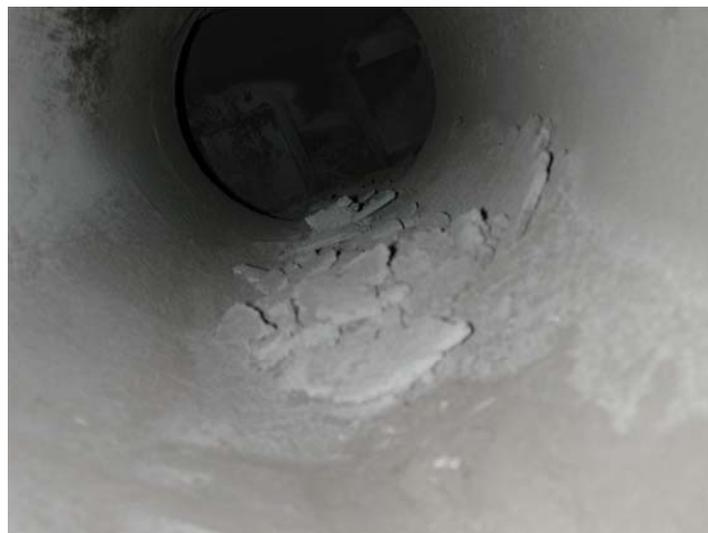
The erupting fireball above the sidewell entered the fume hood, causing burning material to be pulled by the fume separator draft fan along the ducting into the fume separator. This material likely ignited deflagrations inside the ducting and fan housing severe enough to damage the draft fan housing and duct (Figure 27). The cleanout door was blown open on the duct between the fume hood and the fume separator (Figure 28). CSB found that the duct leading to the fume separator contained hard deposits and dust, which likely were the fuel for the fires in this duct (Figure 29).

Figure 29. Interior of fume duct to fume separator (near the cleanout door.)

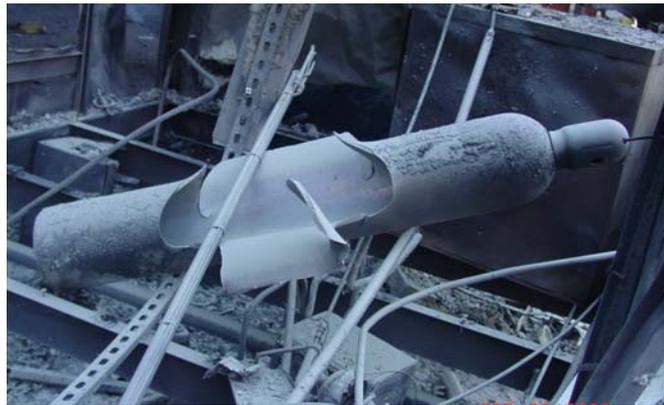
Employees and the Huntington fire chief reported that a series of smaller explosions occurred about 11 minutes after the initial explosion. The fire chief concluded that some of these small explosions could have been the four tires on the contractor trailer failing. After the fire department extinguished the fire, investigators also discovered the remains of high-pressure gas cylinders used for instrument calibration, which had been in the contractor trailer. Figure 30 shows one of the cylinders, lying in the remains of the trailer.

Figure 30. Ruptured gas cylinder in the contractor trailer.

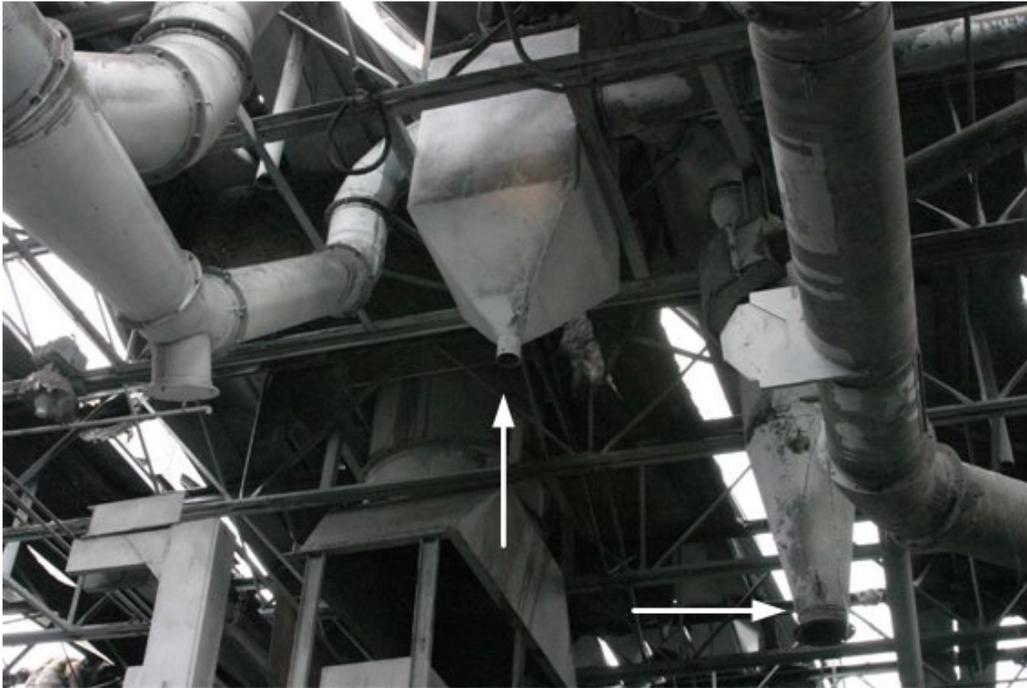
Routine operation of the aluminum melt furnace requires periodic fluxing and drossing to remove impurities from the molten aluminum. Employees recalled that these activities sometimes lofted significant amounts of burning embers.³⁹ At least two openings (one at the bottom of the spark box and another on an unused cyclone separator above and close to the sidewell) existed where such embers could be pulled into the dust stream (Figure 31).

Figure 31. Unused spark box and cyclone, with openings (see arrows) where sparks could be pulled into the dust stream by the airflow.

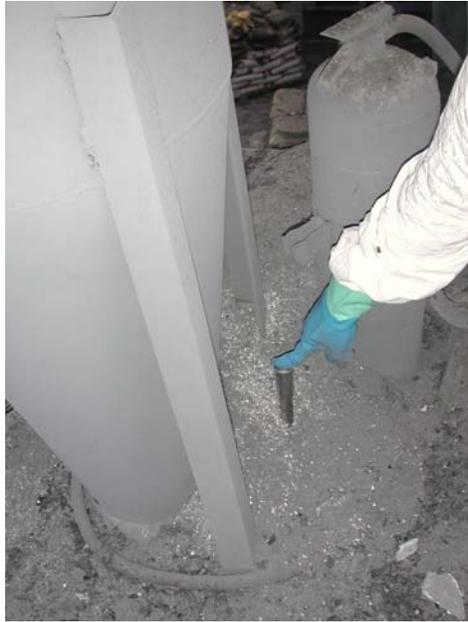
before the incident. Managers and employees CSB interviewed indicated that they were not aware such accumulations presented an explosion hazard.

Figure 33. Typical chip and dust accumulation on floors.
The 4-inch blade of a trowel is buried in the pile.

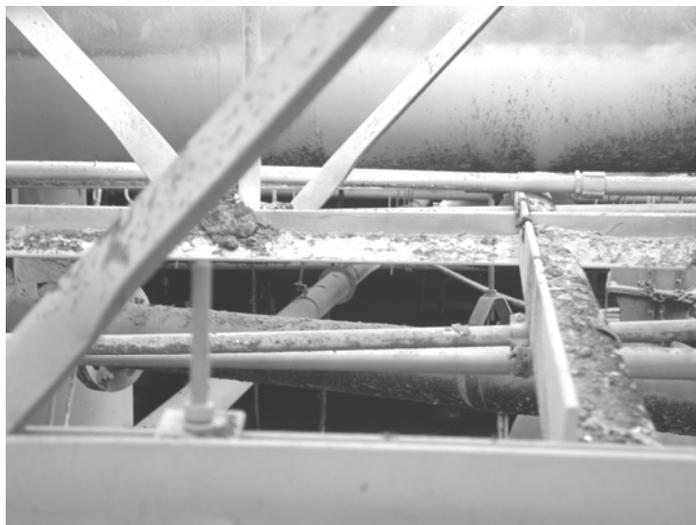
Investigators observed that a layer of dust topped off piles of spilled chips they found throughout the furnace 5 area. Surfaces above the furnace (e.g., ducts, beams, ledges) were covered with even finer dust, which had been carried aloft in air currents. In many areas, dust layers were at least 2 inches thick. (Figure 34). In a dust release of mixed particle sizes, the smaller particles stay aloft longer on air currents and are carried higher. CSB found that dusts on the higher ledges appeared as fine as talcum powder (commercial talc particles are typically in the range of 10 to 20 microns [4-8 ten thousandths of an inch] in diameter.)

Figure 34. Dust accumulation on roof trusses.

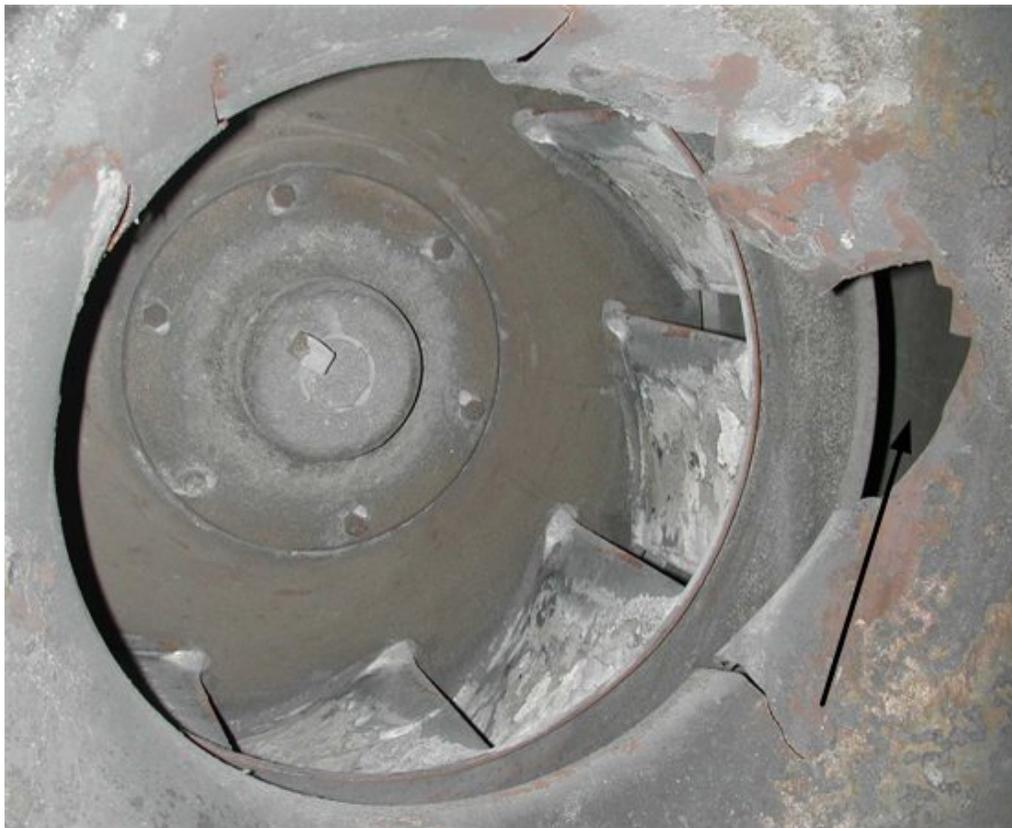
The condition of the dust collector draft fan (Figure 35) was another indication that dust collector maintenance was inadequate. CSB found that the fan housing was eroded, which is typically caused by dust leaking through or past the filters.

Figure 35. Interior of dust collector draft fan housing, showing significant erosion damage (arrow)
