U.S. CHEMICAL SAFETY AND HAZARD INVESTIGATION BOARD

INVESTIGATION REPORT

HONEYWELL INTERNATIONAL, INC.

REPORT NO. 2003-13-I-LA

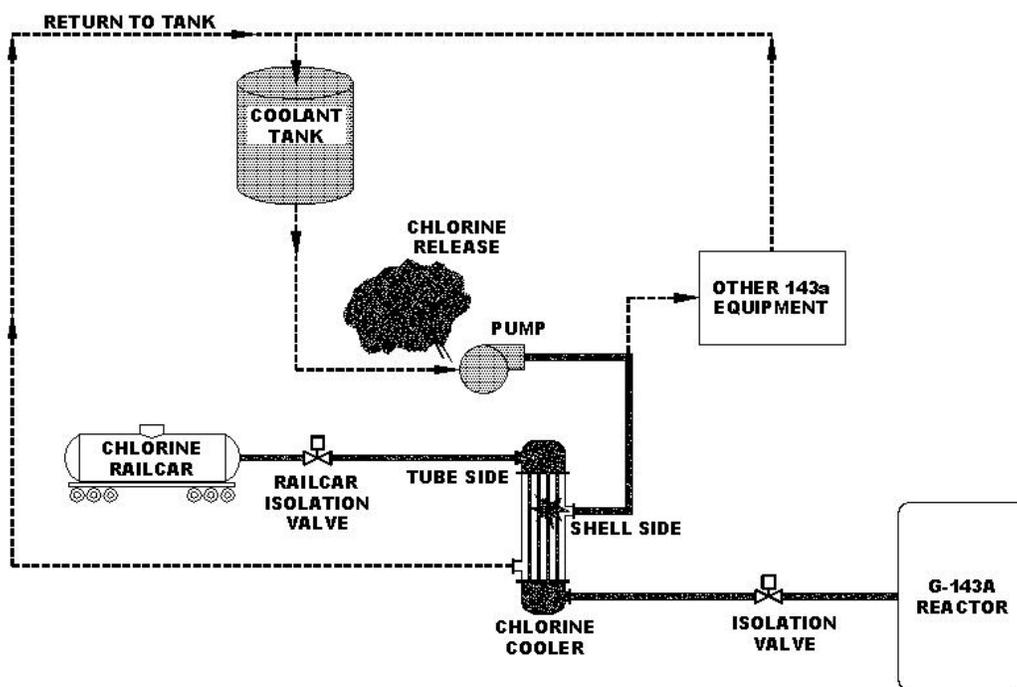
Figure 6. Failure of chlorine cooler, causing release at coolant pumps.

As depicted in Figure 6, the immediate cause of the July 20 release was a failure in the chlorine cooler, which allowed chlorine to enter the coolant system. Because Honeywell did not anticipate the coolant pumps coming into contact with chlorine, their materials of construction were not compatible with it. The pumps failed, releasing chlorine to the atmosphere.

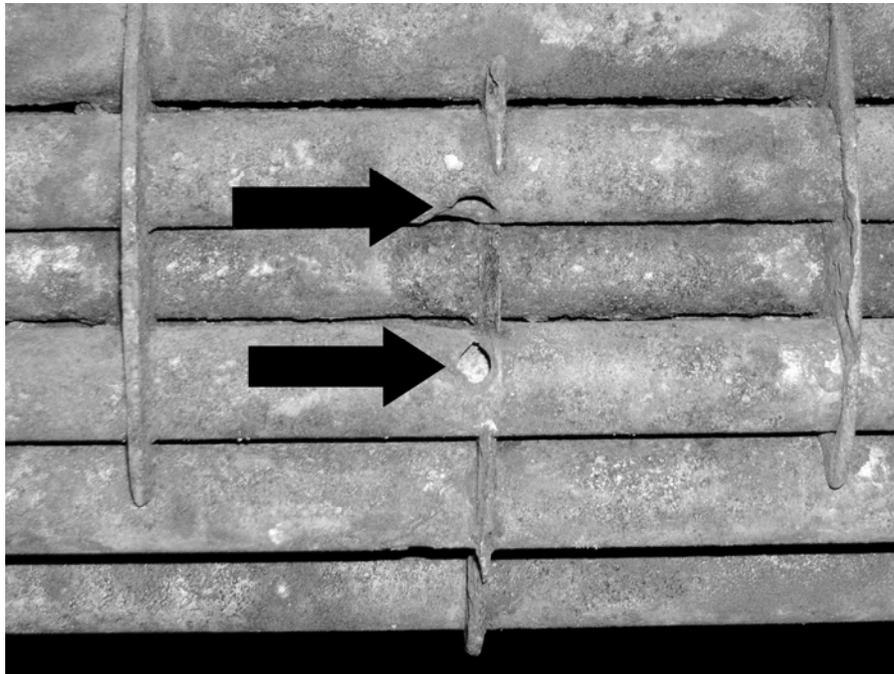
Figure 8. Chlorine cooler tube bundle showing two holes.

Following the July 20 incident, the chlorine cooler was cut open and inspected. Visual inspection revealed three holes in the tubes and a buildup of corrosion products at the bottom (two holes are shown in Figure 8). All corrosion products and the holes were found in the lower section of the cooler; the holes originated on the outside surface of the tubes (refer to Figure 2). One hole was crescent shaped and about 0.5 inch long, while the two other holes were about 0.25 inch in diameter and approximately 5 inches higher on adjacent tubes. After the visual inspection, two holes were confirmed by magnetic flux testing performed by a Honeywell contractor; however, the third hole's test results showed only significant wall thinning.

A magnetic flux leakage inspection in October 2003 followed the July 20, 2003 incident. Two of the three holes were identified by that inspection, but the third showed only as wall thinning. This finding suggests that either the methodology or the testing apparatus is less than adequate to positively detect thinning and failure of the 0.109-inch tube walls.

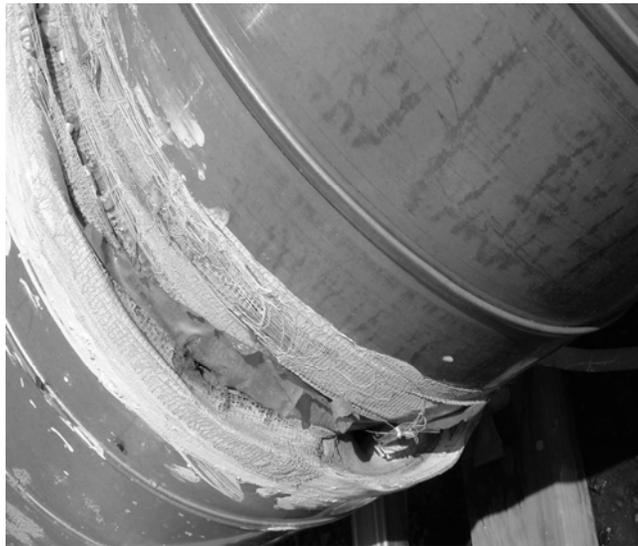
Figure 9. Condition of duct tape used to seal gaps.

During the July 20 release, chlorine entered the control room. CSB investigators found that it was drawn into the building through holes and gaps in the HVAC intake ducts located on the roof. Some holes appeared to have been drilled in the duct and not plugged, while others resulted from gaps in joints. Duct tape was used to seal some gaps, but the tape became dry and brittle over time. Figures 9 and 10 show this deterioration. Figure 11 shows the proximity of the coolant system chlorine leak in relation to the HVAC system.

- There was no maintenance program for the control room, including HVAC ductwork.²³
- Duct tape used to seal some joints in HVAC ductwork eventually became brittle and exposed gaps in the joints.
- There were numerous entrances and exits from the control room—none of which had a double door air lock system.
- There were no toxic gas alarms on the HVAC intake system. Alarms could have warned operators to use the escape respirators and exit the control room.
- Although the positive pressure control room system was listed as a safeguard in a hazard analysis, it was not designated as critical equipment or maintained as such.²⁴

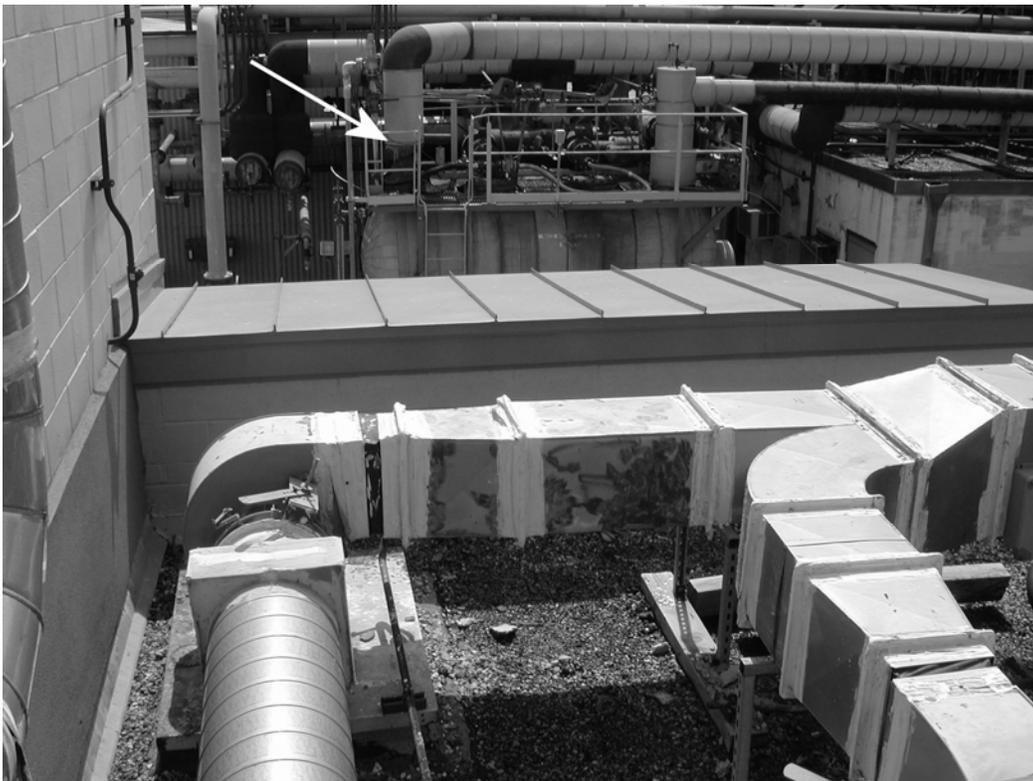
Figure 11. HVAC intake system on control roof (foreground).

Arrow points to location of coolant system chlorine leak.

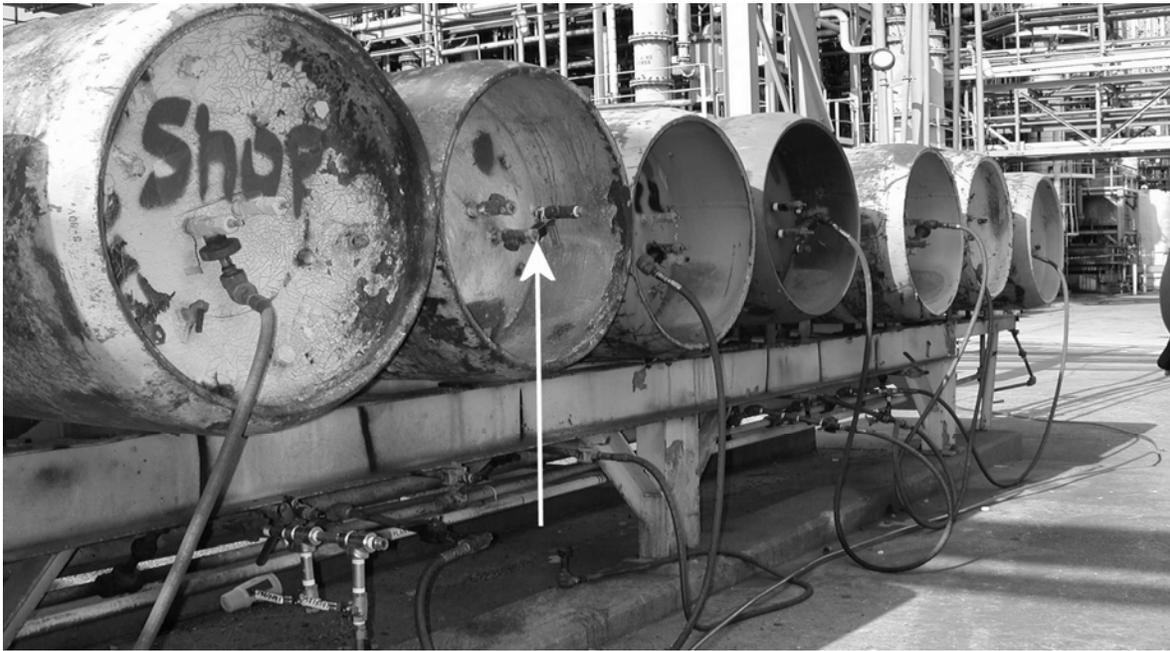
Figure 13. Incident cylinder (83-3410), which is not connected to vent system.

Ten 1-ton cylinders labeled “refrigerant gas” were found on the ton-cylinder rack. Nine of the 10 cylinders were connected to the vent system and properly drained/cleared of residual refrigerant. The 10th cylinder—which had serial number 83-3410 (and was painted white and green as opposed to the standard gray for antimony pentachloride)—was not hooked up to the vent system (Figure 13); and a plug at the five o’clock position had been removed from the end of the cylinder.

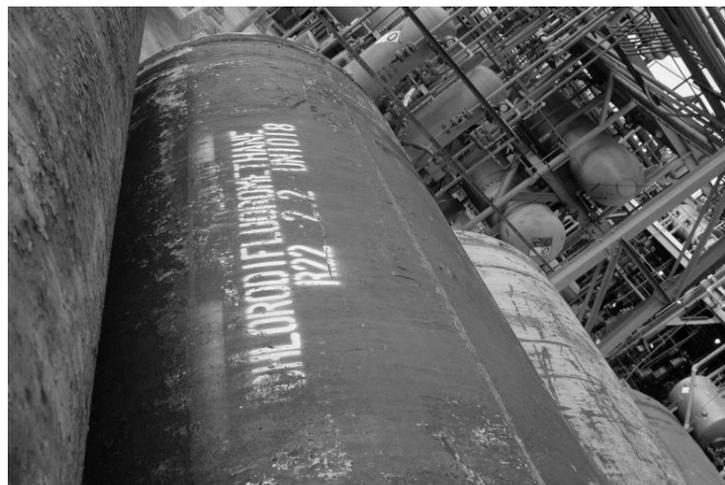
Figure 14. Stencil on cylinder 83-3410.

This cylinder was identified by a “Chlorodifluoromethane R-22” stencil (Figure 14). Further examination of cylinder 83-3410 revealed that the valves would not open due to buildup of corrosion products.
