U.S. CHEMICAL SAFETY AND HAZARD INVESTIGATION BOARD

## SUGAR DUST EXPLOSION AND FIRE

### IMPERIAL SUGAR COMPANY

Report No. 2008-05-I-GA  
September 2009

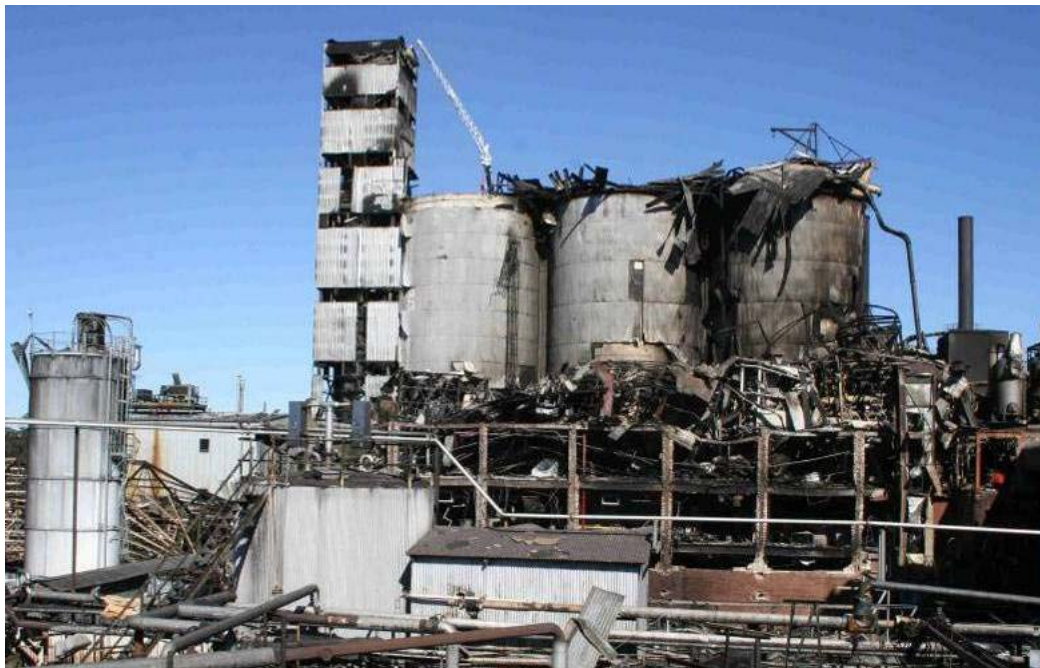
The major fires in the buildings were extinguished the next day, but small fires continued burning for many days. The granulated sugar fires in the 105-foot tall silos continued to smolder for more than 7 days before being extinguished by a commercial industrial firefighting company. The packing buildings, granulated sugar silos, and palletizer room were destroyed. The bulk sugar loading area and parts of the refinery were severely damaged by the explosion and fires (Figure 1).

Figure 1. West bucket elevator tower; silos 3, 2, and 1; and south packing building destroyed by the February 7, 2008, sugar dust explosions and fires

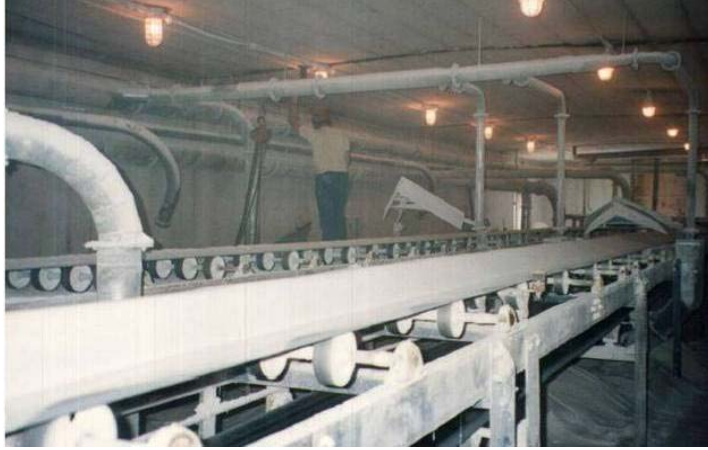
Figure 8. Granulated sugar steel conveyor belts above the silos, circa 1990. Heavy dust accumulation on conduit and spilled sugar on the floor (Imperial Sugar photo)

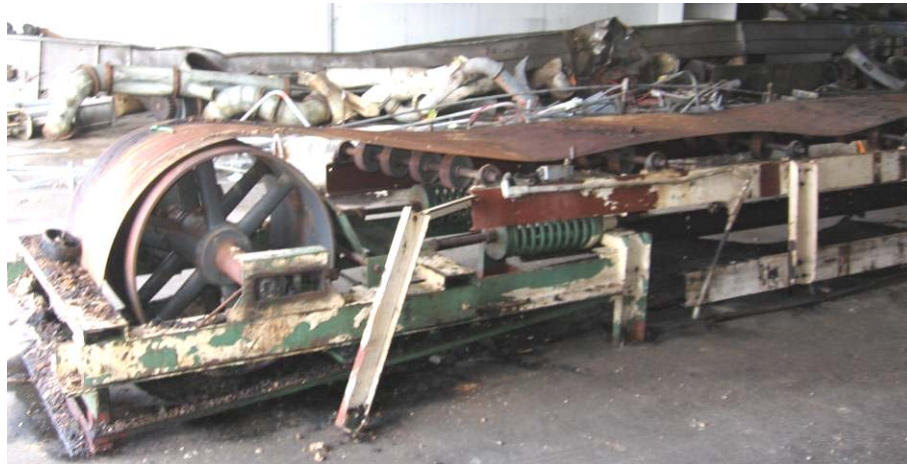
A 32-inch wide, 80-foot long steel conveyor belt (Figure 9) in the silo tunnel transported granulated sugar from silos 1 and 2 into the packaging production bucket elevator pit at the east side of silo 1. Similar steel belt conveyors were located in the penthouse above the silos.

Figure 9. Silo tunnel steel conveyor belt (removed after incident)

and side panels to fully enclose each belt assembly to protect the granulated sugar from falling debris and reduce the possibility of intentional contamination. The top and side panels were removable to provide access for cleaning and conveyor maintenance. Although sugar dust was generated as the sugar flowed onto the belt and when flow blockages caused sugar to spill off the belt, these new enclosures were not equipped with a dust removal system and were not equipped with explosion vents.

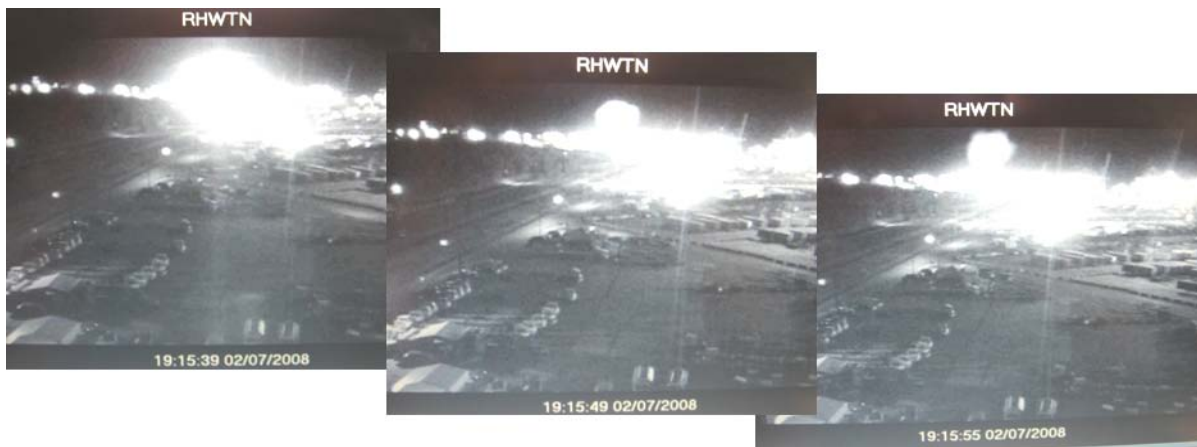
Figure 10. Violent fireball erupting from the facility (elapsed time - 16 seconds)  
(Georgia Ports Authority security video).

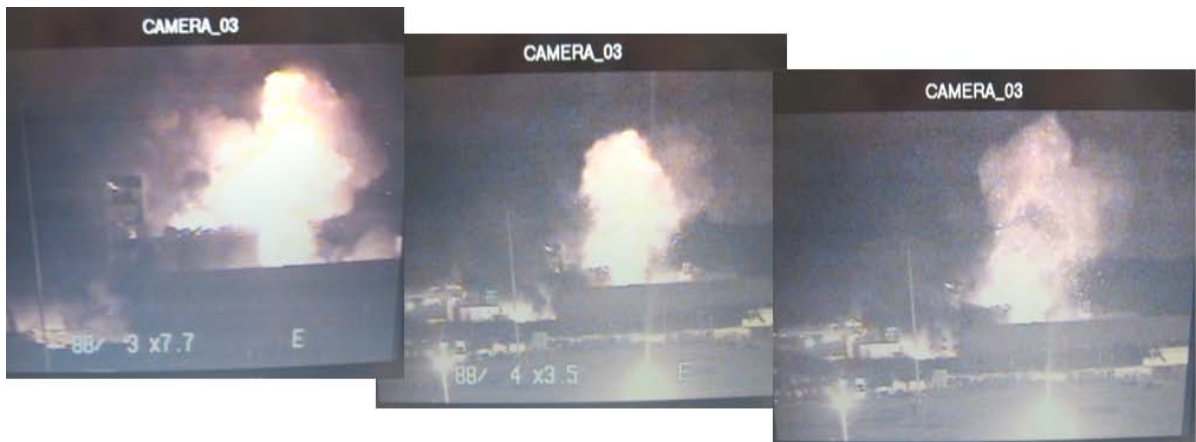
Intense fireballs advanced through the entire north and south packing and palletizer buildings as sugar dust, shaken loose from overhead surfaces, ignited. Heaving and buckling floors opened large crevasses. The piles of granulated and powdered sugar that had accumulated around equipment rained down and intensified the fires burning below. Fireballs advanced through enclosed screw conveyors and ignited fires in the refinery and bulk sugar building hundreds of feet from the packing buildings where the incident had begun. Violent fireballs erupted from the facility for more than 15 minutes as spilled sugar and accumulated sugar dust continued fueling the fires (Figure 11).

Figure 11. Large fireball and burning debris erupt from the packing buildings 15 minutes after first explosion (elapsed time - 10 seconds) (PCS Phosphate security video).

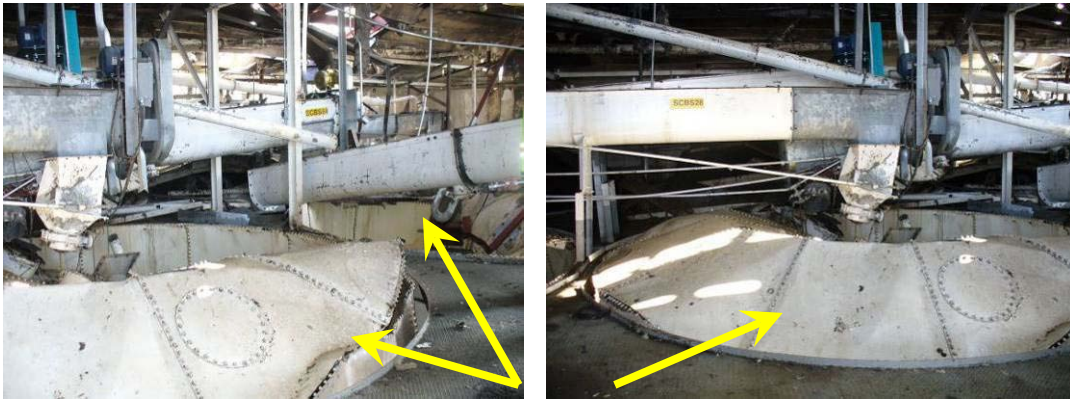
conveyors in the Port Wentworth facility acted as conduits and ignited fires and ruptured equipment hundreds of feet from the packing building where the incident originated (Figure 12).

Figure 12. Pressure waves traveled through screw conveyors and ruptured steel bulk granulated sugar bins (arrows) hundreds of feet from the sources of the dust explosions

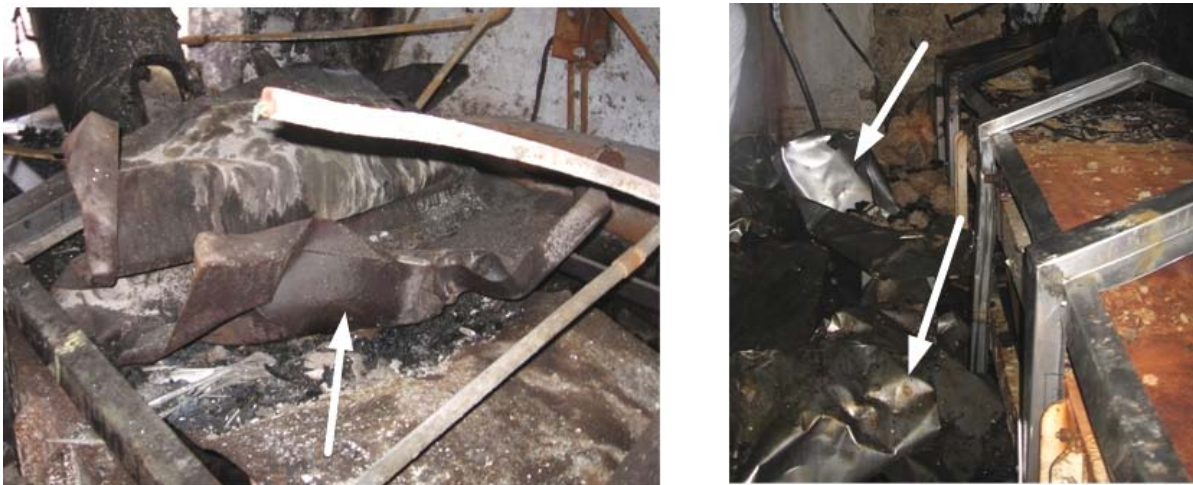
Examination of the equipment in the silo tunnel found that every panel used to enclose the 80-foot long steel belt conveyor had been violently blown off the support frame (Figure 13). Panels east of the approximate midpoint of the conveyor (directly under the silo 1–silo 2 abutment) were deflected eastward, and panels west of the midpoint were deflected westward. Pressure damage inside the pantleg rooms above the tunnel was greatest inside the silo 2 pantleg room and least inside silo 3 pantleg room. Major equipment damage was observed at the east entrance of the silo tunnel with all equipment deflections eastward, away from the tunnel. The equipment under silo 3 and outside the west end of the tunnel had damage patterns clearly indicating that a pressure wave traveled west out of the tunnel.<sup>24</sup>

Figure 13. Steel belt covers (arrows) crumpled from an initial dust explosion inside the steel belt enclosure (steel frame structure, right photo)

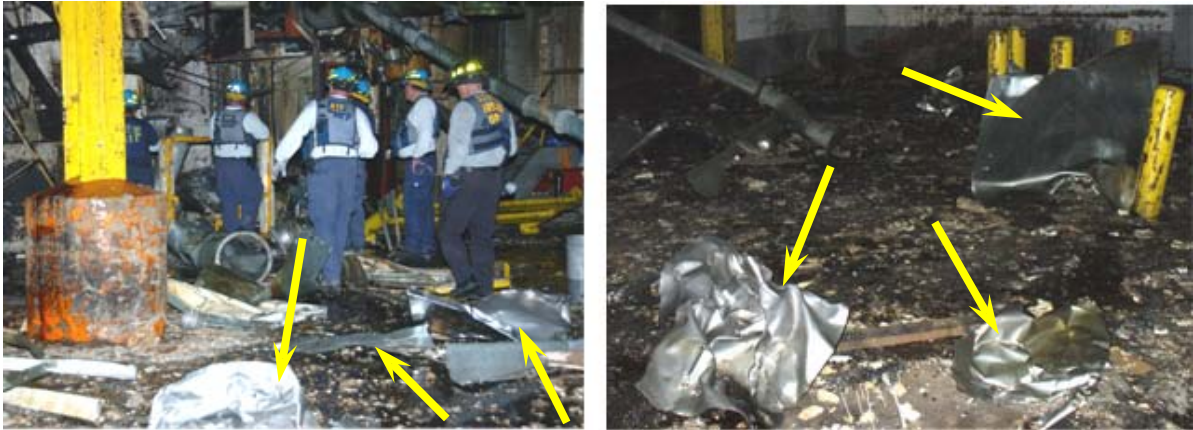
Pressure waves blew the wood walls and doors off the west and east tunnel entrances. Mangled steel belt cover panels were blown out of the east end of the tunnel (Figure 14). The pressure wave also

Figure 14. Stainless steel cover panels (arrows) blown off the steel belt enclosure and out of the tunnel into the packing building

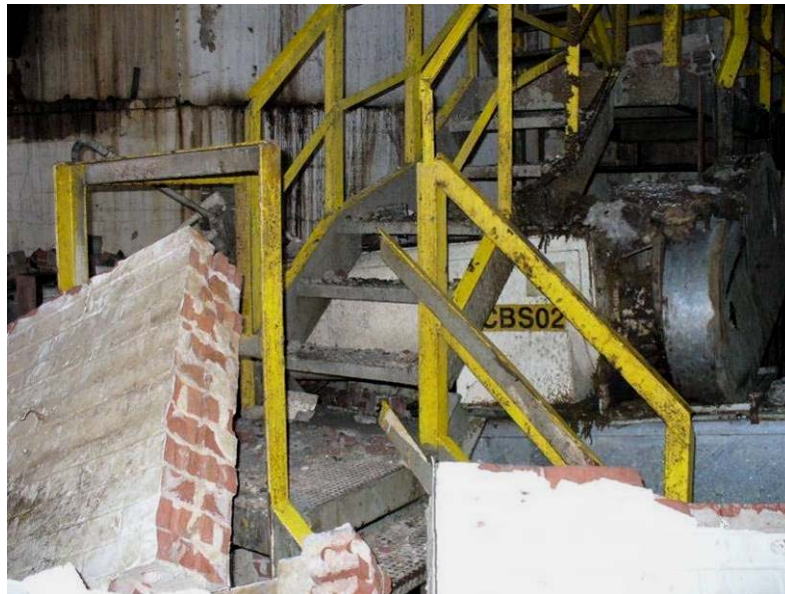
traveled up between silos 1 and 2 and blew the brick walls that enclosed the south stairwell into the work areas on each floor of the south packing building (Figure 15).

Figure 15. South stairwell brick walls blown into the packing building

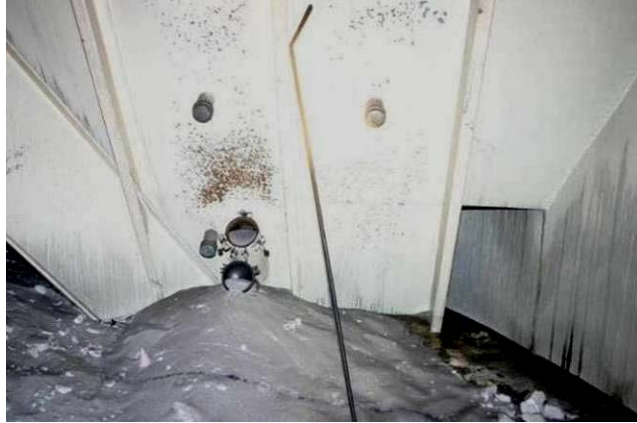
Figure 16. Access port inside the pantleg room and steel rod used to break sugar lumps in the sugar outlet on silo floor

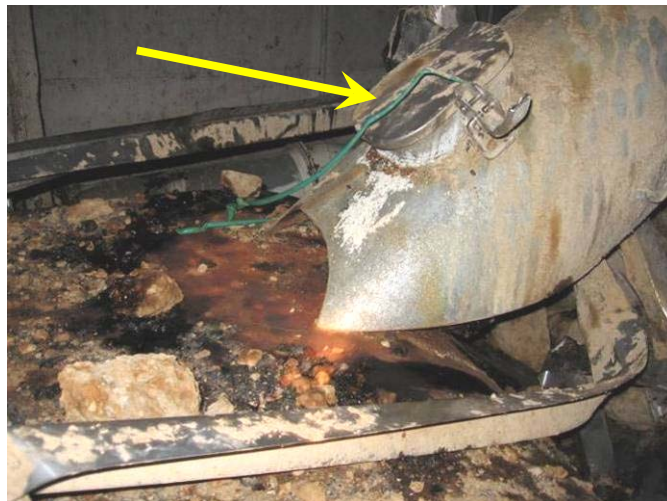
Figure 17. Limited clearance between sugar discharge chute and the steel belt would sometimes be blocked by large sugar lumps; lump-clearing access port (arrow) is on top of the chute

The CSB concluded that as granulated sugar spilled off the moving steel conveyor at the blocked outlet, sugar dust accumulated above the MEC inside the enclosed conveyor, and then ignited. The explosion triggered a series of secondary explosions that rapidly progressed through the packing buildings, palletizer room, and into the bulk sugar station.

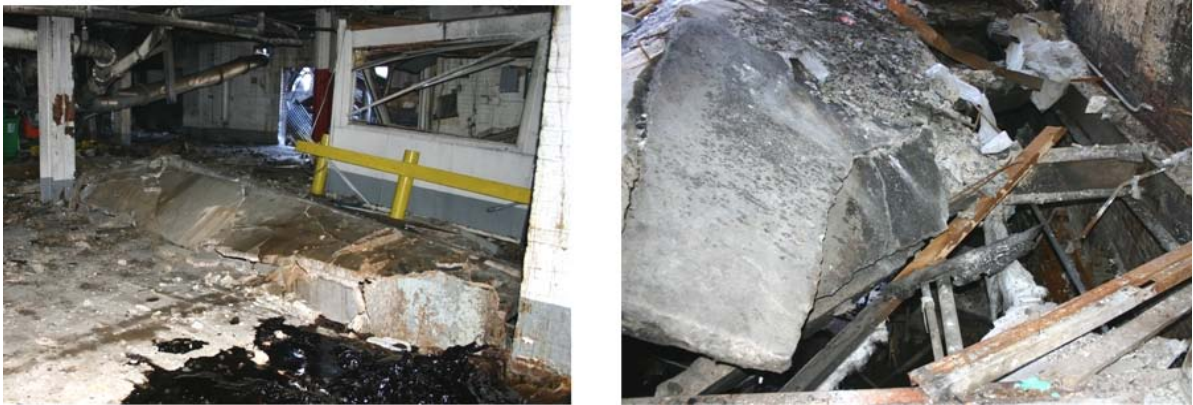
Three-inch thick concrete floors in the south packing building heaved and buckled from the explosive force of the sugar dust-fueled explosions as they progressed through the packing buildings and into

Figure 18. Three-inch thick concrete floor slabs lifted off the steel supports by the explosion pressure waves

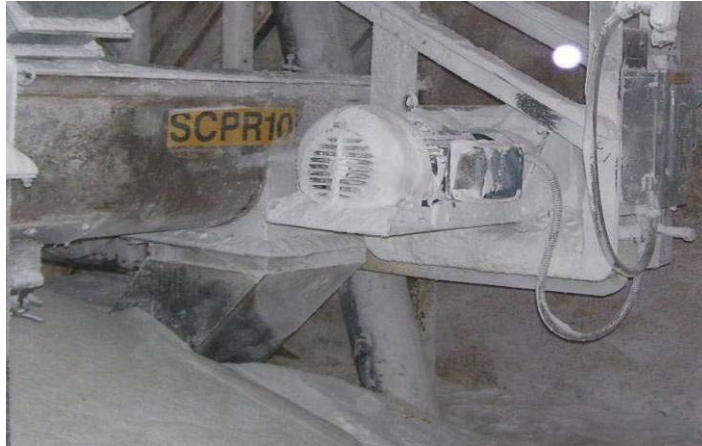
Figure 19. Motor cooling fins and fan guard covered with sugar dust; large piles of sugar cover the floor (Imperial Sugar photo)

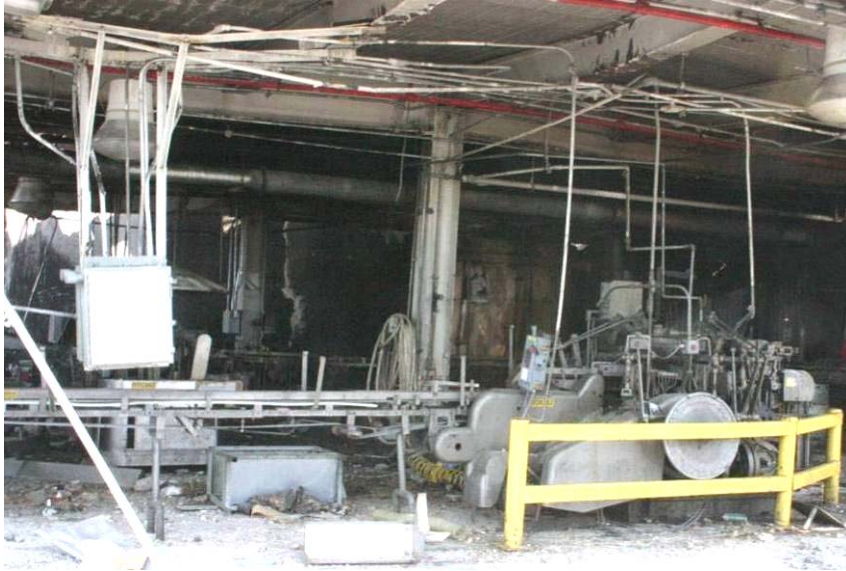
Figure 20. Packaging equipment hindered evacuation in the darkened building

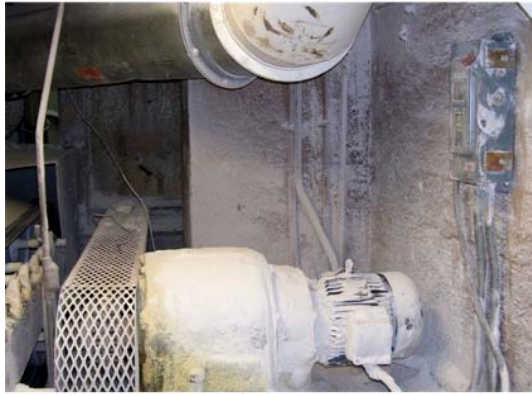
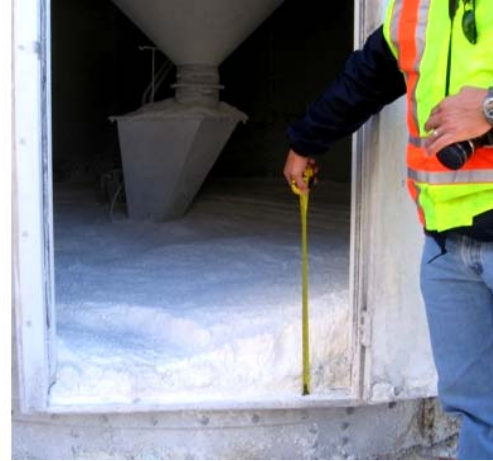
Figure 21. Left: Sugar dust accumulation on steel belt drive motor in silo tunnel (Imperial Sugar Co. photo, Oct. 2006). Right: Cornstarch spilled under cornstarch silo (March 2008).

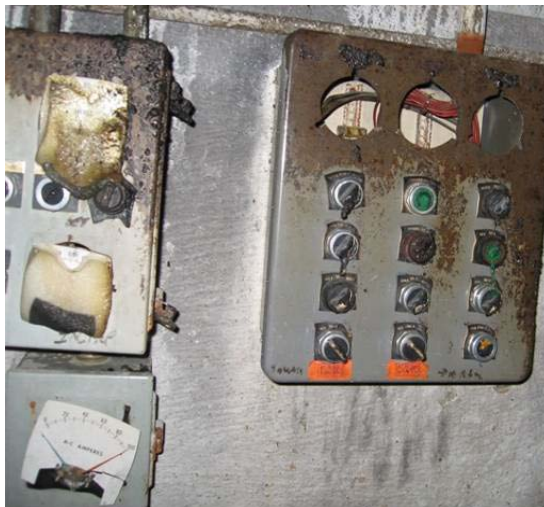
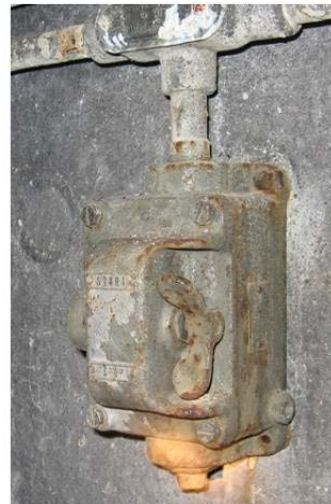
Imperial Sugar had no written policy or procedure to require classifying hazardous areas or require electrical devices rated for such locations at the Port Wentworth facility. Some locations at the facility contained significant accumulations of combustible sugar or cornstarch dust (Figure 21). The CSB investigators noted that some electrical devices were rated for use in hazardous work locations, but non-rated devices were also installed in the same location, frequently near the rated devices (Figure 22). The CSB investigators also observed many non-hazard classified electrical devices installed in dusty work areas and equipment enclosures. Furthermore, some electrical devices in dusty areas were poorly maintained, such as having missing covers or open doors on many breaker panels and other electrical enclosures.

Figure 22. Non-dust rated and rated electrical devices in the silo tunnel

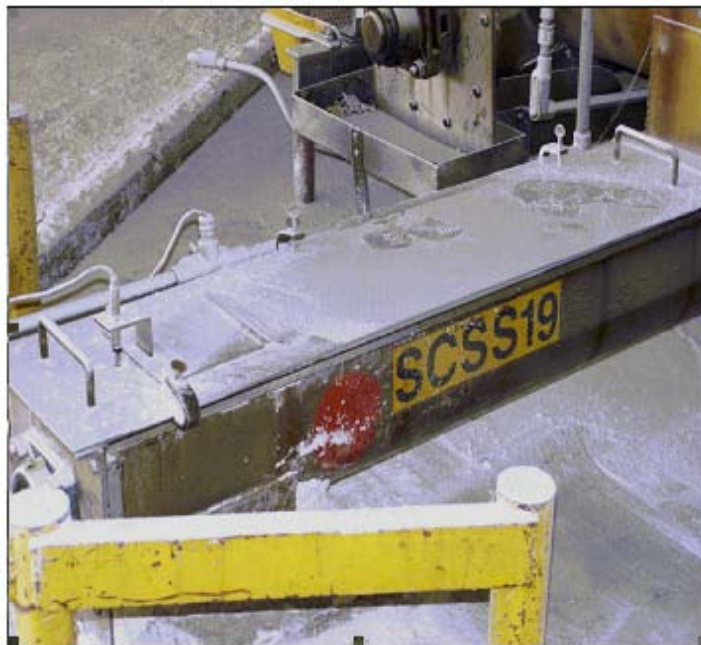
Figure 23. Sugar and dust accumulation on a screw conveyor in the south packing building fourth floor near silo 1 (Imperial Sugar photo)

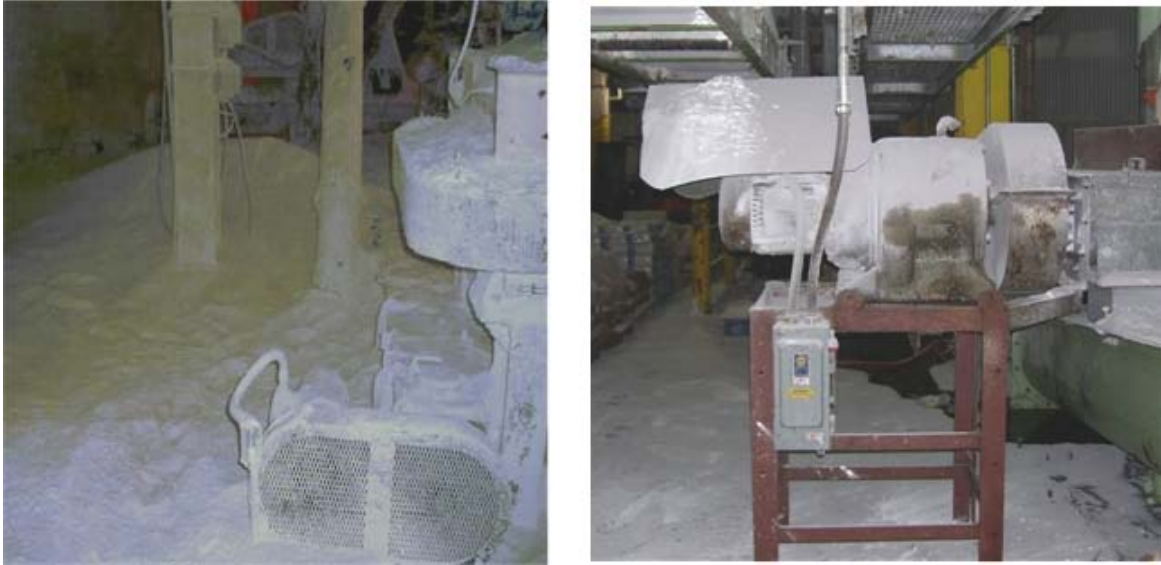
Figure 24. Deep piles of sugar accumulated on floors and equipment. Note shield installed above screw conveyor drive motor to deflect sugar dust (Imperial Sugar photos).
