Ethylene Release and Fire at Kuraray America, Inc. EVAL Plant

Pasadena, Texas | Incident Date: May 19, 2018 | No. 2018-03-I-TX

Investigation Report

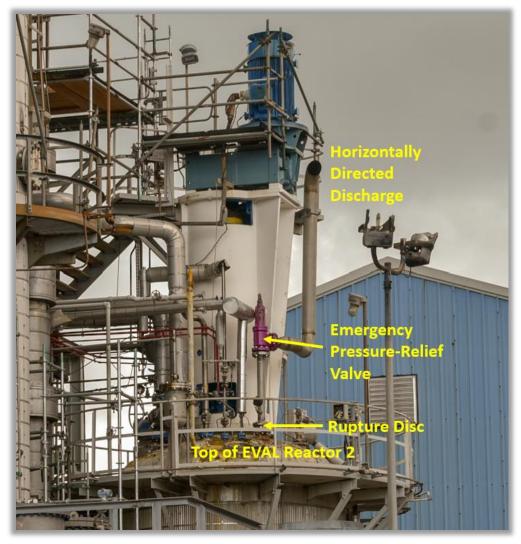
Figure 7. EVAL Reactor 2 Emergency Pressure-Relief System. (Credit: CSB)

The emergency pressure-relief system for EVAL Reactor 2 was designed to discharge reactor vapor to the ambient air (atmosphere) about 40 feet above the ground. Annotating the horizontal 90-degree angle on this piping (**Figure 6, Figure 7**, and **Figure 8**) illustrates that Kuraray did not install the outlet piping from the emergency pressure-relief system vertically upward (180-degree angle). As will be further discussed, this piping design detail directed flammable ethylene vapor through the horizontally aimed piping and toward an area where many workers were performing maintenance activities that included welding operations.

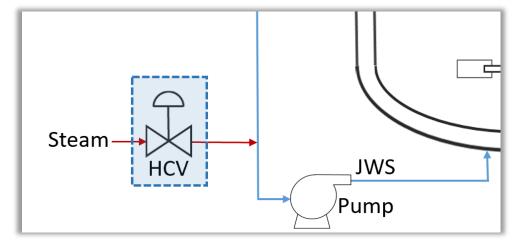
Figure 11. Steam Injection. (Credit: CSB)

To help warm the reactor toward the target operating temperature, at <u>7:08 a.m.</u> Board Operator 1 opened the control valve that added steam to increase the temperature of the water circulating through the reactor's heat transfer jacket (**Figure 11**). **Figure 11** shows an excerpt from **Figure 6** that highlights the hand control valve (blue dashed-line rectangle) that Kuraray operators periodically used to increase the temperature of the reactor jacket water by injecting steam into the circulating water. By raising the jacket water temperature, however, the injected steam was also raising the pressure inside the reactor because some liquid ethylene vaporized.

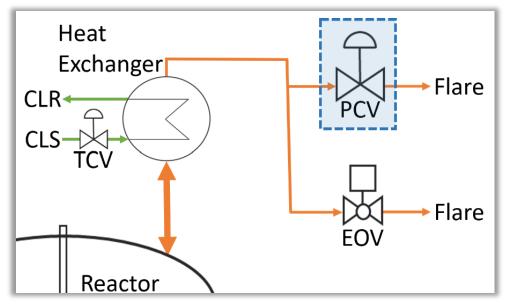
Figure 12. Pressure Control Valve to Flare. (Credit: CSB)

acknowledged by one of the Kuraray board operators, likely Board Operator 1.^a As the pressure inside the reactor continually increased, Board Operator 1 periodically tried to lower the pressure by opening the pressure control valve (**Figure 12**) to send some vapor from the reactor to the flare. **Figure 12** shows an excerpt from **Figure 6** that highlights the pressure control valve (blue dashed-line rectangle) that Kuraray operators periodically used to direct vapor from the reactor to the flare to reduce the pressure inside the reactor.

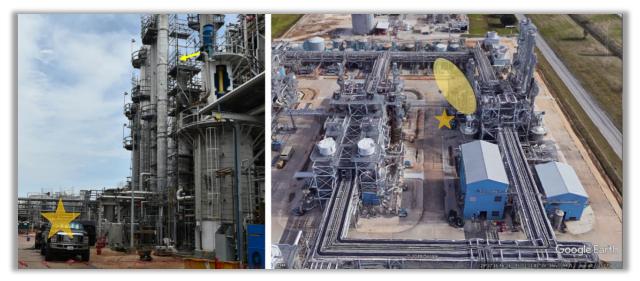
Figure 15. Ethylene Release.^b (Credit: left image, CSB; right image, Google Earth annotated by CSB)

The images in **Figure 15** show the approximate area and direction of the ethylene release from the EVAL Reactor 2 emergency pressure-relief system (yellow oval in the right image). The gold star shows the likely location of the ignition source—an operating welding machine on the bed of a pickup truck.^a

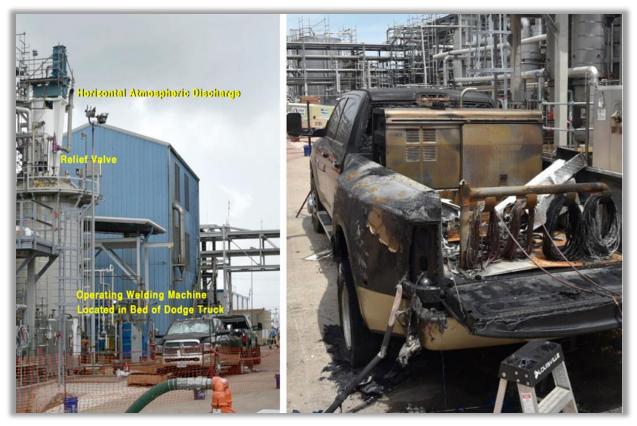
Figure 16. Likely Ignition Source. (Credit: CSB [23])

^a The Harris County Fire Marshal's Office identified the ignition source as "located in or around the operating welder [welding machine] located in the back of the Dodge pickup" [129, p. 13]. The pickup truck was parked next to the reactor structure, under the outlet piping from the EVAL Reactor 2 emergency pressure-relief system. In addition, the Harris County Fire Marshal's report on the Kuraray incident shows 24 worker injuries with 19 of these workers being transported for medical treatment.

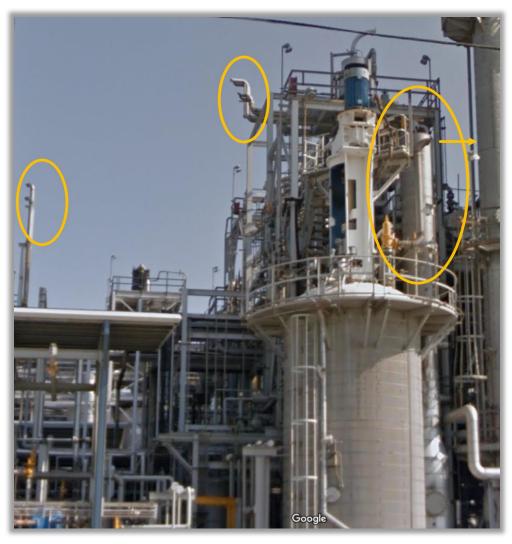
Figure 19. Horizontally Aimed Discharge Piping. (Credit: Google Maps annotated by CSB)

In discussing this other EVAL Reactor's emergency pressure-relief system, one Kuraray supervisor stated that it could discharge flammable ethylene toward Choate Road, a public road that runs outside the southern perimeter of the plant.^a He said:

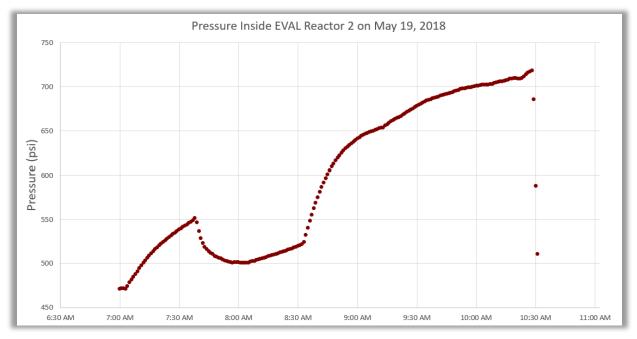
Figure 24. EVAL Reactor 2 Pressure.^c (Credit: CSB)

Figure 24 shows the pressure inside EVAL Reactor 2 in psi (psi) leading up to the incident on May 19, 2018. Kuraray operators stopped adding ethylene to the reactor at <u>8:46 a.m.</u> when the pressure inside EVAL Reactor 2 was 606 psi. At <u>9:01 a.m.</u>, the High-High-Pressure alarm sounded when the pressure inside the reactor was 640 psi. Although actions taken by Kuraray's board operators slowed the rate at which the pressure inside the reactor was increasing, the pressure continued rising until the emergency pressure-relief system activated at <u>10:28 a.m.</u>
