U.S. Chemical Safety and  
Hazard Investigation Board

# Pressure Vessel Explosion at Loy-Lange Box Company

St. Louis, MO | Incident Date: April 3, 2017 | No. 2017-04-I-MO

## Investigation Report

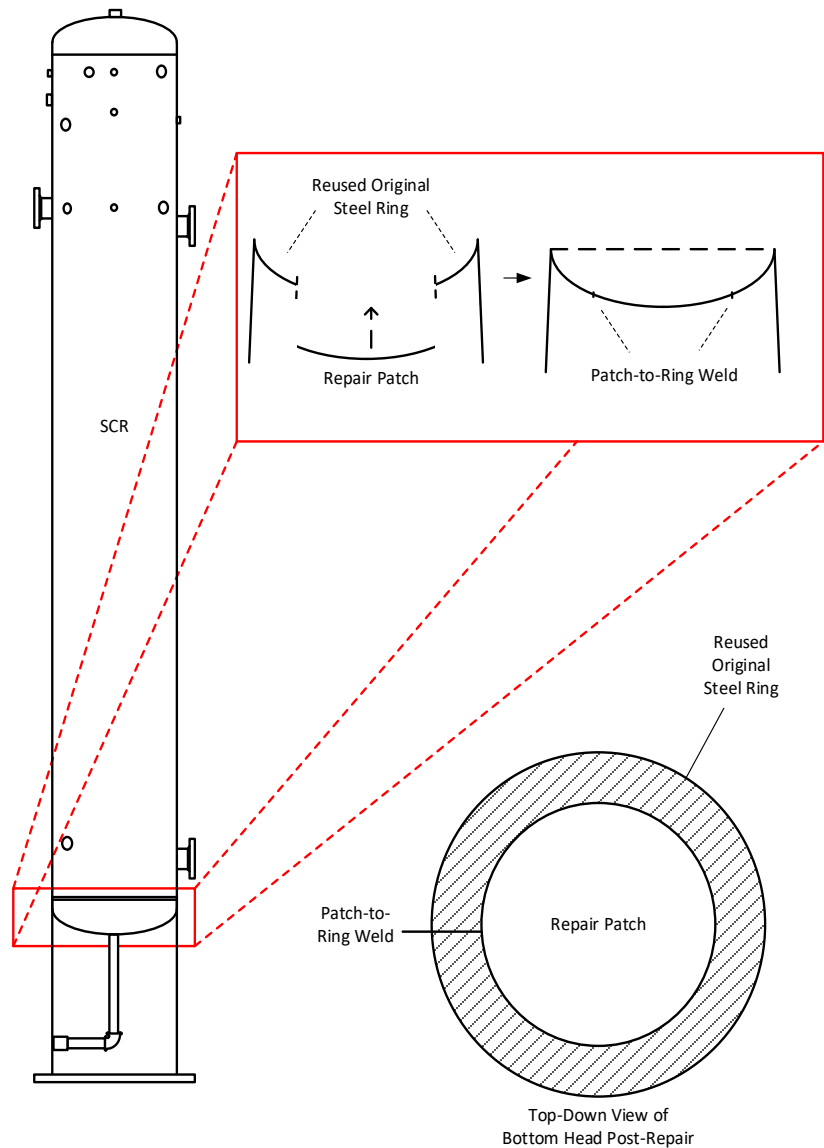
As illustrated in **Figure 7**, Kickham cut the SCR shell from the bottom head, leaving the bottom head attached to the skirt. With the bottom head and skirt removed from the SCR shell, Kickham inspected the inside surface of the SCR. A Kickham employee who oversaw the repair said Kickham observed pitting corrosion damage in the bottom head.

The employee said that the corrosion pits were isolated in the center of the head.

With access to the inside surface of the bottom head, Kickham cut out a circular portion of the center of the bottom head. According to a Kickham employee, the size of the circular portion was chosen to remove all the pitting and corrosion damage. The Kickham employee also told CSB investigators that the repair removed all corrosion damage in the SCR bottom head. In interviews, CSB investigators asked whether Kickham did any ultrasonic thickness (UT) measurement during the course of its repair. CSB investigators also asked whether Kickham inspected visually or used a micrometer.

**Figure 7.** Conceptual diagram showing repair made to SCR bottom head in 2012. (Credit: CSB)

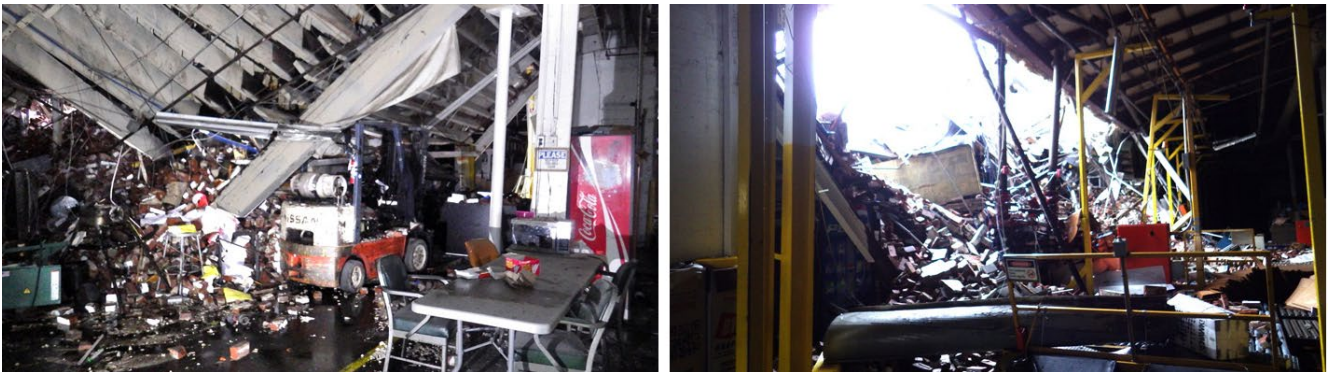
Figure 10. Photos of damage caused by SCR explosion. (Credit: St. Louis Fire Department)

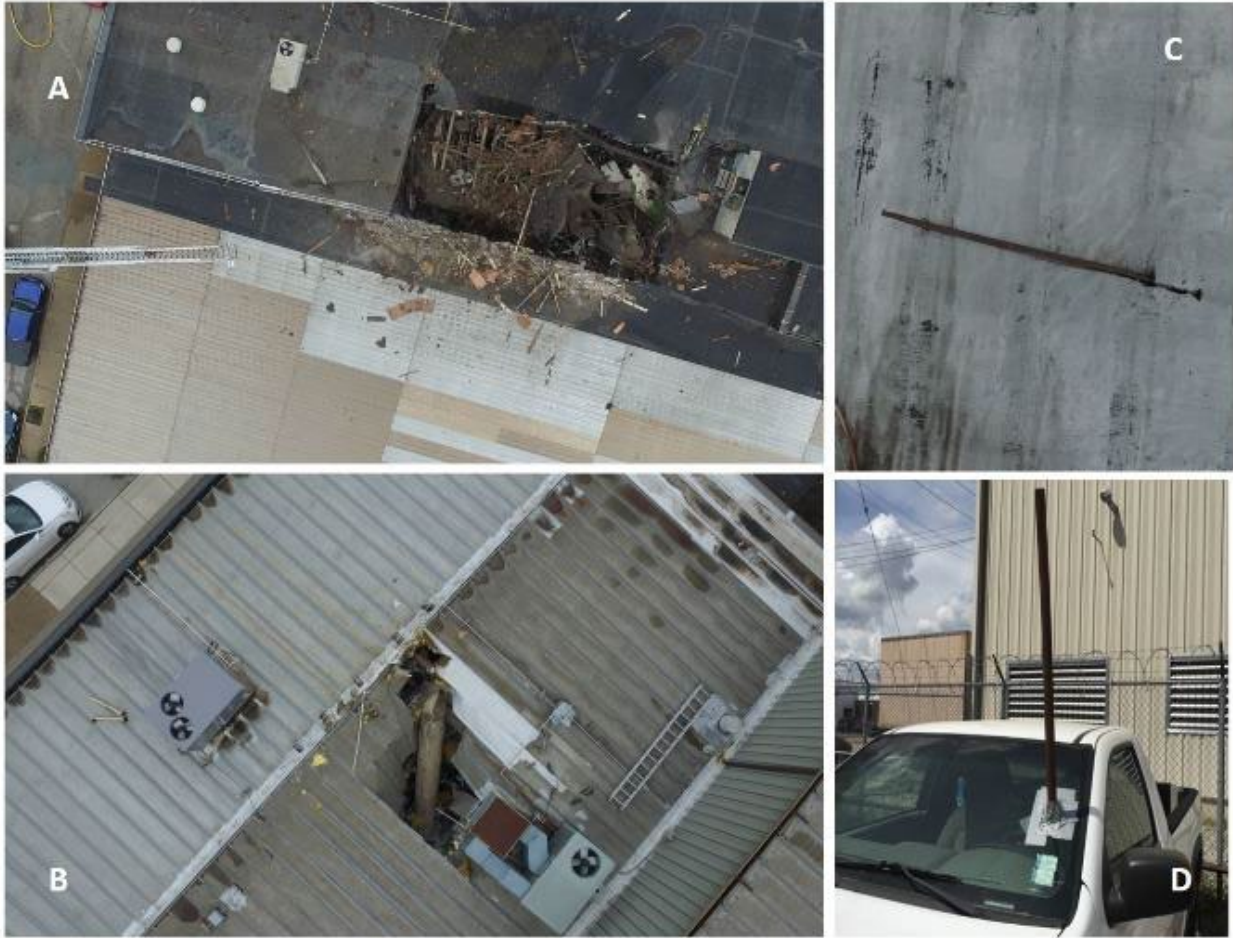
(Figure 11C). A section of 1.5-inch pipe approximately seven feet in length pierced the windshield and embedded in the dashboard and through the floorboard of an unoccupied pickup truck parked in the area (Figure 11D). A map of the debris field is shown in Figure 12. As a result of the incident, one stationary engineer at Loy-Lange was fatally injured. At Faultless Healthcare Linen, three employees were fatally injured when the SCR fell through the roof.

Figure 11. Damage from the incident. (Credit A-C: St. Louis Fire Department, D: CSB)

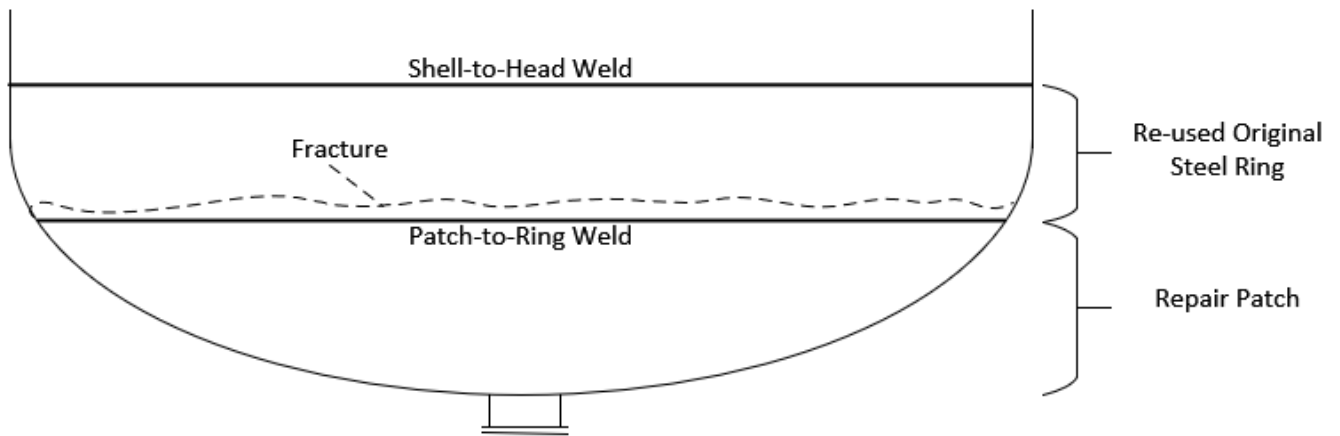
Figure 14. Conceptual illustration of fracture in SCR bottom head. (Credit: CSB)

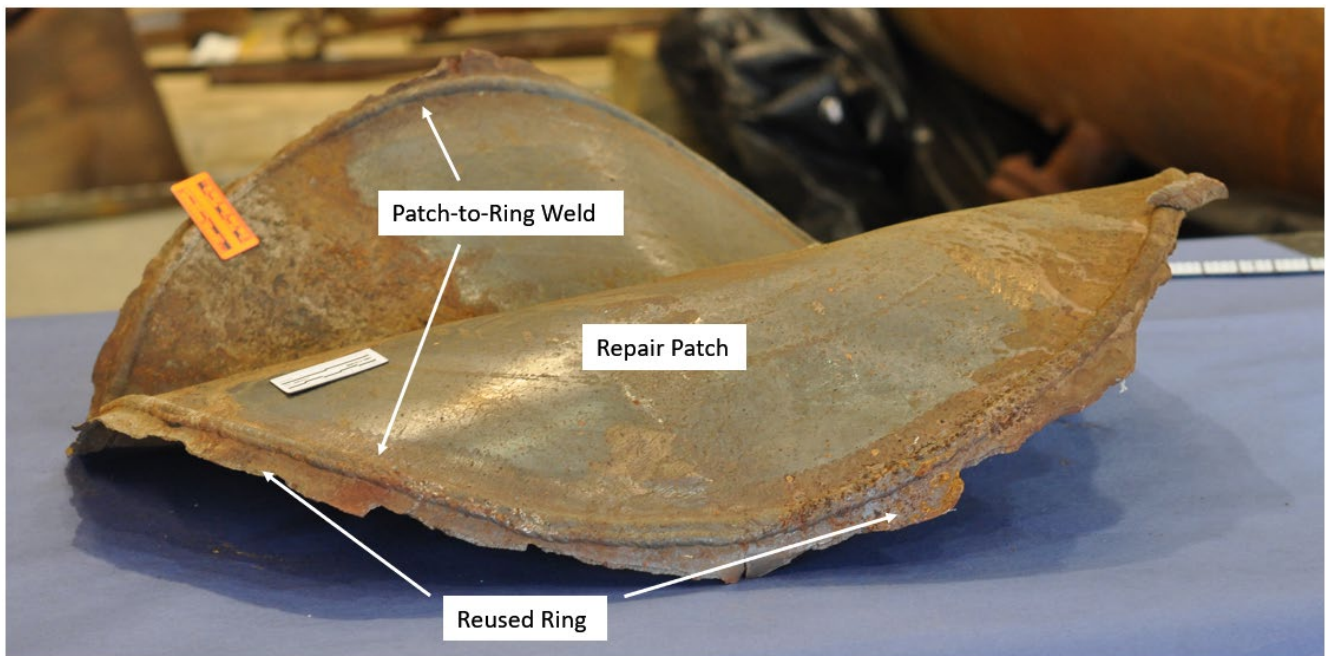
Figure 15. Photo of failed section of SCR bottom head. (Credit: CSB)

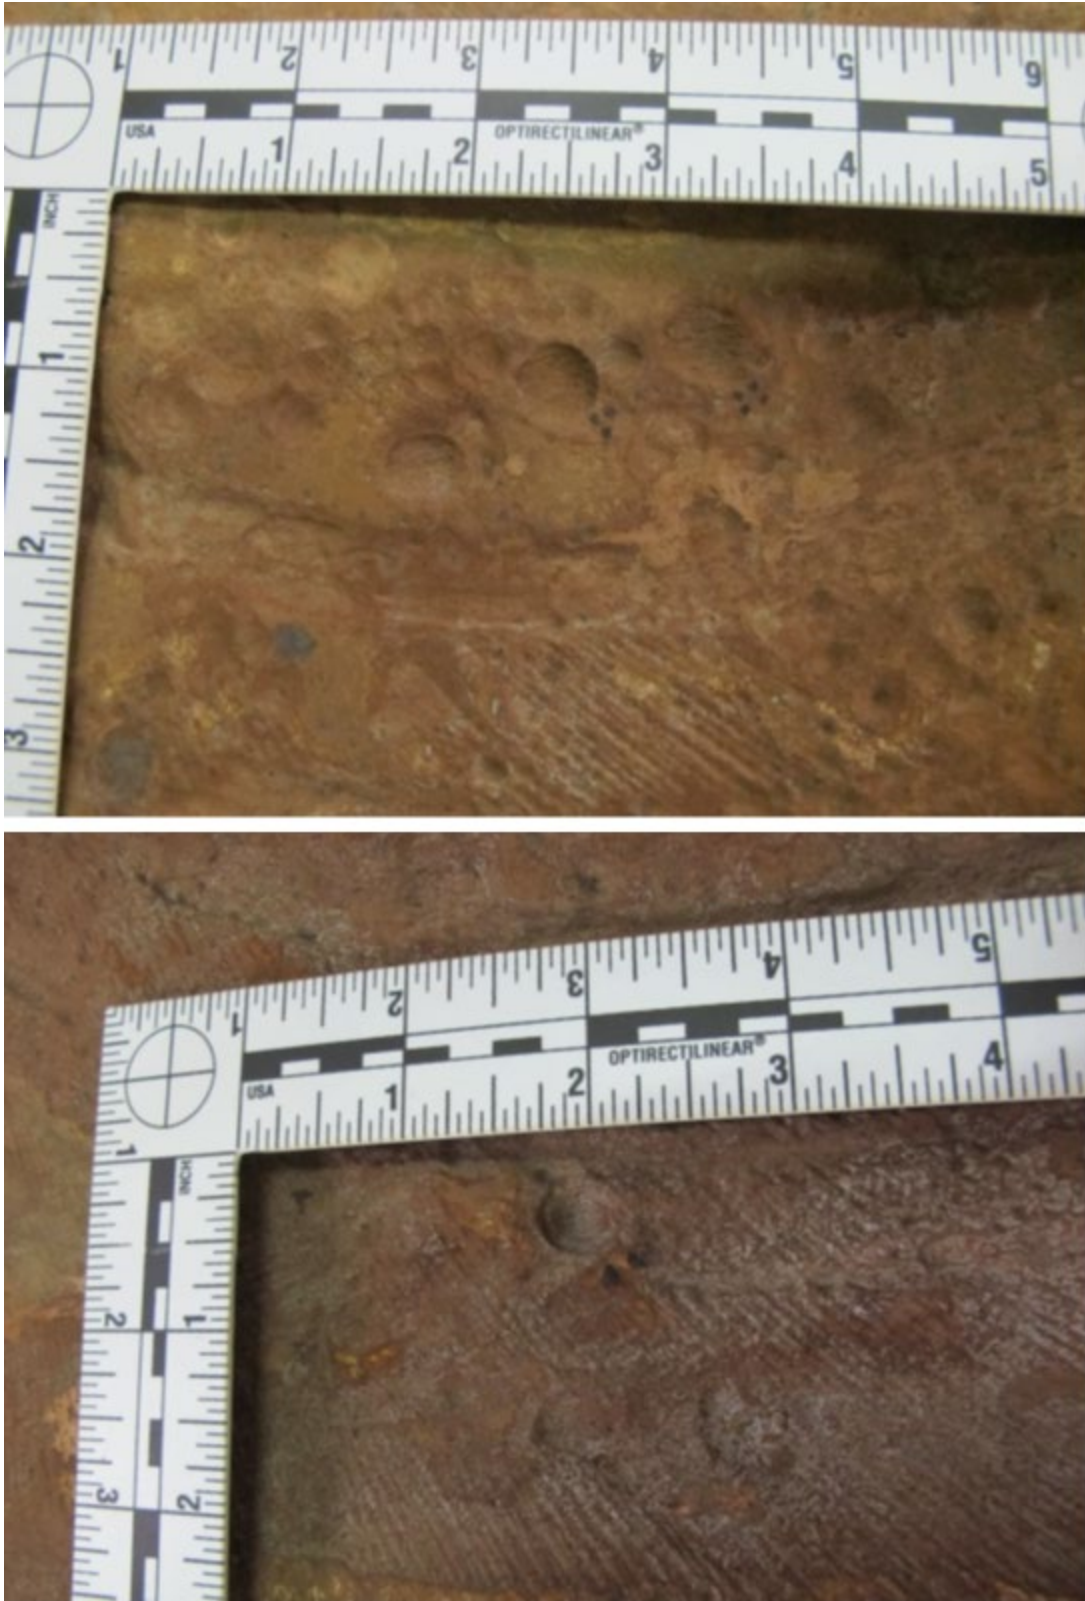
Extensive pitting and generalized corrosion damage (**Figure 16**) was found in both the separated portion of the bottom head and in the portion of the bottom head that remained attached to the SCR shell. This pitting and generalized corrosion damage is consistent with the appearance of oxygen pitting and corrosion damage. The shell and upper head were found to be relatively unaffected by corrosion damage, as pictured in **Figure 17**.

Figure 16. Pitting corrosion damage in SCR bottom head. (Credit: CSB)

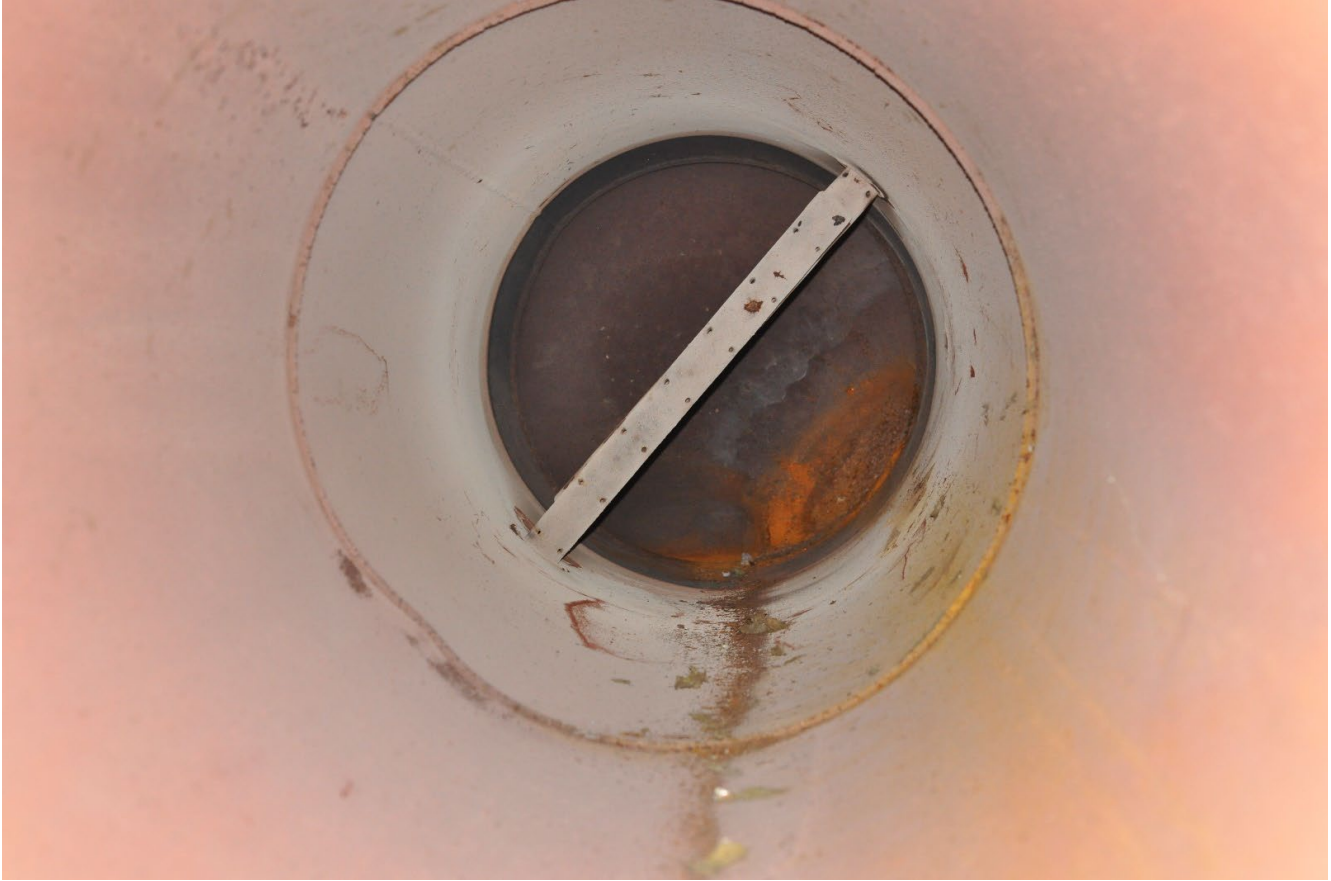
**Figure 17.** Photo of the inside surface of the SCR shell and upper head. (Credit: CSB)

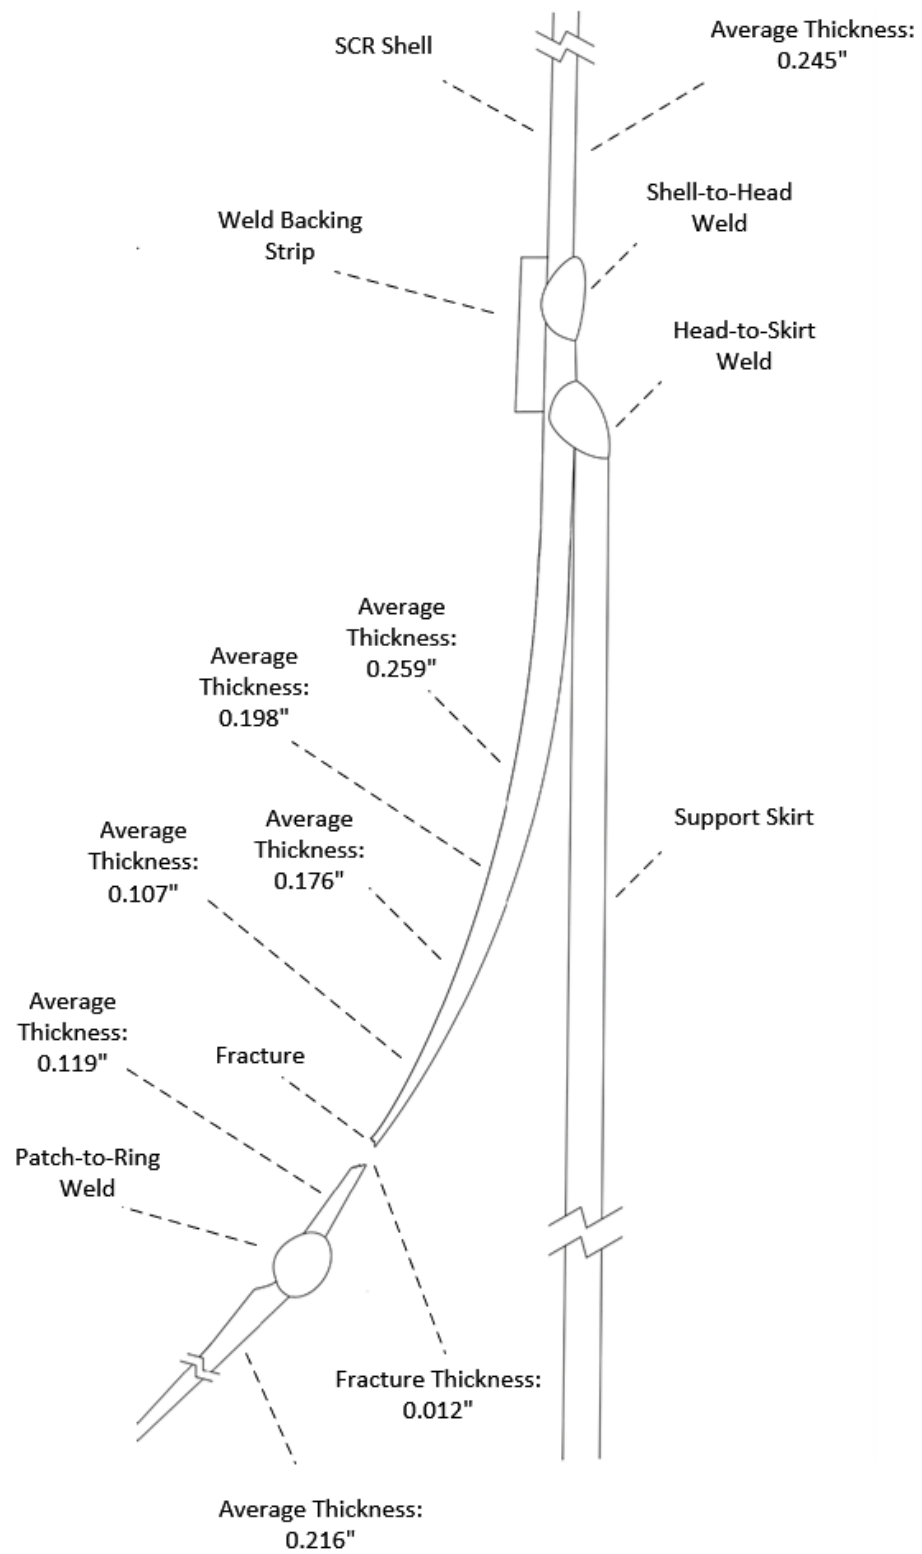
The CSB commissioned comprehensive non-destructive thickness examination of the SCR after the incident. Some of the examination findings are illustrated in **Figure 18**. The thickness of adjacent spots on either side of the patch-to-ring weld were measured and compared (**Figure 19**). On average, the repair patch was almost twice as thick as the re-used original steel ring.

**Figure 18.** Conceptual cross-sectional diagram of the SCR bottom head, showing examination findings. (Credit: CSB)

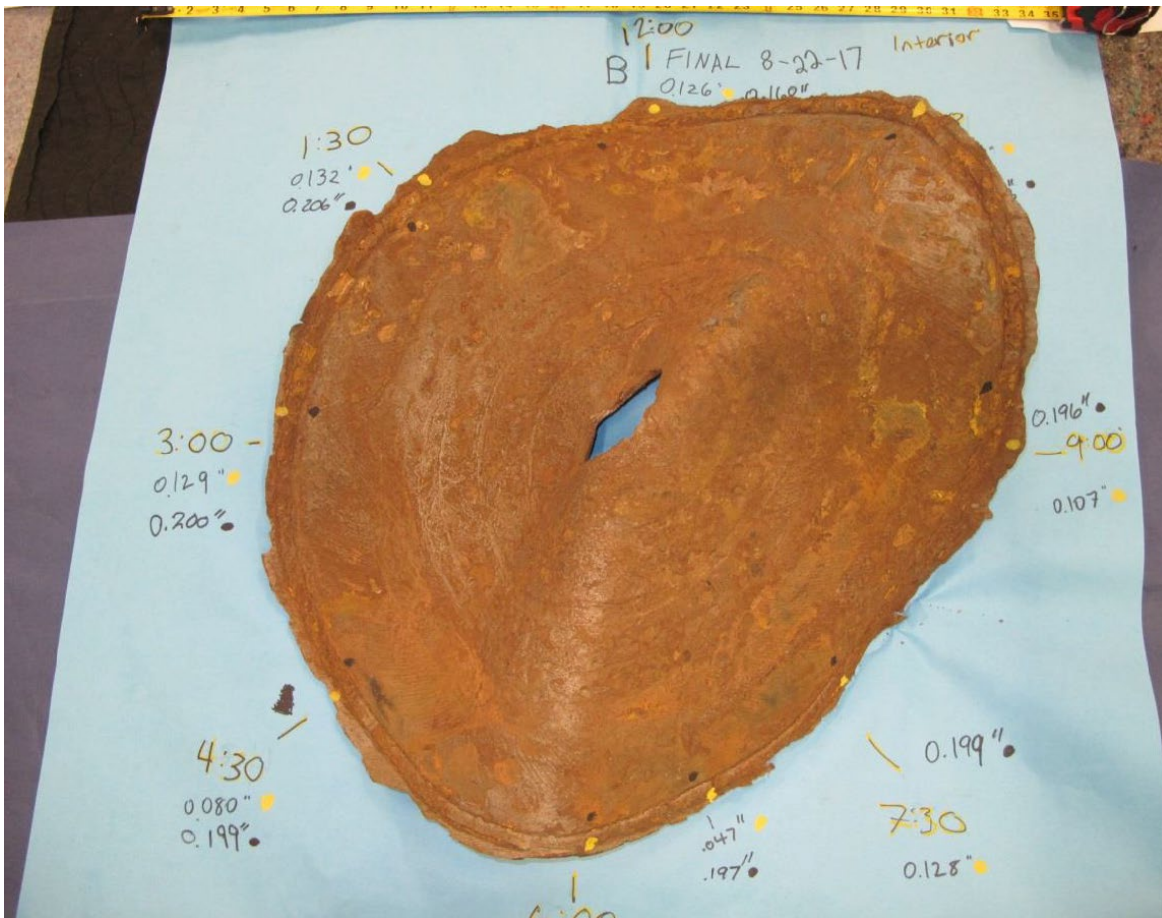
Figure 19. Thickness comparison on either side of patch-to-ring weld. (Credit: CSB)

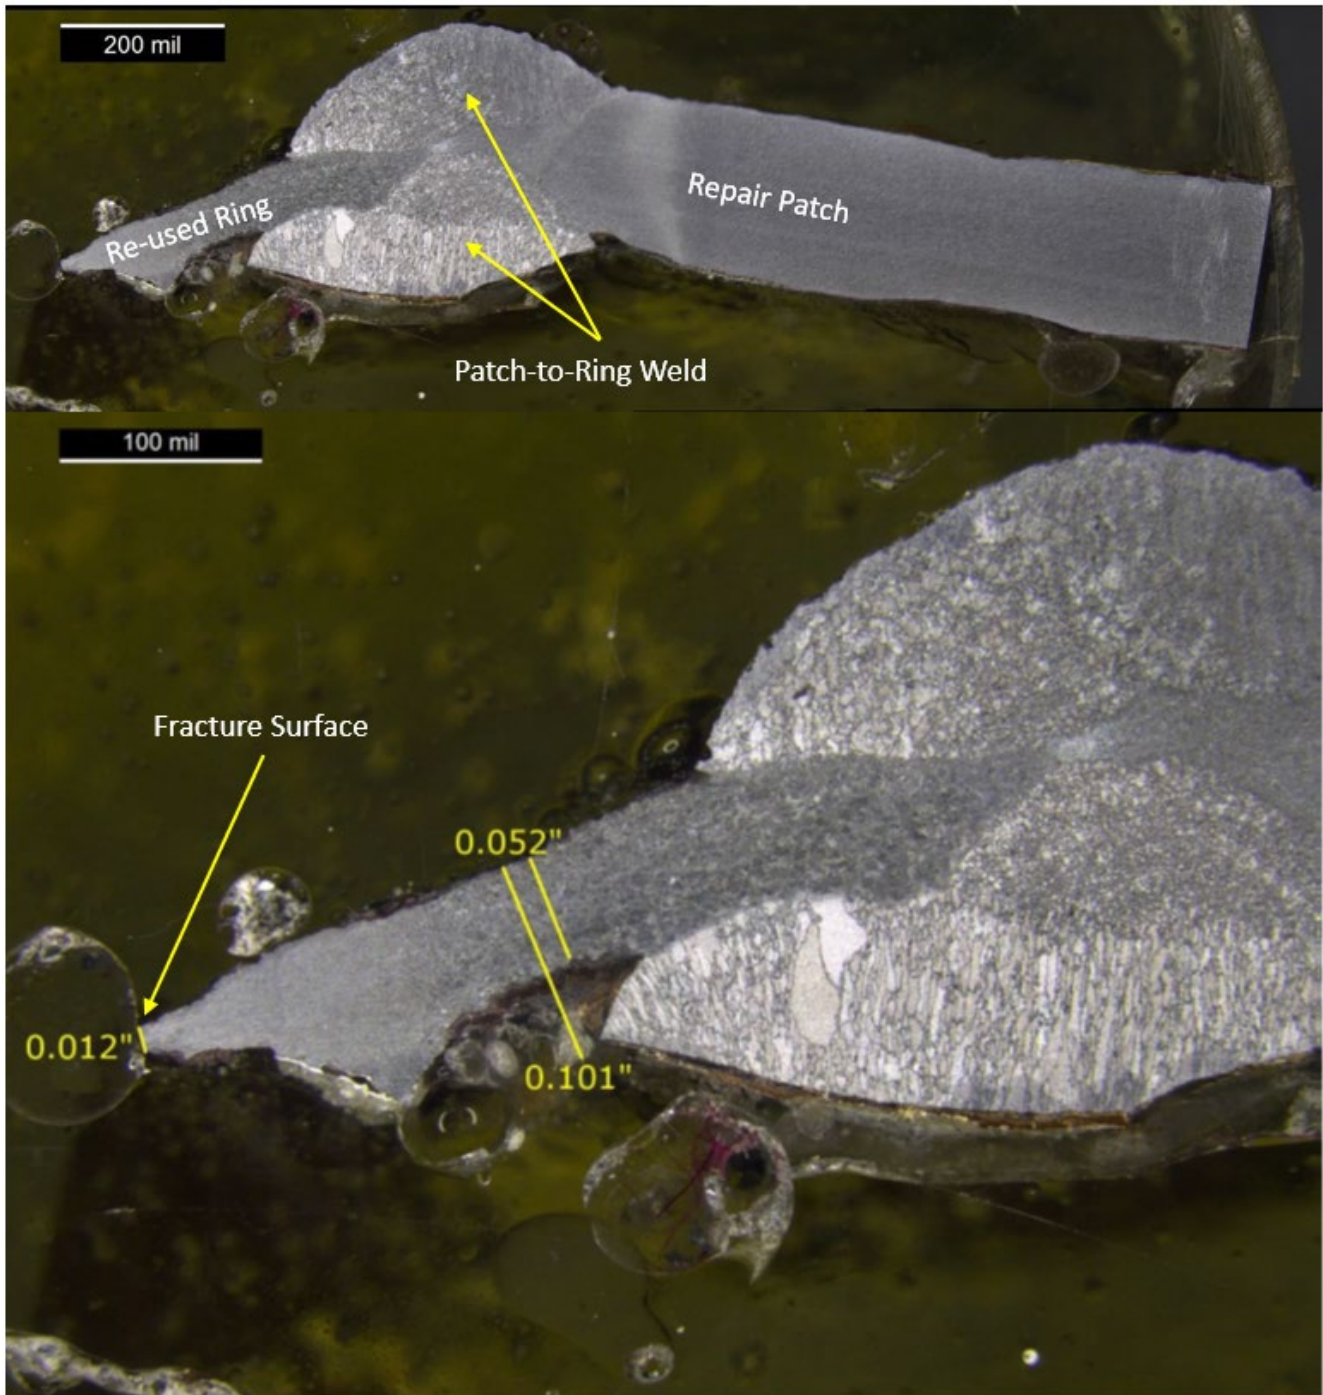
Destructive thickness examination found that corrosive attack reduced the nominally 0.250-inch steel to 0.012 inches at the thinnest spot measured, a thickness loss of 95 percent (**Figure 20**). The spot that measured 0.012 inches was at the fracture edge, in the re-used ring. The average post-incident thickness of the re-used ring around the periphery of the fracture, as measured by calipers, was 0.107 inches. The examination also discovered four weld repairs in the portion of the re-used ring that remained attached to the shell. These welds were cross-sectioned and examined. Three of the four welds were weld overlays, used to fill in thin spots from the inside of the vessel. The fourth was a plug weld, used to plug a full penetration through the thickness of the head. All four of these welds were made to the ring of bottom head material that remained attached to the SCR shell. A photo documenting one of the weld overlays is shown in **Figure 21**, and photos documenting the plug weld are shown in **Figure 22**.

Figure 20. Post-Incident metallurgical examination of patch-to-ring weld and fracture. (Credit: CSB)

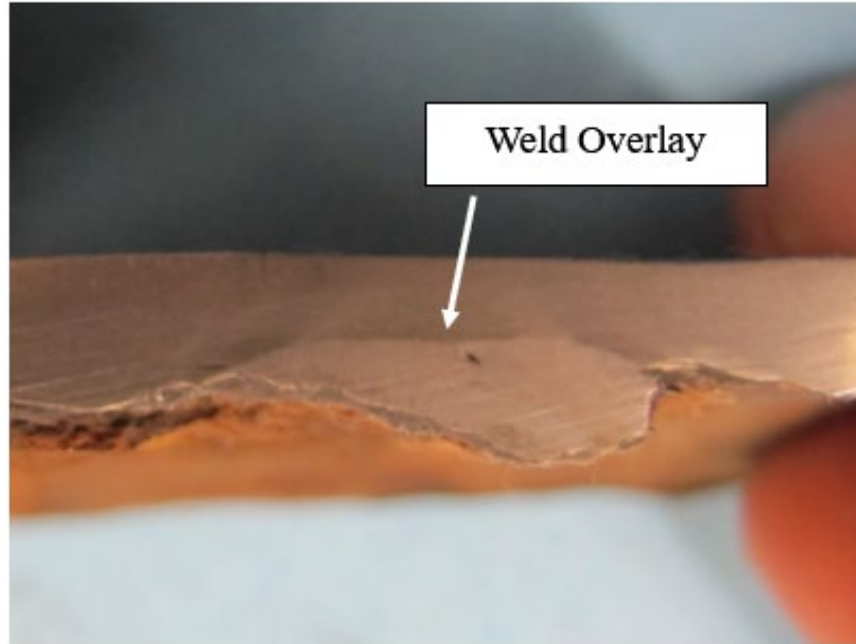
**Figure 21.** Weld overlay found in the ring of steel still attached to the shell, cross-sectioned. (Credit: CSB)

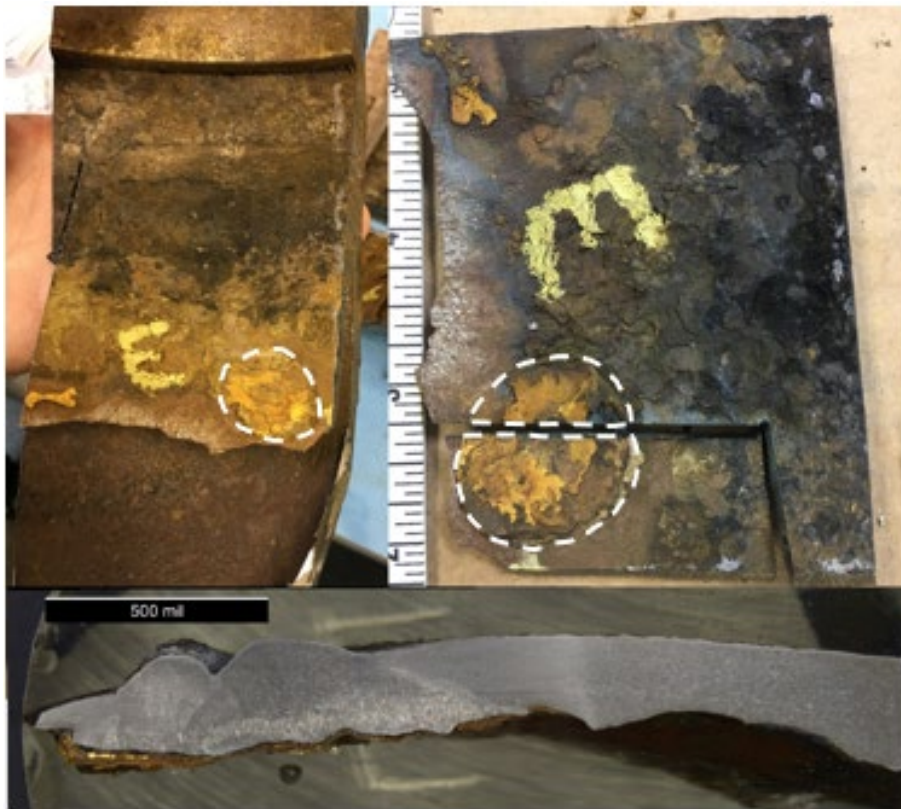
**Figure 22.** Plug weld found in the ring of steel still attached to the shell, cross-sectioned. (Credit: CSB)

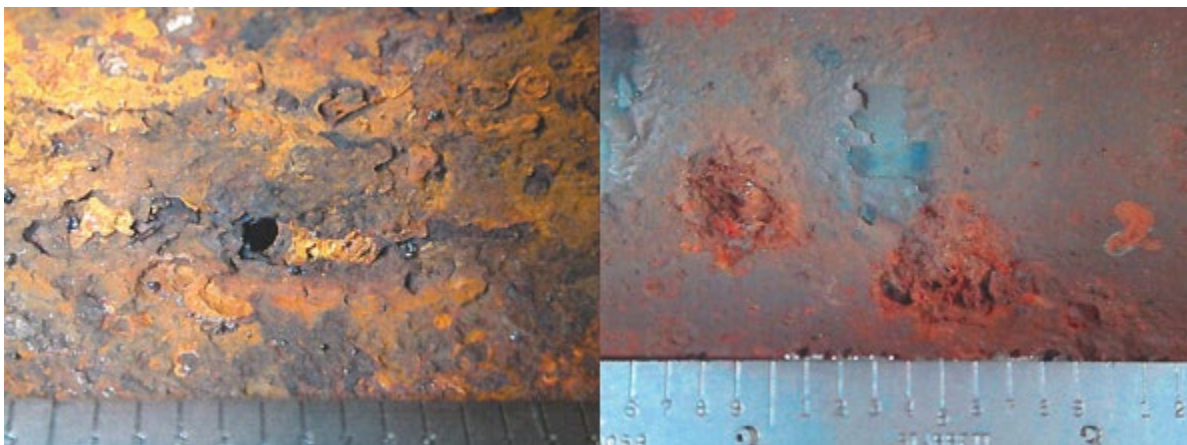
In addition to these leaks in the SCR, Loy-Lange experienced corrosion in other parts of the steam system. The CSB found documentation of one known steam separator leak and four generator coil failures.<sup>a</sup> **Figure 28** shows the oxygen pitting corrosion found in two of the four generator coil failures. The images were taken by Clayton after Loy-Lange submitted the failed coils to Clayton for warranty replacement consideration. The left image is of a 2002 coil failure and the right image is of a 2004 coil failure.

**Figure 28.** Pitting damage in two of Loy-Lange’s steam coils. (Credit: Clayton)

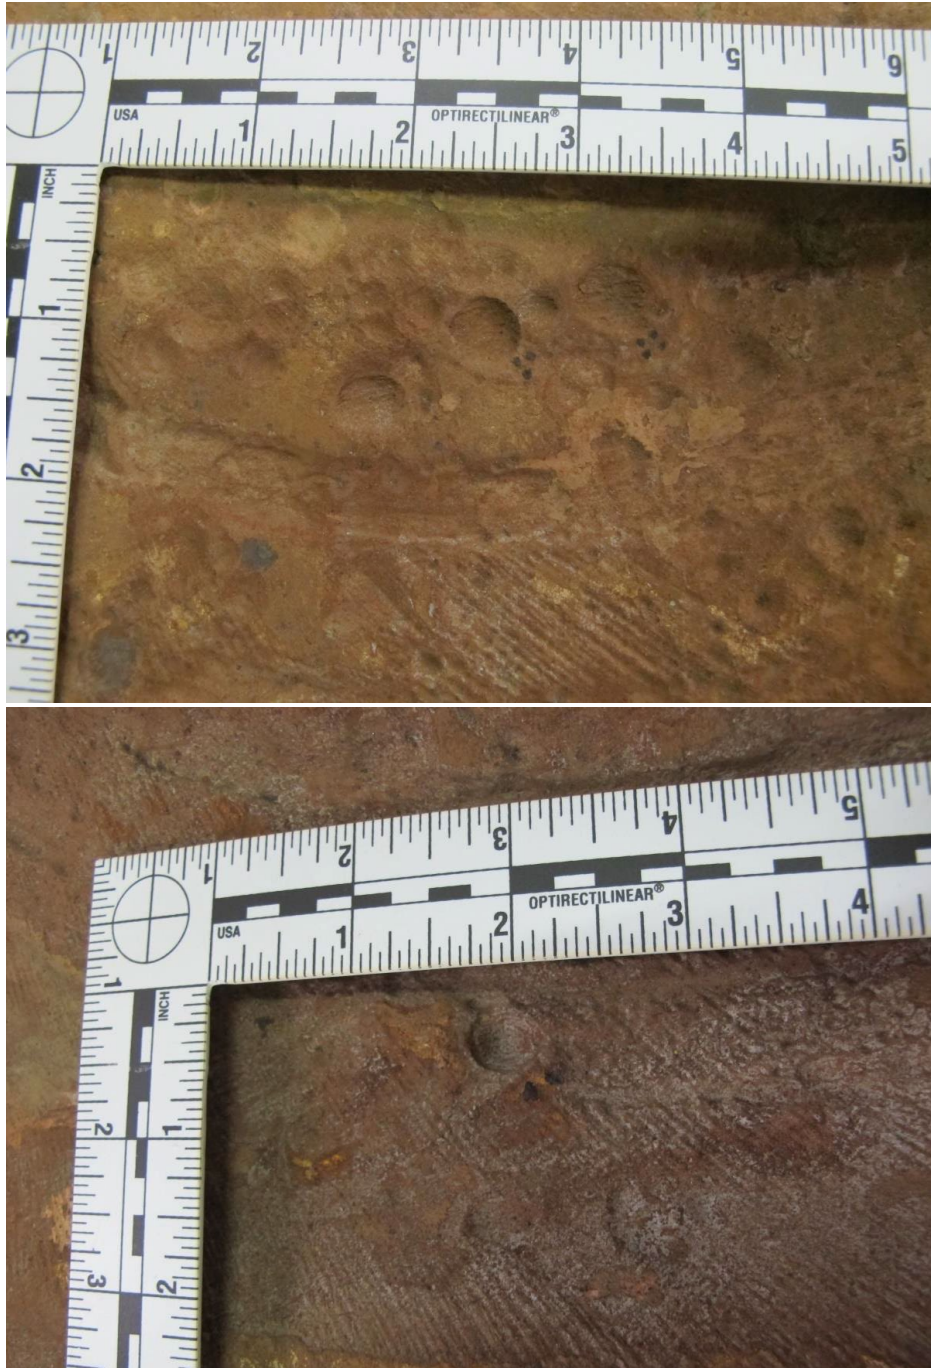
**Figure 30.** Pitting corrosion damage in SCR bottom head. (Credit: CSB)

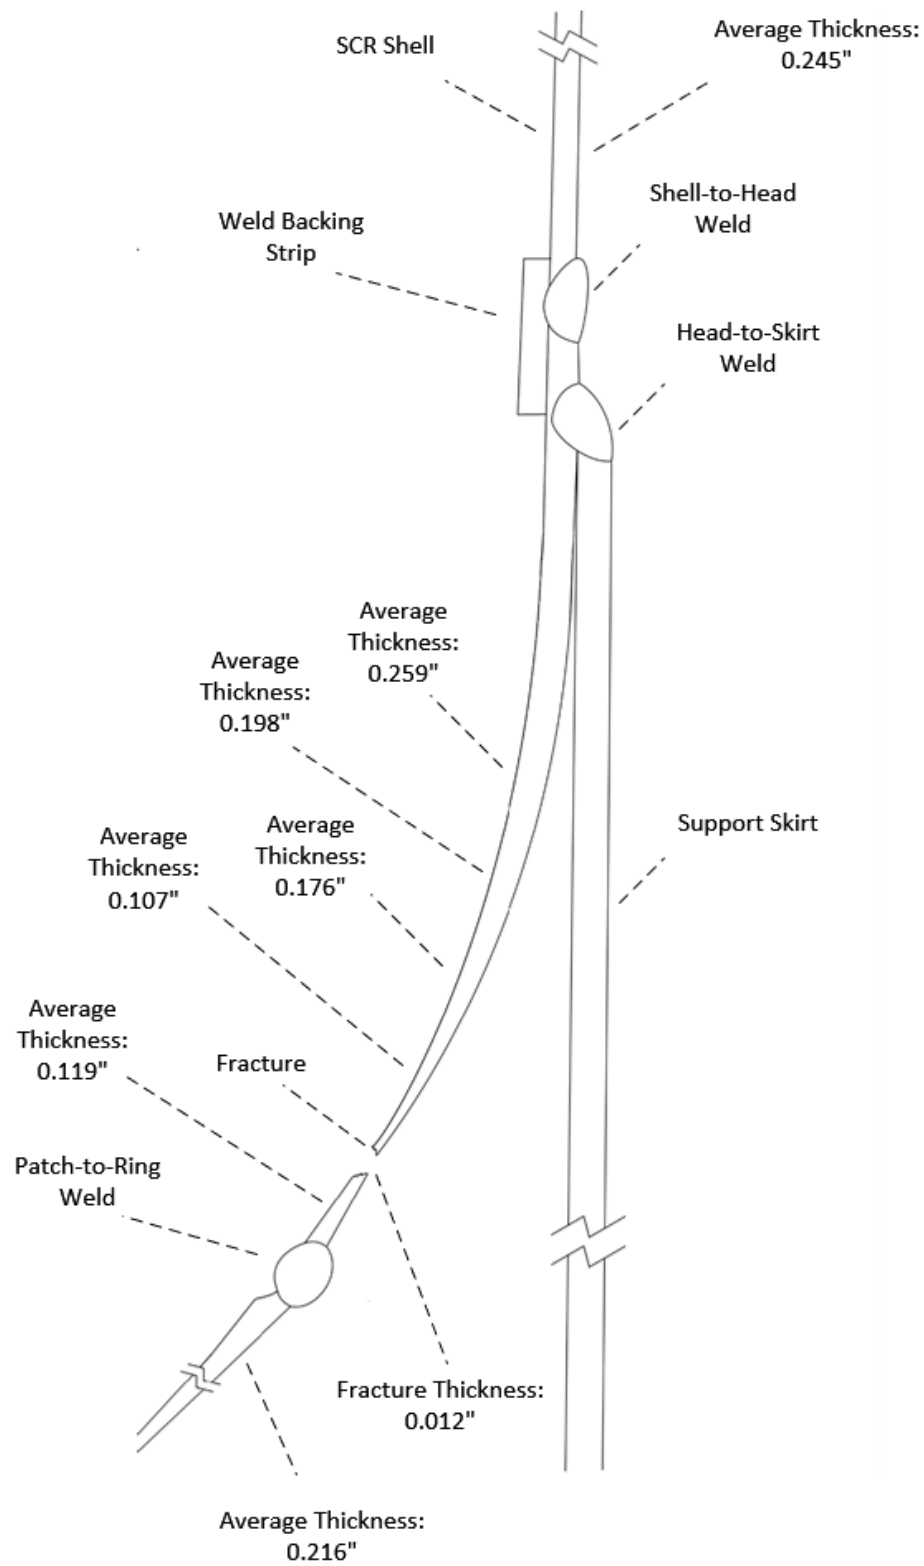
**Figure 31.** Conceptual cross-sectional diagram of the SCR bottom head, showing examination findings. (Credit: CSB)

The minimum thickness of the SCR bottom head, specified on the vessel's U1A form, was 0.2204 inches. As shown above in **Figure 31**, the average thickness of nearly the entire SCR bottom head was thinner than the required thickness after the incident. The thinnest spot measured on the fracture surface, likely the fracture initiation point, was measured at 0.012 inches, and the average thickness near the patch to ring weld was roughly half the minimum required thickness.

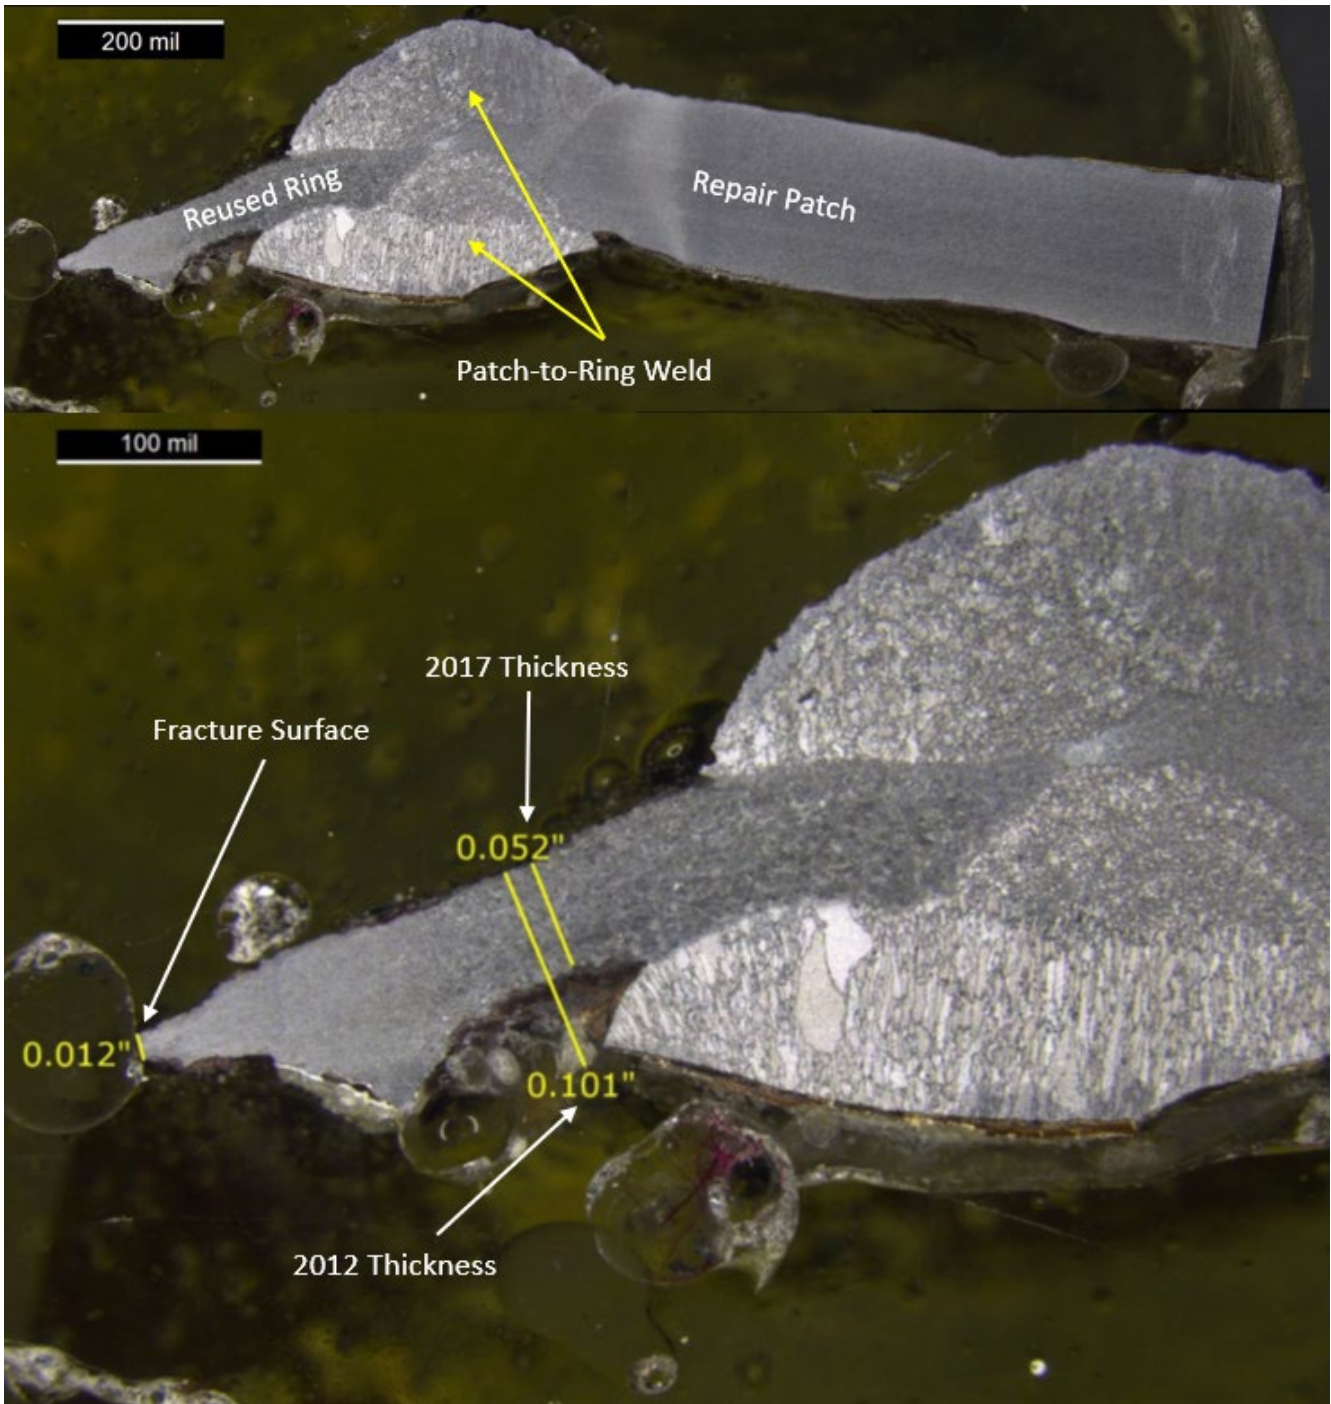
Figure 33. Metallurgical mount examination of a portion of the reused ring. (Credit: CSB)

Based on the metallurgical examination and corrosion calculations, there is evidence that the 2012 repair did not remove all existing corrosion damage. It is important to remove all corroded material that is too thin to meet the vessel's minimum thickness requirements because a decrease in thickness could impact the pressure retaining ability of the vessel. The CSB concludes that Kickham likely left thinned material in place when it repaired the SCR bottom head in 2012, and in so doing did not adhere to the requirements of *NBIC Part 3 Repair and Alterations*.

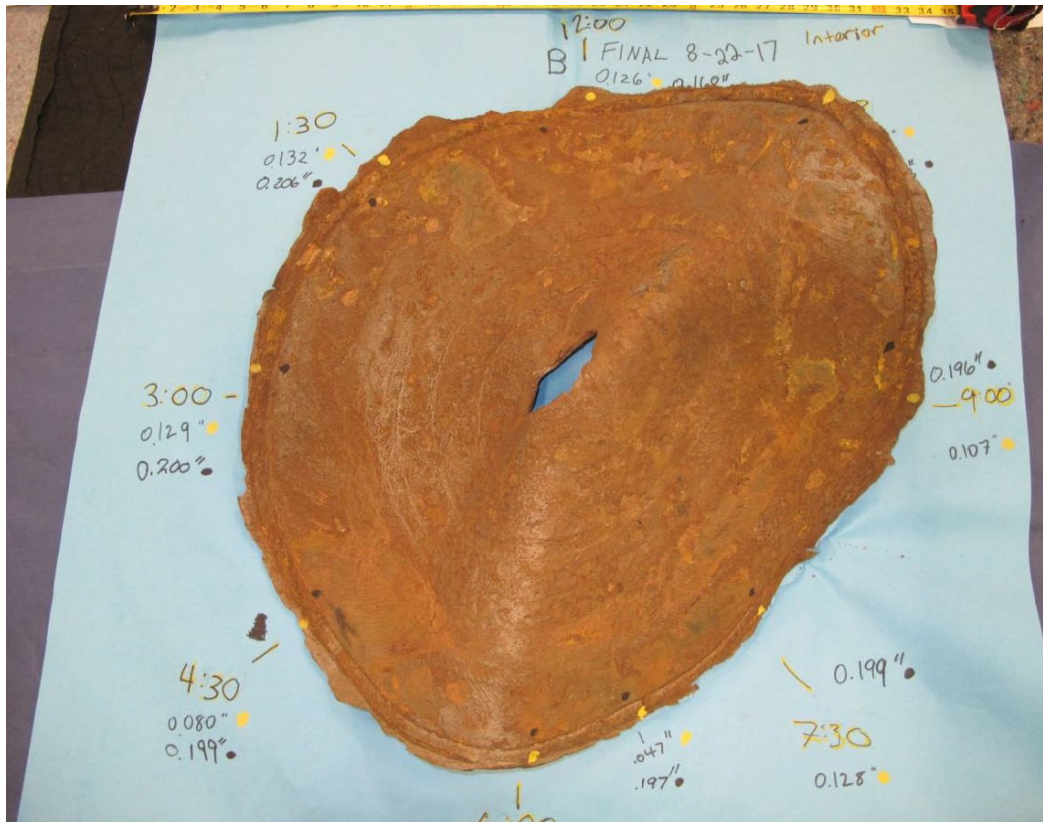
**Figure 34.** Thickness comparison on either side of patch-to-ring weld. (Credit: CSB).
