U.S. CHEMICAL SAFETY AND HAZARD INVESTIGATION BOARD

INVESTIGATION REPORT

TOXIC CHEMICAL VAPOR CLOUD RELEASE

REPORT NO. 2004-09-I-GA

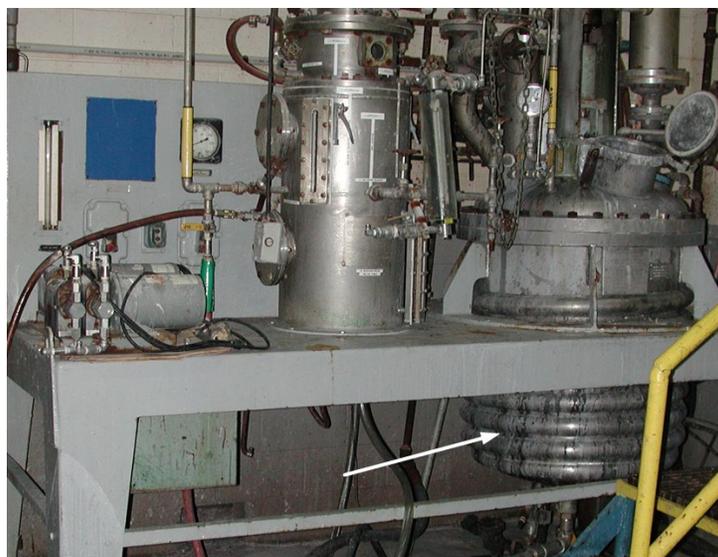
Controlling the temperature of the reacting chemicals was significantly more difficult in the 4000-gallon reactor than in the 30-gallon reactor. The heat removal capacity of a reactor equipped with an external jacket is directly proportional to the ratio of the jacketed surface area to the reactor volume. This surface-to-volume ratio decreases as the reactor volume increases,¹⁰ thus the ability to remove excess heat may be significantly less in a large production reactor compared to the bench-scale reactor. Scaling to the 4000-gallon production reactor made controlling the batch temperature much more difficult.

Figure 3. Small batch test reactors. Reactor cooling jacket (arrow) is similar to the 4000-gallon production reactor.

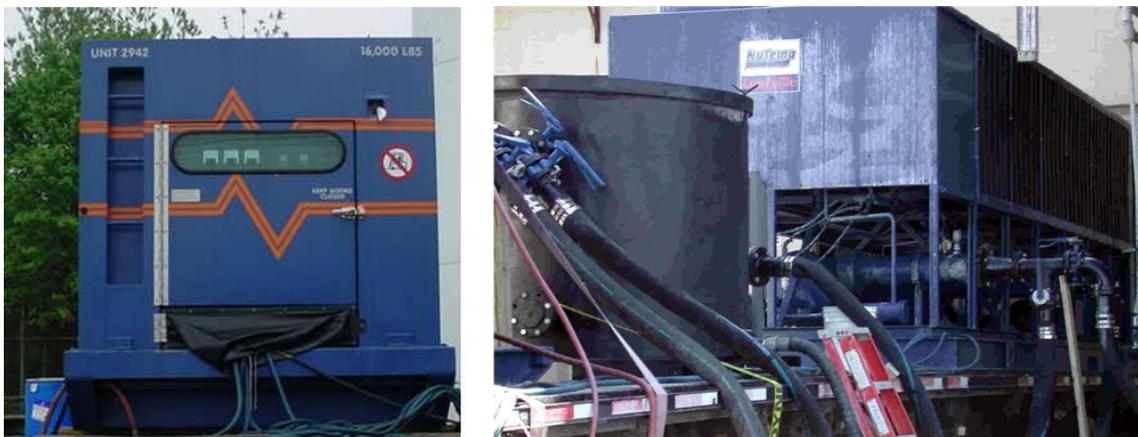
start and stop the system. Since the TAC procedure did not specify any cooling system adjustments, the chiller system was not set up to provide for easy adjustments.

Figure 4. Portable cooling system used to cool the reactor. Generator (left), and chiller (right).

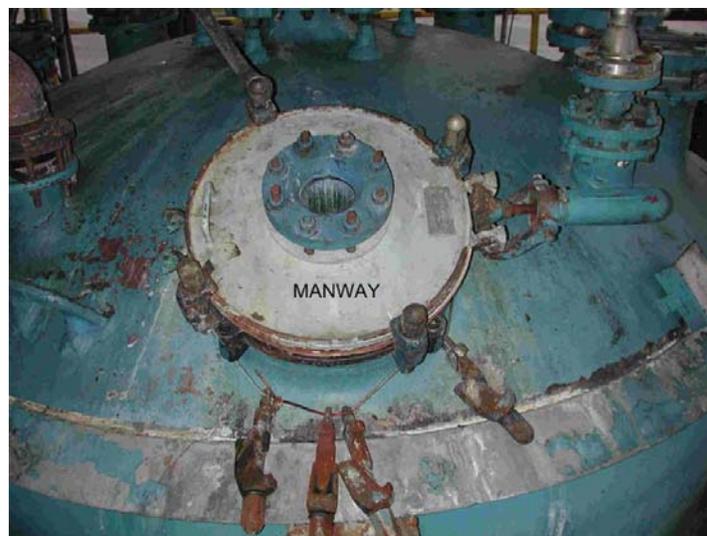
Figure 6. The 18-inch reactor manway.

Operators initially considered approaching the reactor manway to attempt to reseal the gasket, but the leak was too large to stop and the venting vapor was moving toward them. With the two reactants and the catalyst fully charged into the reactor, no ability to increase the cooling rate, no emergency dilution system, and no reactor vent scrubber,¹⁷ they had no choice but to evacuate the area. All seven personnel safely evacuated the facility as the vapor cloud rapidly expanded and began drifting off site to the north and east.

Tuesday afternoon at 1:00 PM, more than 15 hours after the incident began, the reactor had cooled to 70°F and the reaction appeared to have ended. MFG personnel installed a new rupture disk, replaced the manway gasket, and tightened the clamps. The IC terminated the fire department response activities now that the reactor was resealed.

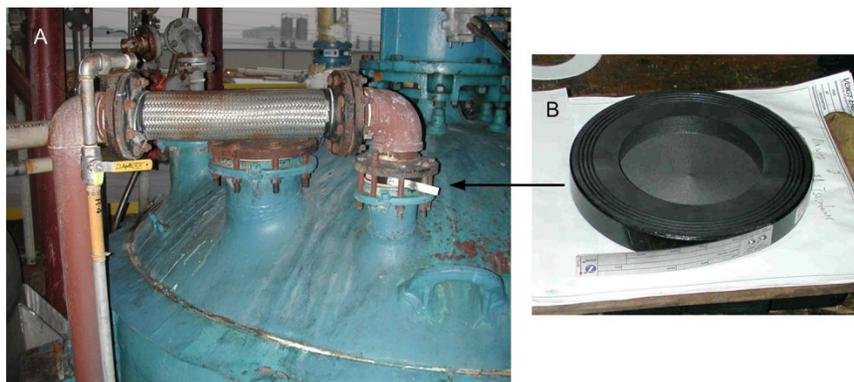
Figure 8. Overpressure rupture disc and vent pipe on top of reactor. An exemplar of the rupture disc (right).

in a runaway reaction. The increasing pressure blew out the manway gasket, and then the rupture disk. The vapor continued venting for many hours, until the reaction consumed all the reactants.

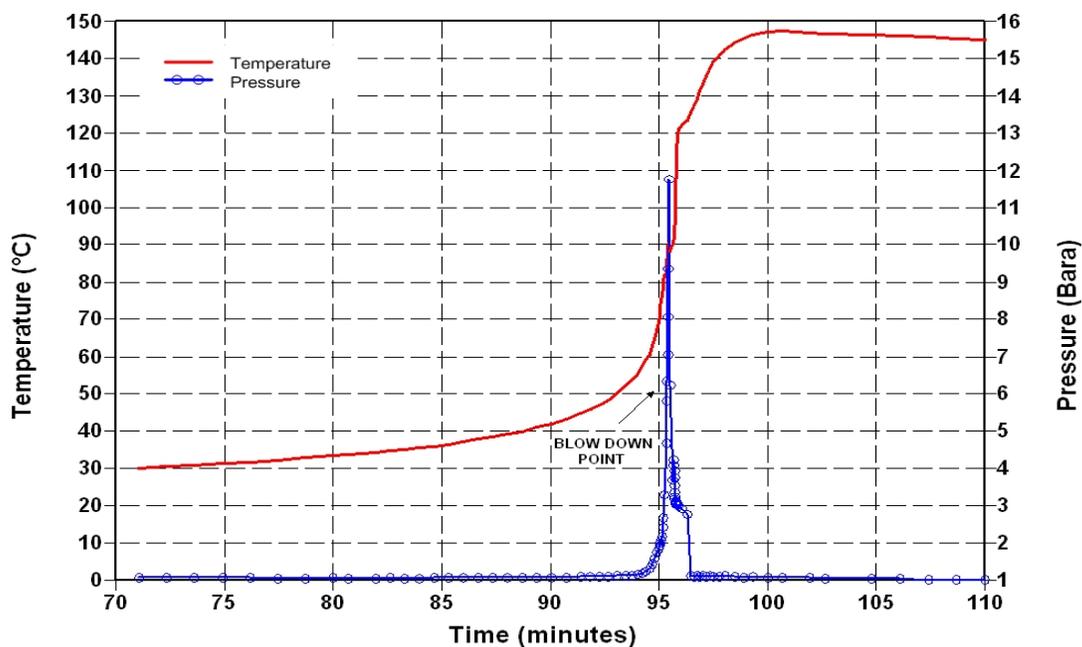
confirmed that the decomposition reaction is highly energetic and capable of causing severe damage to equipment. Appendix A, Table 1 summarizes the test results.

Figure 11. Test cell reaction mass temperature and pressure as a function of time. The blowdown vent opened at six bara (75 psig).

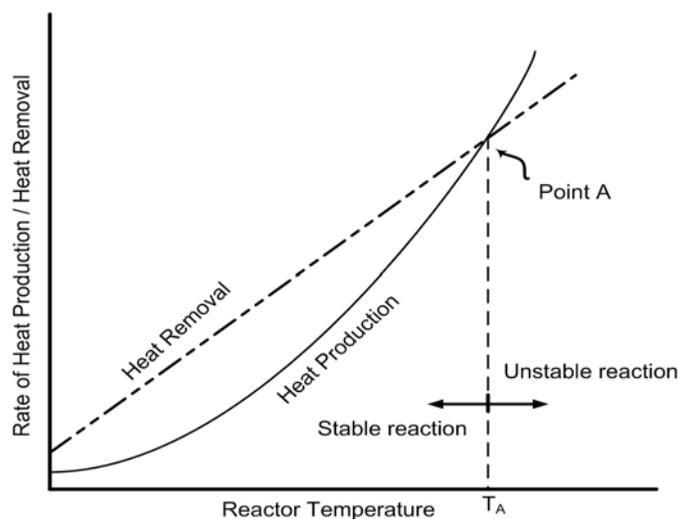
MFG personnel underestimated the heat removal rate required for TAC production because they did not consider either the TAC synthesis reaction or the decomposition reaction when they evaluated reactor cooling requirements. MFG only evaluated the cooling system requirements based on the acid neutralization step that was to occur later in the batch process. Since the procedure did not restrict the chemical addition rates, operators charged the reactor with the entire quantity of each reactant and the catalyst. The cooling system was unable to control the reactor temperature and, as the temperature rose, the decomposition reaction began to dominate, resulting

Figure 12. Typical reaction heat production and cooling system heat removal vs. reactor temperature.

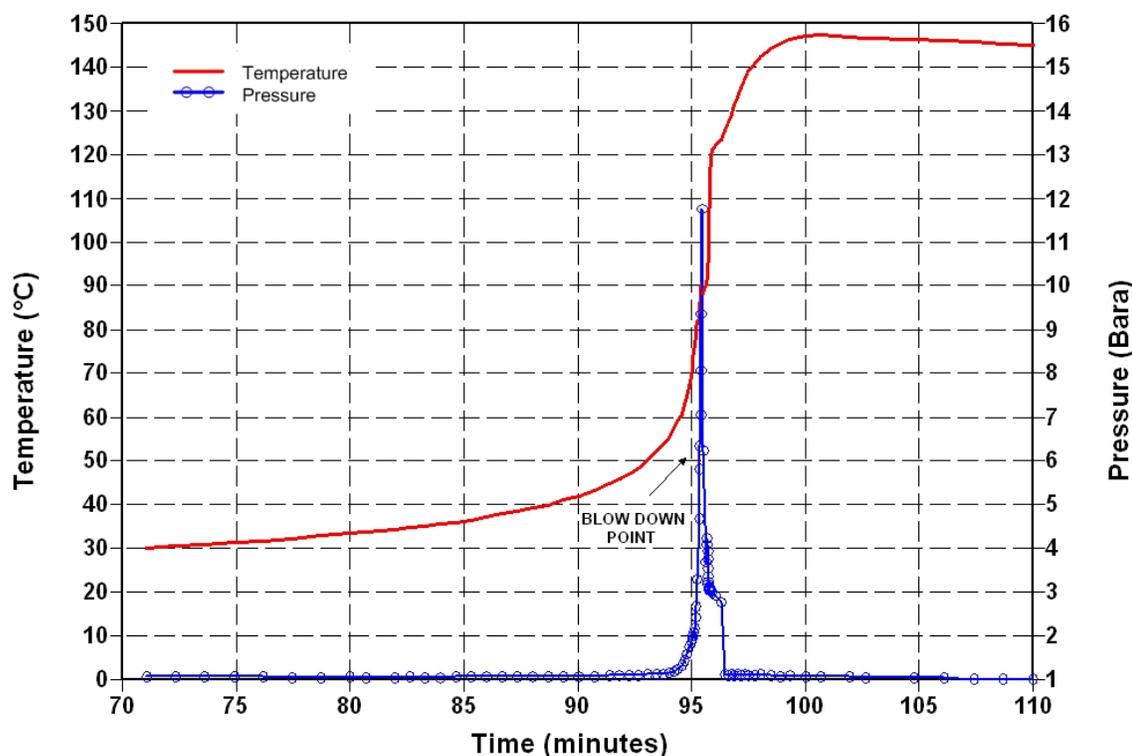
The adiabatic calorimetry testing of the TAC recipe demonstrated the extremely energetic nature of the reaction. The test that simulated the rupture disc opening (Table 1- Low Thermal Inertia, Vented) showed that the reaction progressed very slowly for about 90 minutes, after which the

temperature rapidly increased at a rate exceeding 500 °F/minute (260 °C/minute) with a pressure rise rate approaching 2260 psi/min (155 bar/minute). The test data is presented in Figure 1.

Figure 1. Test cell pressure and temperature for the low thermal inertia, vented at 6 barg (75psig) test.

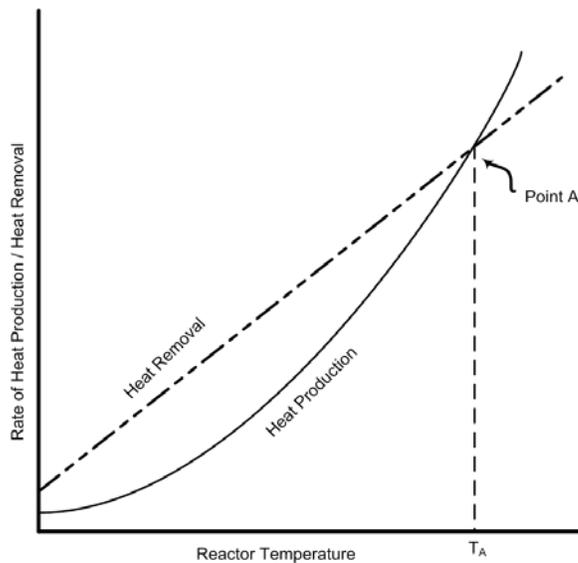
Equations 1 and 2 are shown graphically in Figure 2. If the reaction temperature exceeds the value at point A, the rate of heat production by the reaction exceeds the rate of heat removal provided by the reactor cooling jacket and the reaction will run away.

Figure 2. Heat Generation versus Heat Removal Rate

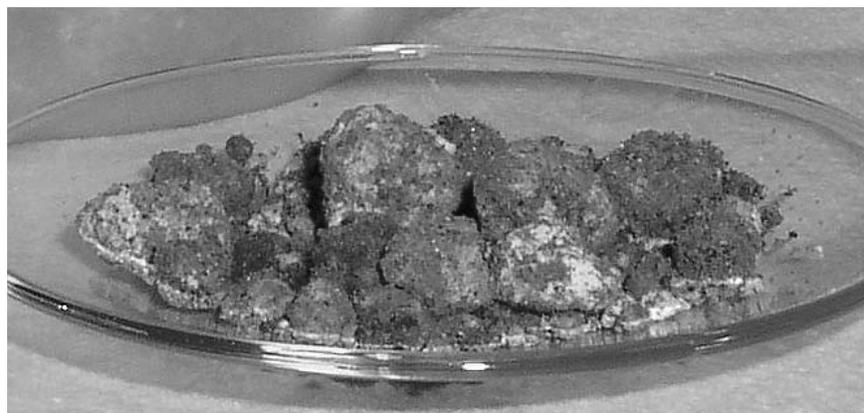
A sample taken from inside the R4 reactor was analyzed both visually and chemically. The material consisted mostly of a white solid interspersed with a small amount of granular black material (Figure 3). The black material could be elemental carbon arising from a high temperature event, such as a thermal runaway, or auto-ignition of allyl alcohol during the final stages of the runaway reaction. Auto-ignition of the allyl alcohol was possible because the maximum

temperature reached during the lab experiments of the allyl alcohol/cyanuric chloride runaway reaction was 425 °C, which exceeds the reported auto-ignition temperature of allyl alcohol (375 – 378 °C). Chemical analysis of the sample, by GC/MS, was not successful due to insolubility of the material.

Figure 3. Residue removed from the reactor after the runaway reaction.

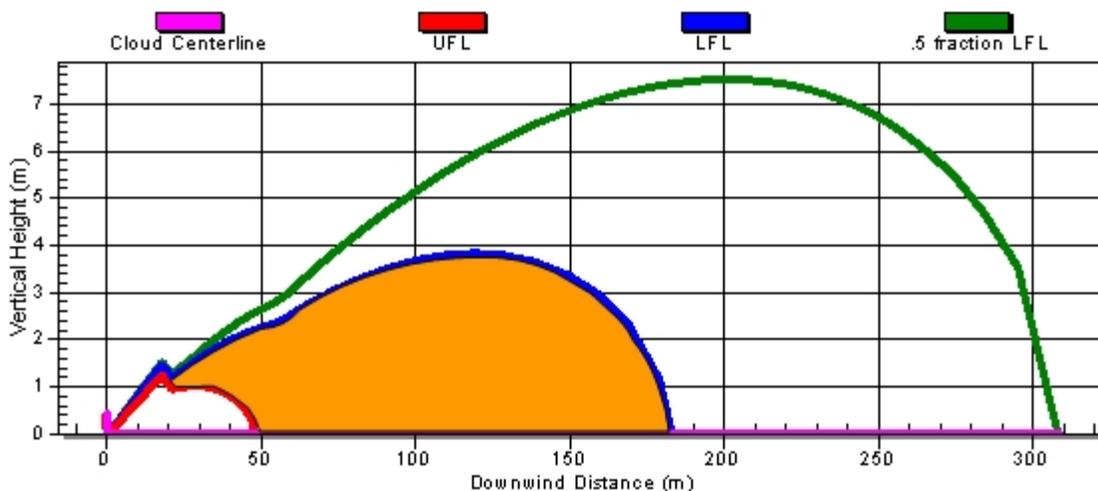
The upper and lower flammable limits for the mixture released from the reactor were calculated using LeChatelier's rule. Figure B-2 is the side-view plot of the vapor cloud rupture disc release concentration limits. The flammable concentration profiles used a 15-second averaging time, essentially the instantaneous concentration in the plume. The model predicted that the flammable range occurred between 50 and 180 meters (164 and 591 feet) from the release (shaded area in Figure 2).

Figure 2. Plume Side View Plot of Rupture Disc Release

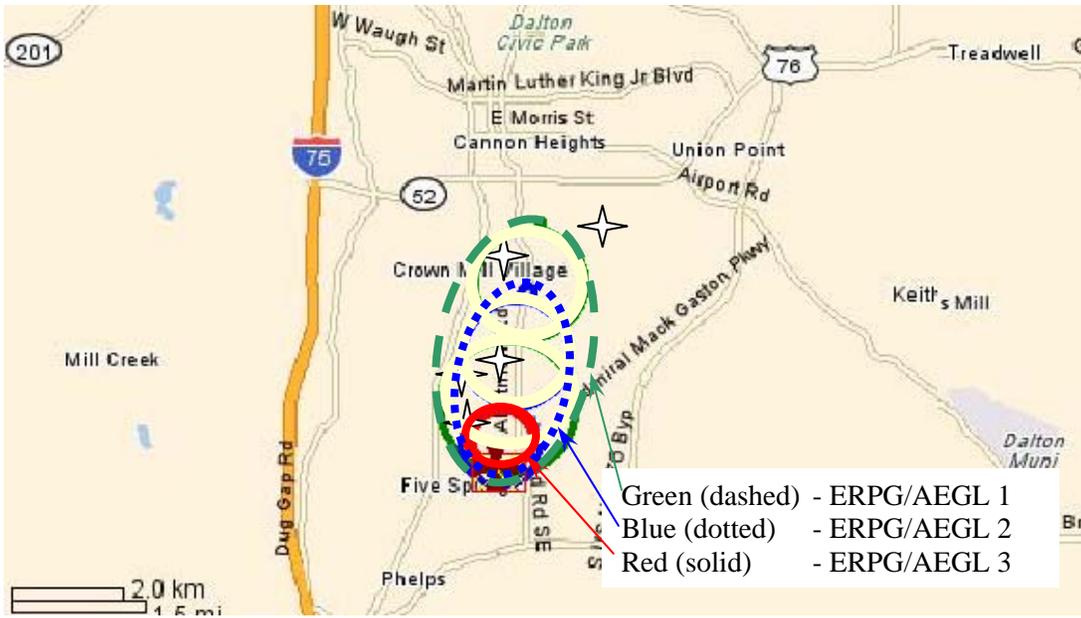
Figure 3 shows the hazard zones for the weighted average contour values for the rupture disc vent release. The stars indicate locations where people exposed to the toxic vapor made calls to the Dalton 911 call center.

Figure 3. Predicted hazard zones for the rupture disc release.

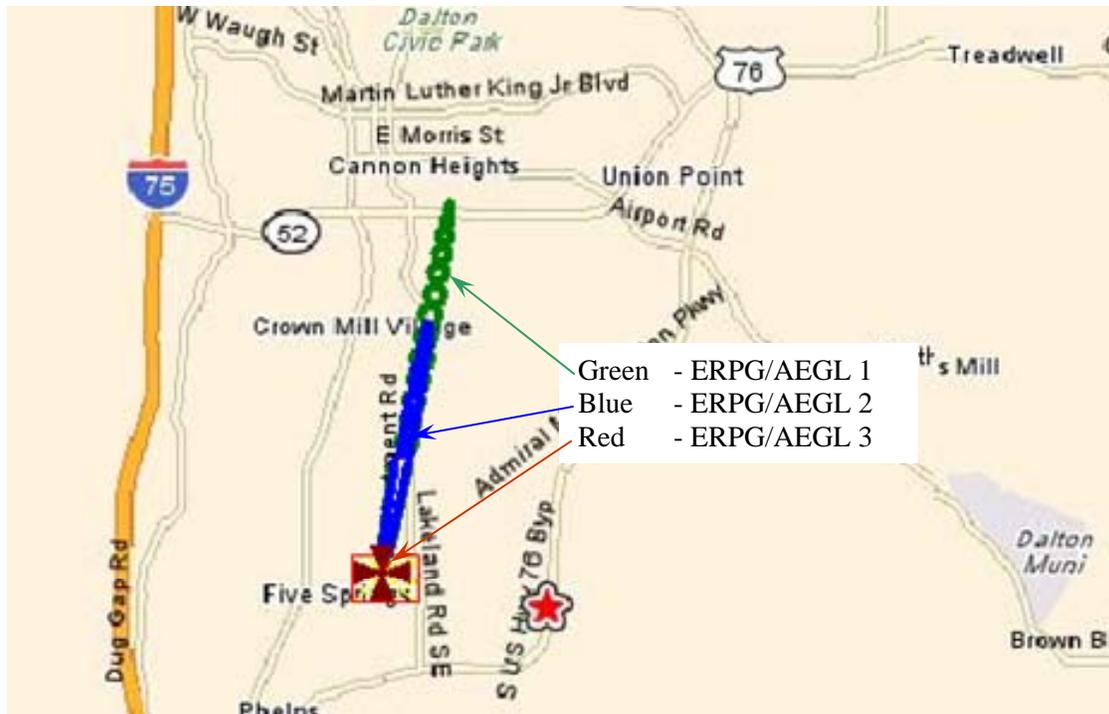
Figure 4 shows the hazard zones for the weighted average contour values for the manway gasket release. Although the manway discharge is a weaker source and the predicted dispersion is low, the small puff extends a considerable distance due to the low wind speed (approximately one meter/second) during the release. However, in dispersion prediction uncertainty increases as wind speeds decrease below about three meters/second.

Figure 4. Predicted hazard zones for the manway gasket release.
