Investigation Report

Published: June 12, 2019

On January 22, 2018, a blowout and rig fire occurred at Pryor Trust 0718 gas well number 1H-9, located in Pittsburg County, Oklahoma. The fire killed five workers, who were inside the driller's cabin on the rig floor. They died from thermal burn injuries and smoke and soot inhalation. The blowout occurred about three-and-a-half hours after removing drill pipe ("tripping") out of the well.

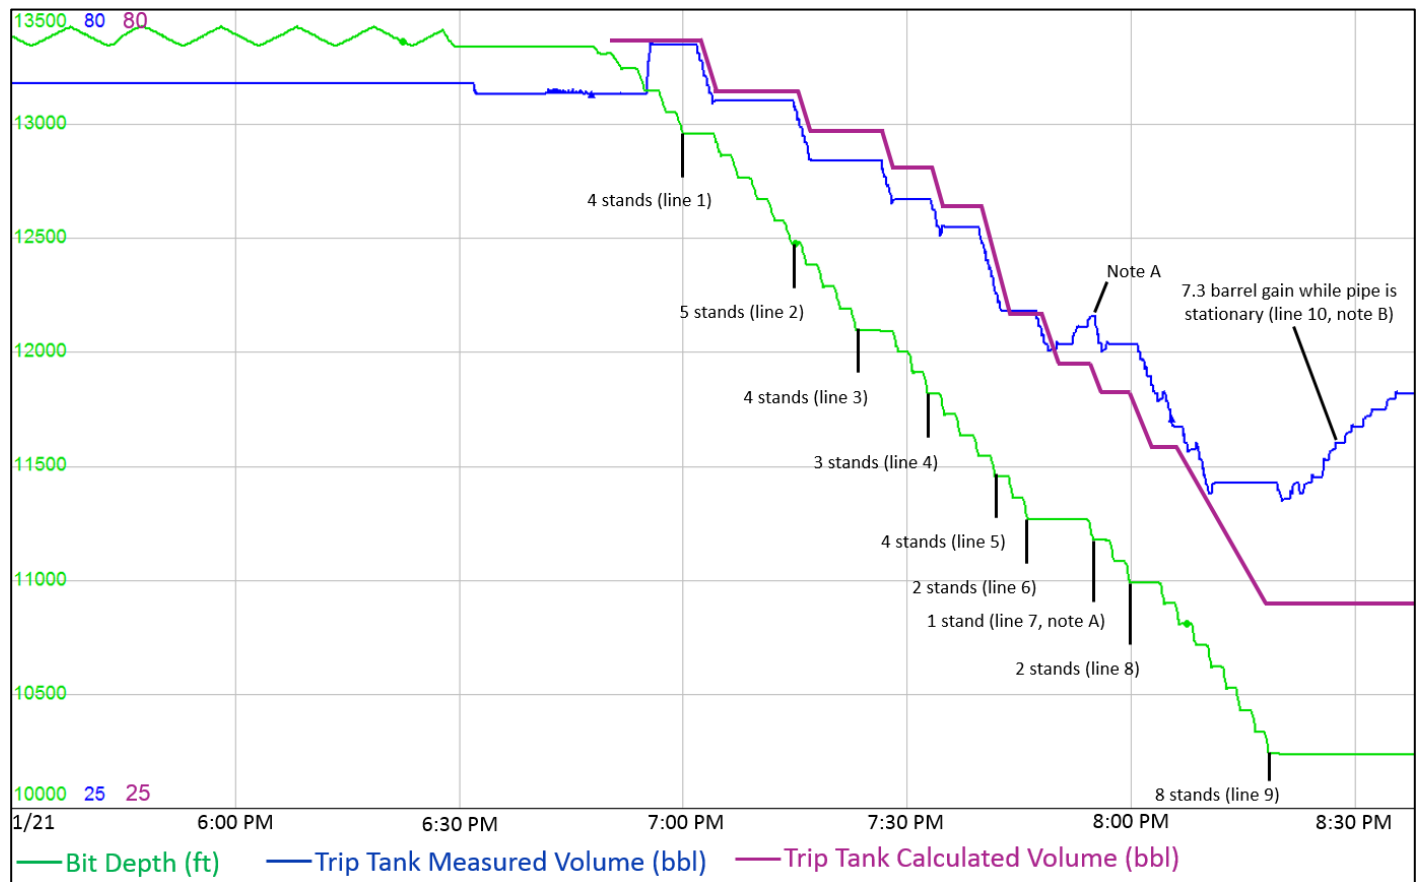
Figure 13. Rig data during the trip out of the wellbore from 13,337 feet to 10,237 feet. The blue line shows the actual, measured trip tank volume, and the purple line shows what the trip tank volume would be had a mud volume equal to the calculated volume of the drill pipe removed been pumped into the well. The line numbers and notes indicated in parentheses correspond to the line numbers and notes in Table 1 below.

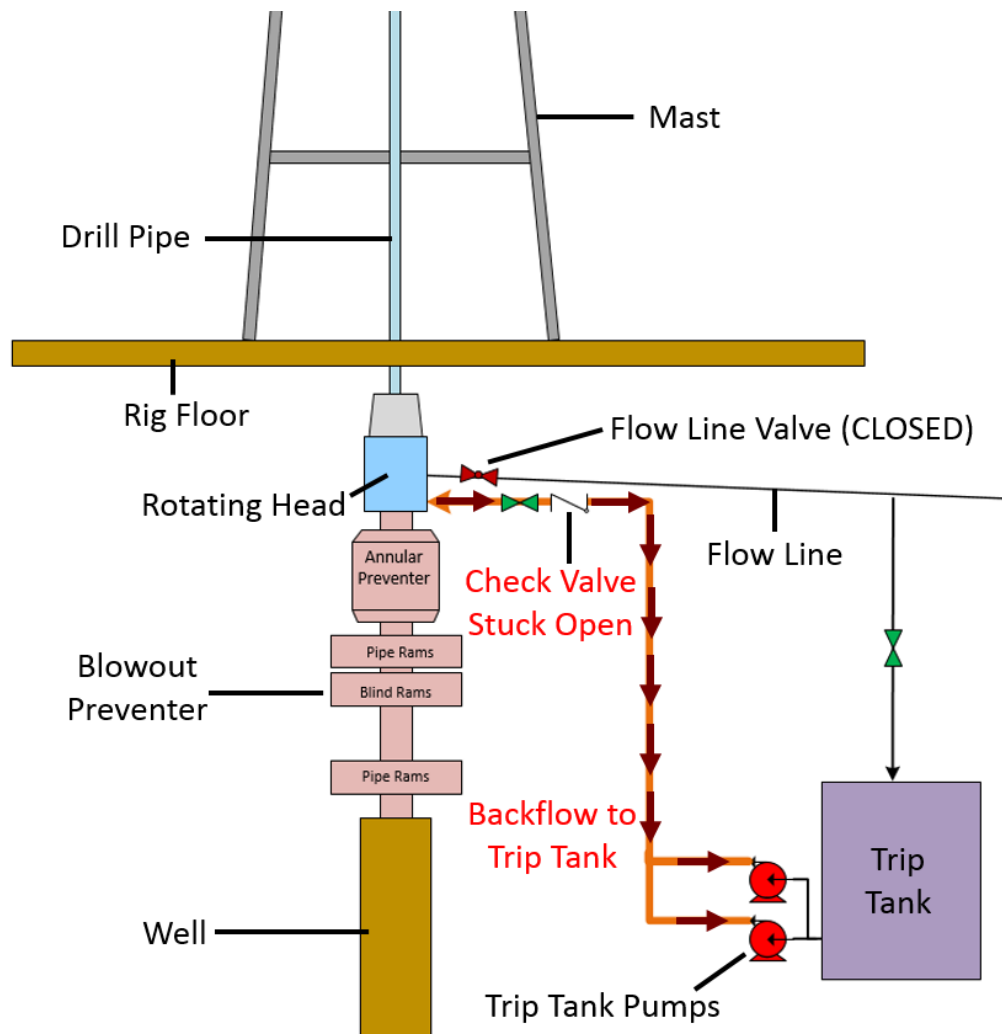
Figure 14. Pressurized mud backflowed through trip tank discharge piping, stuck-open check valve, and centrifugal pumps into trip tank.

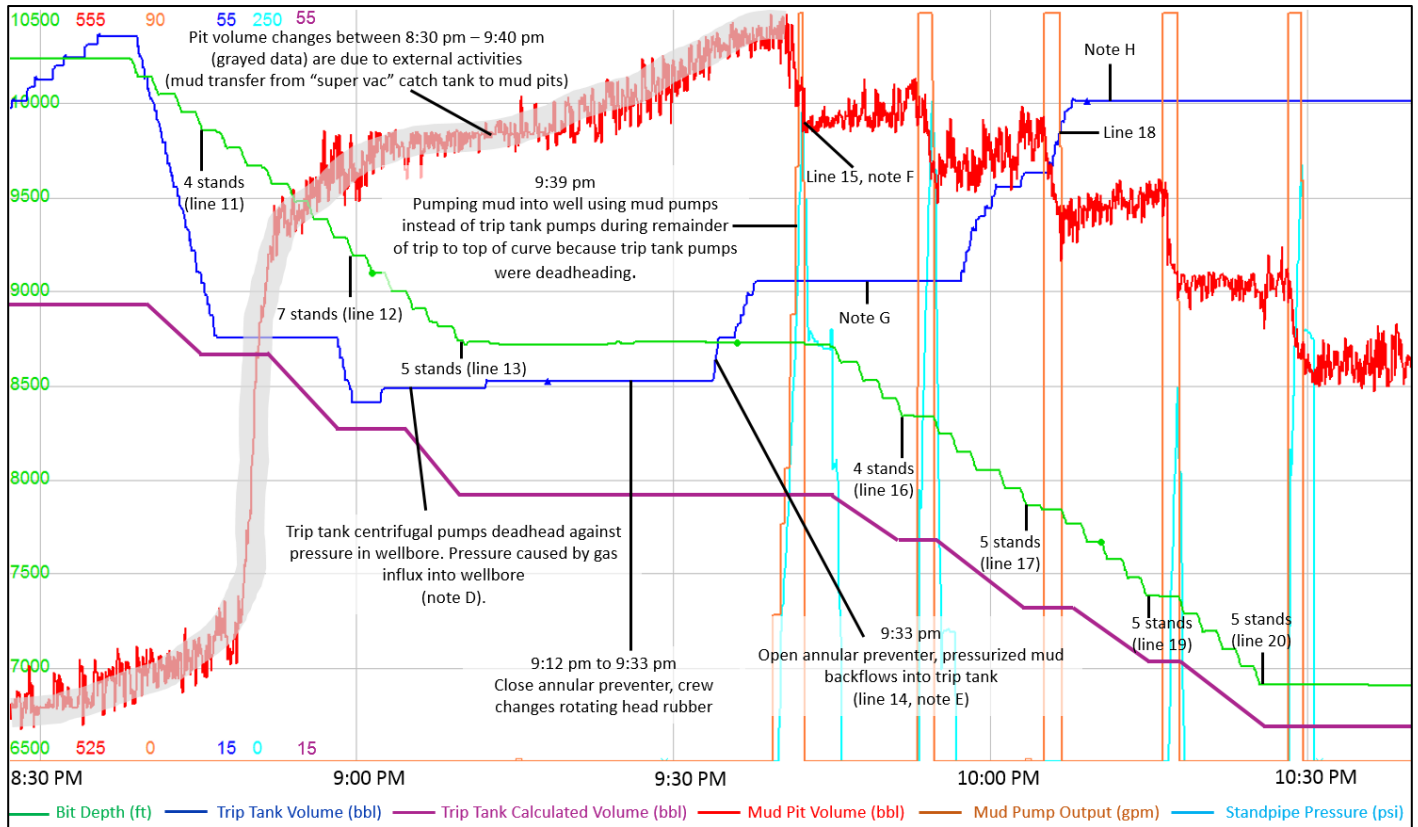
Figure 15. Rig data during the trip out of the wellbore from 10,237 feet to 6,905 feet. The blue line shows the actual, measured trip tank volume, and the purple line shows what the trip tank volume would have been had the calculated drill pipe volume been pumped into the well. The line numbers and notes indicated in parentheses correspond to the line numbers and notes in Table 2 below.

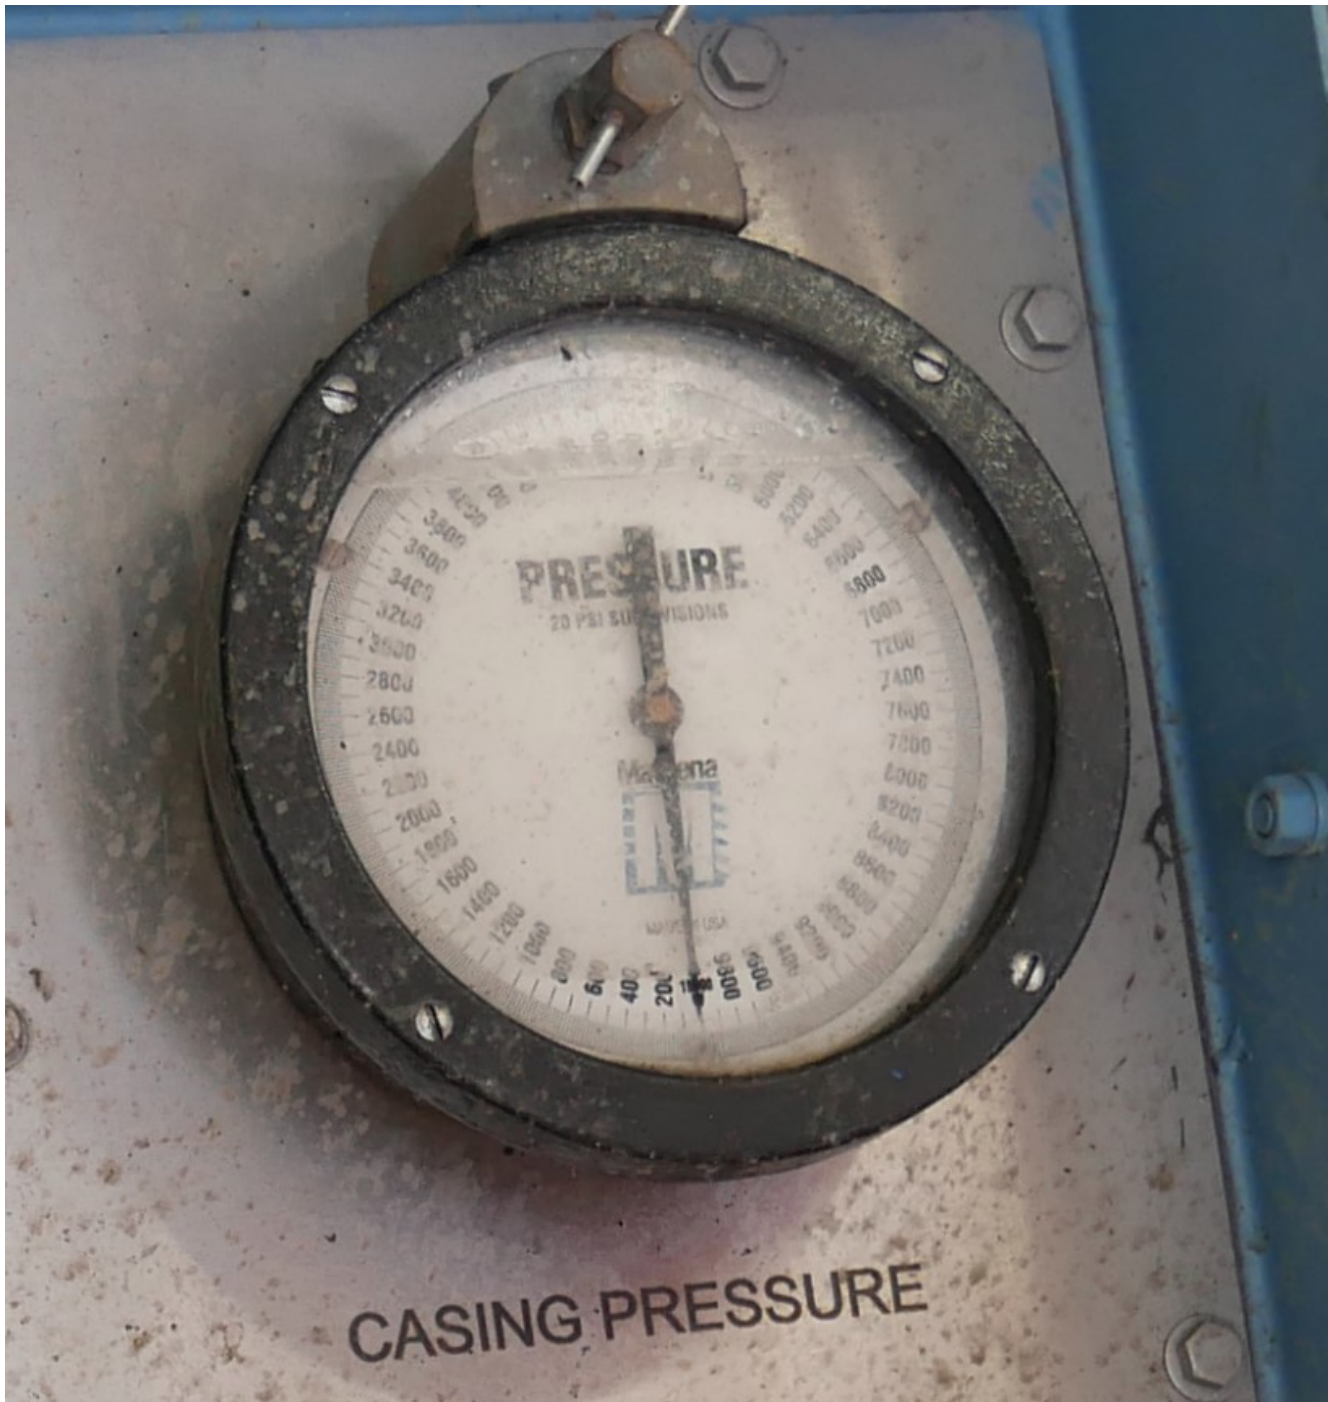
Figure 16. Photo of casing pressure gauge on an exemplar Patterson drilling rig. The pressure gauge could indicate pressures up to 10,000 psi. Low pressures might have been difficult to read on the Rig 219 pressure gauge, or the pressure gauge might not have worked properly at low pressures. The valve on the choke system (“HCR valve”) that needed to be opened to measure annular pressure might have been closed during pressure readings, or the line might have been plugged.

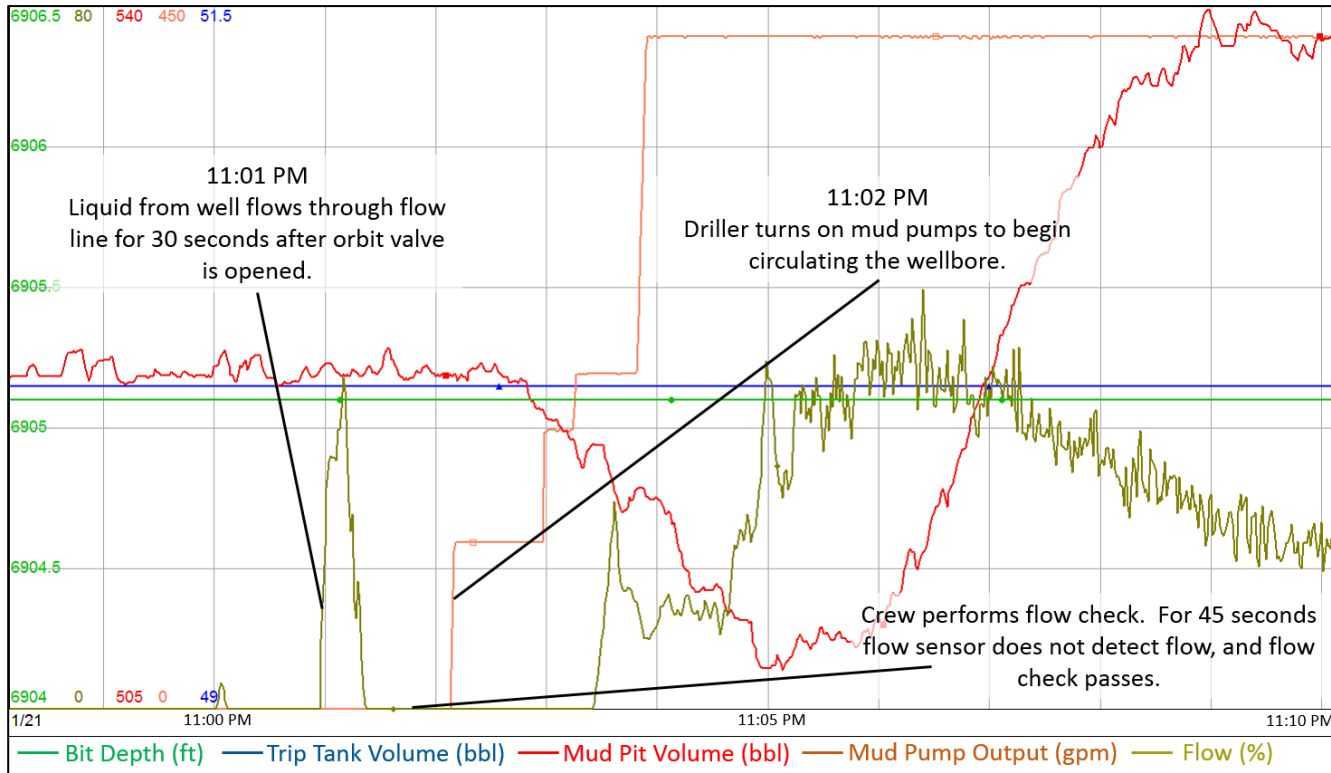
Figure 18. Rig data when the drill bit reached the top of curve. Crew performed a flow check at top of curve. No flow was observed for 45 seconds. Driller turned on pumps to circulate the well.

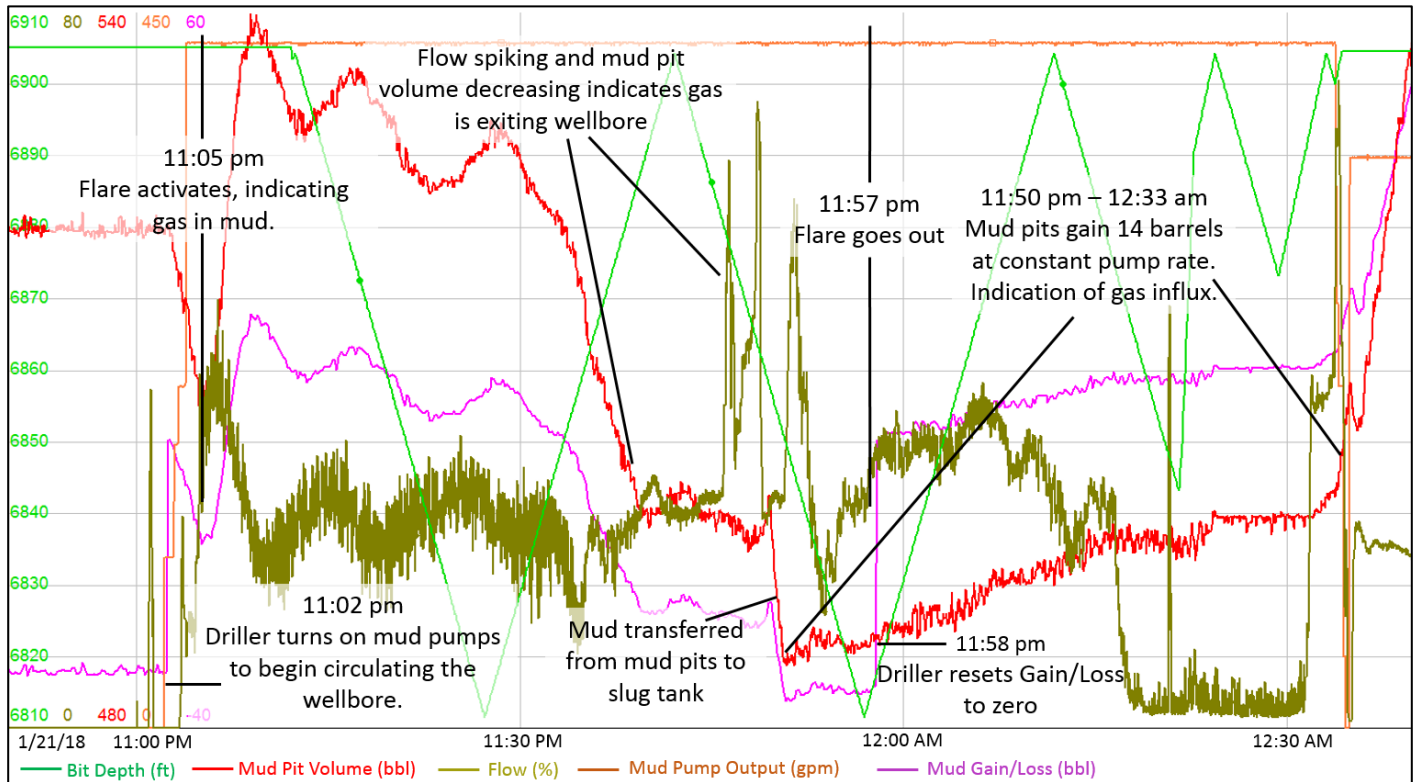
Figure 20. Rig data while circulating the wellbore at the top of the curve. The flare activated while circulating, indicating gas in the mud. Between 11:50 pm and 12:33 am, the mud pits gained 14 barrels while the mud pumps were circulating at a constant pump rate. This pit gain indicates there was gas in the well.

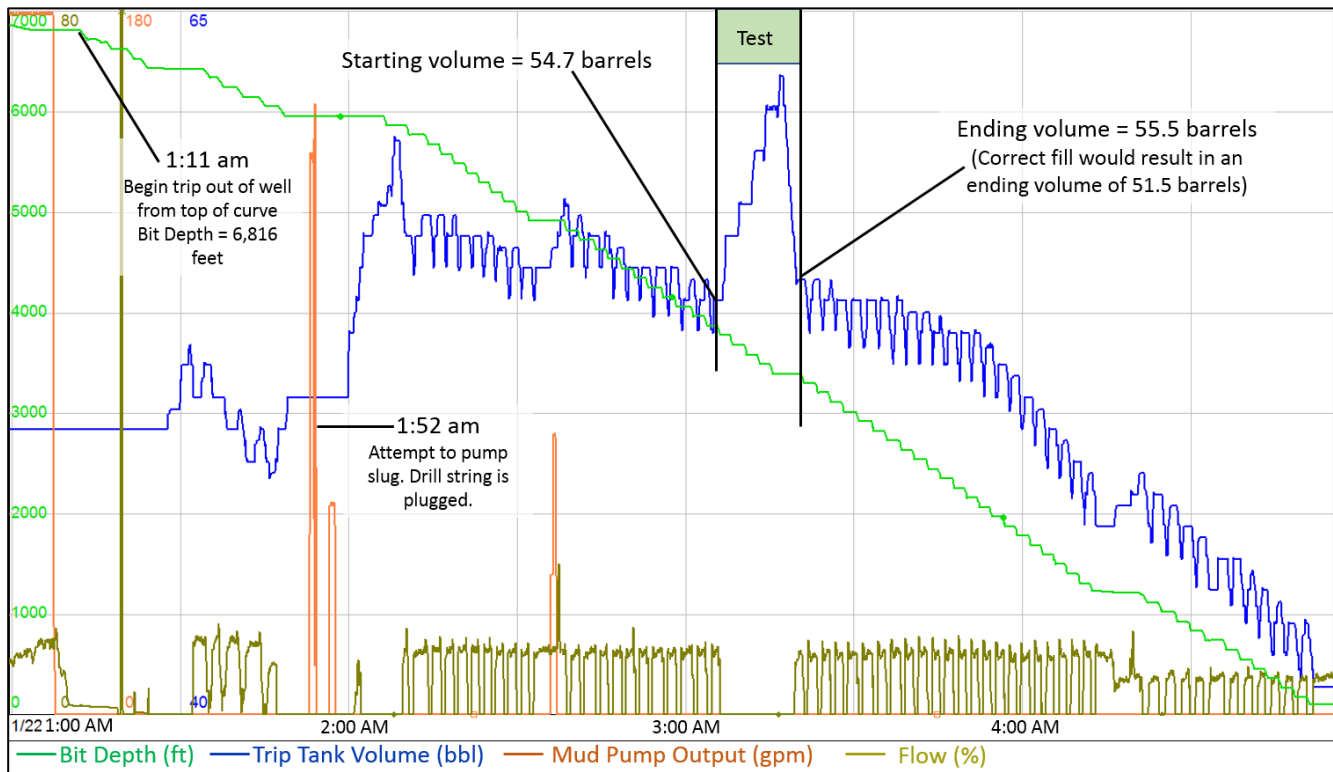
Figure 25. Rig data during trip out of vertical portion of the well on January 22, 2018. The driller and company man were confused by the trip tank volume fluctuations and about what pipe volume to use in trip sheet calculations. The company man and driller incorrectly concluded that the test they performed to determine if the well was taking proper fill had passed.

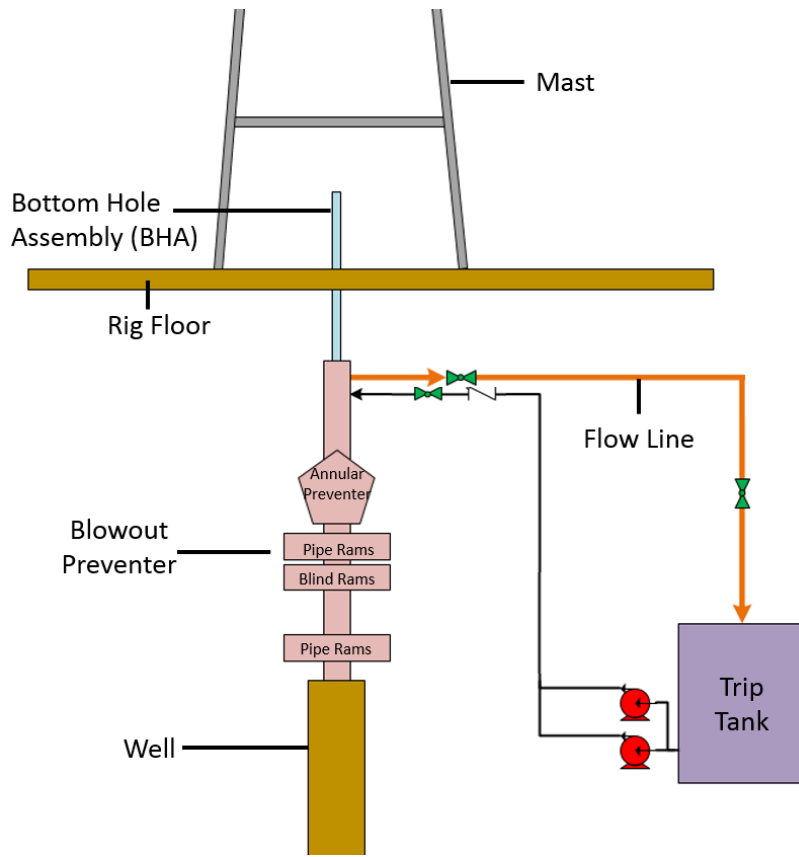
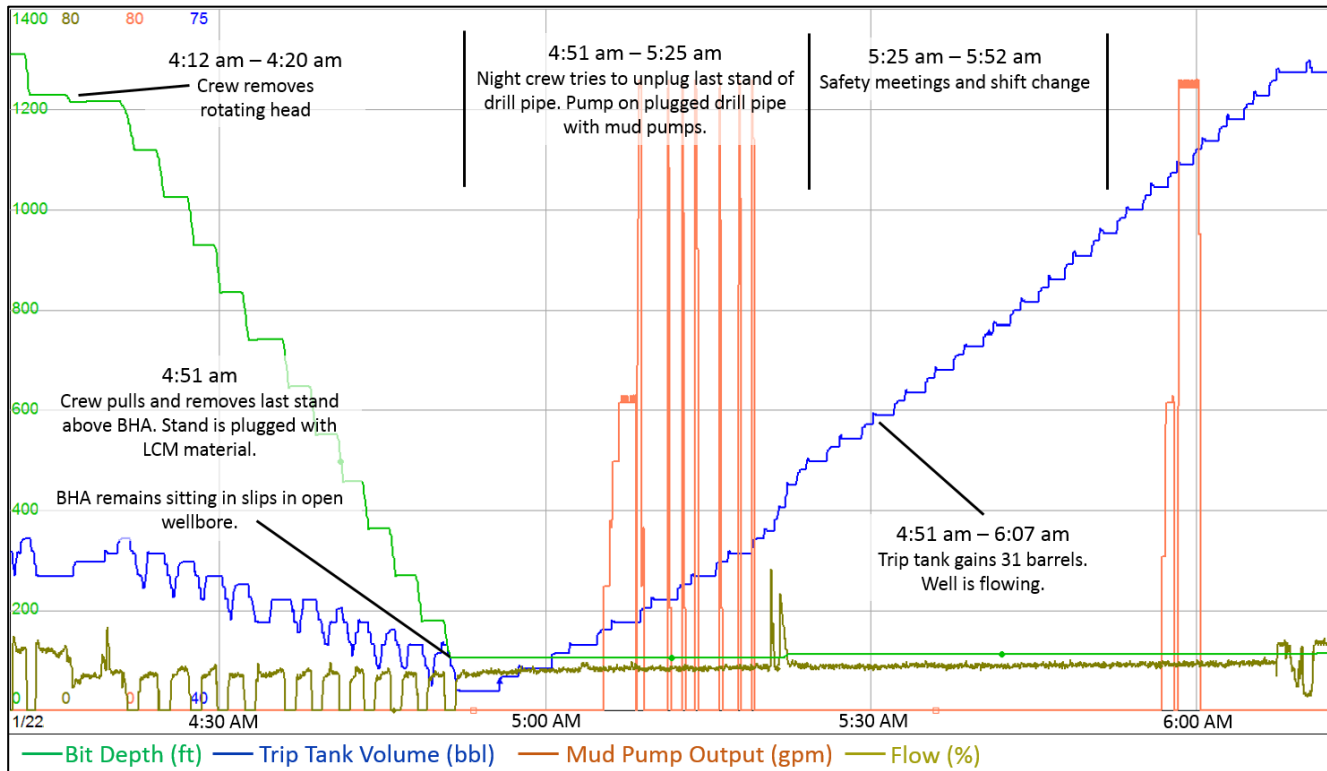
Figure 26. Rig equipment lineup and rig data between 4:10 am and 6:12 am. Between 4:51 am and 6:07 am, the trip tank gained 31 barrels of mud.

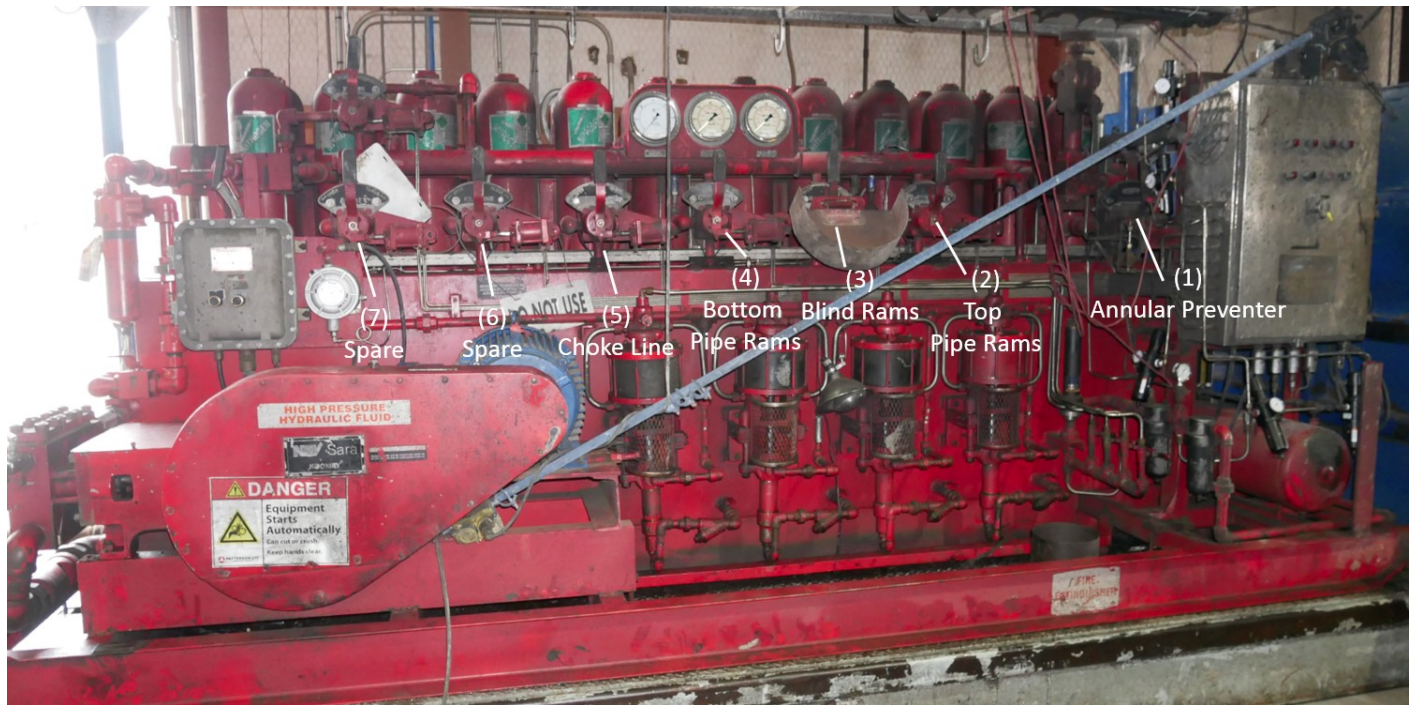
Figure 31. Photo of the BOP accumulator, which is used to function the BOP rams. The rig manager closed the BOP control handles in the following order: (1) annular preventer, (2) top pipe rams, (3) blind rams, and (4) bottom pipe rams. The blowout preventer did not seal the well to stop the blowout when the rig manager functioned the control handles.

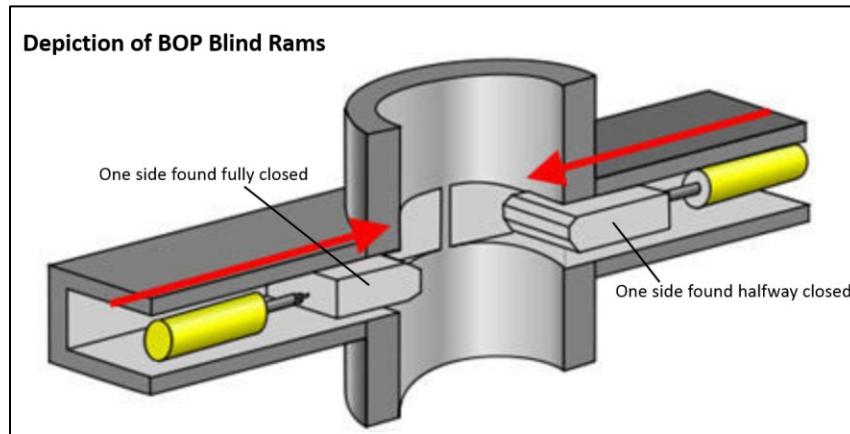
Figure 33. Depiction of BOP blind rams. A Boots & Coots responder found that the south-side blind ram was fully closed, and the north-side blind ram was halfway closed. Source: drillingformulas.com [11] with notations by CSB.

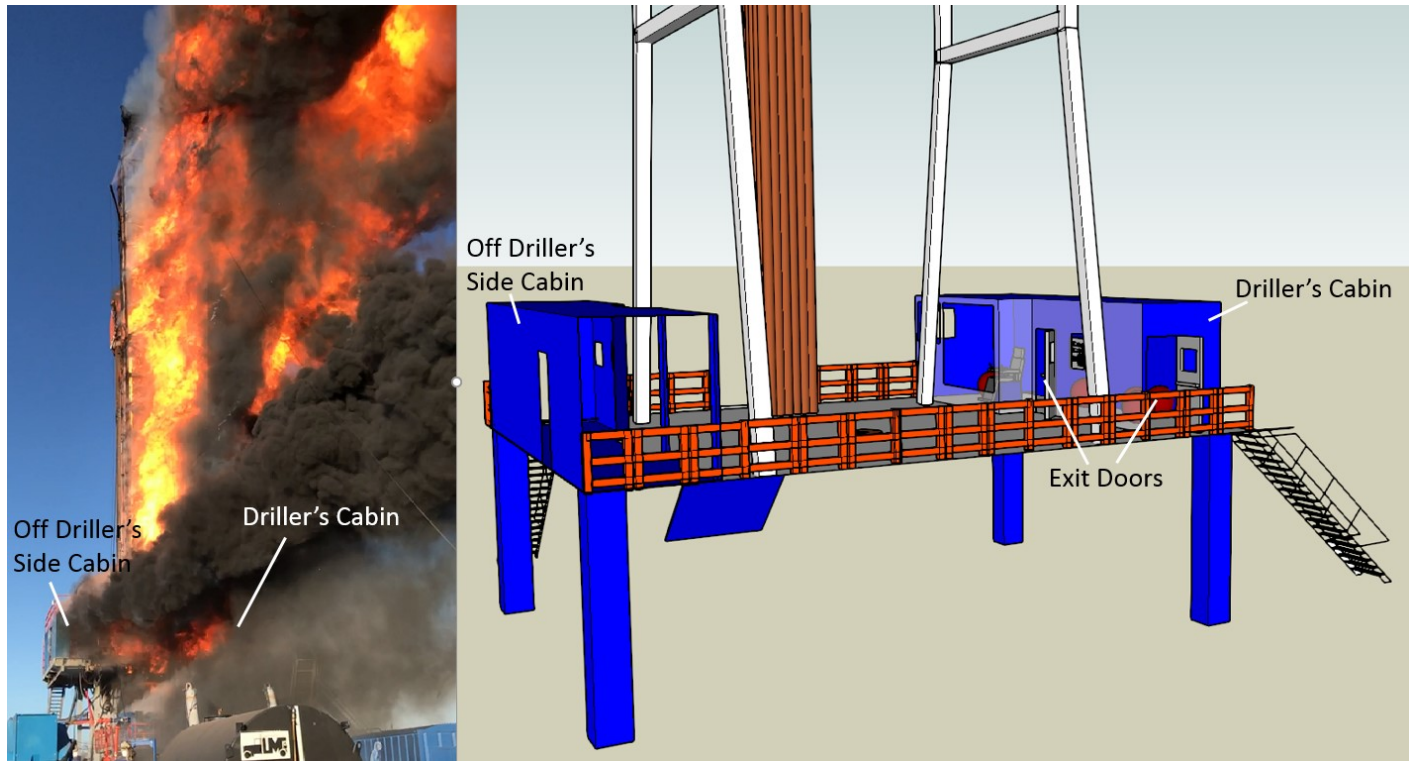
Figure 44. Both exits from the driller's cabin were engulfed by fire.

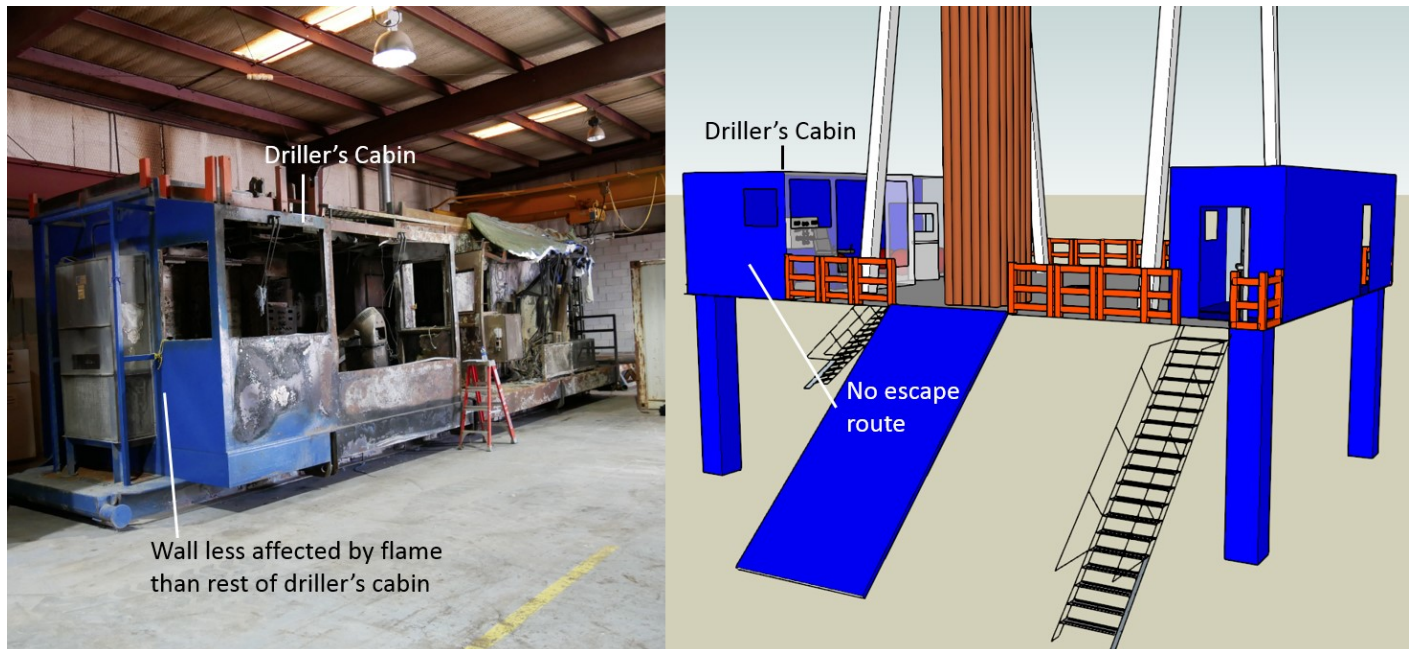
Figure 45. One part of the driller's cabin appeared to be less affected by fire, evident by the paint remaining post-incident. There was no escape route near that location.

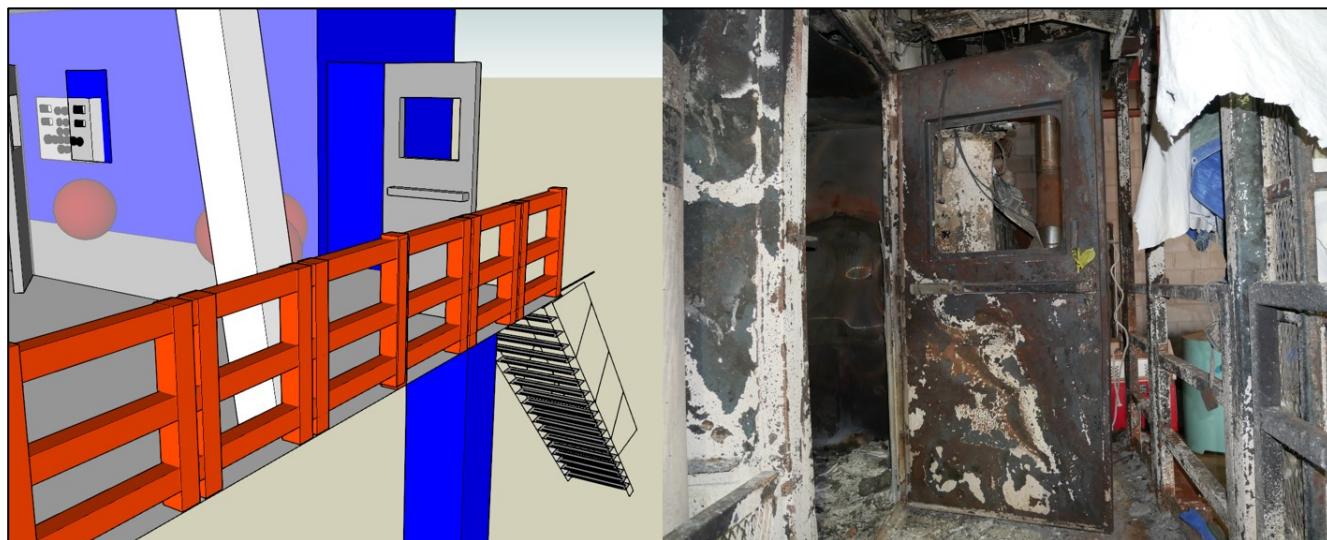
Figure 46. The most viable exit door was hinged such that when the door was opened, the door blocked the escape path to the ground.

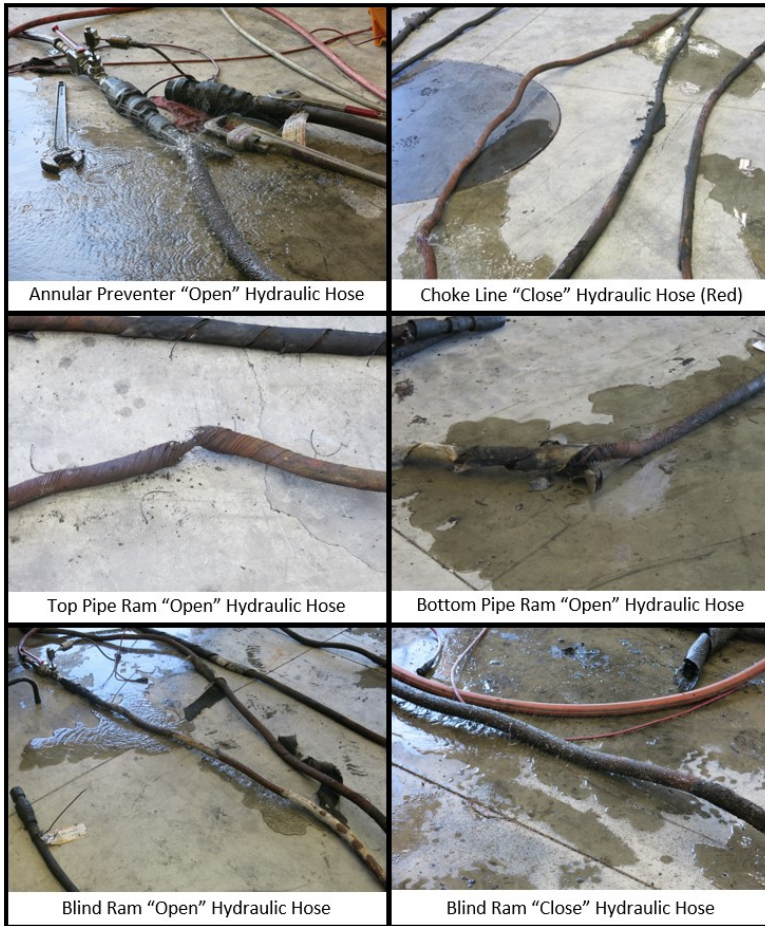
The blowout preventer also failed to close when its activation was attempted after the fire started. The CSB determined the BOP did not function likely because the control hoses that supplied hydraulic fluid to the BOP to function the rams had burned in the fire and leaked the hydraulic control fluid, soon depleting the accumulator stored pressure to the point the blowout preventer could not be closed.

Figure 50. Photos of hydraulic hoses that were installed between the accumulator and BOP, used to send high-pressure hydraulic fluid to the BOP rams to open or close the rams. The hoses were damaged by fire. The hydraulic hoses were leak tested using 40-50 psig water, and all hoses leaked water.

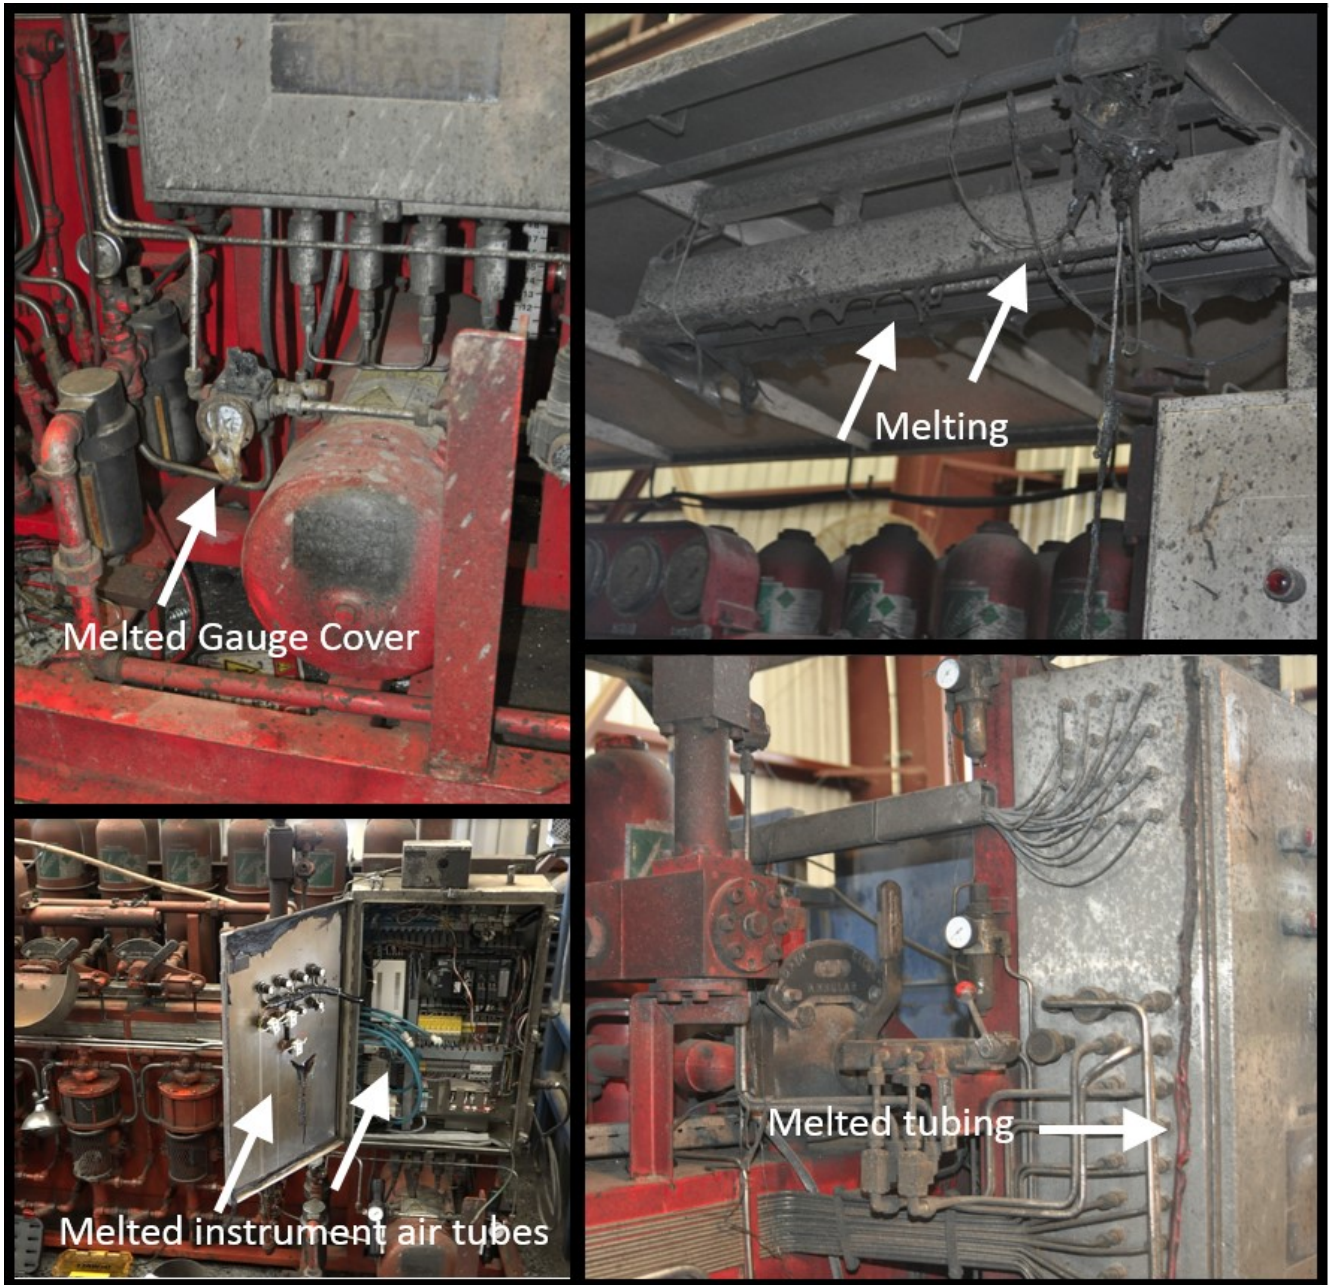
Figure A- 2. Photos of observed heat damage to Patterson Rig 219 accumulator

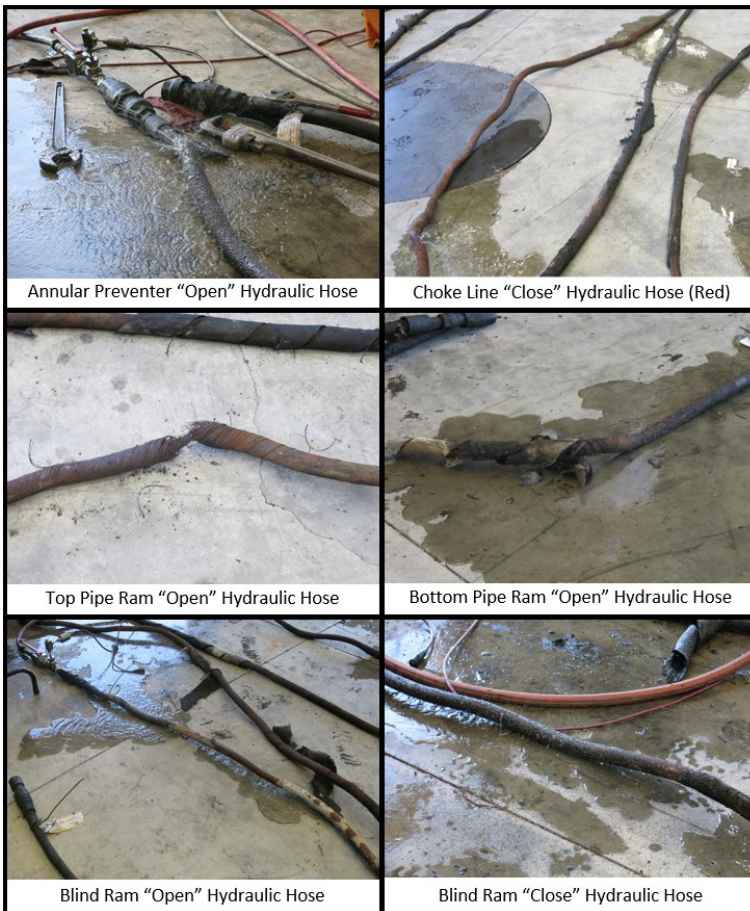
Figure A- 5. Photos of hydraulic hoses that were installed between the accumulator and BOP, used to send high-pressure hydraulic fluid to the BOP rams to open or close the rams. The hoses were damaged by the fire. The hydraulic hoses were leak tested using 40-50 psig water, and all hoses leaked water.

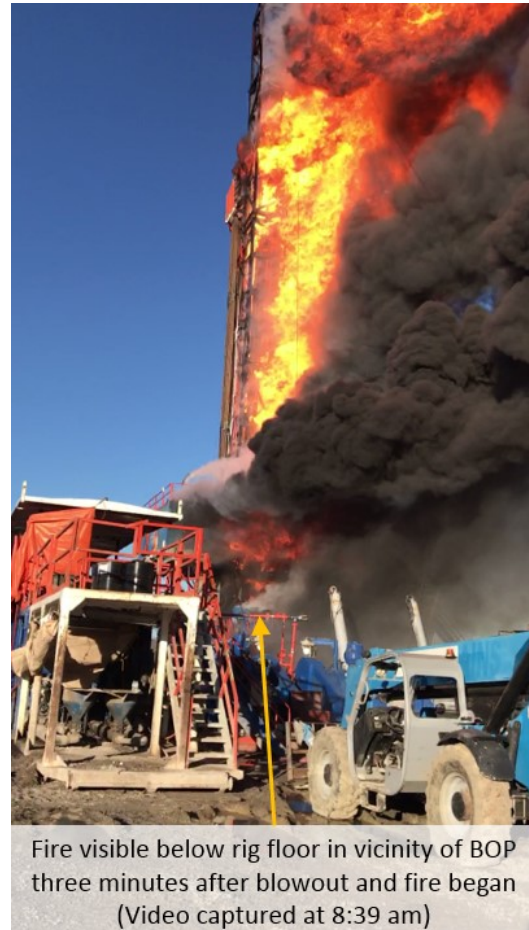
Fire visible below rig floor in vicinity of BOP three minutes after blowout and fire began (Video captured at 8:39 am)

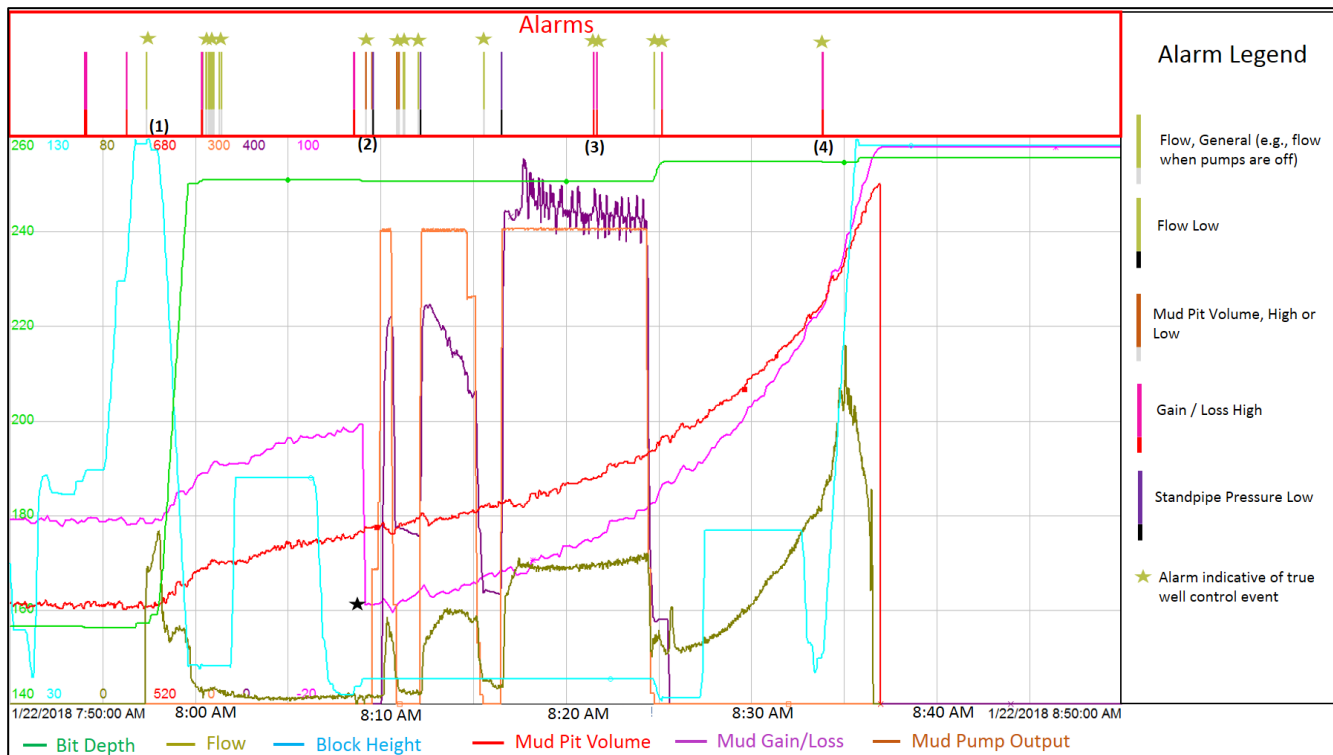
Figure E- 5. Information from alarm system data, indicating what alarms would have activated between 7:50 am and 8:36 am (blowout), if the alarm system was on. Almost all of the alarms would have alerted to the well control event. Information about the specific alarms is in Table E- 5 below. The numbers in parentheses correspond with the note numbers in Table E- 5.
