# INVESTIGATION REPORT

Draft Report for Public Comment

## E.I. DUPONT DE NEMOURS & Co., INC.

### METHYL CHLORIDE RELEASE JANUARY 22, 2010

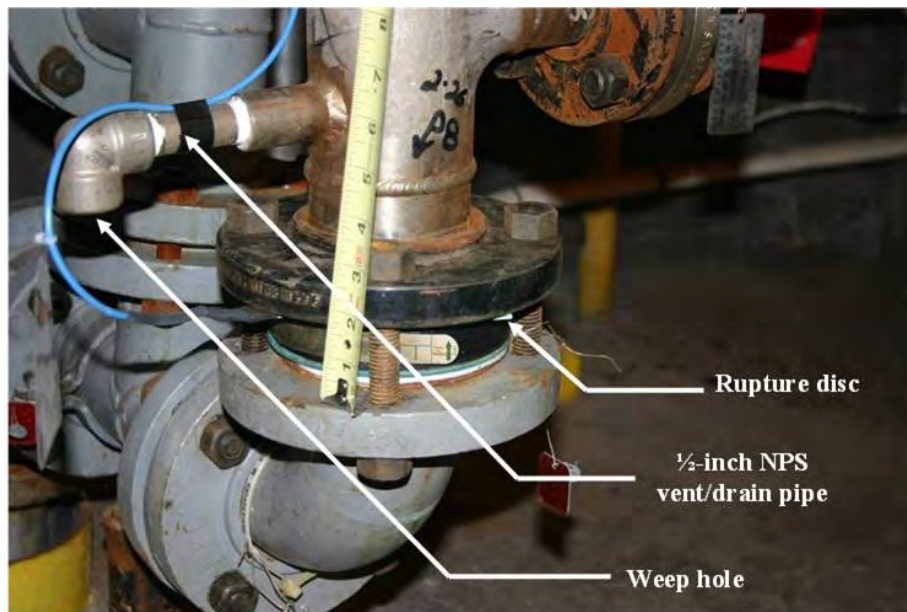
diffused fog and a liquid puddle near a 0.5-inch nominal pipe size (NPS) vent/drain pipe referred to as a weep hole (Figure 3). This connection was associated with a thermal oxidizer “vent stack,” which, vents to the atmosphere on the roof of the building under normal operation. Operators notified the board operator at 5:19 a.m. when they found the source of the release.

Figure 3. 0.5-inch NPS vent/drain pipe and rupture disc

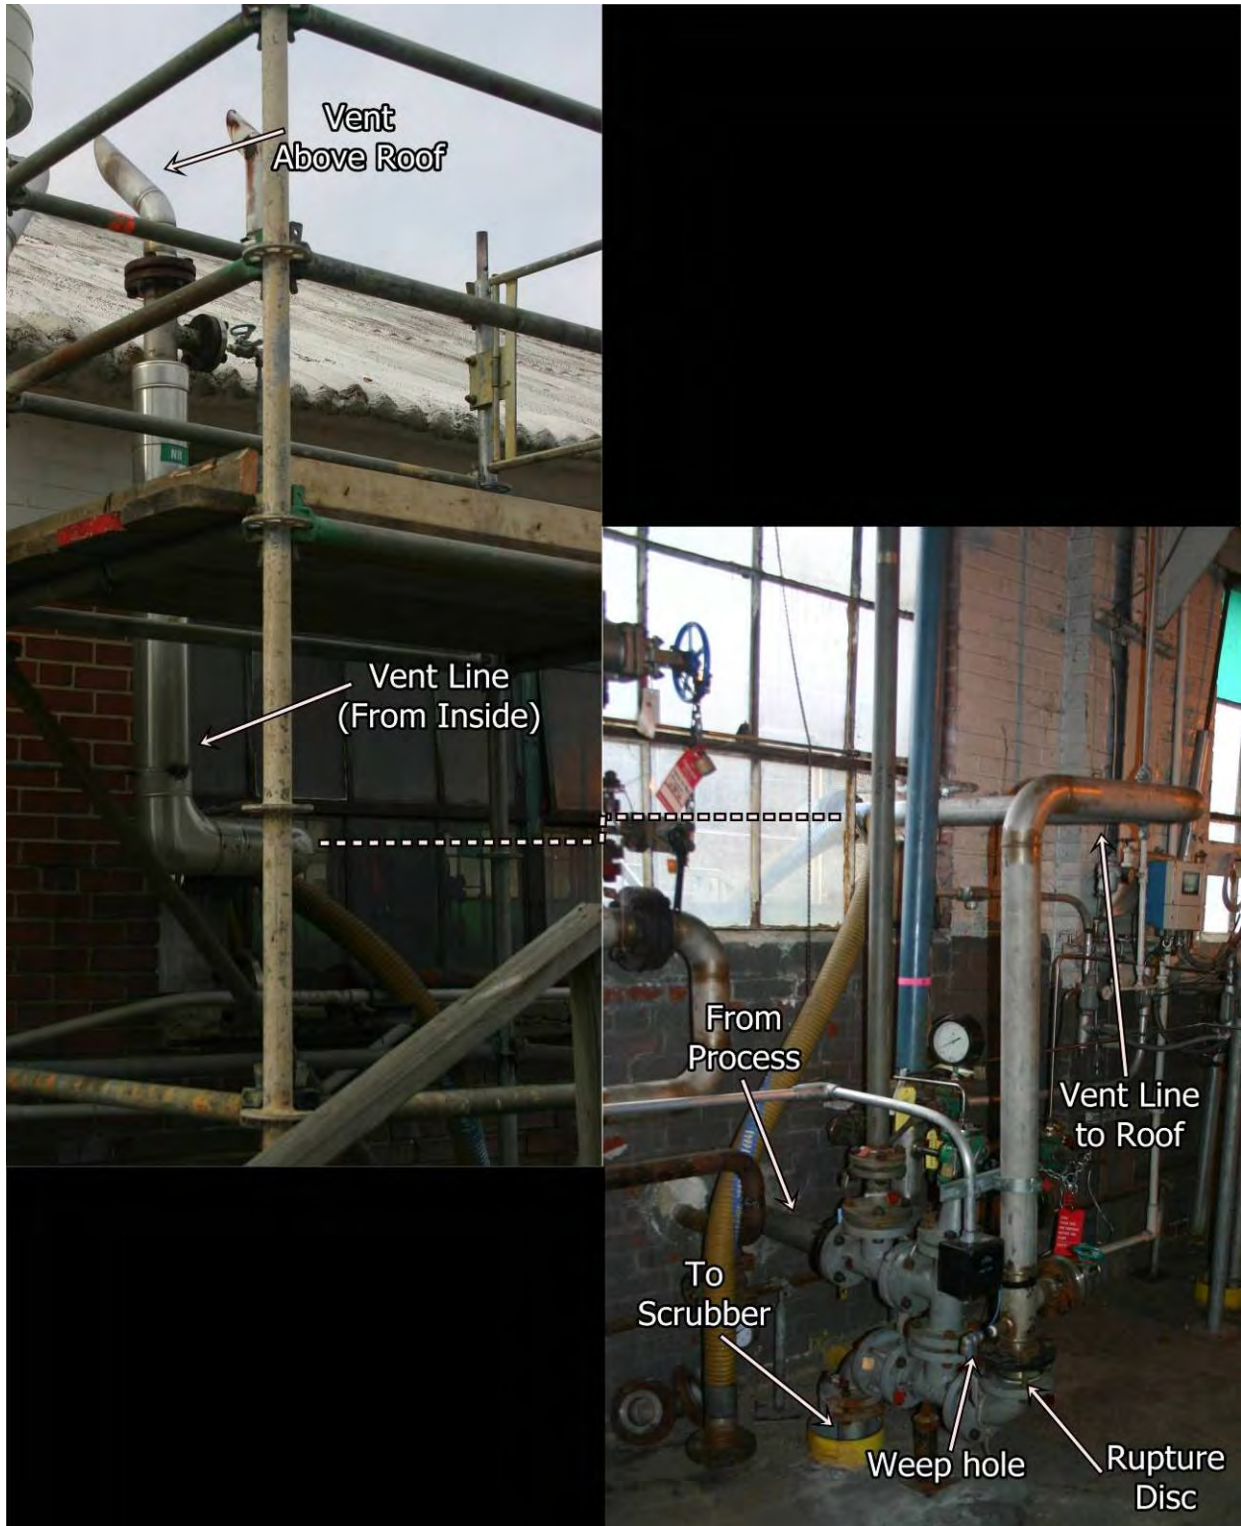
The rupture disc piping was routed to the atmosphere above the roof of the building, which would have provided an outlet path for the methyl chloride vapor where it would have dissipated and dispersed without notice.

Figure 4. Rupture disc piping and vent pipeline to atmosphere on roof

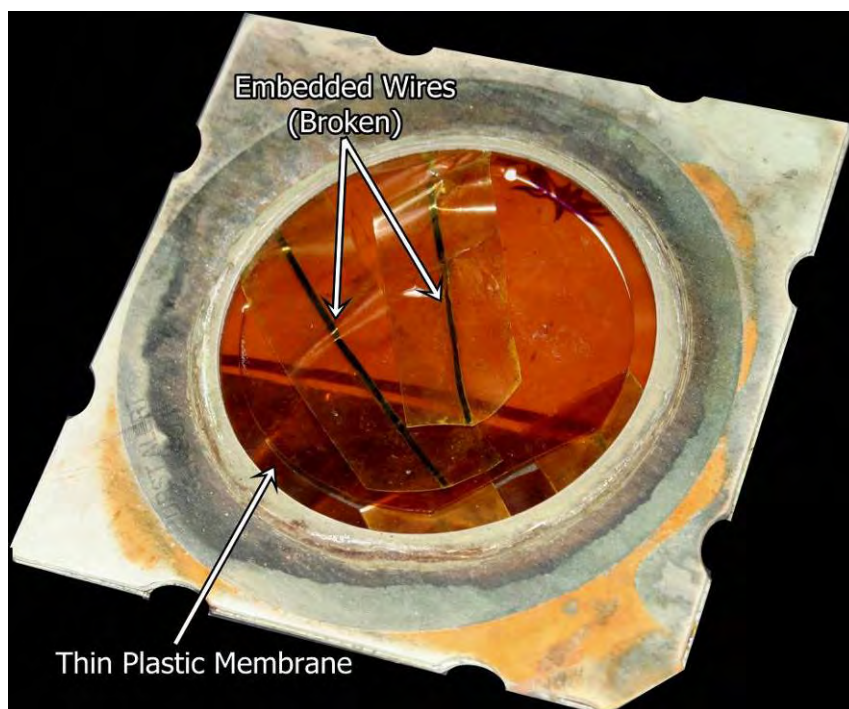
Figure 5. Rupture disc burst sensor post-incident

DuPont Belle used a “burst sensor” intended to notify the board operator that the rupture disk (Figure 5) activated. A burst sensor is a thin plastic membrane with embedded wires installed on top of the rupture disc. Small electrical current passes through the wires. If the rupture disc activates, it breaks the membrane and embedded wires and triggering the alarm.

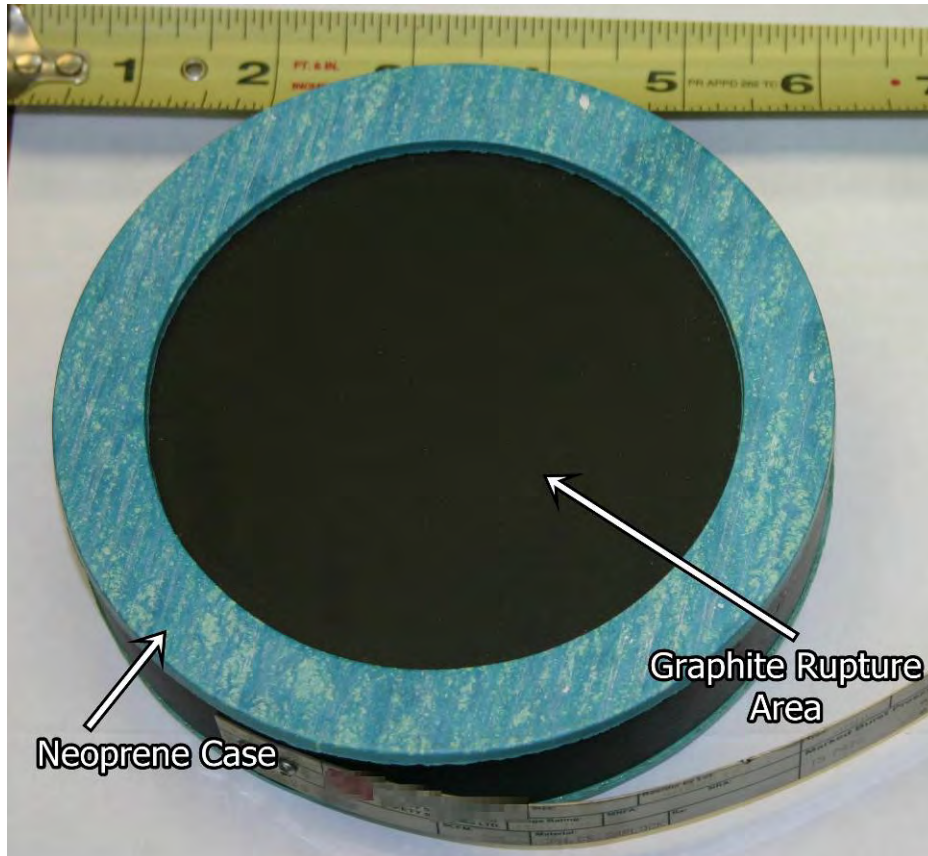
The rupture disc involved in the incident was a 4-inch diameter graphite rupture disc, designed to rupture at 15 psig, and mounted in neoprene casing (Figure 6). While the rupture disc is on a preventive maintenance (PM) schedule, the annual frequency was so infrequent that the disc is only replaced when it has activated or when it is removed for certain processes. Operators told CSB investigators that once removed, the rupture discs, intact or compromised, are thrown away and are replaced with new ones.

Figure 6. New rupture disc

Even without a burst sensor, all overpressure protection devices, including rupture discs, should be routinely checked on an effective PM schedule as a layer of protection.<sup>16</sup>

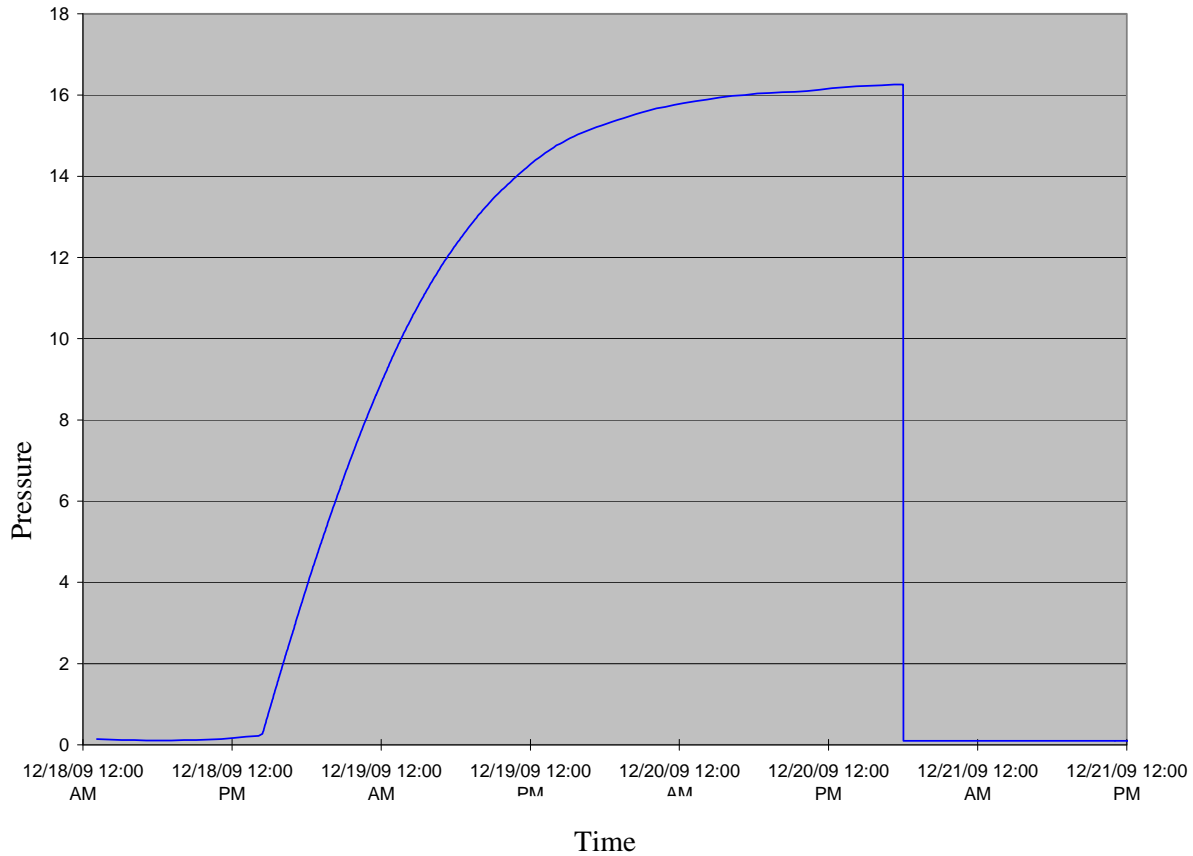
Figure 7. Process data showing sudden pressure decrease when rupture disc burst

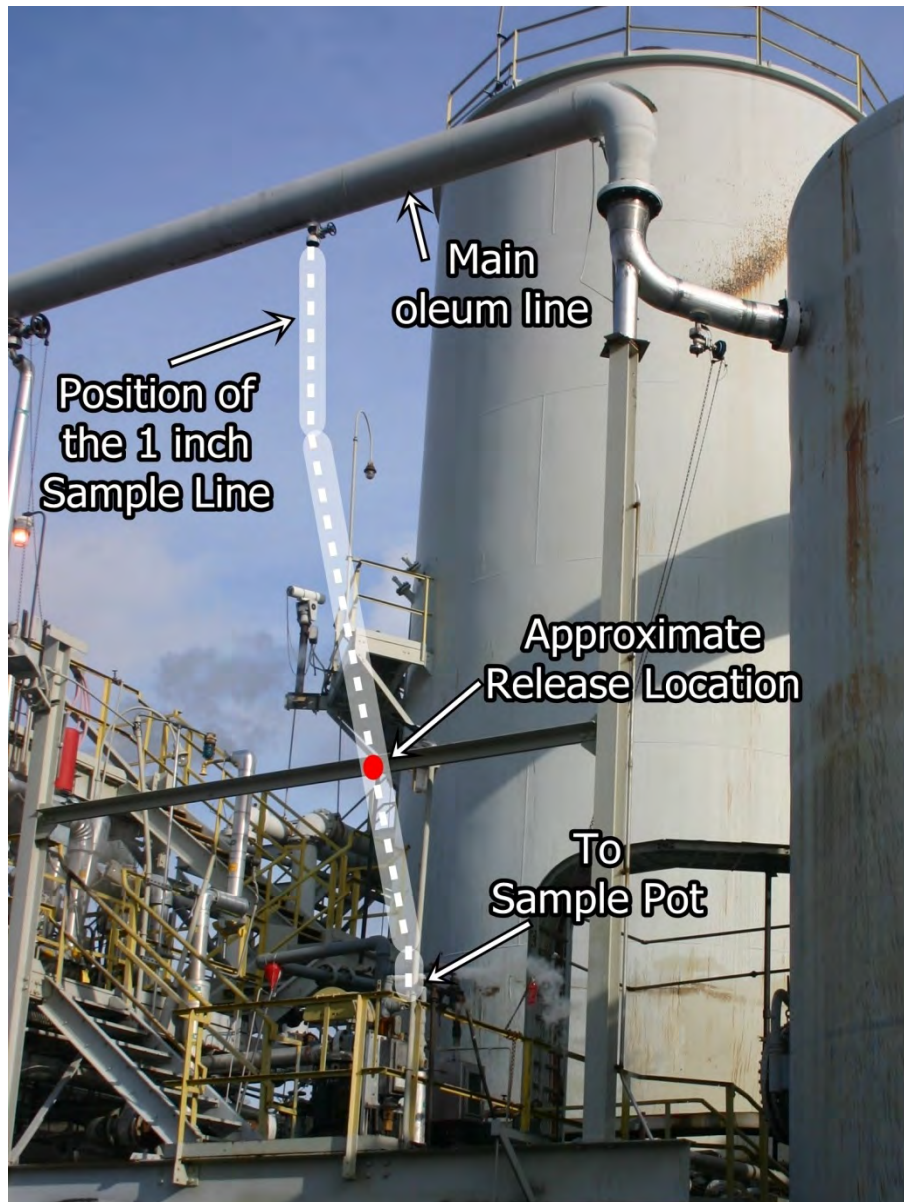
Figure 8. Photo of the position of the 1-inch sample line, which had not yet been replaced

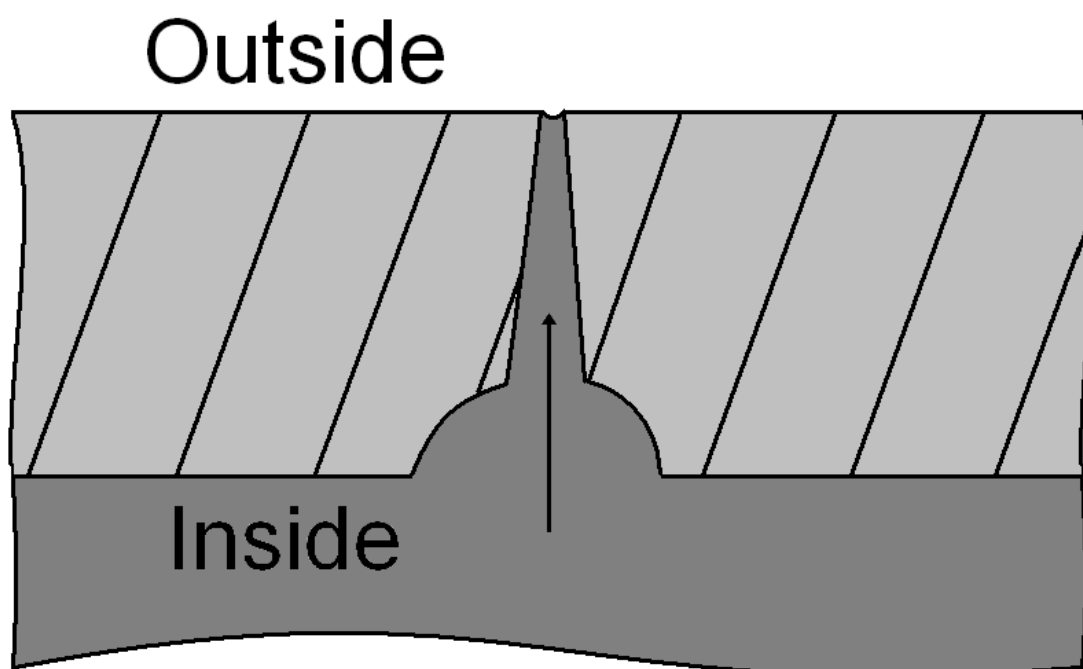
Caused by an unknown defect, oleum corroded through a small section of the pipe involved in the release on January 23, 2010. Starting as a pitting phenomena and finishing slightly larger than a pin hole, the corrosion penetrated the insulated stainless steel sample pipe (Figure 9).

Figure 9. The pitting phenomena observed in the small initial hole of the oleum sample line wall

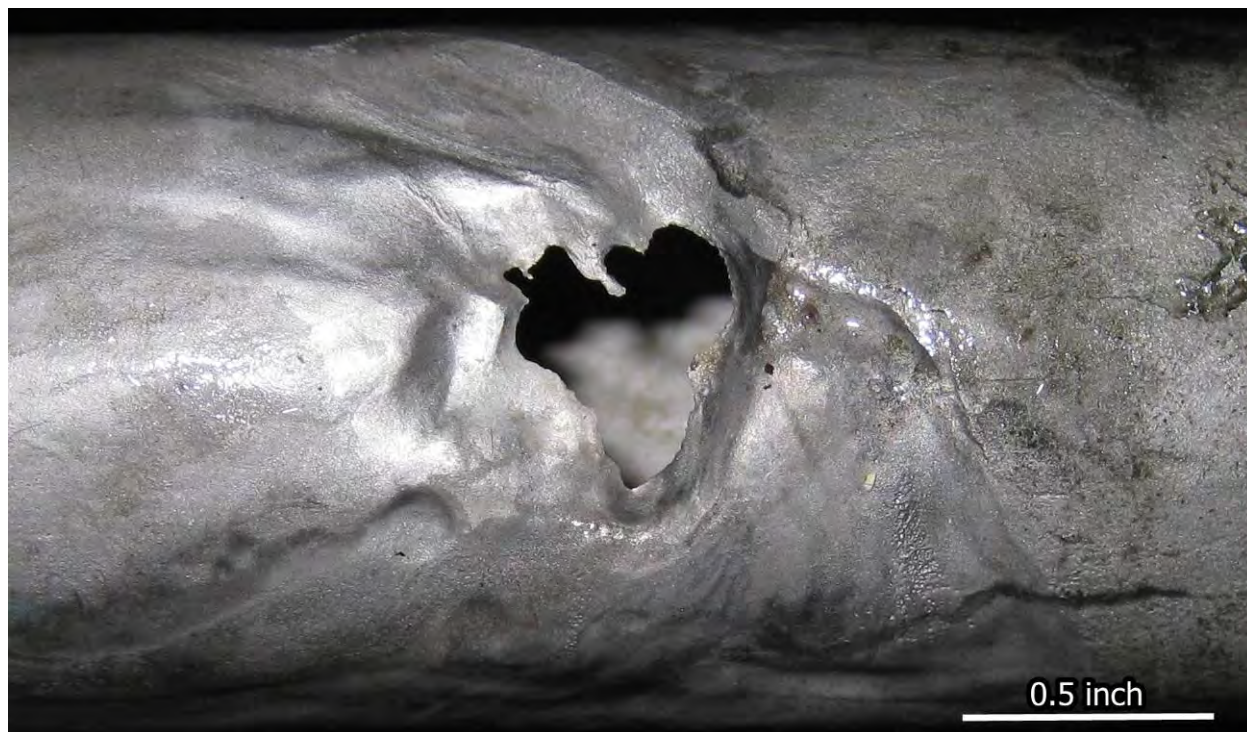
Once oleum was present on the exterior of the oleum pipe, it readily corroded the insulation and steam tracing line and then created a leak in the steam tracing, causing the steam and oleum to mix. This reaction created a strong solution of sulfuric acid that rapidly and effectively corroded the stainless steel sample line exterior, until a second larger hole developed at a location near the original small leak. The second hole clearly shows corrosion occurring from the outside-in (Figure 10).

Figure 10. The large hole eroded from the outside-in on the oleum sample line<sup>26</sup>

<sup>26</sup> Due to a delay in the decontamination of the oleum pipe for purposes of evidence preservation, the size of the holes may have marginally increased from continued corrosion prior to examination.

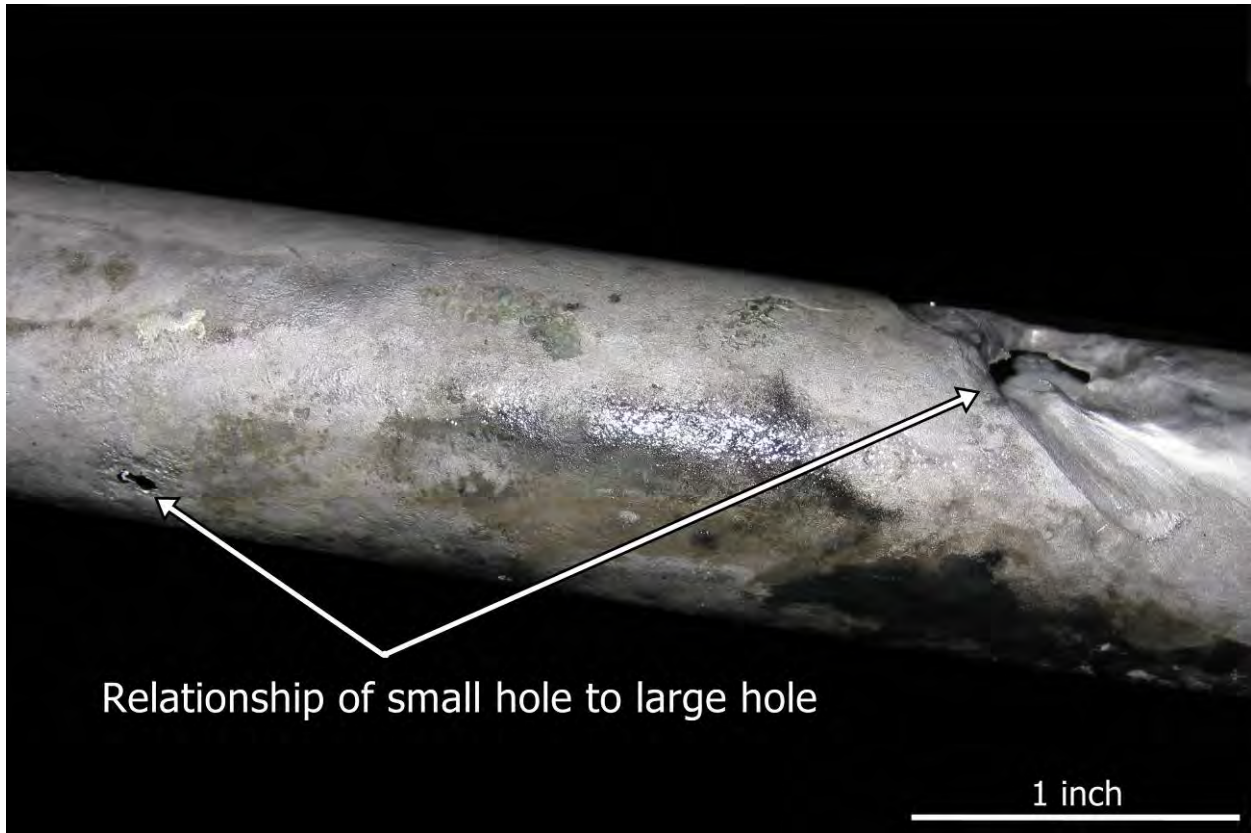
When DuPont removed the oleum-soaked insulation and cover, a large hole was visible; the acid had also corroded a large amount of the steam tracing. When the sample line was properly cleaned, inspection revealed that the smaller hole was only a few inches away from the larger hole, and after thorough examination, metallurgists concluded that the small hole in the sample line initiated the oleum release (Figure 11).

Figure 11. Photo showing the orientation of the small hole to the main hole

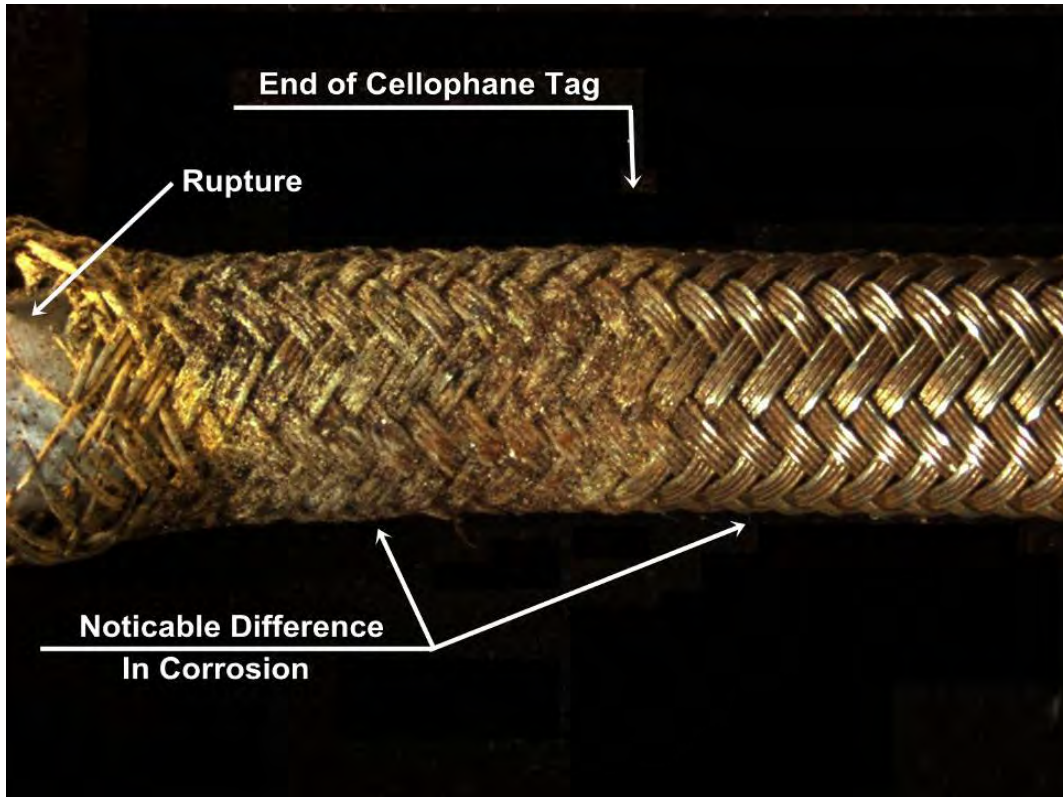
The PTFE, 304 stainless steel, and the clear plastic adhesive tape contributed to the incident. The PTFE inner core was permeable and susceptible to phosgene vapor diffusing through the hose. The adhesive tape used to secure the tag contributed to the retention of phosgene gas on the exterior of the stainless steel overbraid. The phosgene gas converted to HCl, and 304 stainless steel overbraid is subject to corrosive attack by HCl. Since the clear plastic adhesive tag trapped the phosgene permeating through the PTFE inner core, the resulting concentration of HCl was much higher under the tag than elsewhere on the hose (Figure 14).

Figure 14. The distinct effect of the clear plastic adhesive tag on the corrosion of the stainless steel overbraid

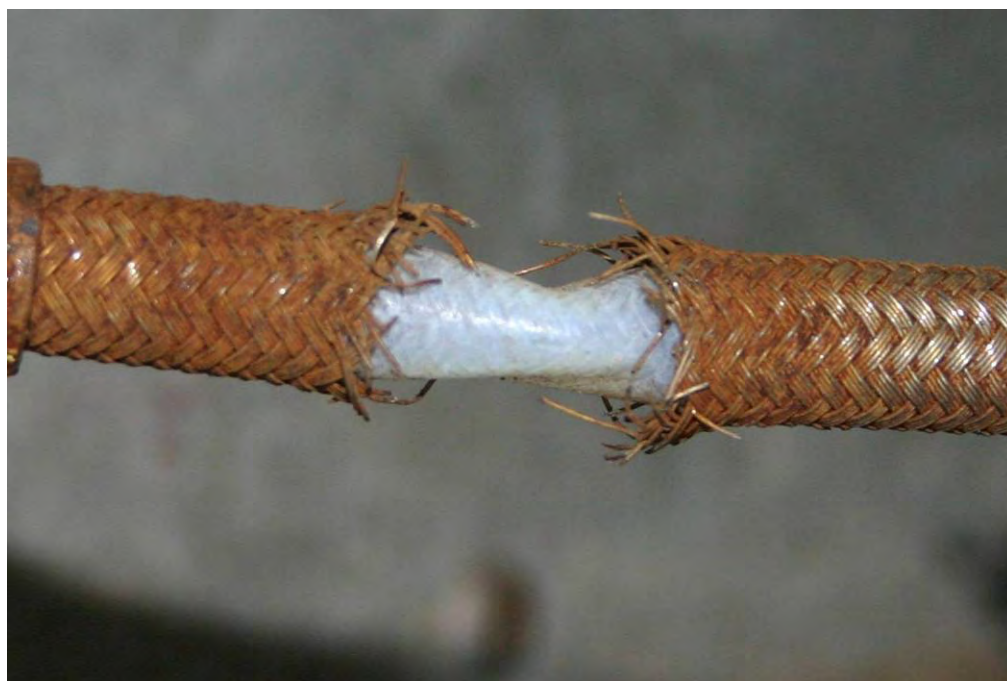
The hillside phosgene supply hose and valve assembly were removed and decontaminated in a water bath. When the hose was removed from the water, the clear adhesive ID tag had fallen off, revealing a broken stainless steel braid and collapsed PTFE liner, a possible cause of the flow restriction (Figure 15).

Figure 15. Damaged hillside phosgene hose removed from phosgene cylinder. The plastic adhesive tag that covered the damaged section fell off during the hose decontamination procedure.

An operator stated during an interview that when he saw the physically defective section of the frayed hose, he told his co-workers, stressing that the hose was close to rupturing and that they were lucky to have found it and changed out the hose in time. Unfortunately, this discovery was not captured as a near-miss, since supervisors were not made aware of the issue.

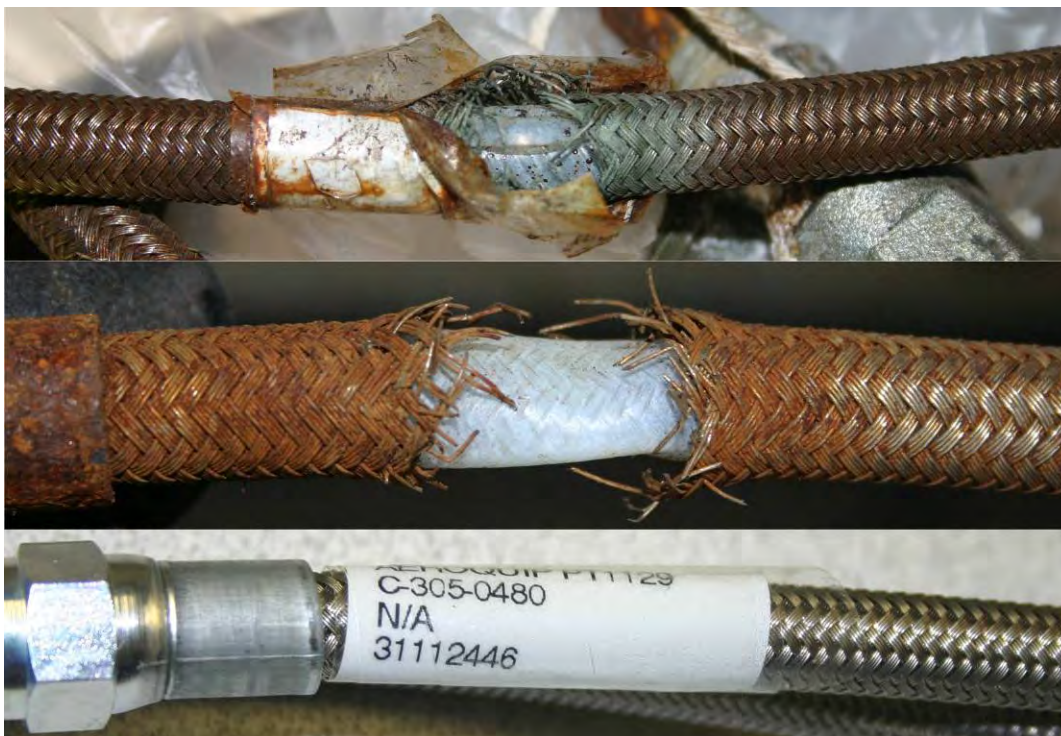
Figure 16. Flex hose comparison photographs: (top to bottom) ruptured riverside hose, flow restricted hillside hose, a new hose with attached ID tag

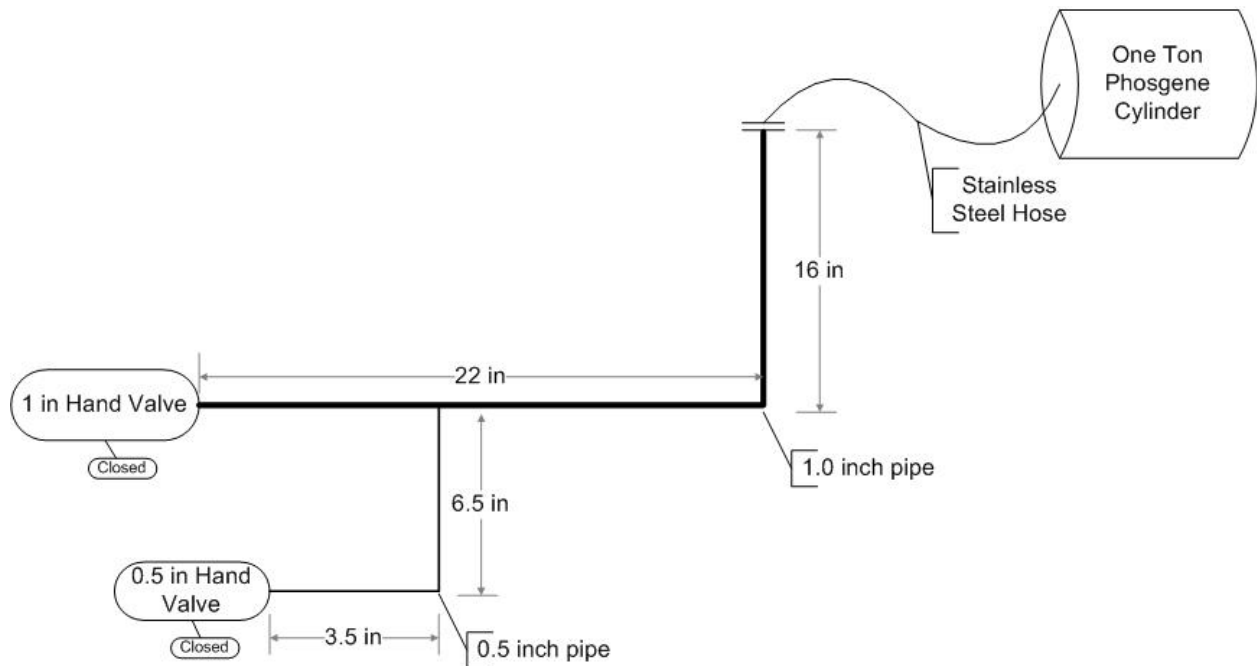
Figure 18 shows the hose and piping dimensions and the maximum amount of phosgene present in the piping system associated with the hose failure.

Figure 18. The hose and piping system that supplied phosgene for the release
