INVESTIGATION REPORT

STERIGENICS

ONTARIO, CALIFORNIA AUGUST 19, 2004

REPORT NO. 2004-11-I-CA ISSUE DATE: MARCH 2006

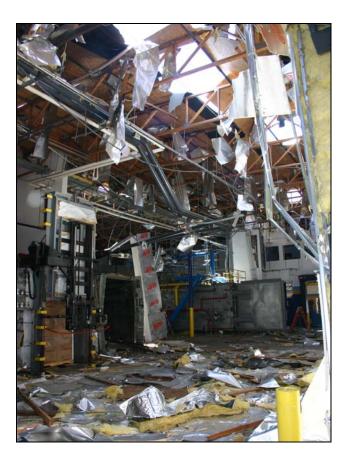
Figure 1 Facility Damage

On August 19, 2004, an explosion inside an air pollution control device and medical products sterilization chamber at Sterigenics International, Inc., in Ontario, California, injured four workers and severely damaged the facility (see Figure 1). Neighboring businesses were evacuated for several hours and operations at the Ontario facility were disrupted for 9 months.

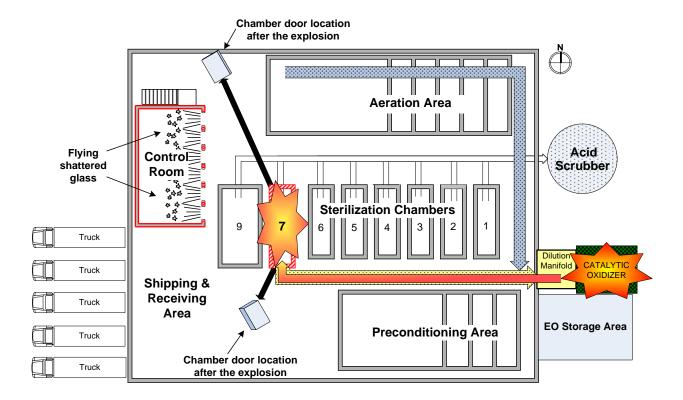
Figure 8 Explosion Overview

To advance the cycle to completion the maintenance supervisor verbally gave the required password to a maintenance technician. The technician typed the command into the Antares system thereby skipping the gas wash phase. Minutes later, the technician cracked the sterilizer door to the pre-determined ventilation level, which automatically opened the backvent and caused approximately 50 pounds of EO remaining in the chamber to move into the ventilation system. EO immediately began to leak out of the chamber door into the building, causing nearby LEL monitors to alarm. The alarms, however, did not allow sufficient time to shut down the oxidizer or evacuate the facility before the EO-laden air reached the oxidizer and ignited. The flame flashed back through the duct to the chamber and ignited the remaining EO, resulting in a powerful explosion. The explosion occurred shortly after 2 PM on August 19, 2004. There were no employees working in the chamber area at the time of the explosion.

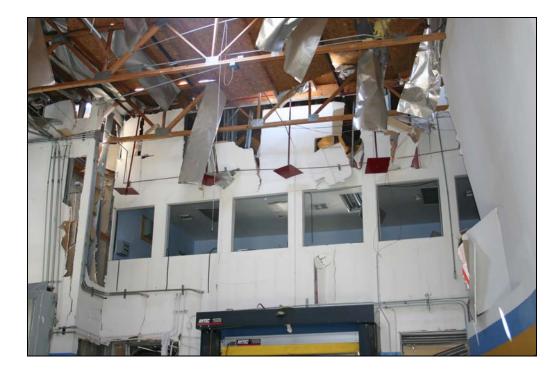
Figure 9 Blown Out Control Room Windows

The control room used to monitor and control the sterilization process is located approximately 75 feet from Chamber 7. Primarily constructed of drywall over metal stud frames, the control room includes six glass windows that provide a view of the sterilization chamber area. The explosion resulted in minor damage to the control room structure, but all windows were shattered. The windows were tempered window glass without any shatter-resistant treatments, and the walls were not designed to resist pressure from an explosion. All of the injuries resulted from flying glass from the shattered control room windows.

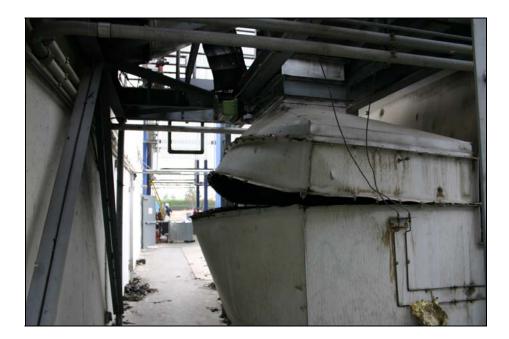
Figure 10 Oxidizer Manifold Damage

The location and magnitude of the damage to the ventilation system and Chamber 7 indicate that explosive EO-laden air was transported through the ventilation ducting to the oxidizer where it initially ignited. A large section of the manifold connecting the chamber ducts to the oxidizer was blown outward, on the upstream side of the oxidizer. This indicates that an explosive overpressure occurred inside the oxidizer (see Figure 10).

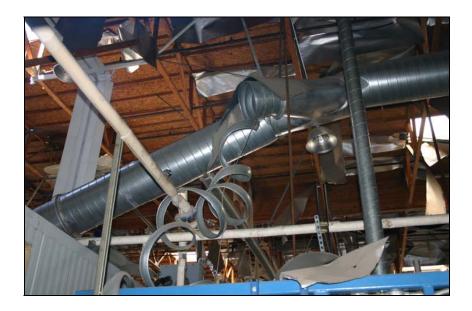
Figure 11 Damage to Ventilation Ducting

Once the explosive airflow was ignited, the flame traveled through the ventilation duct back to the chamber. The pressure created inside the duct as the flame front traveled back to the chamber destroyed a large section of the ventilation ducting from the oxidizer to the chamber (see Figure 11). The flame front, entering the chamber through the open backvent, initiated a powerful explosion.

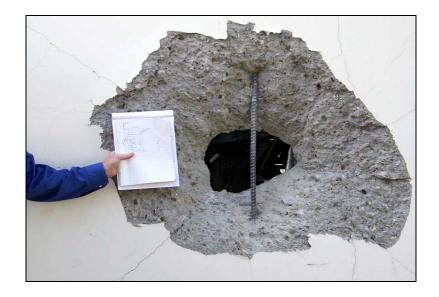
Figure 12 Building Damage from Chamber Door

The force of the explosion sheared the hinges and propelled both chamber doors outward.¹⁵ The loading (south) door came to rest approximately 15 feet away, after colliding with and damaging a steel column. The unloading (north) door came to rest approximately 75 feet from the chamber after striking and fracturing the south wall of the building (see Figure 12). The pressure flexed the entire chamber structure outward, leaving it permanently disfigured (Figure 13).
