## Investigation Update

September 2022

This document provides an update on the CSB investigation of the November 13, 2020, incident at Wacker Polysilicon North America LLC (“Wacker”) in Charleston, Tennessee. The investigation is ongoing. Complete findings, analyses, and recommendations, if appropriate, will be detailed in the CSB’s final investigation report.

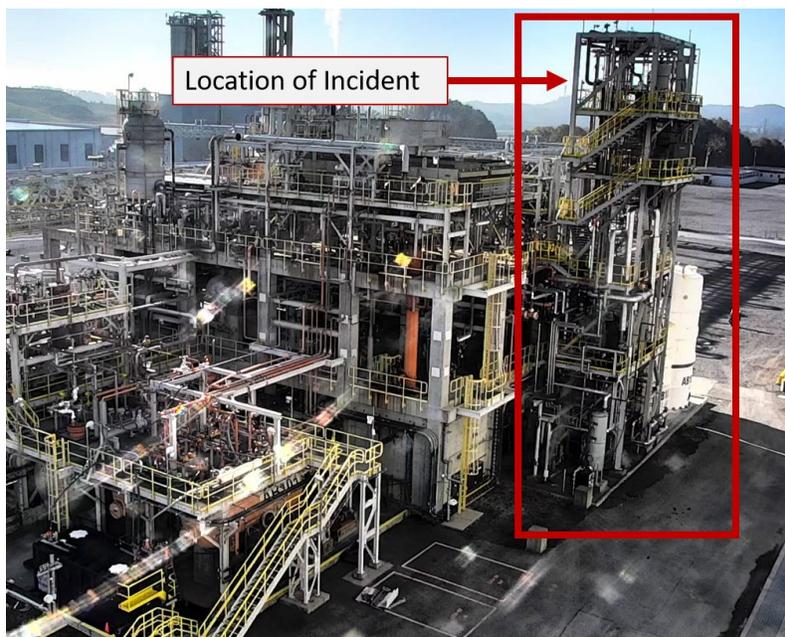
- The HCl release originated from a heat exchanger on the fifth floor of a five-story structure (**Figure 1**). Wacker uses the heat exchanger in its HCl regeneration process. This process converts concentrated hydrochloric acid (30% hydrogen chloride and 70% water) into anhydrous hydrogen chloride gas and dilute hydrochloric acid (18% hydrogen chloride and 82% water). The gas is used in other processes within the facility.

**Figure 1.** Five-story structure. The hydrogen chloride release occurred on the fifth floor of the structure. (Credit: Wacker)

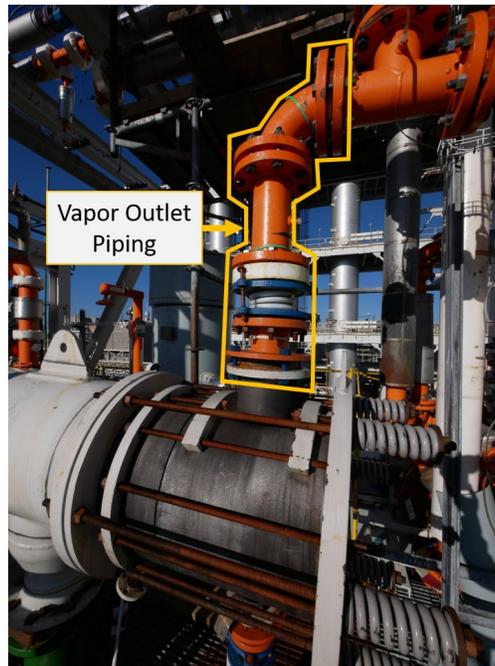
- Jake Marshall was tasked with checking the torque on all of the bolts on the heat exchanger vapor outlet piping (**Figure 2**). Earlier in the week, the piping was re-installed after maintenance work on the heat exchanger was performed. To complete the torque check, Jake Marshall employees planned to use a click type torque wrench that would “click” with both an audible and tactile response when the desired torque was reached.

**Figure 2.** Jake Marshall Scope of Work. Wacker employees verbally requested the Jake Marshall employees check the torque on all of the bolts on the heat exchanger vapor outlet piping, which had been installed earlier in the week. (Credit: CSB)

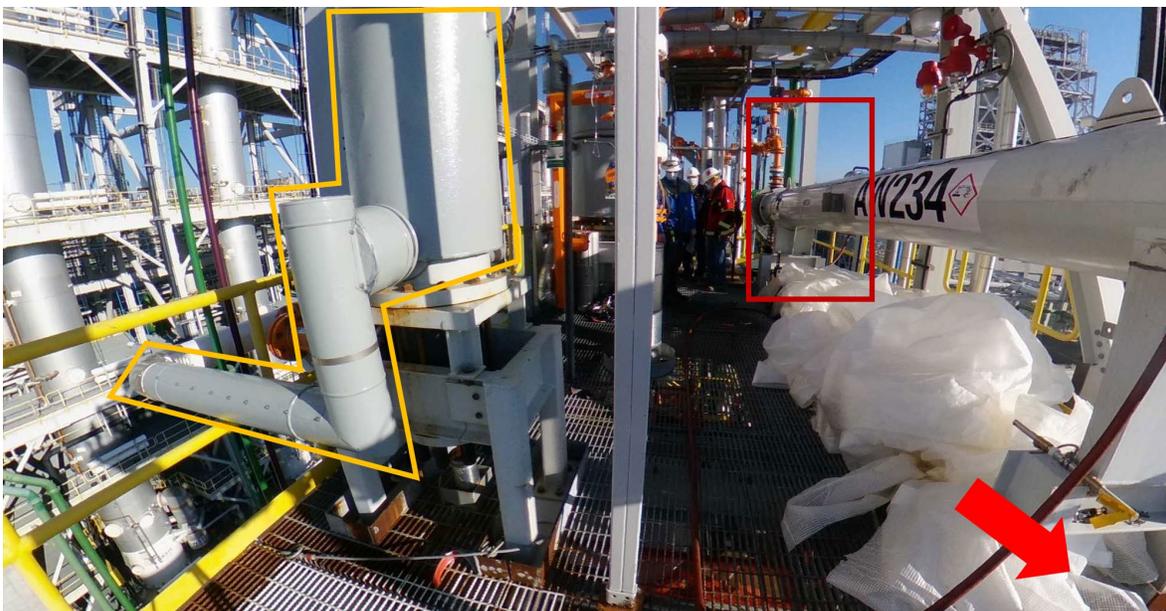
- The scope of work for both Jake Marshall and Pen Gulf authorized the contract employees to be on the fifth floor of the structure (**Figure 1**). There were three Jake Marshall and four Pen Gulf employees working on the platform at the time of the incident.<sup>a</sup> One Jake Marshall employee was working on the north end of the platform. The two other Jake Marshall employees and all four Pen Gulf Employees were working on the south end of the platform. The approximate work locations of the employees are shown in **Figure 3**.

**Figure 3.** Pen Gulf and Jake Marshall work locations. Four Pen Gulf employees were repairing/replacing damaged insulation within the yellow lines on the south side of the platform. One Jake Marshall employee was working on the north end of the platform (red box). The other two Jake Marshall employees were also working on the south end of the platform next to the Pen Gulf employees (red arrow). (Credit: CSB)

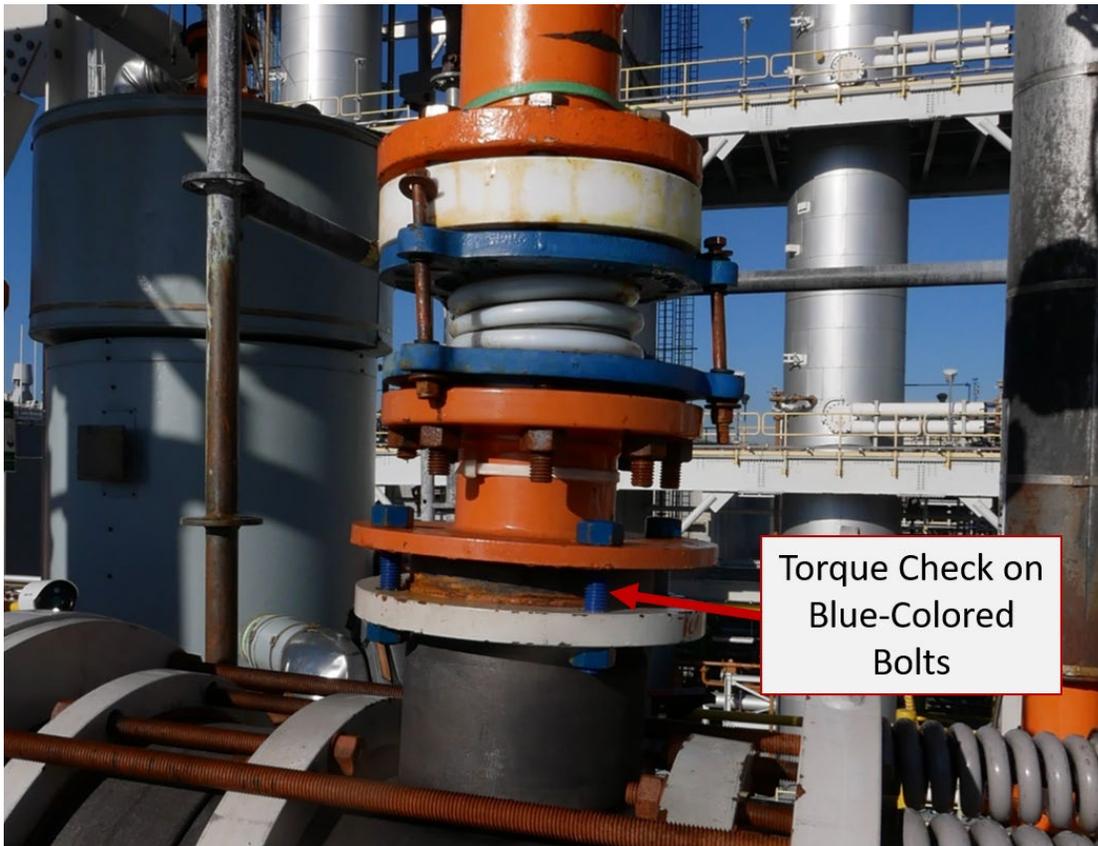
- Jake Marshall employees wore full-body chemical resistant suits, rubber boots and gloves, and full-face respirators with acid-gas cartridges. Pen Gulf employees were wearing flame-resistant clothing, steel-toe safety boots, and hard hats.
- Just after 10:00 a.m., as a Jake Marshall employee was checking the torque on the blue-colored bolts shown in **Figure 4**, a loss of containment occurred, resulting in an HCl release (**Figure 5**).

**Figure 4.** Torque check location. A Jake Marshall employee was checking the blue bolts in the image when the release occurred. (Credit: CSB)

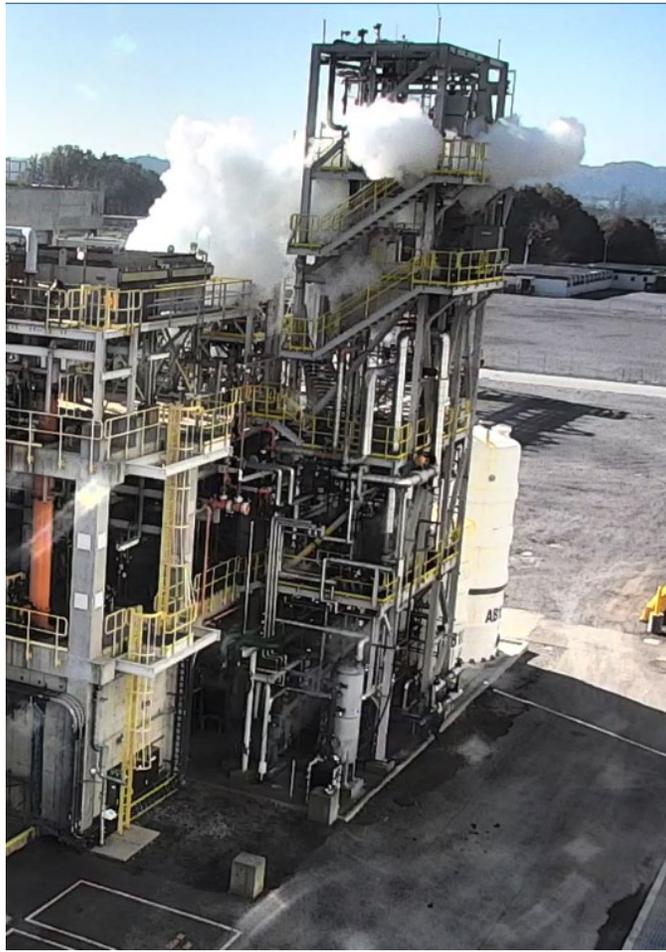
**Figure 5.** Image of HCl Release. Image taken during the release of HCl. (Credit: Wacker)

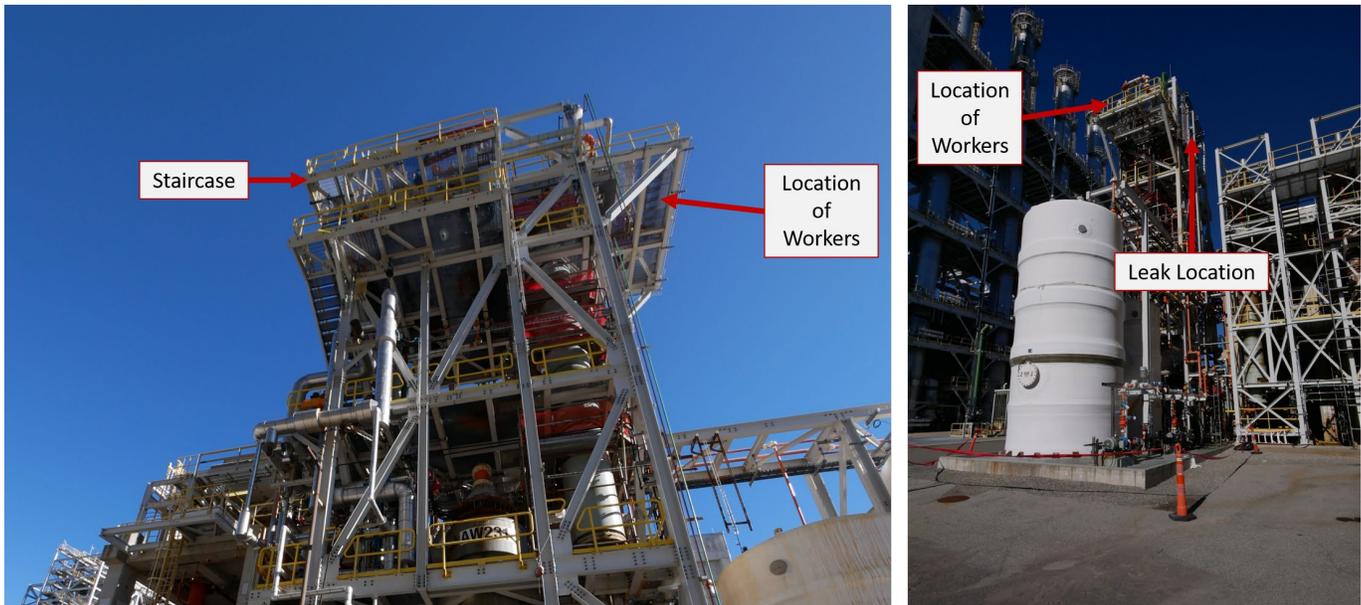
- The 5th floor platform was equipped with a single staircase for access and egress. No other mode of egress was present.
- When the Jake Marshall employee attempted to move away from the release, his chemical suit became entangled and tore open. The tear allowed HCl to get inside the suit, injuring the employee (chemical burns). Due to poor visibility on the platform as a result of the release, the employee was unable to go to the single staircase to exit the platform. The employee was able to go to the south side of the platform where the other Jake Marshall and Pen Gulf employees were working (**Figure 6**).
- The location of the release and resulting lack of visibility prevented all of the workers from being able to access the single staircase to exit the platform.

**Figure 6.** Location of Trapped Workers. When the release occurred, two Jake Marshall employees and four Pen Gulf employees were working on the south end of the platform. (Credit: CSB)

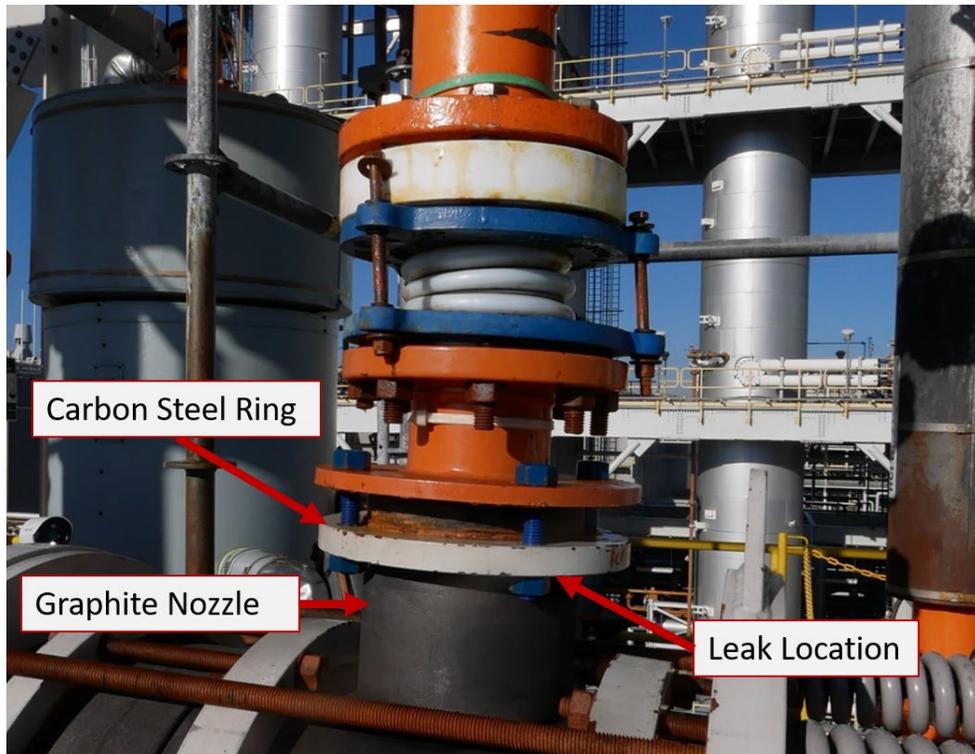
- After the incident, the CSB oversaw a leak test on the heat exchanger involved in the incident. The test identified a leak on the heat exchanger vapor outlet nozzle. The leak was under a carbon steel ring that was connected to the bolts that the Jake Marshall employee was torque checking (**Figure 7**).

**Figure 7.** Location of Leak. Leak tests on the heat exchanger revealed a leak from the graphite nozzle underneath a carbon steel ring used to attach the nozzle to carbon steel piping. (Credit: CSB)

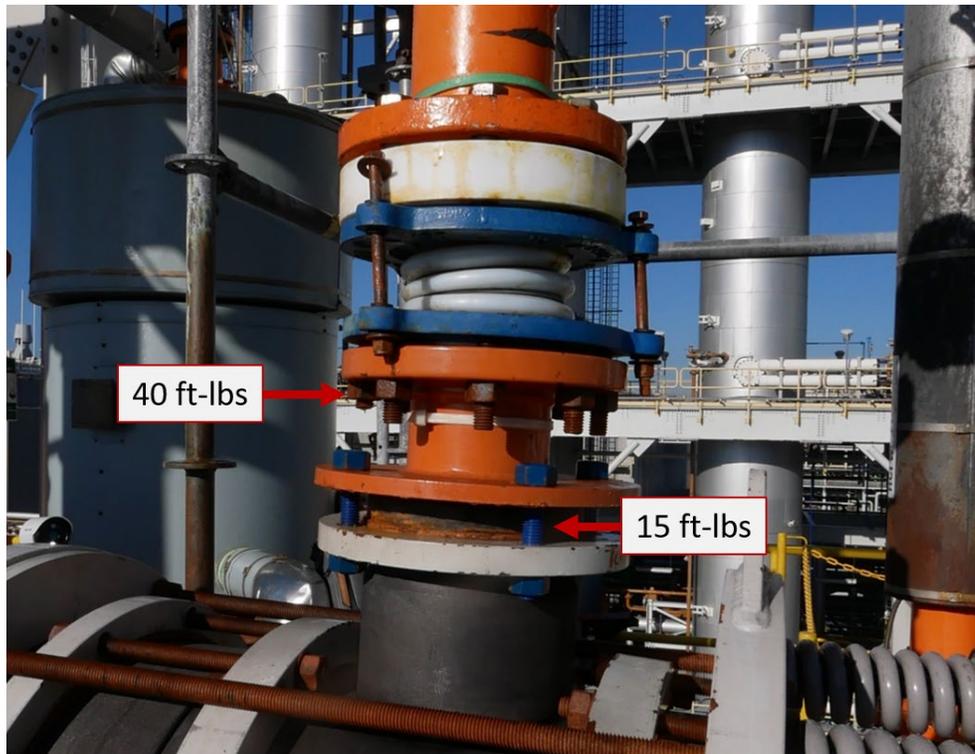
- The heat exchanger vapor outlet nozzle was constructed of graphite. The vapor outlet piping was constructed of Resistoflex brand Polytetrafluoroethylene (PTFE) lined carbon steel pipe manufactured by Crane ChemPharma & Energy.
- For exchanger-to-piping connections, the manufacturer of the heat exchanger states the recommended bolt torque is 15-foot pounds (ft-lbs).
- For piping-to-piping connections, the Resistoflex manual specifies the minimum required torque is 40 ft-lbs (**Figure 8**).
- A Jake Marshall employee reported that on the day of the incident, the torque wrench used to torque the bolts was set to 40 ft-lbs.

**Figure 8.** Bolt torque requirements. Two sets of bolts on the vapor outlet nozzle of the heat exchanger have different torque requirements. (Credit: CSB)
