## Investigation Update

July 2026

This document provides an update on the CSB's investigation of the January 27, 2026, incident at the Woodland Pulp mill in Baileyville, Maine.

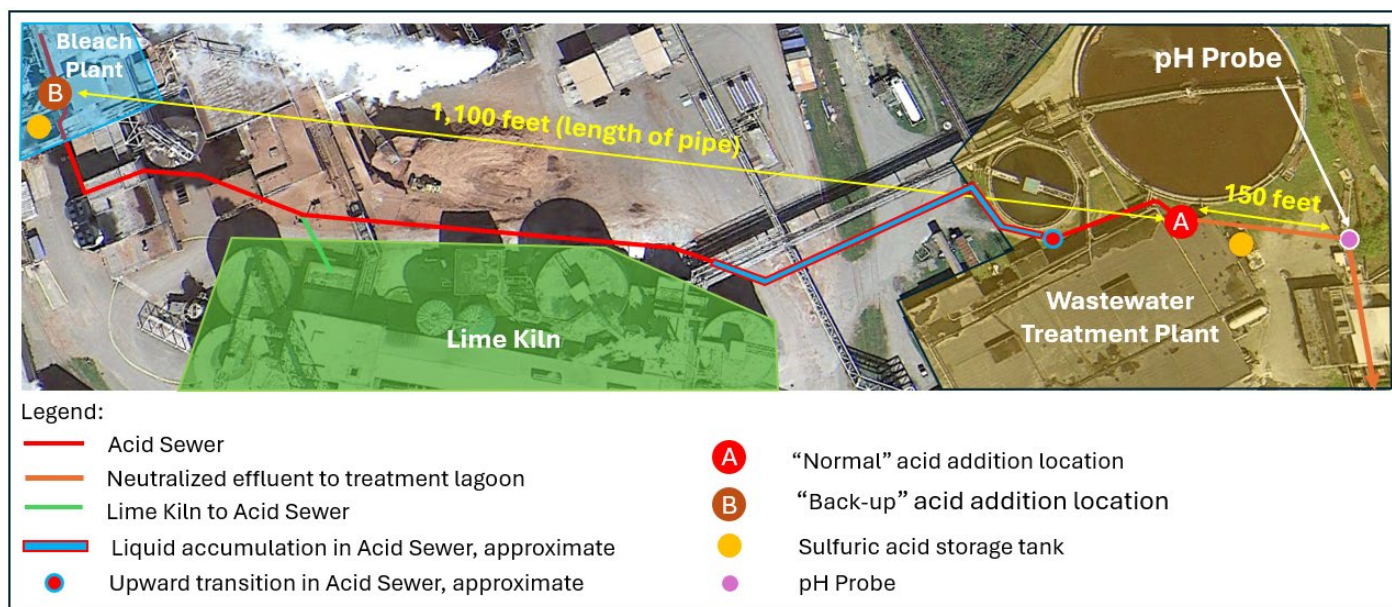
- The pulp mill is equipped with an acid sewer pipe, over 1,000-feet-long, that flows by gravity from the Bleach Plant to the pulp mill’s Wastewater Treatment Plant (**Figure 2**). The acid sewer collects discharges from multiple sources as it travels to the Wastewater Treatment Plant, including liquid overflow from the Bleach Plant’s scrubber and from another unit called the “Lime Kiln”. These discharges can be high in various alkaline (also called “basic” or “high-pH”) process fluids, such as solutions of sodium hydroxide, sodium sulfide, sodium carbonate, calcium carbonate, and calcium oxides, as well as other compounds and organics used or produced in the pulping process. Sulfuric acid is added to the acid sewer to control the pH of the total plant effluent before it is pumped to the secondary treatment lagoon, located approximately one and a half miles from the Wastewater Treatment Plant.

**Figure 2.** Acid sewer with locations of acid addition points from the Bleach Plant. (Credit: CSB)

- The acid sewer was installed in the mid-1960s and underwent numerous modifications, including in the mid-1970s, when a portion of upward-flowing piping (an "upward transition") was added (**Figure 2**). The upward transition spans about five feet vertically and 35 feet horizontally. The upward transition causes the upstream portion of the acid sewer, consisting of greater than 300 feet of piping, to accumulate liquid (**Figure 3**).

- About six months before the incident, the acid injection system, which feeds sulfuric acid to the acid sewer at the Wastewater Treatment Plant (see **Point A** in above **Figure 2**), was damaged, and subsequent maintenance efforts failed to repair the acid injection system in a timely manner. As a result, Woodland Pulp began using a backup sulfuric acid feed system, located over 1,000 feet upstream of the original feed location (see **Point B** in above **Figure 2**), to reduce the pH of the total plant effluent before it was pumped to the secondary treatment lagoon. About a month before the incident, the acid addition controls at this back-up location were modified to automatically add sulfuric acid to the acid sewer based on the pH measurements from a pH probe at the Wastewater Treatment Plant (above **Figure 2**).

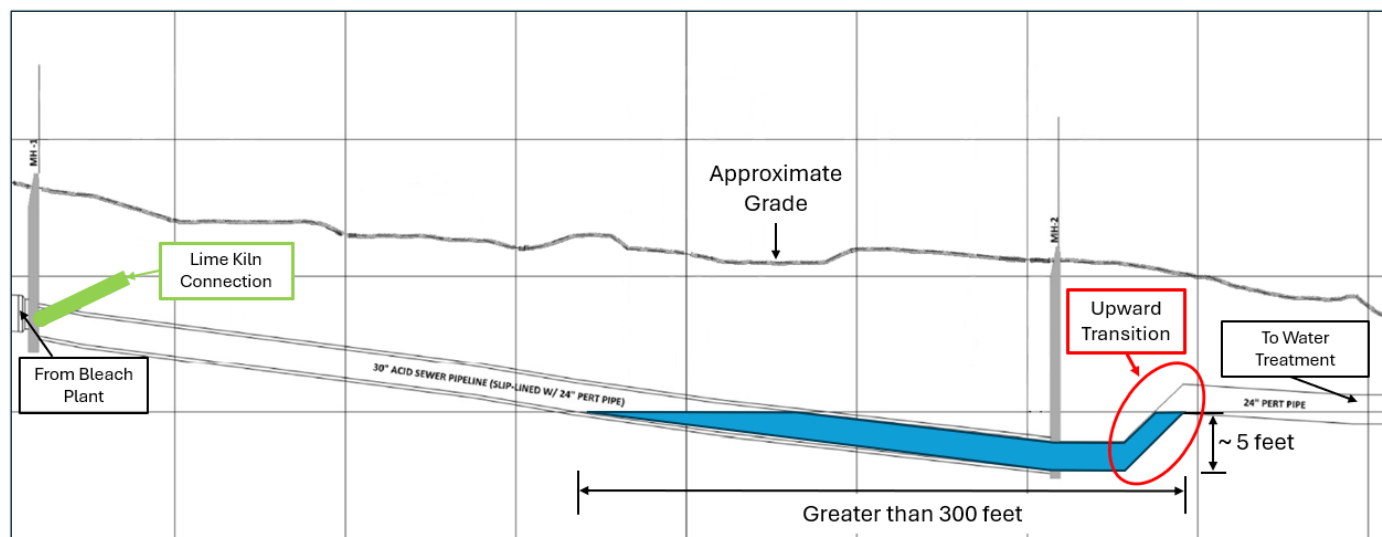
**Figure 3.** Upward transition and portion of acid sewer piping where liquid accumulates. (Credit: CSB)

- Both the sulfuric acid and the high-pH process fluids accumulated upstream of the acid sewer piping's upward transition. Some of the accumulated materials reacted and formed hydrogen sulfide gas.<sup>a</sup>

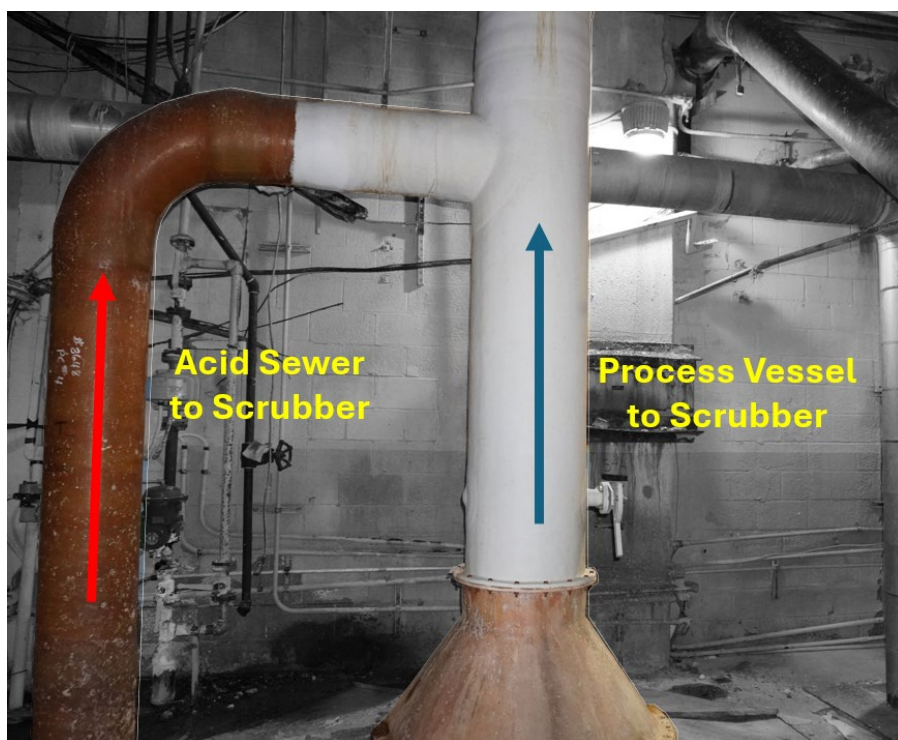
- The Bleach Plant’s scrubber creates a vacuum on equipment in the Bleach Plant, including the portion of the acid sewer in the Bleach Plant (**Figure 4**). The vacuum is created by a fan connected to the scrubber outlet that pulls the gas through the scrubber. The scrubber removes contaminants from the gas streams before discharging to the atmosphere.

**Figure 4.** Connections to the Bleach Plant Scrubber from the acid sewer and from a process vessel. (Credit: CSB)

- At approximately 11:40 a.m., the Bleach Plant's scrubber fan was turned off as part of the shutdown operations. As a result, the toxic hydrogen sulfide gas that was formed inside the acid sewer was not removed from the piping in the Bleach Plant. Instead, the toxic hydrogen sulfide gas accumulated in the acid sewer at the Bleach Plant, the gas collection piping that fed to the scrubber, and the connected process vessels.

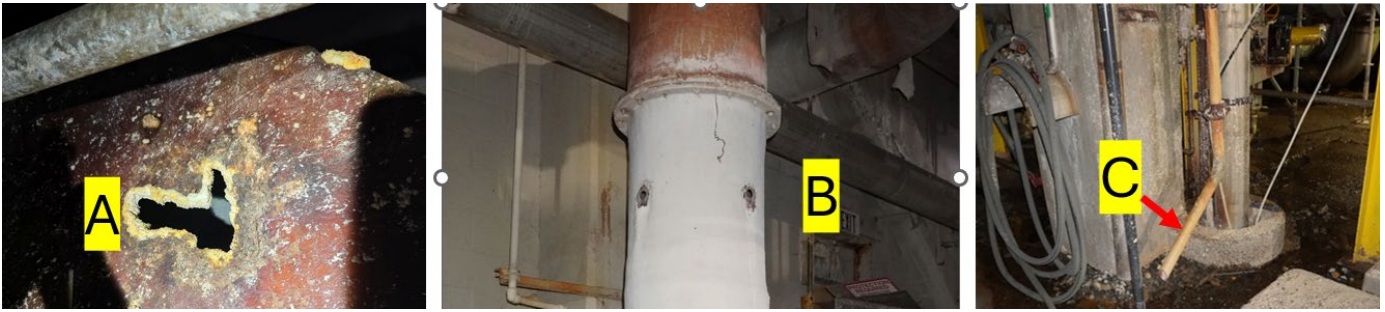
- On the second floor of the Kraft Mill, multiple holes and process openings in the equipment allowed toxic hydrogen sulfide gas to enter that floor of the building, including (A) an irregularly shaped, roughly six-inch by two-inch hole in a fiberglass gas collection pipe, likely caused by unintentional impact during maintenance work in the area, (B) a tank vent pipe with two one-inch diameter holes drilled, which in 2006 were used for gas flow measurements but were never plugged, and (C) a two-inch diameter, open drain pipe that, by design, was typically used to remove condensation from the gas collection piping (**Figure 5**). These process openings were all in close proximity in one area on the second floor of the Kraft Mill, referred to herein as the "hydrogen sulfide release zone" (**Figure 6**).

**Figure 5.** Process openings on the second floor of the Kraft Mill (Credit: CSB)

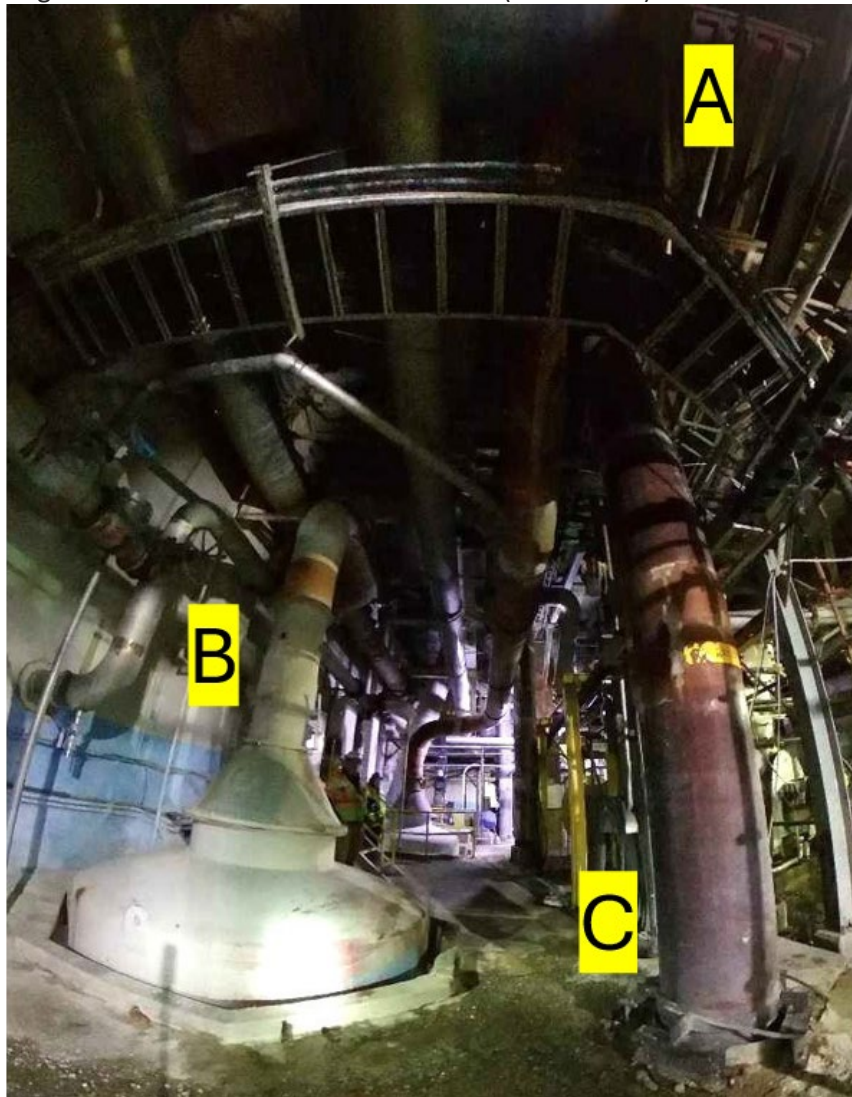
**Figure 6.** Locations of the three process openings on the second floor of the Kraft Mill, which created the “hydrogen sulfide release zone.” (Credit: CSB)

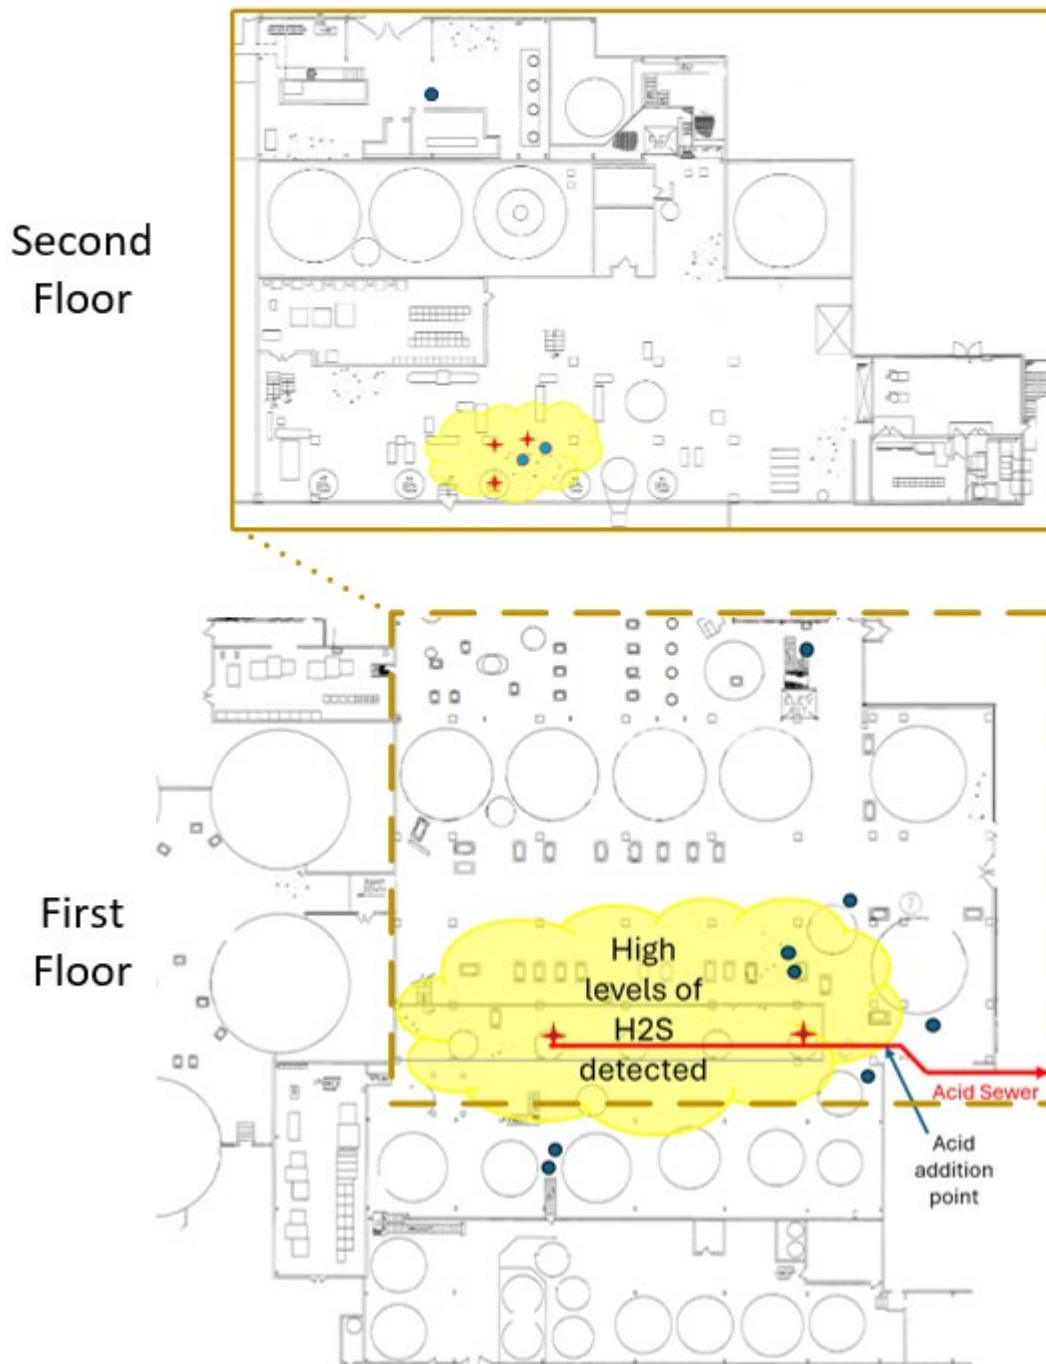
- **Figure 7** shows the locations of toxic hydrogen sulfide releases into the Kraft Mill and the locations of employees who were exposed to the toxic hydrogen sulfide gas.

**Figure 7.** Dark blue dots indicate approximate locations of the employees exposed to non-fatal concentrations of toxic hydrogen sulfide gas, and light blue dots indicate the location of the two fatally injured employees on the second floor. The red “+” indicates the approximate locations of the open drain valves on the first floor and the holes and process openings in the equipment on the second floor. An additional exposure (not shown) was on the third floor. (Credit: CSB)
