U.S. CHEMICAL SAFETY AND HAZARD INVESTIGATION BOARD

INVESTIGATION REPORT

ALLIED TERMINALS, INC.— CATASTROPHIC TANK COLLAPSE

REPORT NO. 2009-03-I-VA

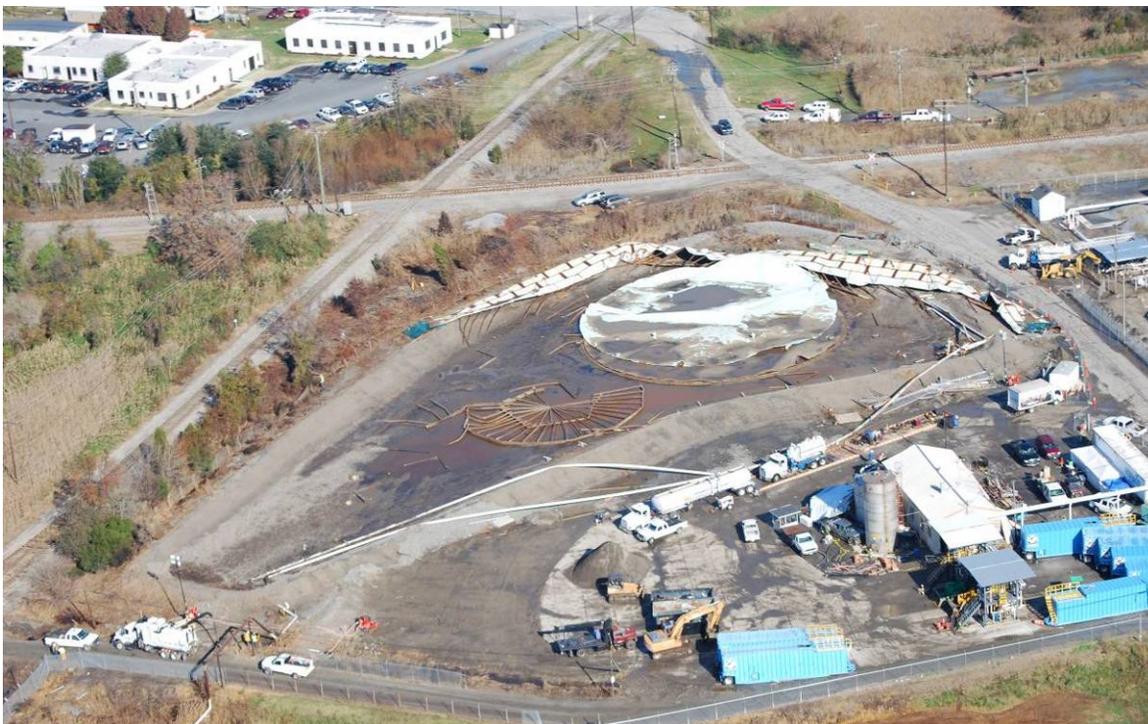
Figure 1. Allied collapsed tank and neighboring business.

On November 12, 2008, at about 2:20 pm, a 2-million-gallon nominal capacity liquid fertilizer tank catastrophically failed at the Allied Terminals, Inc. (Allied) facility in Chesapeake, Virginia (Figure 1). The tank split open vertically and nearly instantaneously released about 2.1 million gallons of liquid fertilizer. A welder and his helper were working on the opposite side of the tank as it collapsed. Both sustained serious injuries due to the collapsing tank and immersion in the liquid fertilizer. Employees from a neighboring business (shown in upper left of Figure 1) rescued the two workers.

As the liquid fertilizer released, it overtopped the secondary containment berm¹ surrounding the tank. The product flooded Rosemont Avenue, blocking egress for more than 100 employees at the adjacent business. It reached portions of the South Hill neighborhood, an adjacent residential community of 43 homes bordered on two sides by Allied's property (Figure 2). The City of Chesapeake Fire Department ordered residents to evacuate for several days. Weeks later, residents again had to leave their homes while an environmental cleanup firm repaired the damage to their property.

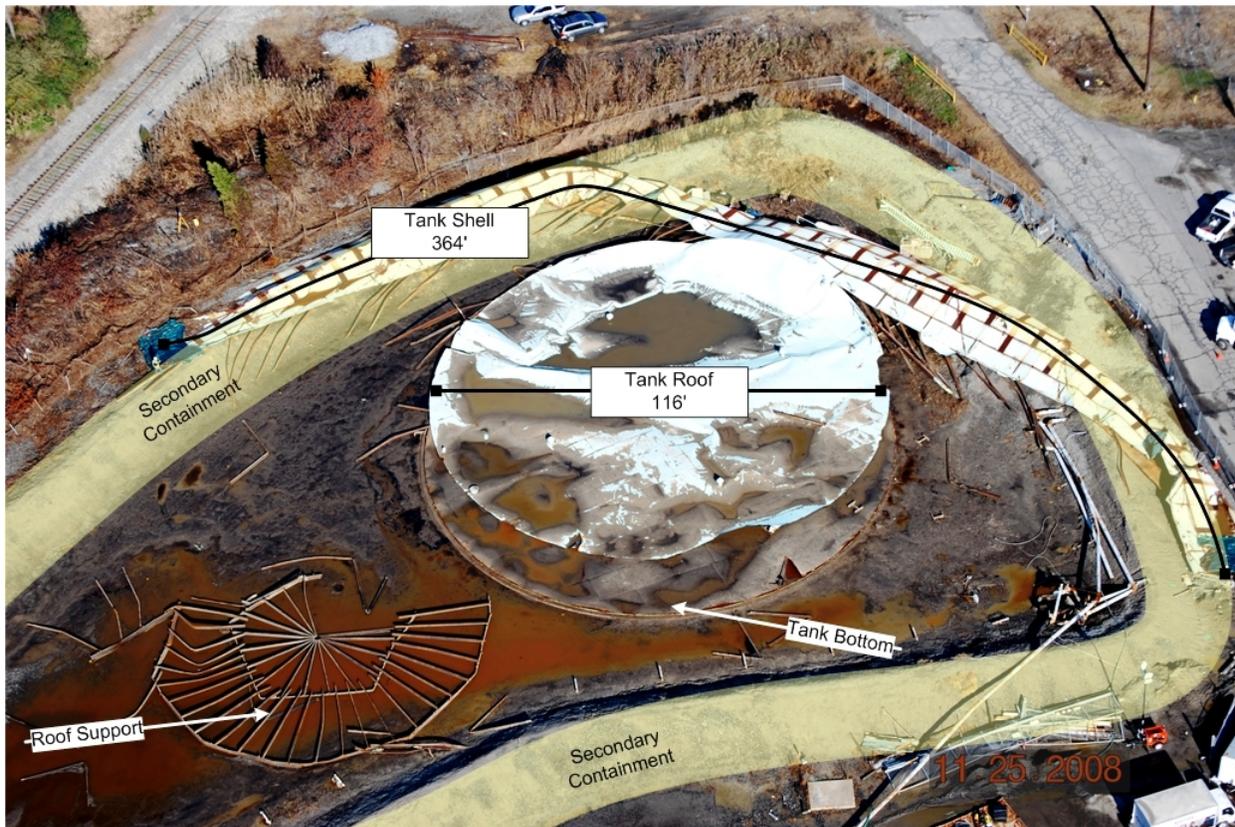
Figure 4. Tank 201.

At about 2:20 pm, as the tank reached a level of 26.72 feet, a vertical split started midway up the shell and rapidly extended to the floor and roof of the tank on the side opposite the workers. As the pressure of the liquid fertilizer inside the tank opened the split, the tank shell separated from the bottom and roof (Figure 4), rapidly releasing the tank's contents.

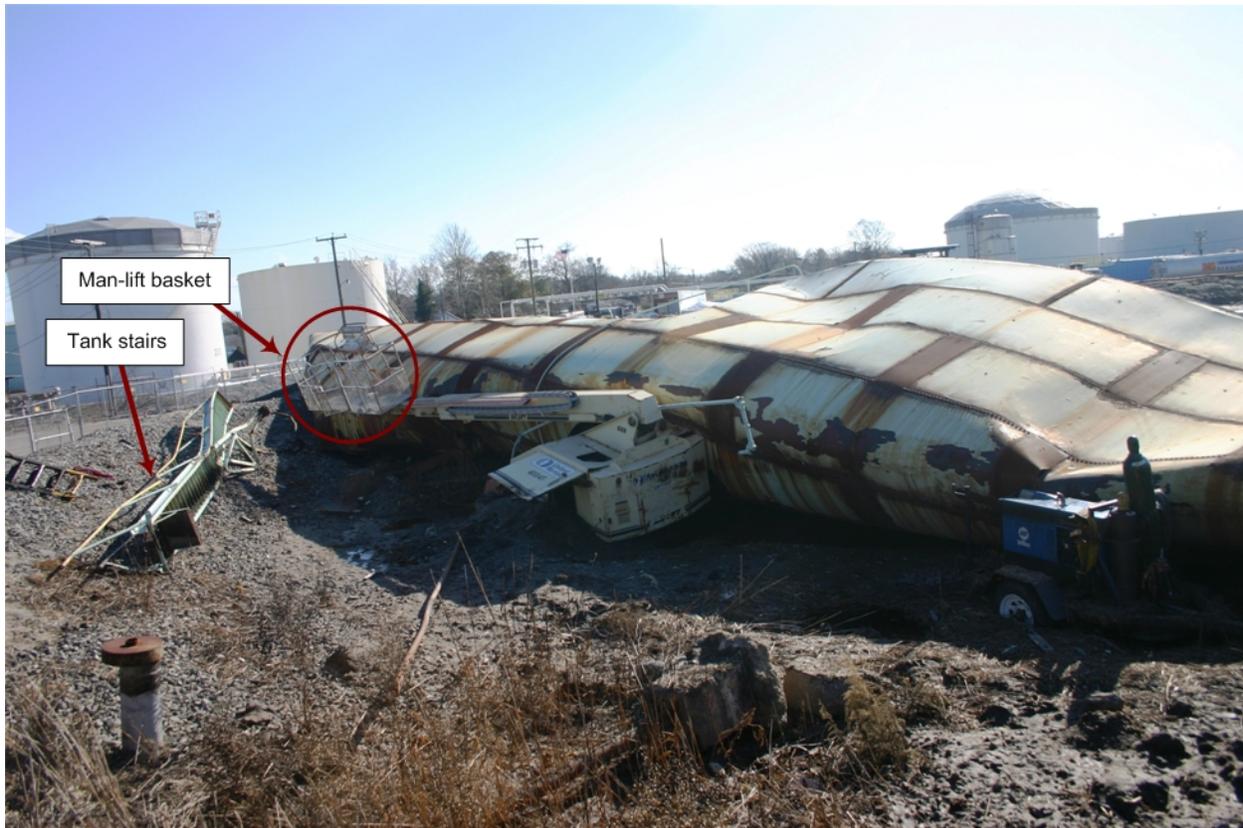
Figure 5. Location of injuries.

The collapsing tank shell impacted the man-lift, seriously injuring the welder in the man-lift basket. The tank stairs fell away from the tank and pinned the helper to the ground. Both workers were briefly submerged under the liquid fertilizer. Employees from a neighboring business witnessed the accident and quickly extricated the workers. Figure 5 is a close-up of the accident scene showing the man-lift and stairs.

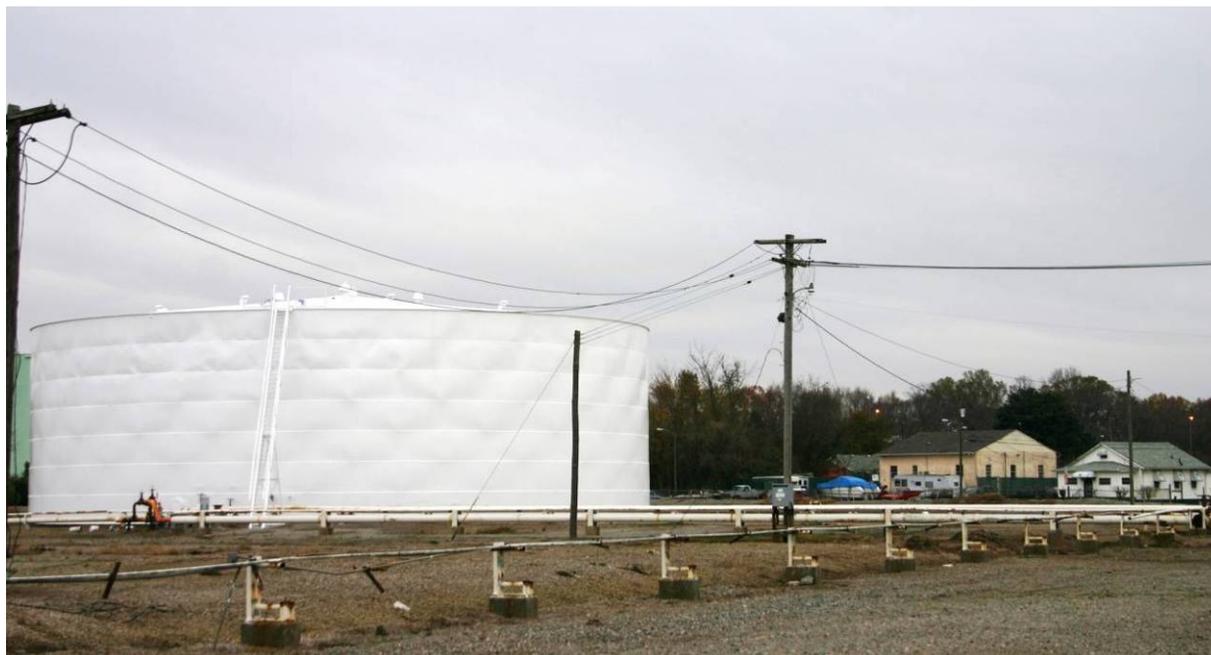
Figure 6. Tank 209.

The City of Chesapeake, through the Fire Marshal's Office, independently investigated the Allied incident. Based on the evidence collected and the concern for the safety of the residents of the South Hill neighborhood, the City of Chesapeake found Tank 209 to be an imminent danger, condemned the tank on December 22, 2008, and ordered Allied to drain it within 30 days. Allied drained the tank in accordance with the City's order.

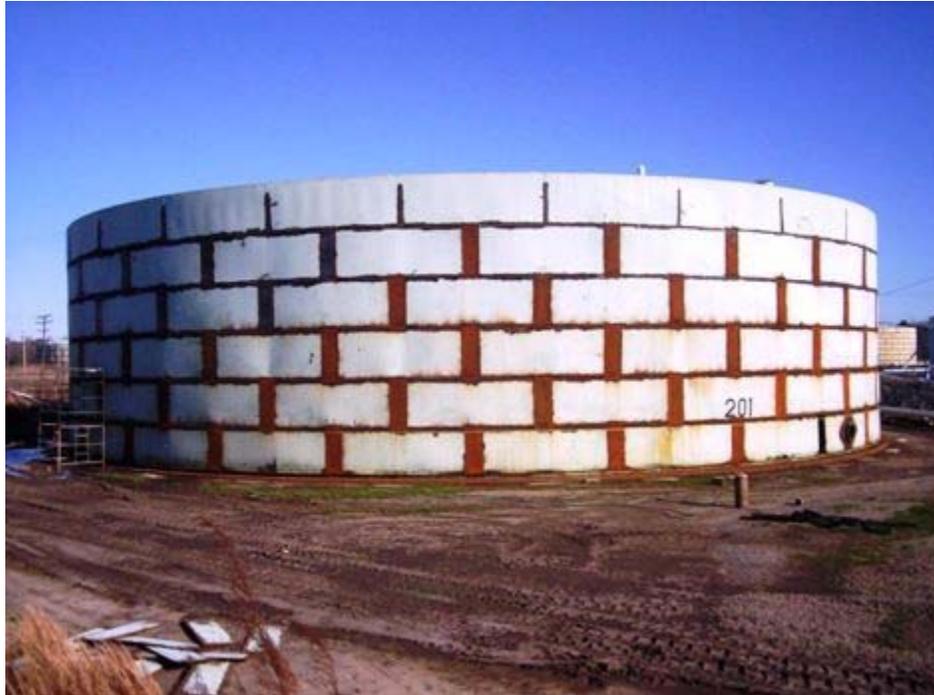
Figure 9. Modified Tank 201.

Following the modifications, Allied paid a non-destructive testing company to examine the welds for defects using spot radiography.¹⁵ However, Allied paid for the examination of only the lower two courses of Tanks 202 and 209. The upper courses of Tanks 202 and 209 and the entirety of Tanks 201 and 205 were not radiographed prior to returning these tanks to service. The radiography performed identified multiple weld defects in the lower courses of both 202 and 209.¹⁶

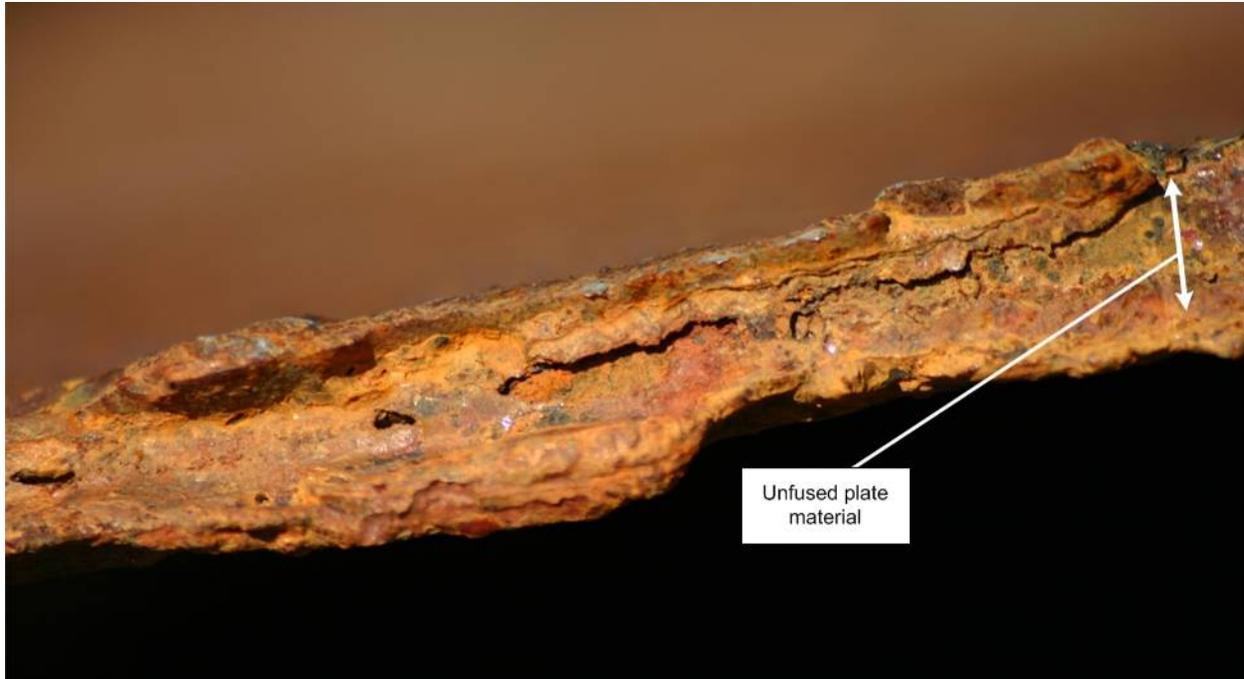
Figure 10. Failed tank weld on course three.

Welds on the plates to replace the vertical riveted joints failed because the welds (Figure 10) did not meet generally accepted industry quality standards for tank fabrication. The welds did not penetrate the full thickness of the plates. Furthermore, the welds contained defects—porosity (holes from gas bubbles in

the weld) and undercut (insufficient weld material along the edge of the weld)—that significantly degraded the strength of the welds.

Had the welds been radiographed as required by API 653, these weld defects would most likely have been detected and should have been repaired.
