**API 653
Inspection Report**

**Internal Inspection and
Out-of-Service
or
Internal Inspection
w/ External Checklist**

4-METHYLCYCLOHEXANEMETHANOL (MCHM)

Tank Number
396

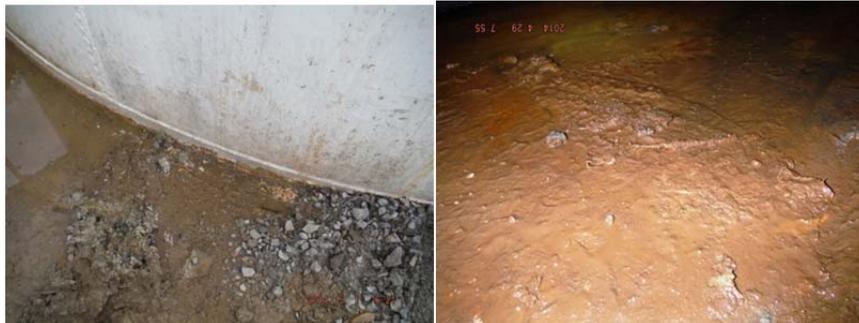
Muddy Conditions around the base of the tank and debris inside tank

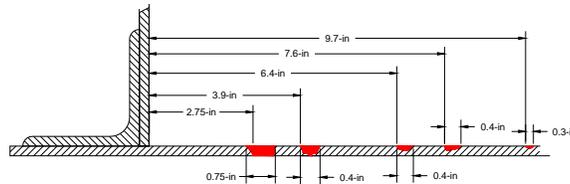
- 1.2. **Product Side Visual Bottom Inspection:** At the time of the inspection a series of deep isolated product side pits were identified on bottom plate 9. A hole through the bottom from product side corrosion was present in the pit nearest the shell resulting in an active leak path. The edge of the ¾-in diameter hole is 2 ¾-in from the shell is located in the API 653 designated critical zone (3-in from shell of the inside edge of the shell, measured radially inward).
- 1.3. Product side Corrosion Rate: (loss/age of bottom = 0.25-in/25 years= 0.01 in/year)

**Hole on Bottom Plate 9**

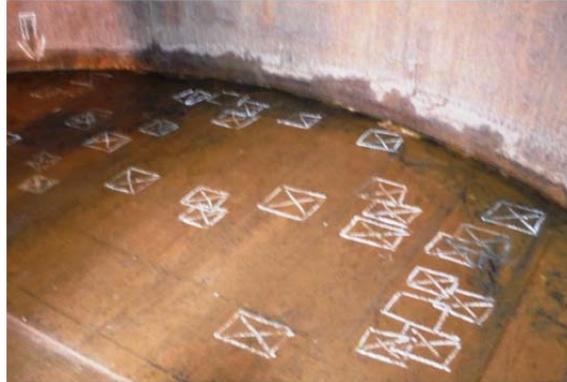
- 1.6. During the MFE 2412 bottom scan each significant MFE indication was marked on the bottom with "Mark-al® Paint stick".

**MFE Bottom Indication Marks
(Immediately after marking)**

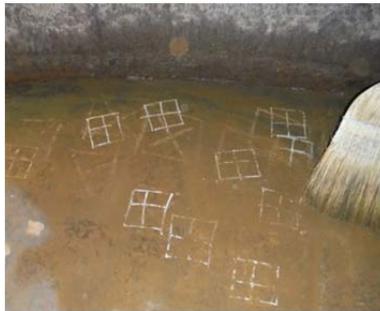
- 1.7. The marks were quickly obscured by dirt and mud.

**MFE Bottom Indication Marks
(shortly after marking)**

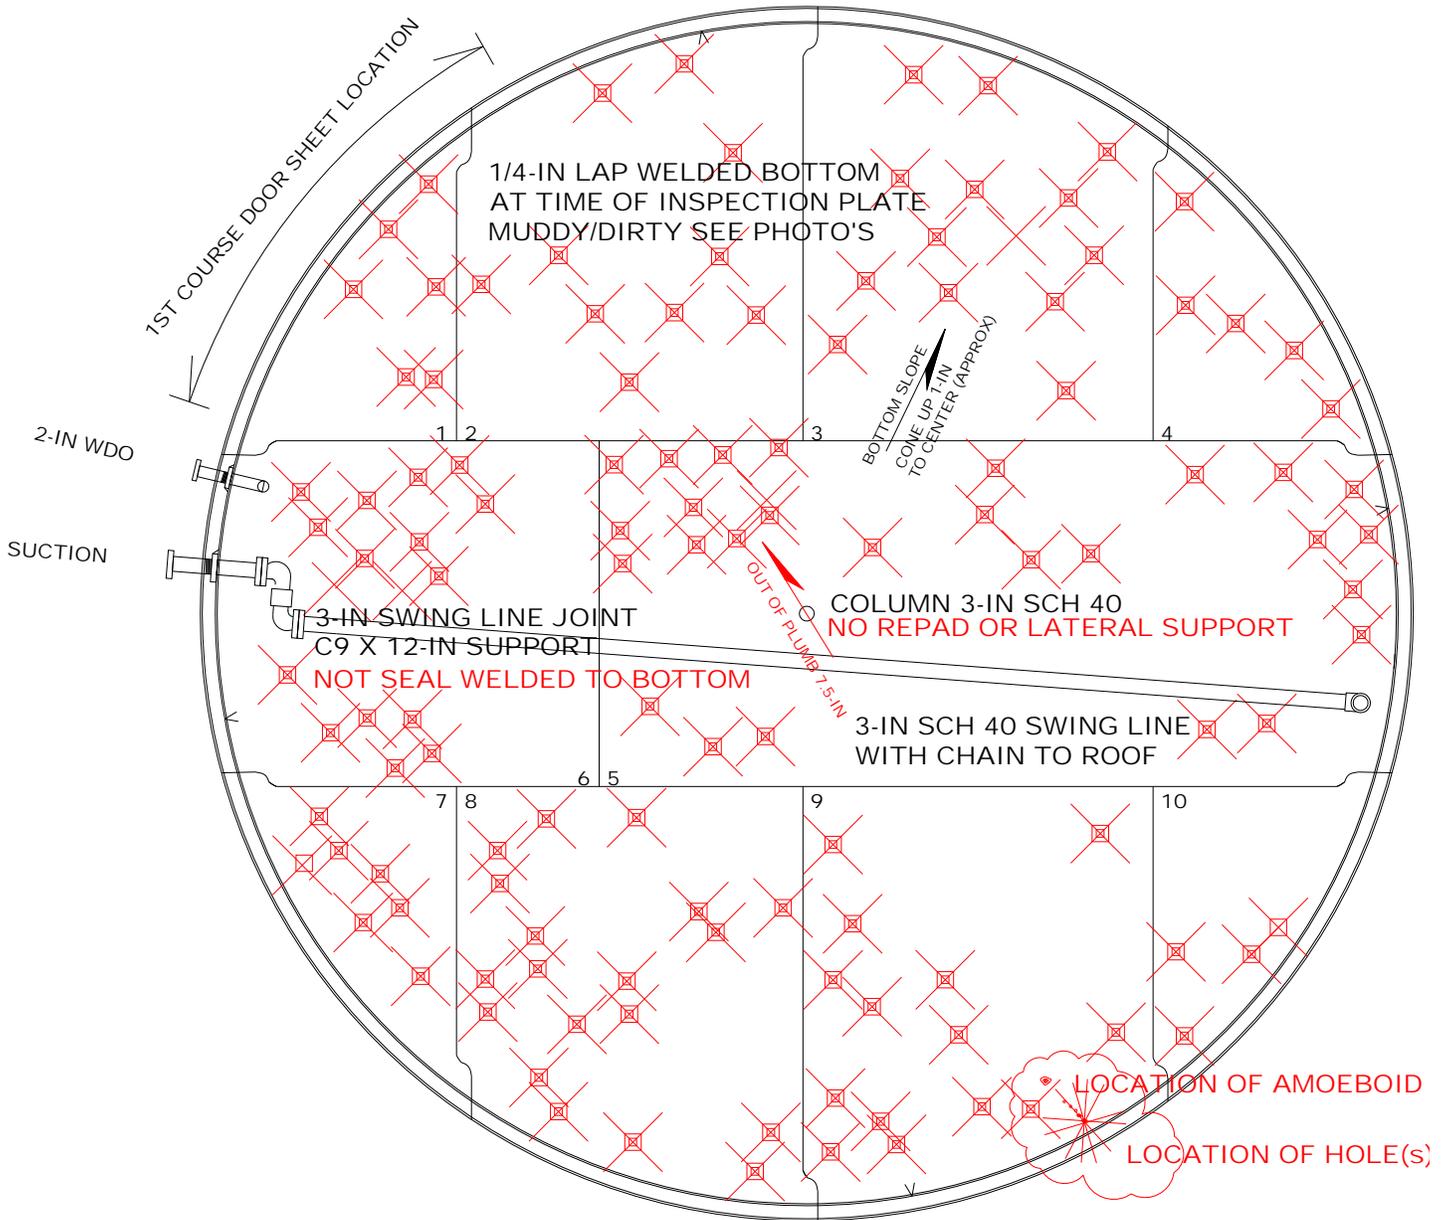
BOTTOM CORROSION MAP

- 1.8. Limited prove-up of the MFE indications resulted in remaining UT thickness of 0.18-in or a loss of 0.25-0.18=0.07-in). Note it is the inspector's opinion that the limited UT prove up did not identify the worst are of soil side corrosion. In order to conduct this type inspection at a minimum a full inspection blast of the bottom to remove all scale/dirt and debris would need to be conducted.

- 1.9. Soil side corrosion rate. 0.07-in loss/25 years age of bottom = 0.0028-in/year.

1.10. In the Bottom Corrosion Map the MFE indications are marked with red X's.

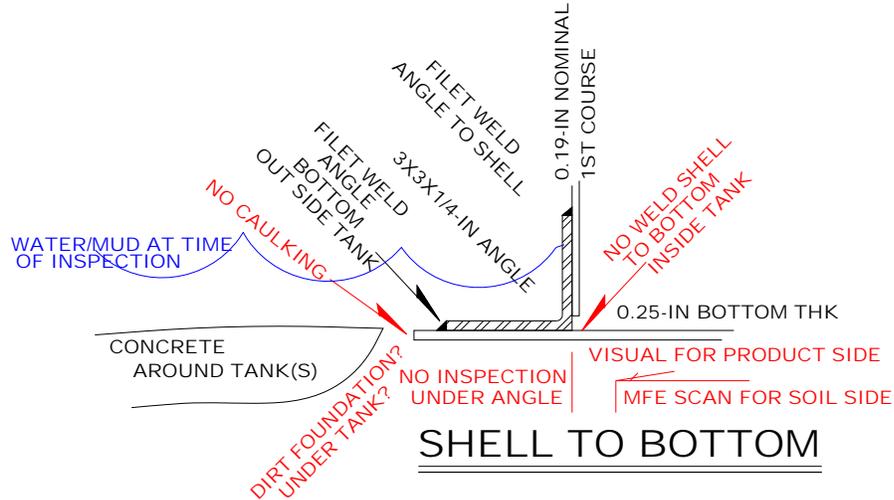
2.1. **There is a possibility that significant undetected bottom corrosion is present under non API 650 tank shell to bottom joint.** This joint is formed with a 3 x 3 x 1/4-in angle as illustrated. Note: Inspection of the bottom plate under the shell and extending outward is almost impossible short of excavating around the base of the tank and utilizing mirrors to view the bottom condition in this area.

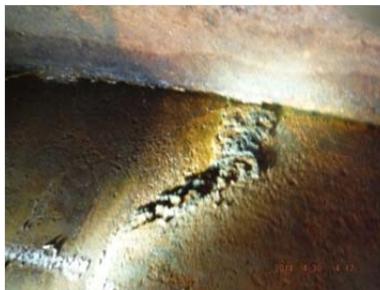
2.2. **There may be existing cracks or weld defects in the existing bottom butt welds.** The lap welded bottom is 1/4-in nominal thick plate with an under the shell bottom breakdown detail (as illustrated) that transitions from a lap weld to a butt weld. This joint is susceptible to cracking and is located in the API 653 area of the bottom called the “Critical Zone” or CZ. Most of the CZ joint is obscured from inspection by the shell to bottom angle detail.

Photo of typical lap weld to butt weld transition

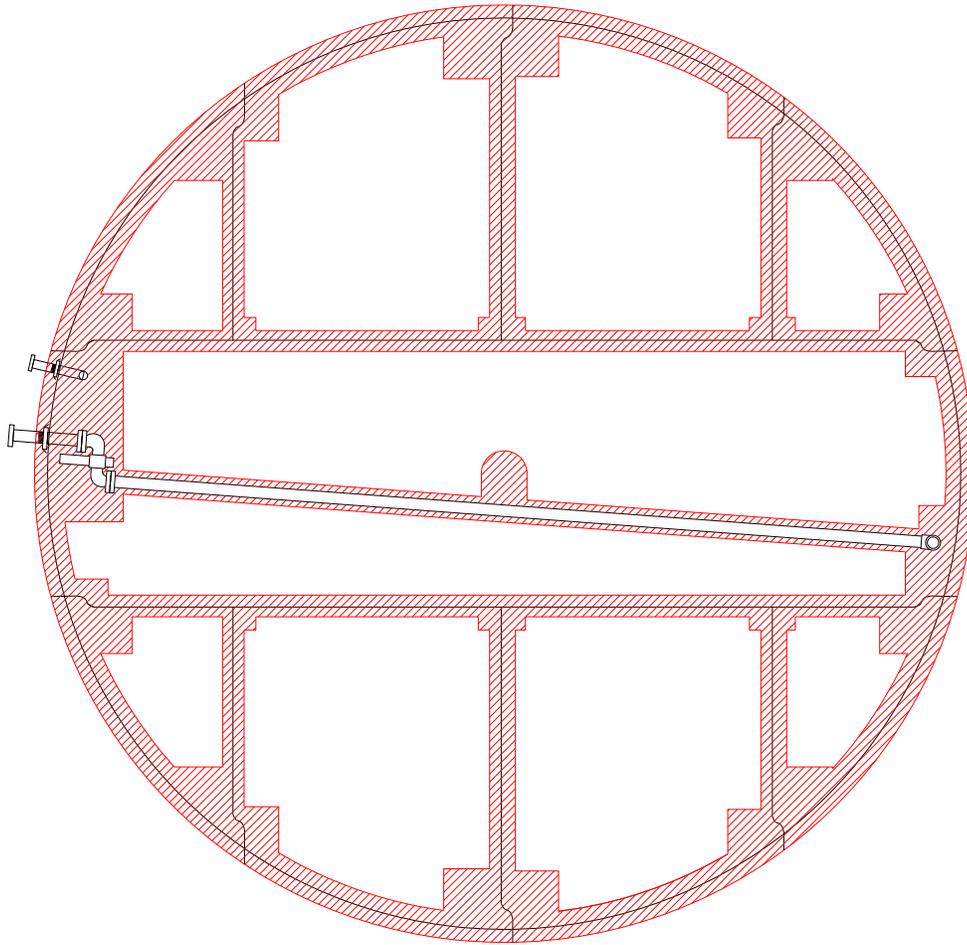
MFE SCAN COVERAGE

- 2.3. **There may be significant soil side corrosion in the areas of the bottom difficult for access with the MFE 2412 scanner.** The MFE coverage was limited to approximately 75% of the bottom area and indicated in the next drawing. Under normal conditions the scanner coverage near the bottom to shell joint is plus or minus 1 to 2-in, at the square plate intersections plus or minus 4-in, around nozzles and swing lines plus or minus 3 to 12-in, and near the triangular corners of sketch plates plus or minus 6 to 12-in. In addition on this tank the shell to bottom detail eliminates from MFE coverage, the outer 4 inches of the bottom that extends under the shell.

- 2.4. These areas that were difficult to reach with the scanner (<2-in from the corner weld, tight angled bottom plates, under columns and base plates, around supports, and under low shell nozzles). If conditions were optimal Ultrasonic thickness testing or UT would be performed in these areas, however because of the rough and dirty bottom conditions, effective UT of these areas was not possible.

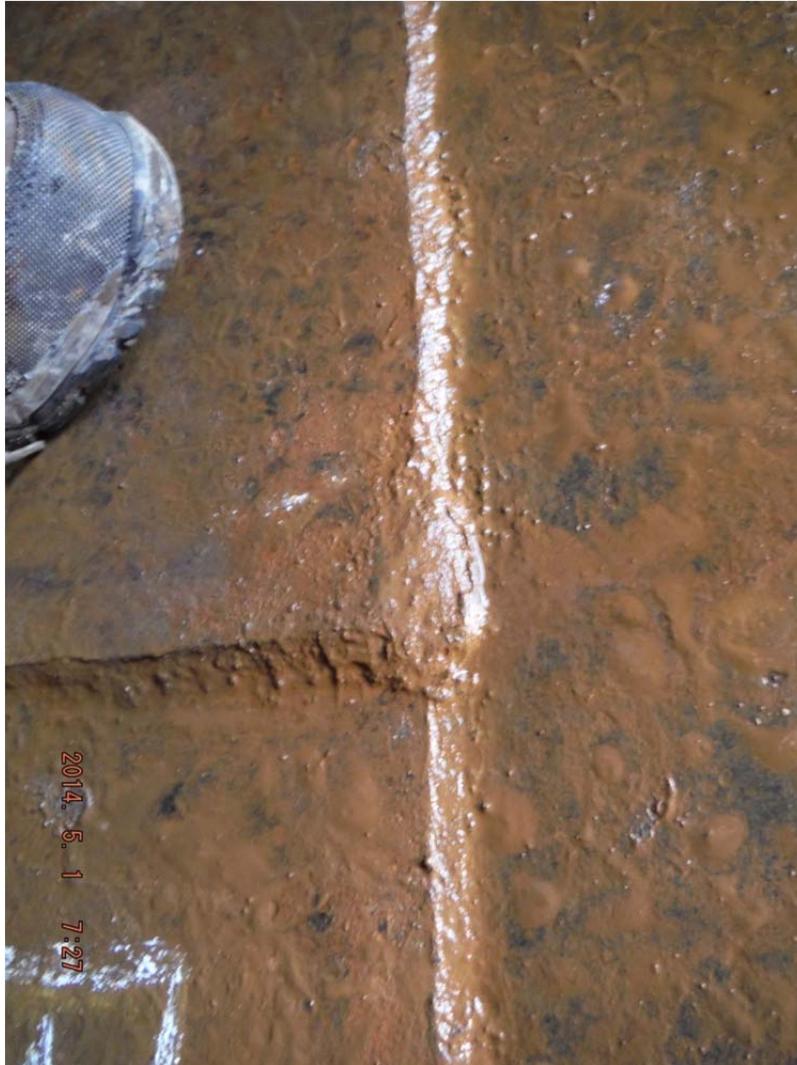
- 2.5. In addition to visual inspection the bottom lap welds are typically tested with a Vacuum Box, during an API 653 bottom inspection. Unfortunately the conditions did not allow for affective inspection by either method.

Typical Bottom Lap Weld

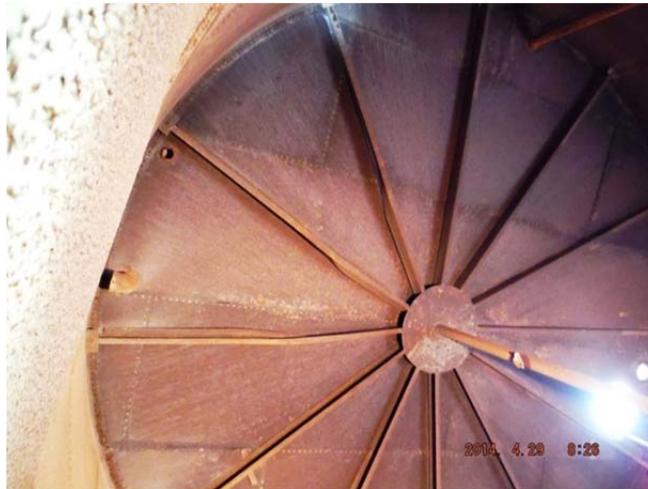
- 3.1. **Shell Settlement.** The maximum out-of-plane base of shell settlement was approximately 0.5-in, which is within acceptable limits of API 653 Appendix B calculations for differential settlement. See survey results.
- 3.2. **Shell Verticality.** The shell has some existing cosmetic dents and minor deformation. (see shell roll out drawing and photos)
- 3.3. **Access Structure.** The roof access is via a common catwalk servicing all 3 tanks. The vertical handrail support and connection to the catwalk is poorly designed allowing deflection of the handrail.
- 3.4. **Roof Support Rafters.** Several of the roof deck support rafters are damaged.

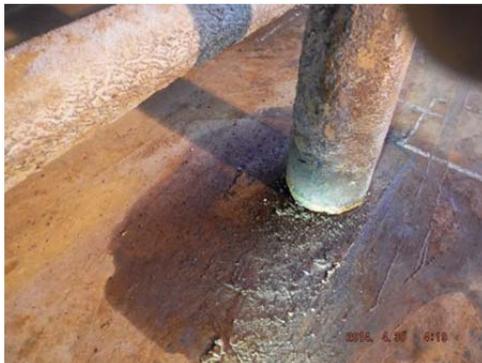
- 3.5. **Roof Support Column.** The roof support column is a pipe design and is susceptible to undetected internal corrosion damage.
- 3.6. **Column Base.** The base of the column does not appear to be restrained from lateral movement. A doubler plate or repad is not present underneath the column. There is a risk that an undetected leak path is present underneath the column.

Base of Column (no repad or lateral restraint present)

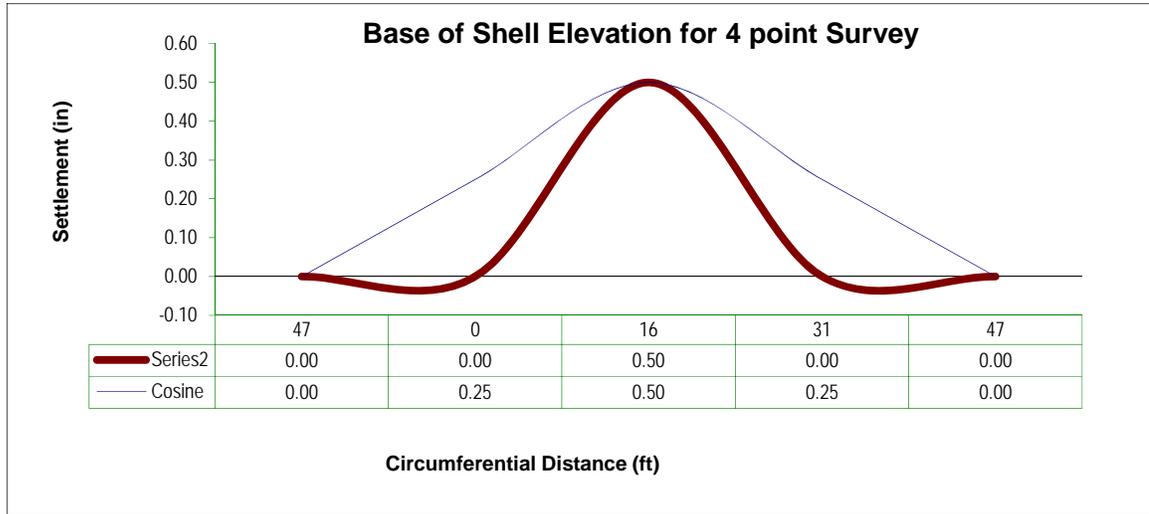
SHELL SETTLEMENT SURVEY

- The settlement for the tank is planer or roughly approximates the shape of a cosine curve.
- The evaluation of this “out-of-levelness” or settlement, utilizing the criterion for “out-of-plane distortion” as described in API 653 Appendix B.3.2, indicates that the settlement is well within the acceptable limits.

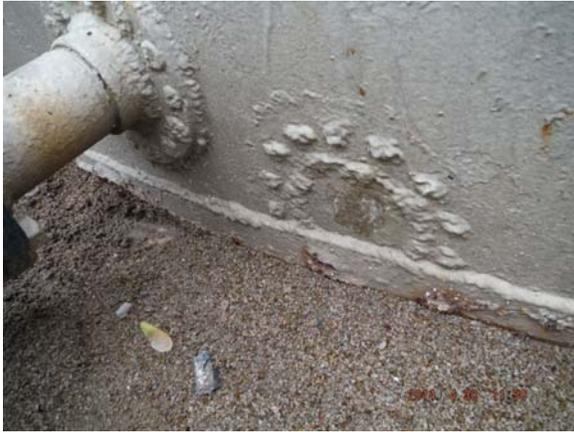
B. FOUNDATION
PORTIONS OF BOTTOM EXTENSION COVERED BY SOIL

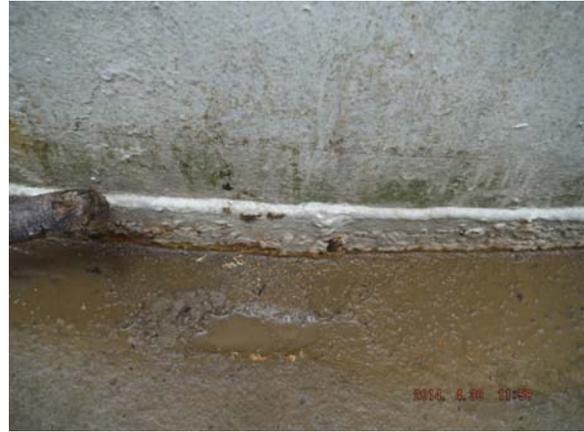
B. FOUNDATION
RAINWATER IN CONTACT WITH BOTTOM PLATES

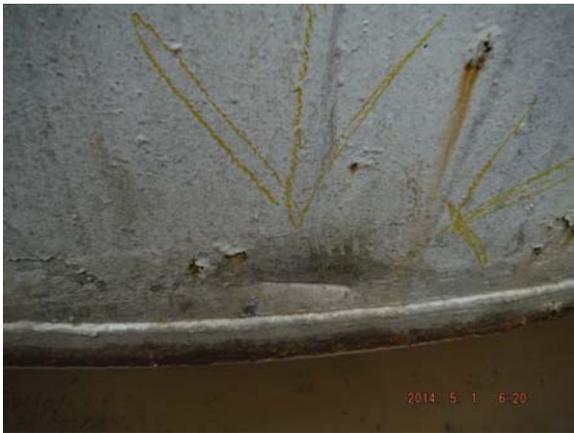
B. FOUNDATION
MECHANICAL DENT IN LOWER SHELL

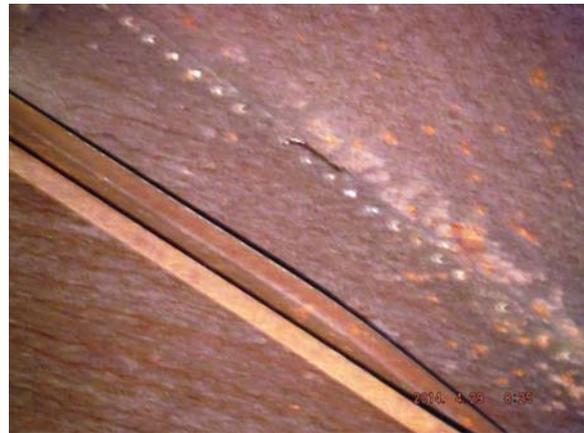
D. ROOF
DAMAGED ROOF

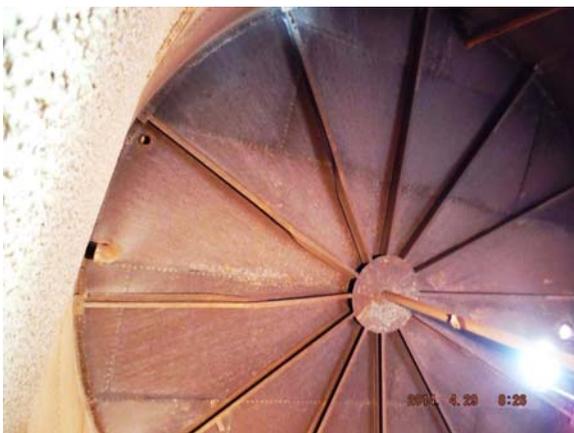
D. ROOF
TWISTED RAFTERS

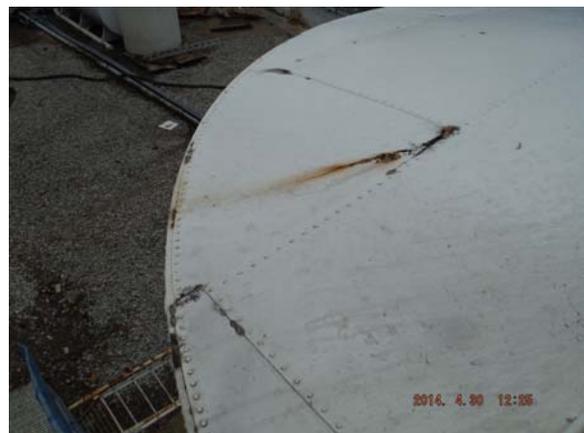
| 65 | C.1.4.2.a | Visually inspect for paint failure, holes, pitting, and corrosion product on the roof deck. | SEVERAL ISOLATED AREAS OF COATING FAILURE AND CORROSION THAT MAY EVENTUALLY PRODUCE THRU HOLES. |

D. ROOF
COATING FAILURE AND CORROSION ALONG CONE ROOF

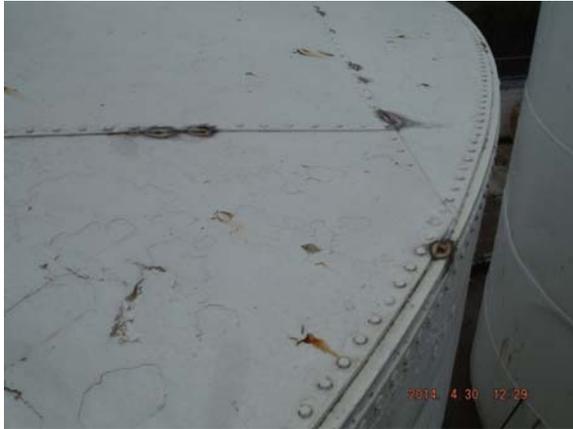
D. ROOF
CORROSION ALONG UPPER ANGLE

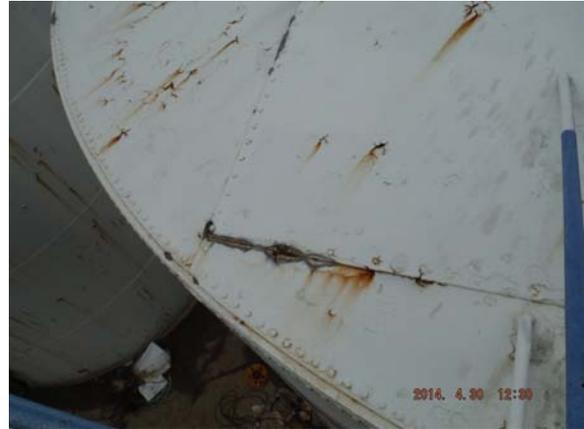
D. ROOF
CORROSION ALONG ROOF LAP WELDS

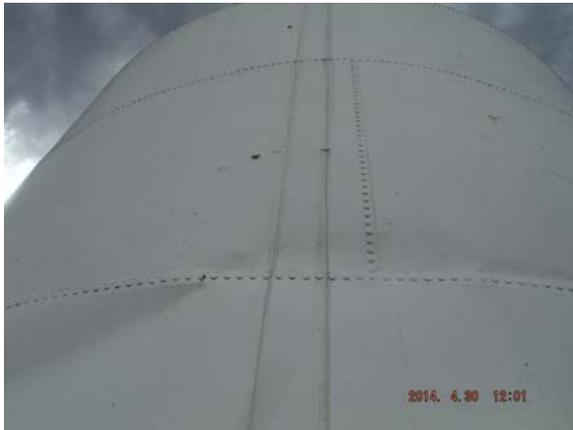
E. SHELL
CREASE IN SHELL PLATES

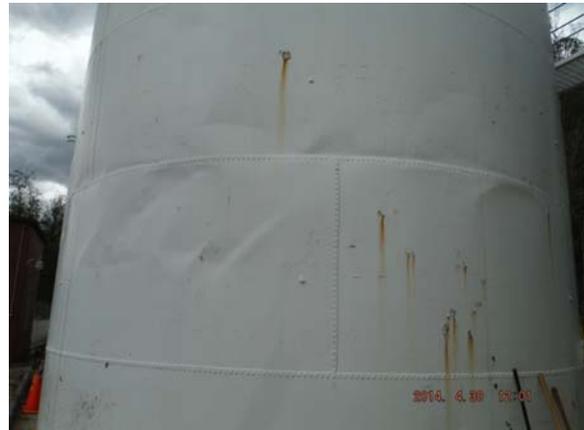
E. SHELL
CREASES IN SHELL

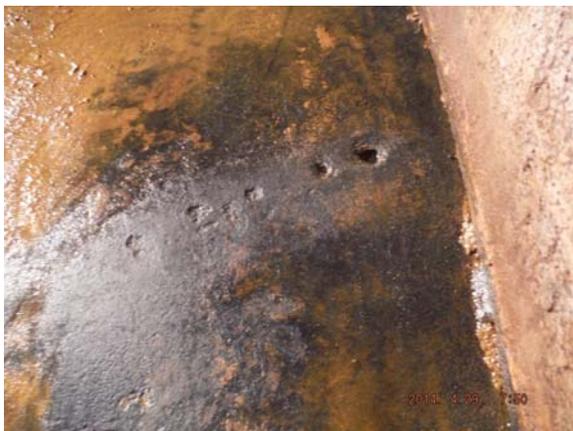
F. BOTTOM
**THROUGH-HOLE SOIL-SIDE CORROSION ALONG THE
BOTTOM PLATES**

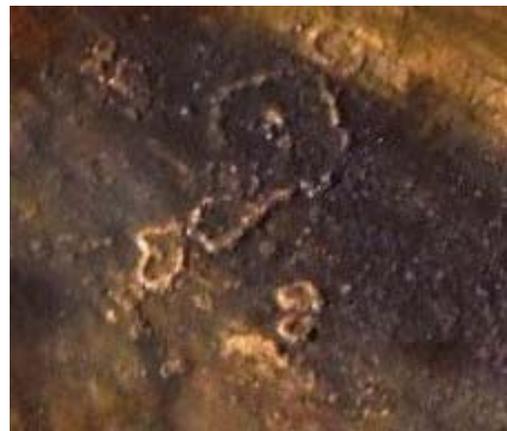
- 1.4. A “Amoeboid” shaped deep product side area of pitting (possible indication of MIC – microbologically induced corrosion) was also found on bottom plate 9. This isolated area of pitting was approximately 2-in in diameter and resulted in a loss of 0.07-in as determined via pit gauging. Remaining thickness (0.25-0.07=0.18-in +/-)

F. BOTTOM
**POSSIBLE INDICATIONS OF MIC (MICROBIOLOGICALLY
INDUCED CORROSION)**

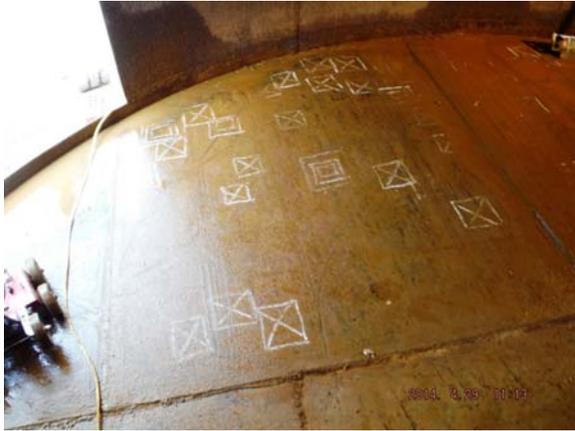
F. BOTTOM
WIDESPREAD MFL INDICATIONS OF SOIL-SIDE CORROSION ON BOTTOM PLATES

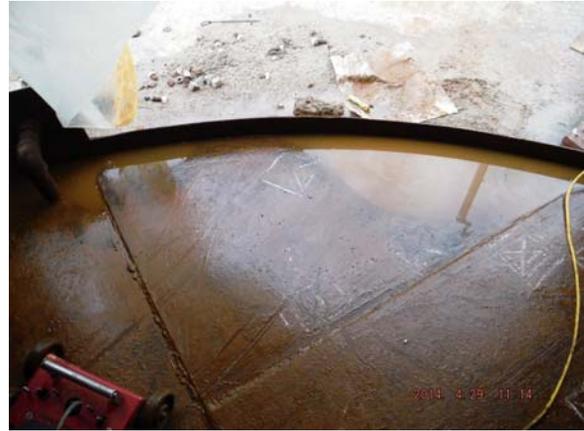
F. BOTTOM
WATER AND DIRT PREVENTED ACCURATE UT PROVE-UP OF MFL INDICATIONS

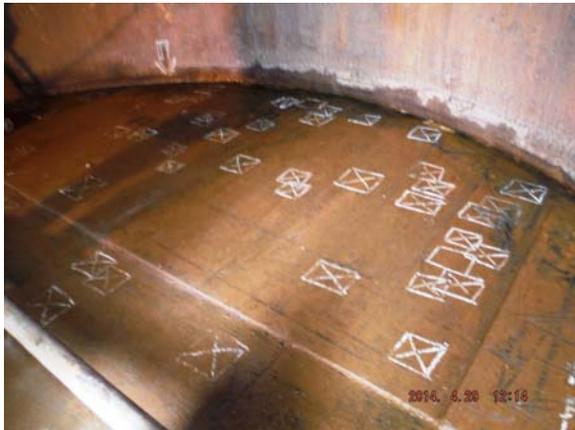
F. BOTTOM
WIDESPREAD MFL INDICATIONS OF SOIL-SIDE CORROSION

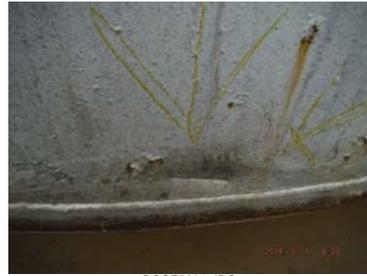
DSCF5831.JPG

MECHANICAL DENT IN LOWER SHELL

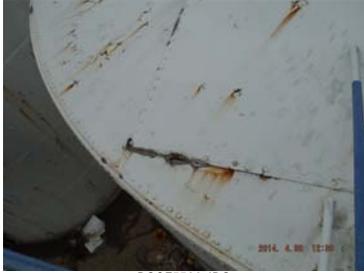
DSCF5529.JPG

CORROSION ALONG ROOF LAP WELDS

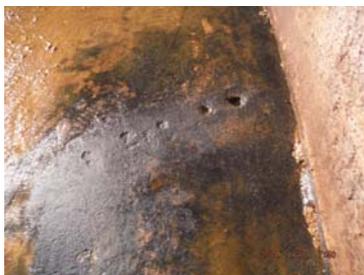
DSCF5314.JPG

THROUGH-HOLE SOIL-SIDE CORROSION ALONG THE
BOTTOM PLATES

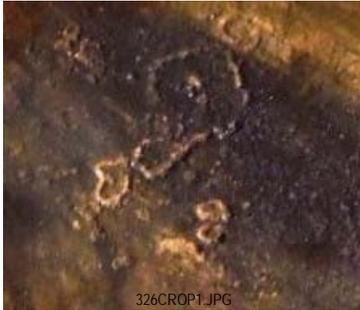
326CROP1.JPG

POSSIBLE INDICATIONS OF MIC (MICROBIOLOGICALLY INDUCED CORROSION)
