Anamet, inc *Materials Engineering & Laboratory Testing*

26102 EDEN LANDING ROAD, SUITE 3 • HAYWARD, CALIFORNIA 94545 • (510) 887-8811 • FAX (510) 887-8427

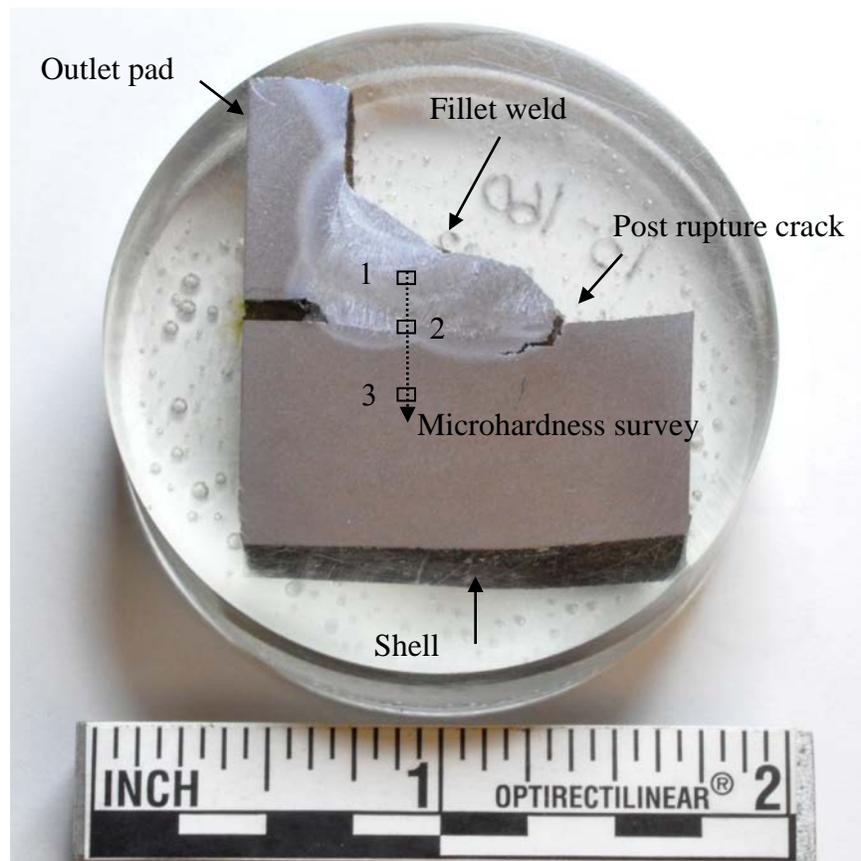
(a) Specimen 164-4.02.2

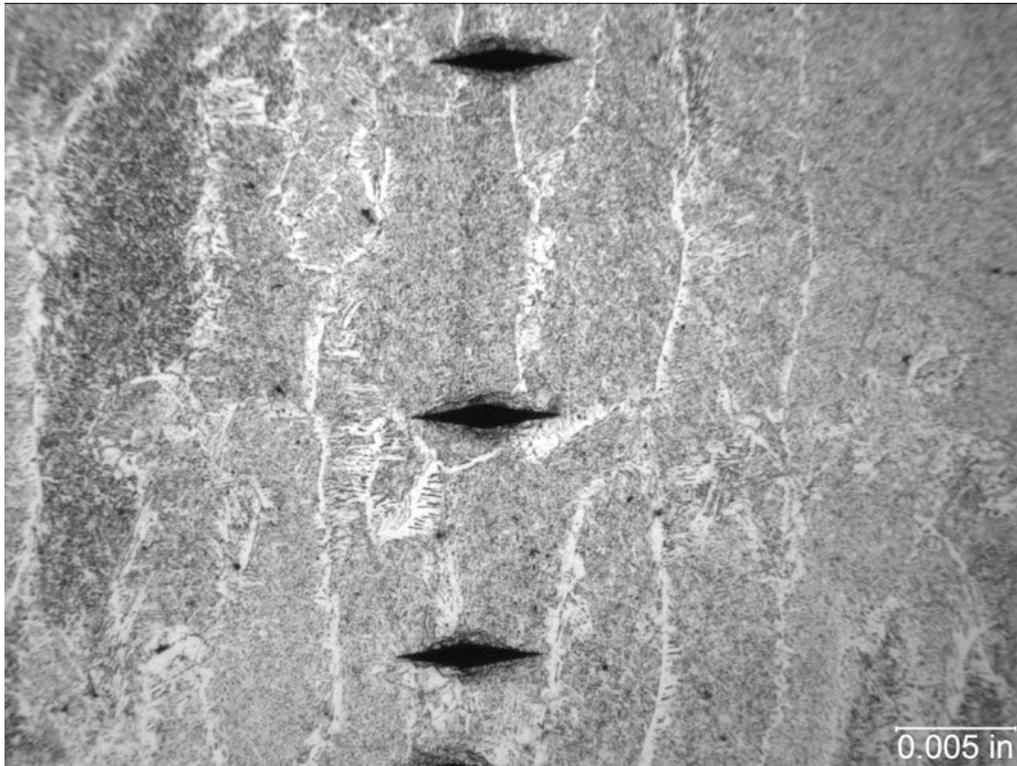
Figure 63 Fracture initiation site 2 and a specimen prepared for metallography from a section cut 0.5-inch below the fracture plane shown.

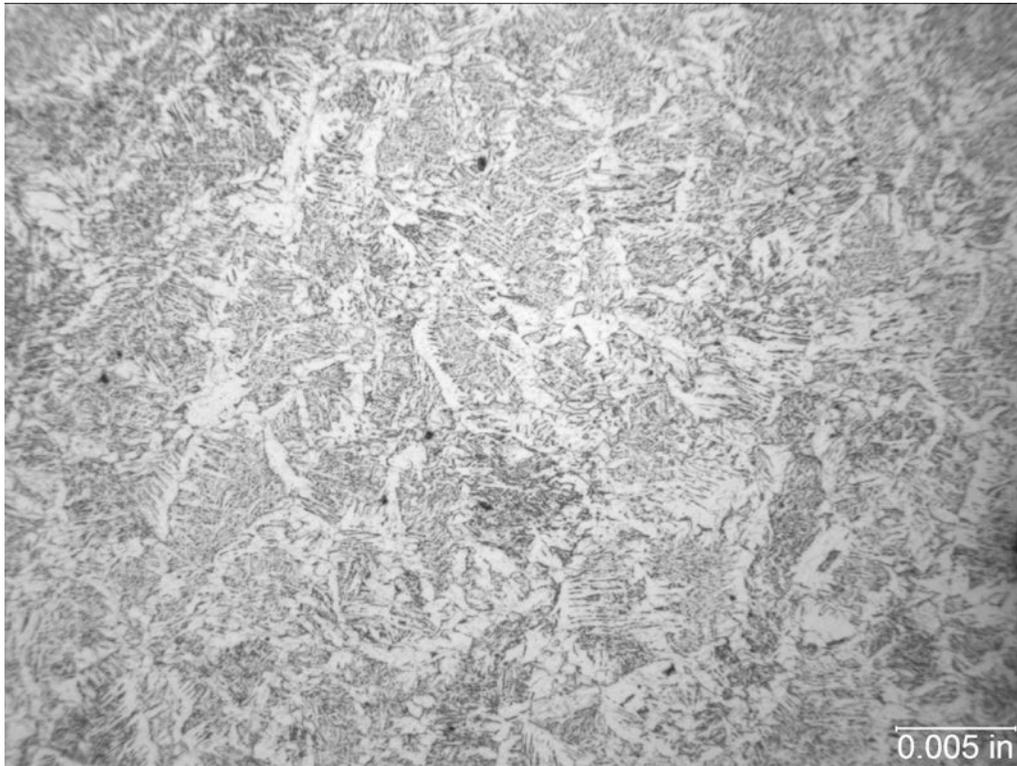
Figure 70 Fracture initiation site 2 and a specimen prepared for metallography from a section through the outlet pad indicated by the dashed lines in (a).

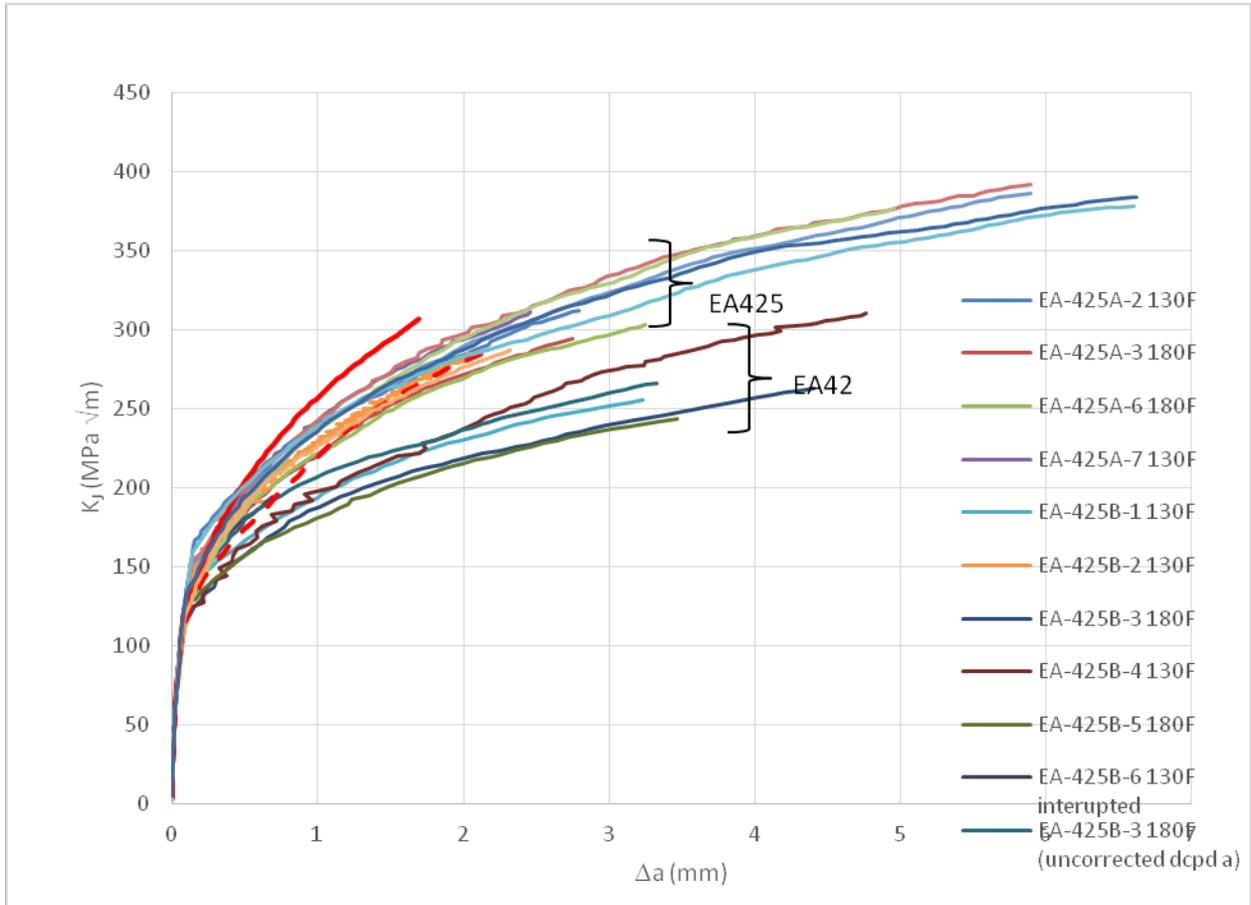
Figure 76 Crack growth resistance curves.

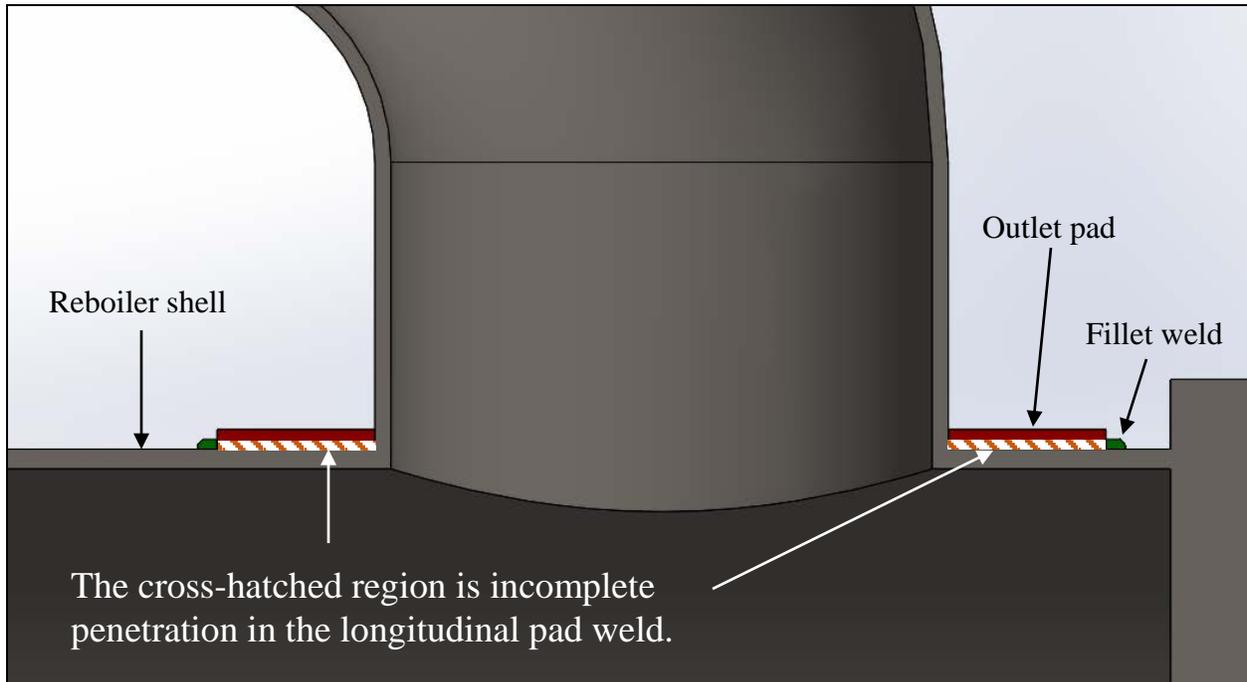
Figure 77 Representation of the outlet pad geometry.

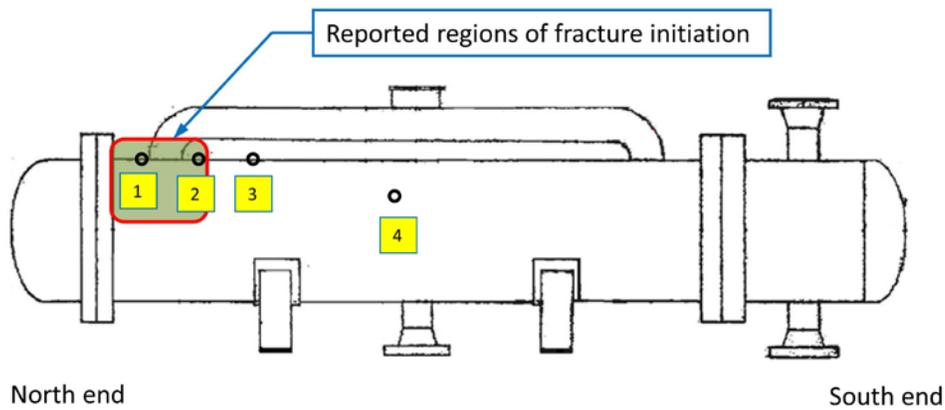
The U.S. Chemical Safety Board (CSB) contracted Anamet, Inc. (Anamet) to be one of the primary accident investigators of the Williams-Olefins vessel rupture event. Anamet contracted Measurement Analysis Corp. (MAC) to perform a finite element analysis of the ruptured pressure vessel. The diagram below shows the two primary crack initiation locations, including the partial penetration weld along the doubler's longitudinal axis, used in the finite element model to represent the rupture event for the EA-425B vessel.

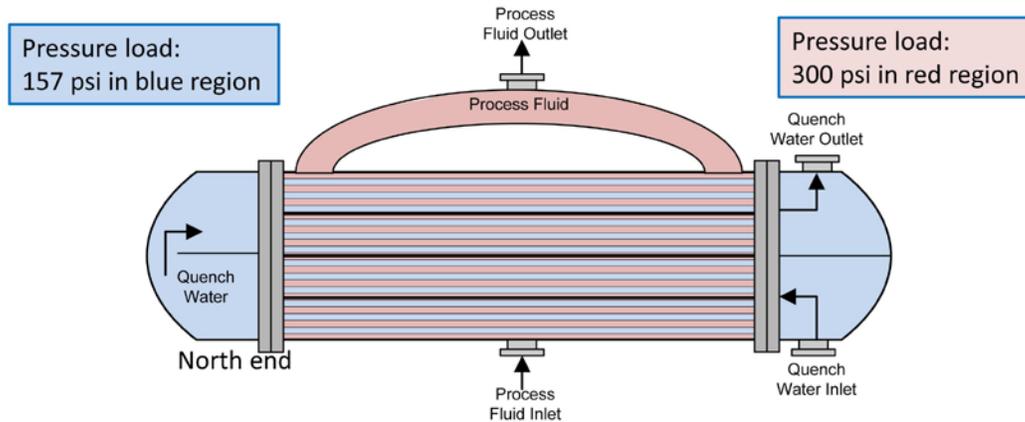
The pressure vessel includes 3020 SA-214 tubes (0.750" OD with a 0.085" nominal wall thickness) that carry the "quench water". These tubes are press fit/swaged into the 3.125" thick tubesheet at both ends of the vessel and experience 157 psig internally. This 157 psig also loads the elliptical end caps. The interior of the pressure vessel is loaded to a maximum allowable working pressure (MAWP) of 300 psig. The nominal shell thickness is 0.6875". Note that *hydrostatic fluid loads have not been accounted for in these models* as the maximum hydrostatic load is only ≈ 0.66 psi at the *bottom* of the vessel, if 2/3 full of process fluid.

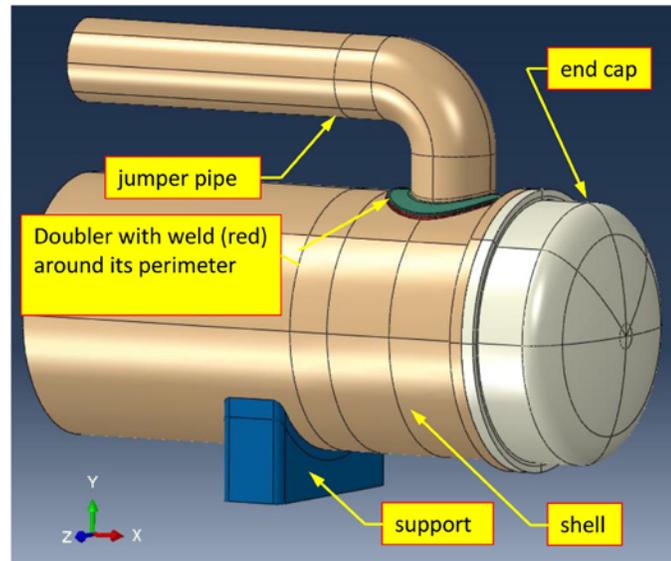
The model is a “half model” which includes the north end of the vessel, the tubesheet, and the elliptical end cap. The tubes are represented by *equivalent* area beam elements that are distributed on the interior of the pressure vessel and are connected to the tubesheet using kinematic constraints that apply only axial load. The nozzles near the mid-plane are not included in the model because the failure initiated in the region of where the “jumper pipe” enters the shell of the pressure vessel. Excluding the nozzles allows for a smaller analysis model.

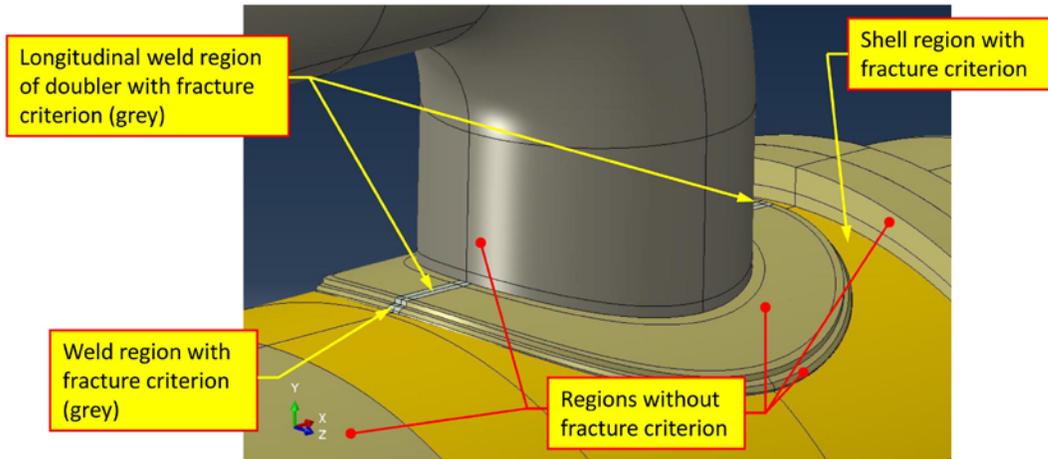
The fracture toughness data was derived from recent compact tensile tests of the shell material. Again, multiple specimens were tested at 130°F and 180°F. The baseline energy release rate ($\approx 504 \text{ in-lb/in}^2$) used for shell material is based on tests at the lower temperature of 130°F. However, most finite element models used a derated energy release rate (400 in-lb/in^2) in the region of the weld around the outer perimeter of the doubler and the longitudinal weld region of the doubler.

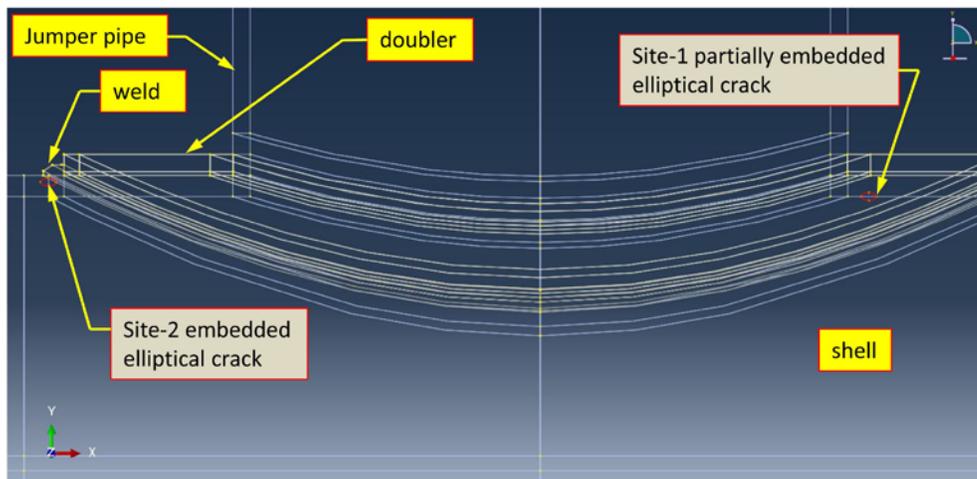
Elevation view of the shell (with crack sites 1 & 2), jumper pipe, doubler, and weld

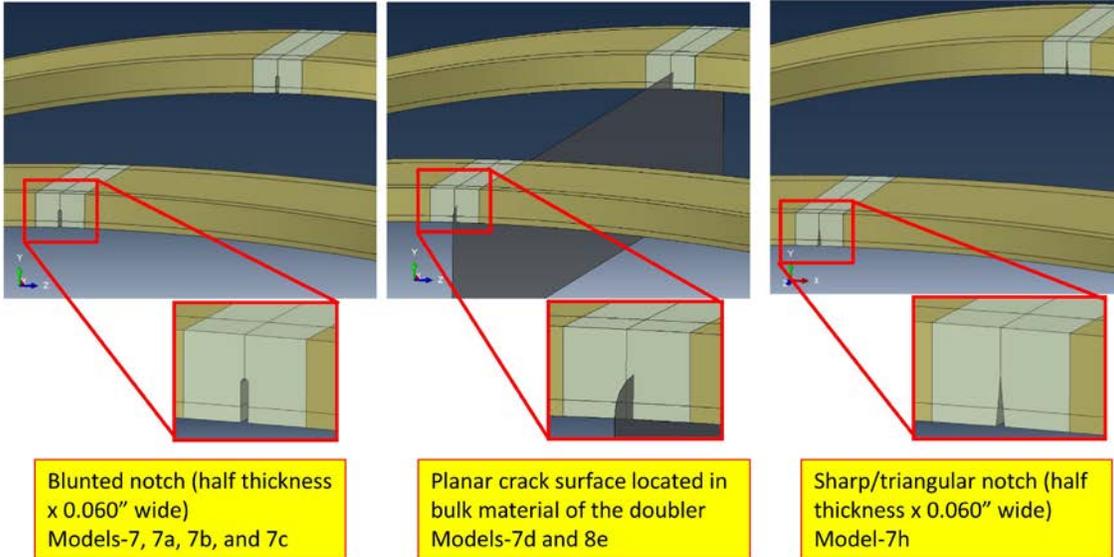
Note that the grey region in the doubler is the longitudinal region where the material can initiate crack growth

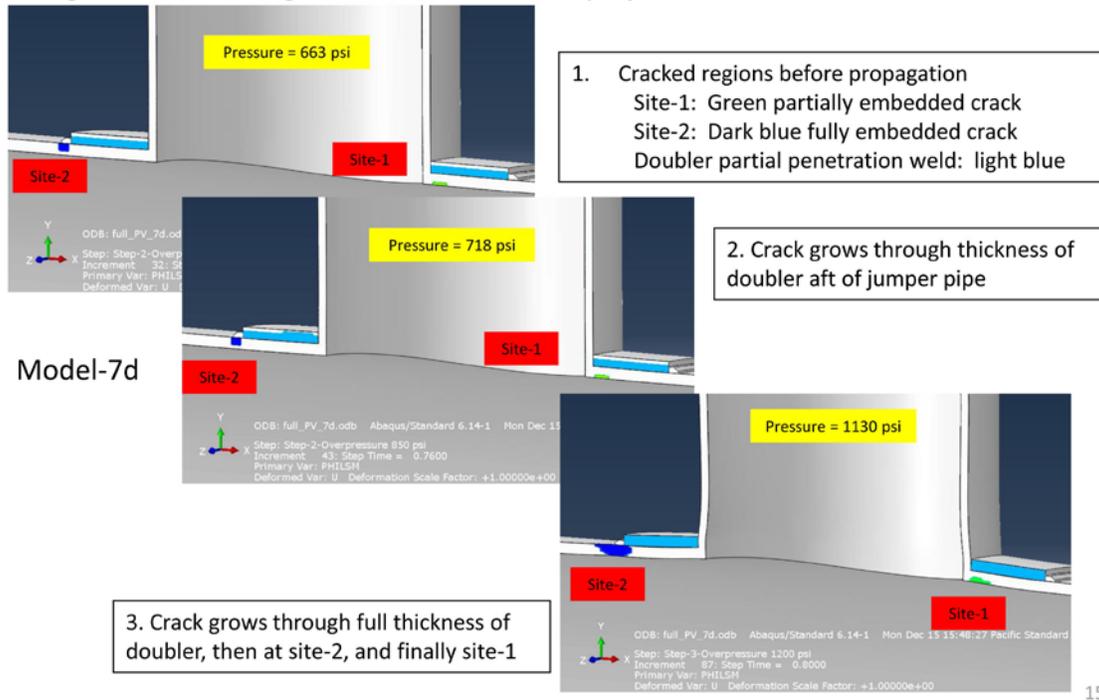
Progression of crack growth – crack surfaces projected onto finite element mesh
