BETA LAB No.M10198- CS4-01/ LS3 BOTTOM	TESORO REFINING AND MARKETING COMPANY ANACORTES REFINERY 10200 W. MARCH POINT ROAD T91WA4428 ANACORTES, WA 98221	CUSTOMER P.O. NO.: 4501667904
PART: 6600-E HEAT EXCHANGER CS4 01/BOTTOM PART 18/14		DATE: AUGUST 25, 2010
PAGE 31 OF 51

**LABORATORY REPORT-CS4-01/ LS3 Bottom**

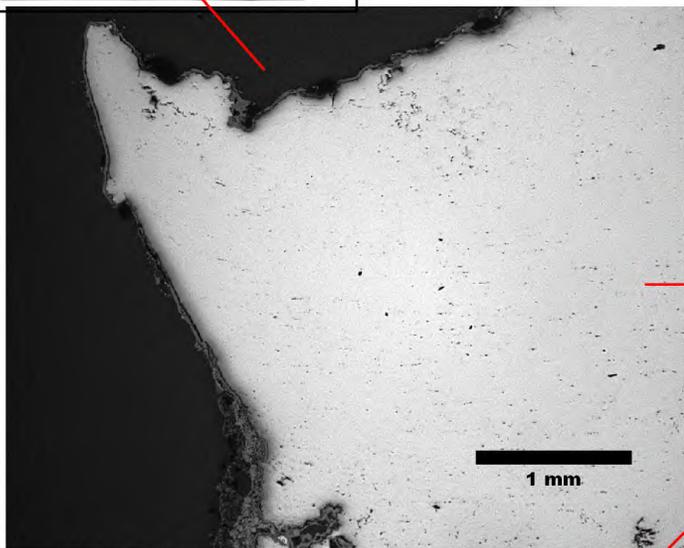
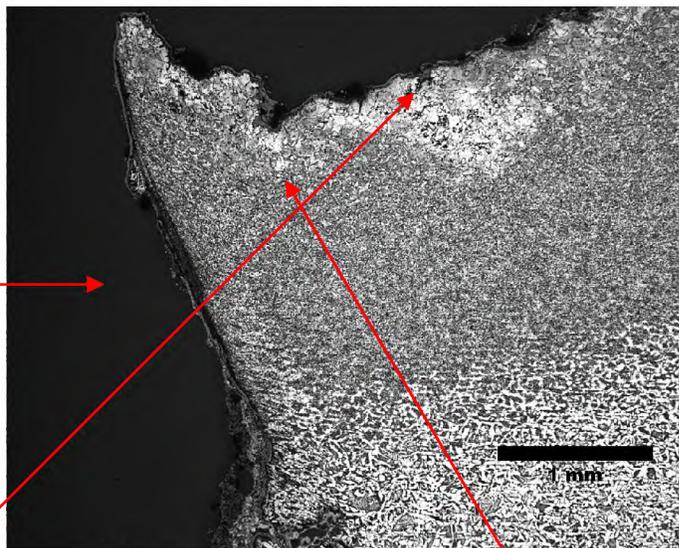
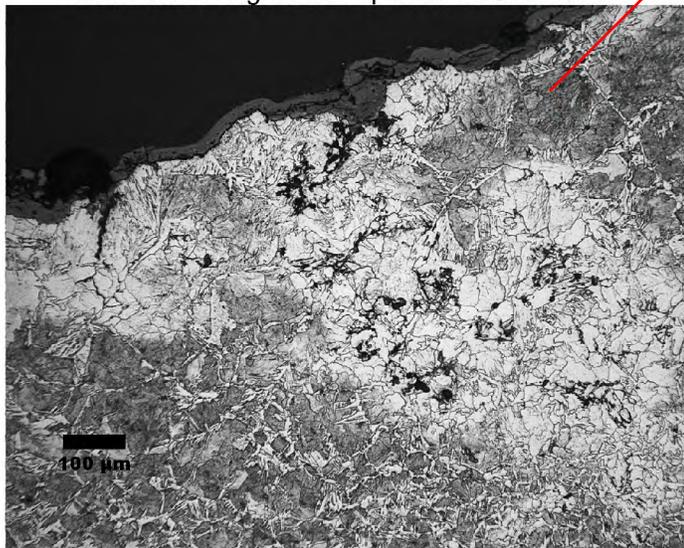
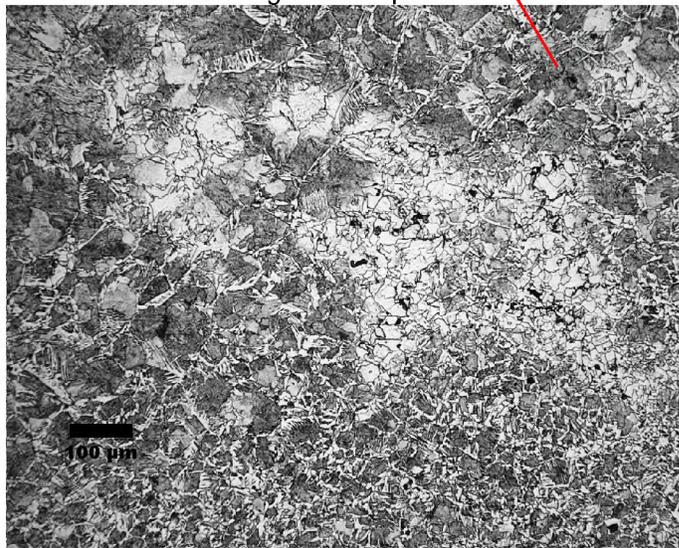
Figure 24- OD on top

A. Fracture edge at the tip of HAZ. Un-etched

B. Fracture edge at the tip of HAZ. Etched

C. Indicated area at higher magnification

D. Indicated area at higher magnification

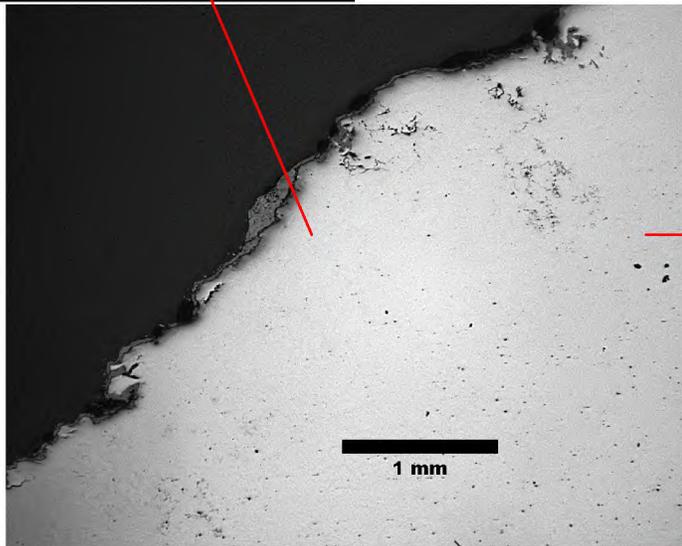
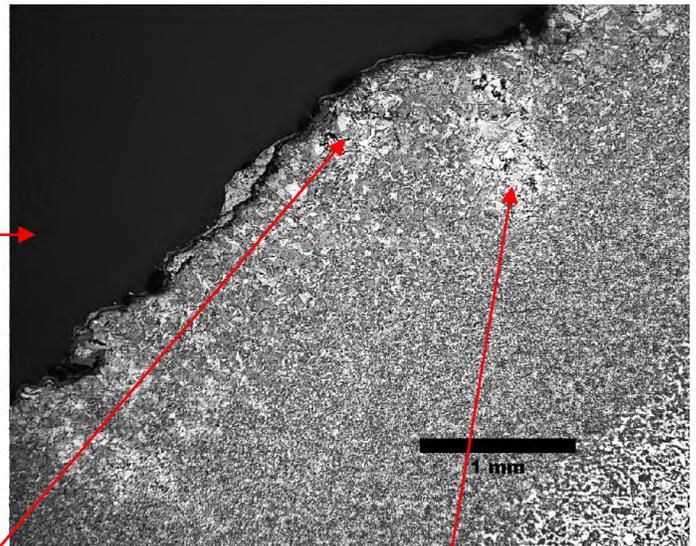
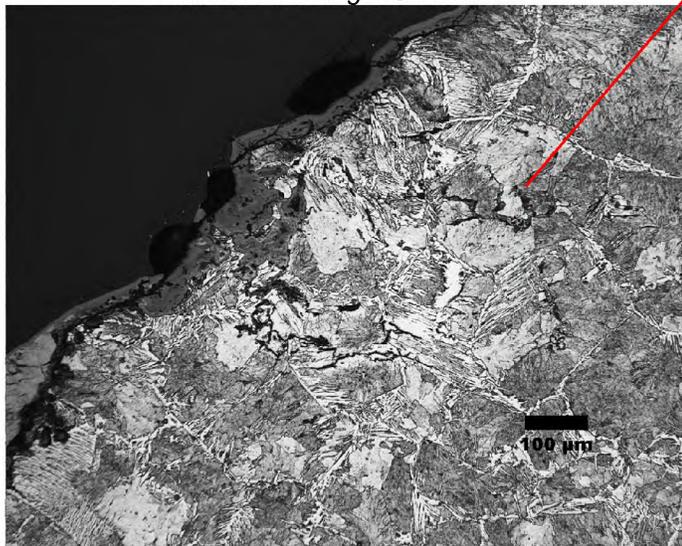
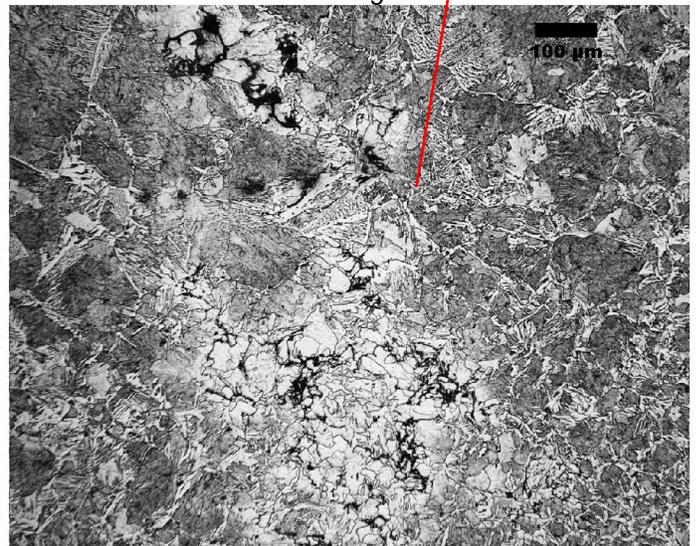
Figure 25- OD on top

A. Fracture edge. Un-etched

B. Fracture edge. Etched

C. Indicated area at higher magnification

D. Indicated area at higher magnification

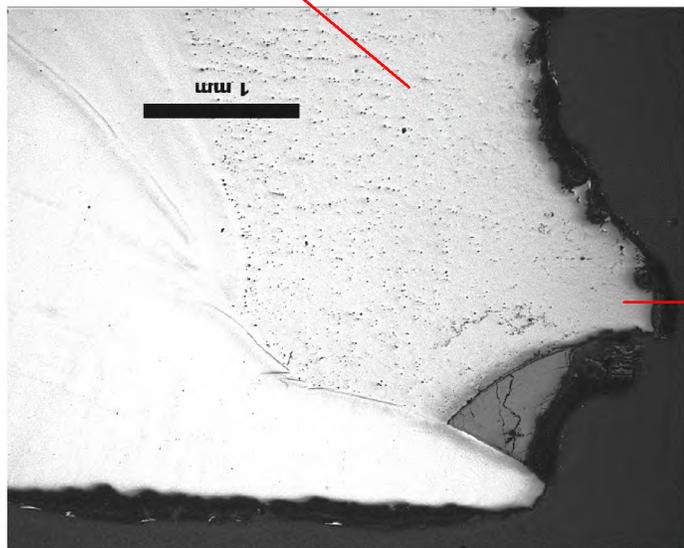
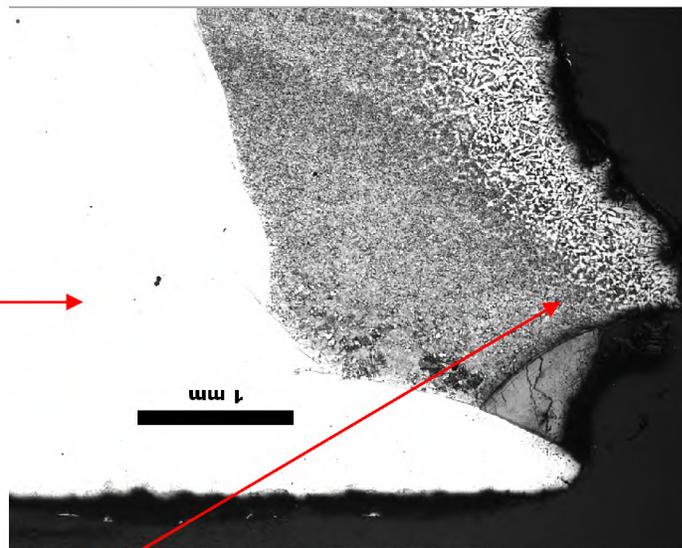
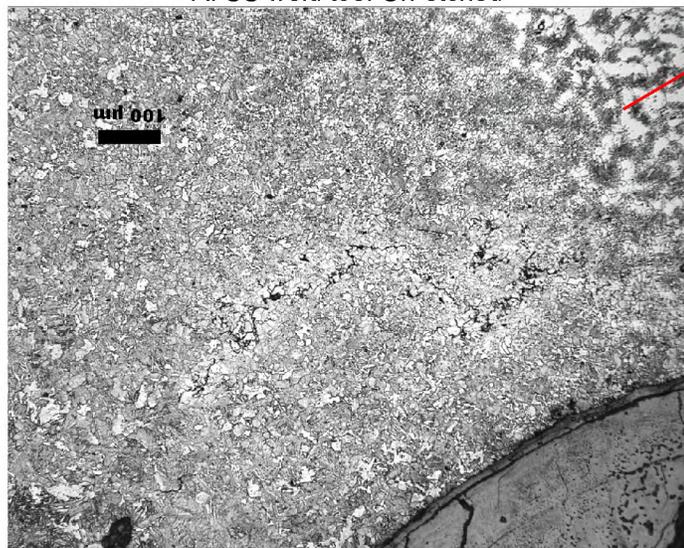
Figure 26.  
 Microphotographs flipped so they coincide with macro photographs-- OD on top

A. SS weld toe. Un-etched

B. SS weld toe. Etched

C. Indicated area at higher magnification

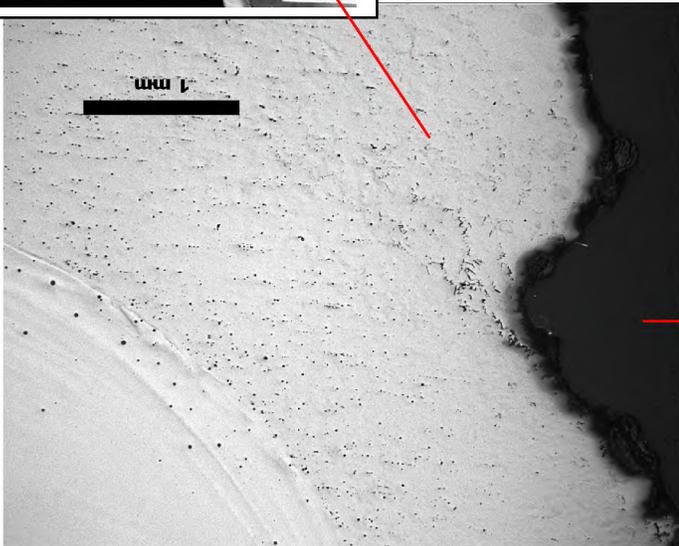
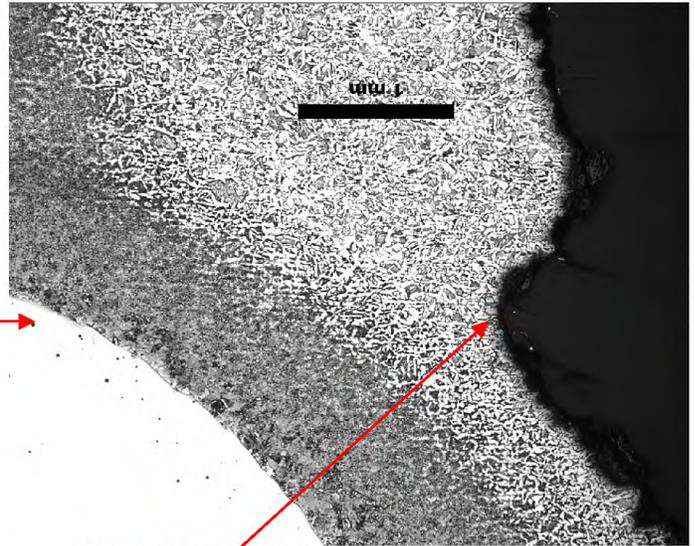
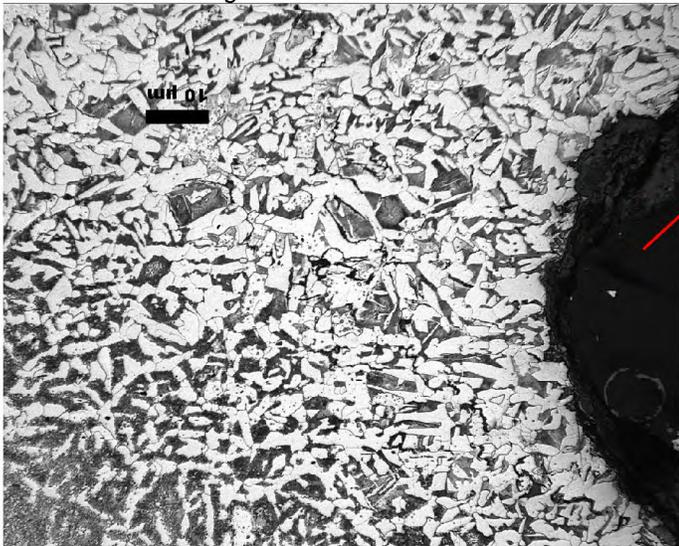
Figure 27

A. Fracture edge at indicated location. Un-etched

B. Fracture edge at indicated location. Etched

C. Fracture edge at indicated location at higher magnification.

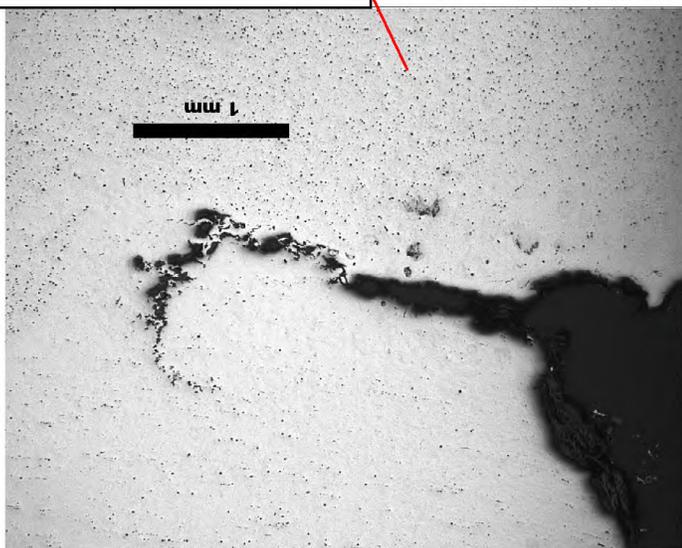
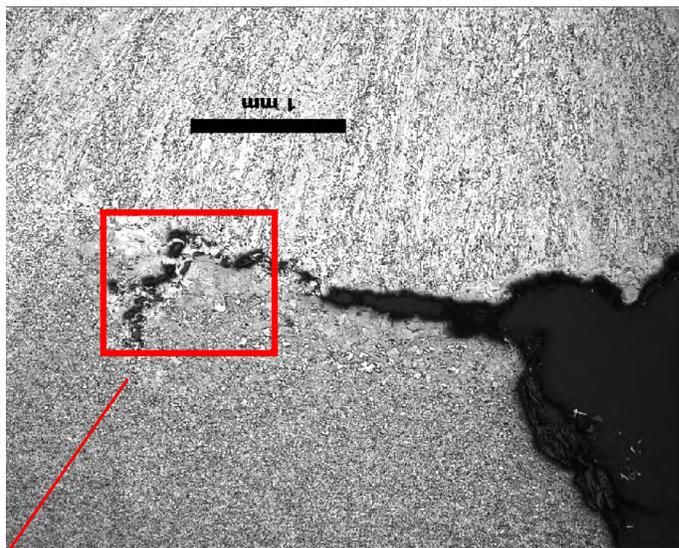
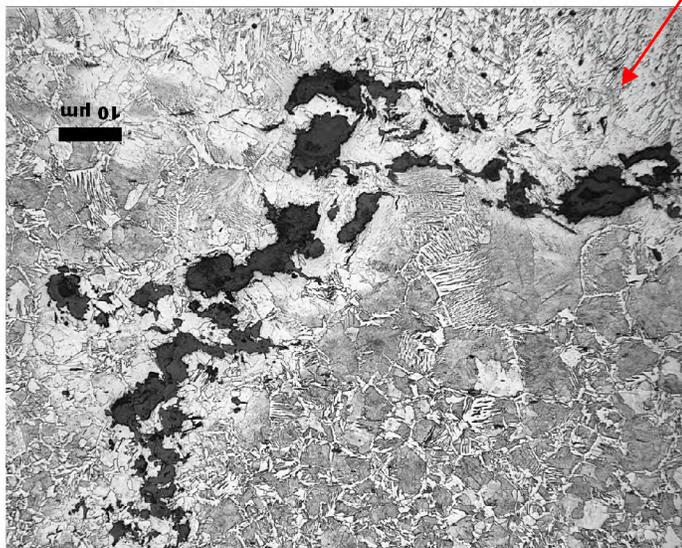
Figure 28

A. Fracture edge under the weld cap.

B. Fracture edge under the weld cap. Etched

C. Indicated area at higher magnification.

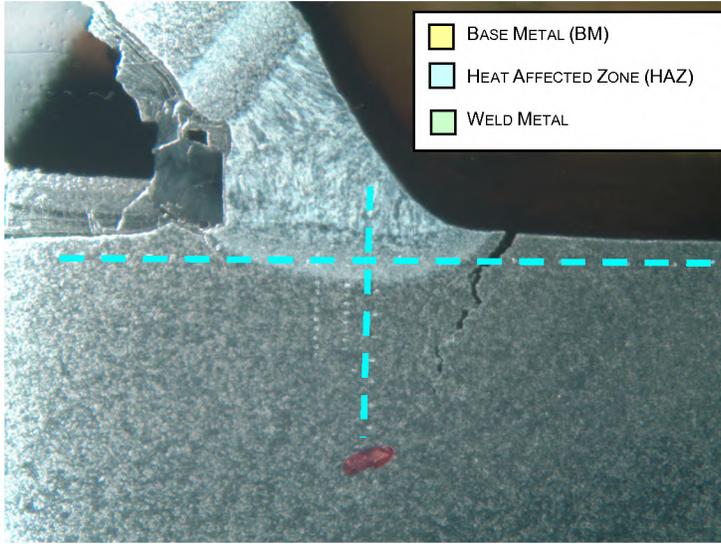
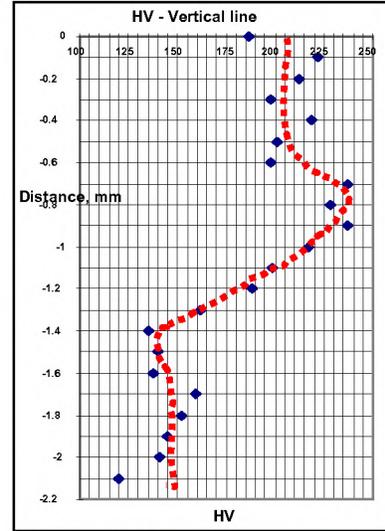
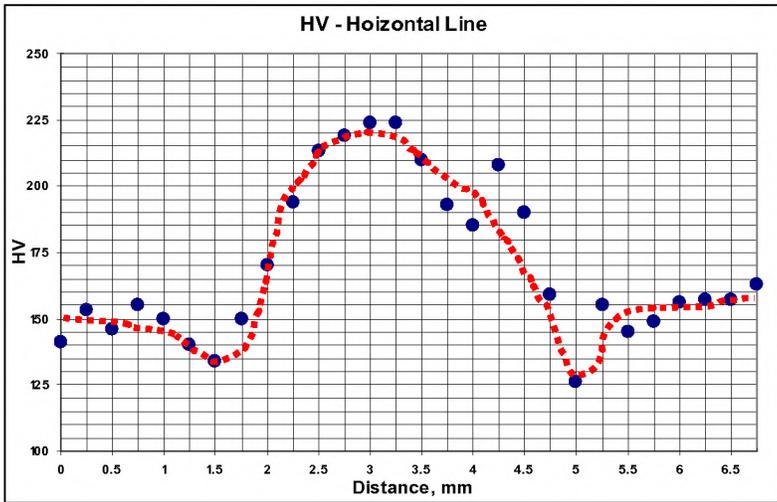
Figure 29

HORIZONTAL		VERTICAL	
Dist. mm	HV @ 500g	Dist., mm	HV @ 500g
0	141	0	187
0.25	153	0.1	222
0.5	146	0.2	212
0.75	155	0.3	198
1.00	150	0.4	219
1.25	140	0.5	201
1.50	134	0.6	198
1.75	150	0.7	237
2.00	170	0.8	228
2.25	194	0.9	237
2.50	213	1.0	217
2.75	219	1.1	199
3.00	224	1.2	188
3.25	224	1.3	162
3.50	210	1.4	135
3.75	193	1.5	140
4.00	185	1.6	138
4.25	208	1.7	159
4.50	190	1.8	152
4.75	169	1.9	145
5.00	126	2.0	141
5.25	155	2.1	120
5.50	145		
5.75	149		
6.00	156		
6.25	157		
6.50	157		
6.75	163

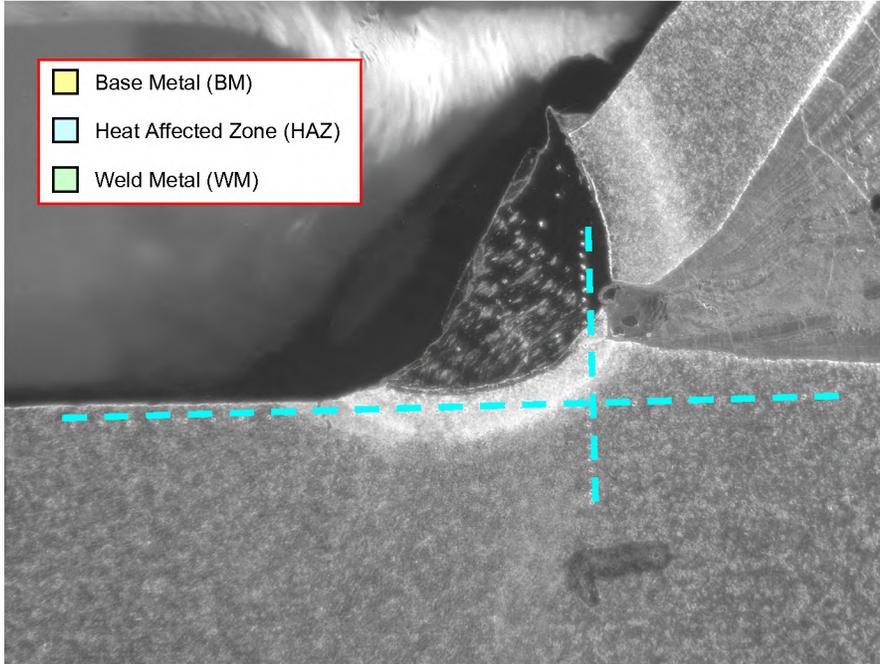
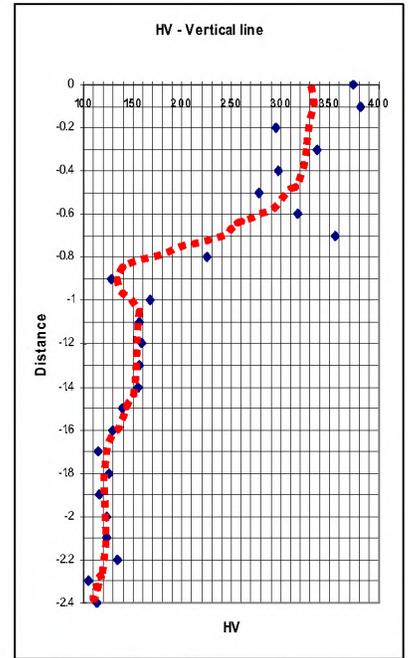
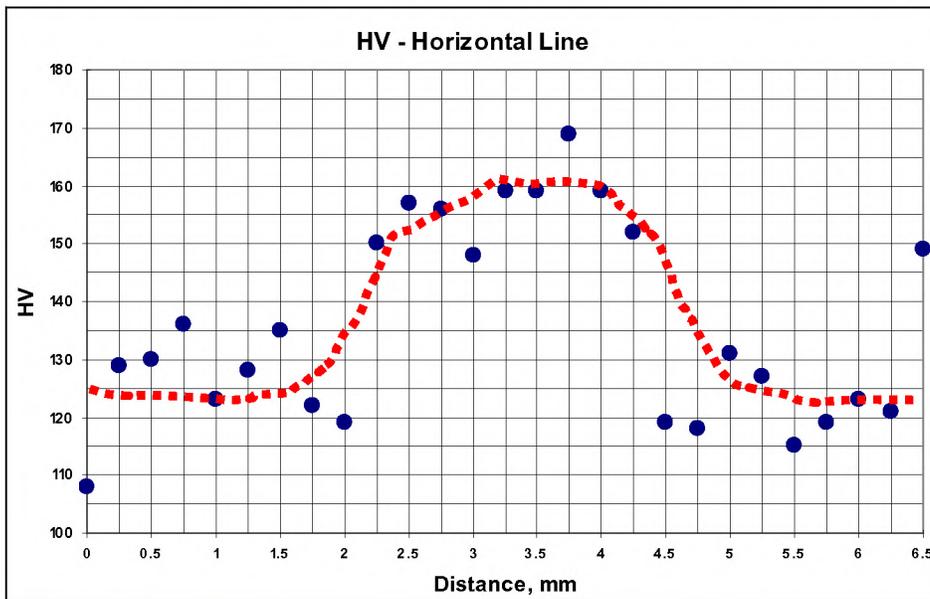
Figure 30

HORIZONTAL LINE	
DIST., MM	HV @ 500G
0	108
0.25	129
0.50	130
0.75	136
1.00	123
1.25	128
1.50	135
1.75	122
2.00	119
2.25	150
2.5	157
2.75	156
3.00	148
3.25	159
3.50	159
3.75	169
4.00	169
4.25	152
4.50	119
4.75	118
5.00	131
5.25	127
5.50	115
5.75	119
6.00	123
6.25	121
6.50	149

VERTICAL LINE	
DIST., MM	HV @ 500G
0	374
0.1	381
0.2	295
0.3	337
0.4	298
0.5	278
0.6	318
0.7	356
0.8	226
0.9	128
1.0	168
1.1	156
1.2	159
1.3	157
1.4	155
1.5	139
1.6	129
1.7	115
1.8	126
1.9	116
2.0	123
2.1	123
2.2	135
2.3	105
2.4	113
