BETA LAB NO.M10198- CS4-02	TESORO REFINING AND MARKETING COMPANY ANACORTES REFINERY 10200 W. MARCH POINT ROAD T91WA4428 ANACORTES, WA 98221	CUSTOMER P.O. NO.: 4501667904
PART: 6600-E HEAT EXCHANGER CS4 PART 19 & 20		DATE: AUGUST 5, 2010
PAGE 1 OF 57

LABORATORY REPORT-CS4

This report is the first of a series on failed parts of 6600E heat exchanger. The LS# and CS# refer to longitudinal and circumferential weld seams while the part number refers to the chain of custody

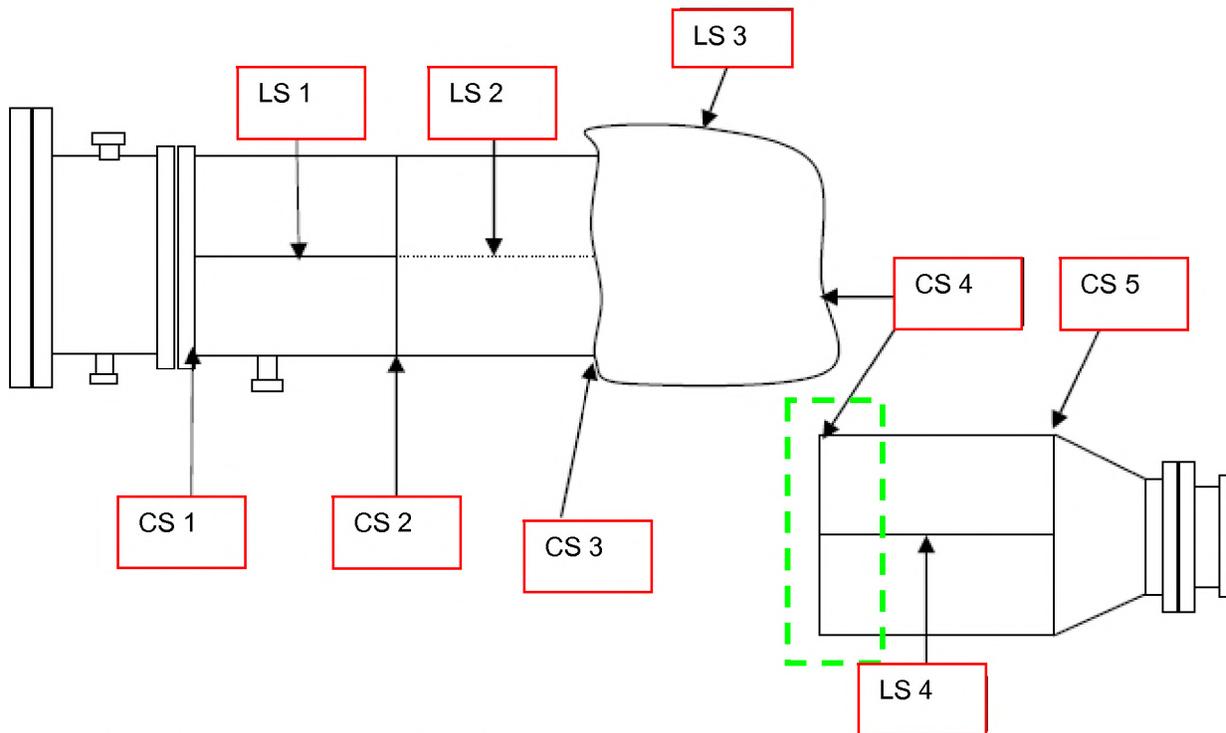
Sketch of main heat exchanger Cans 1-3 and separated back head Can 4- green dotted line is item for this report

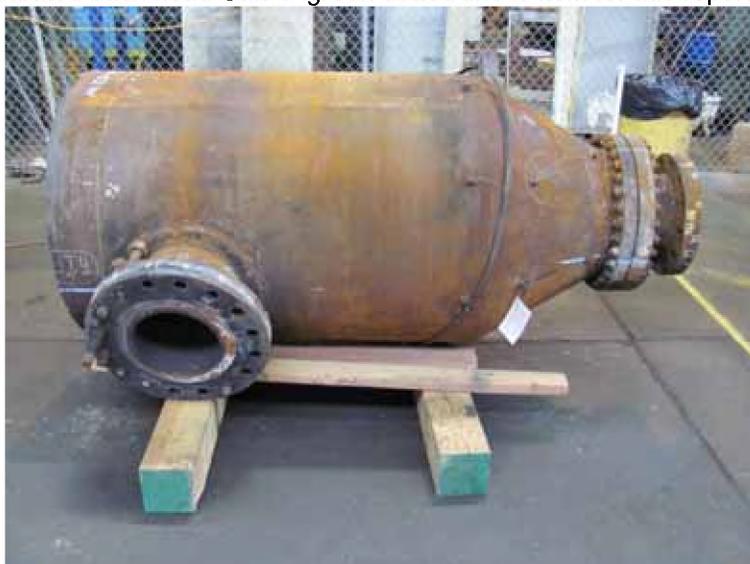
FIGURE 1 Un-packed back head of the 6600E heat exchanger

Back Head with fracture on left at CS4

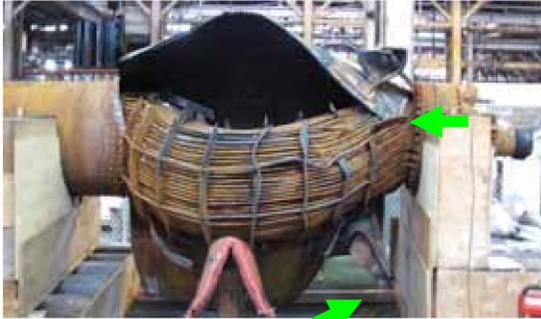
Fracture along CS4 seam between the green arrows mates up with fracture on back head shown below

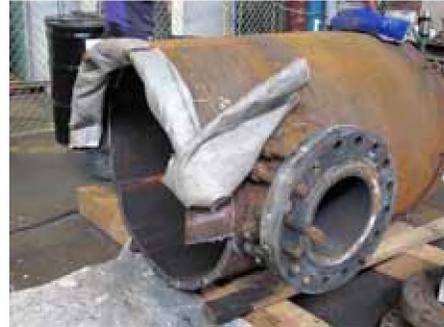
Bottom half of about 6 inch wide ring is cut- red line is zero degrees

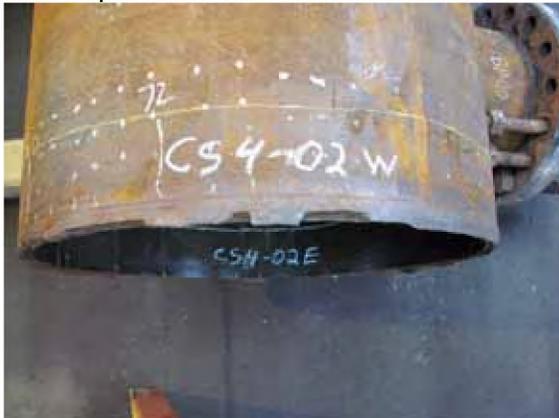
Fracture edge of CS4 from one angle

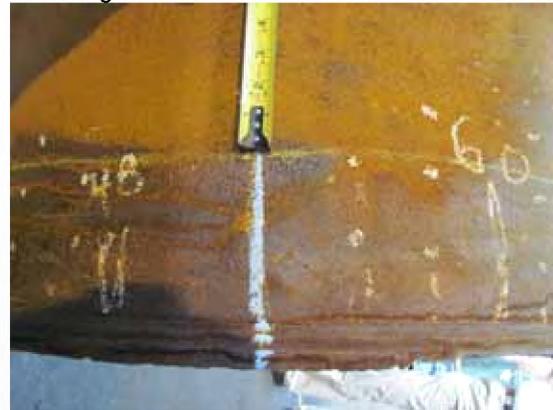
Fracture edge of CS4 from another angle

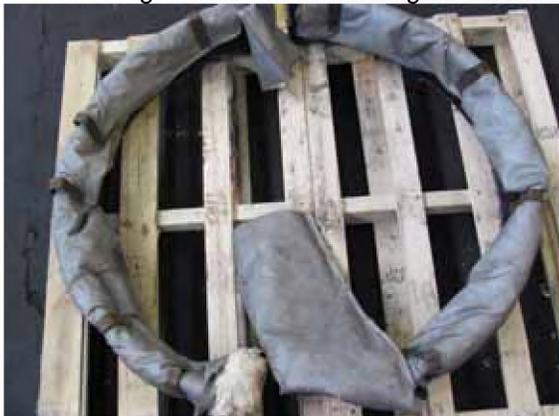
CS4cut samples with fracture edge protected

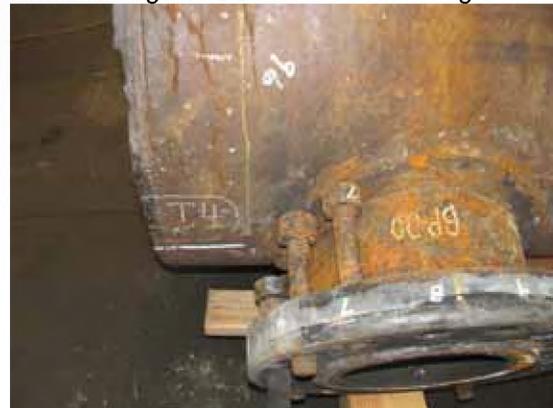
Fracture edge of CS4 from nozzle angle note T4 UT

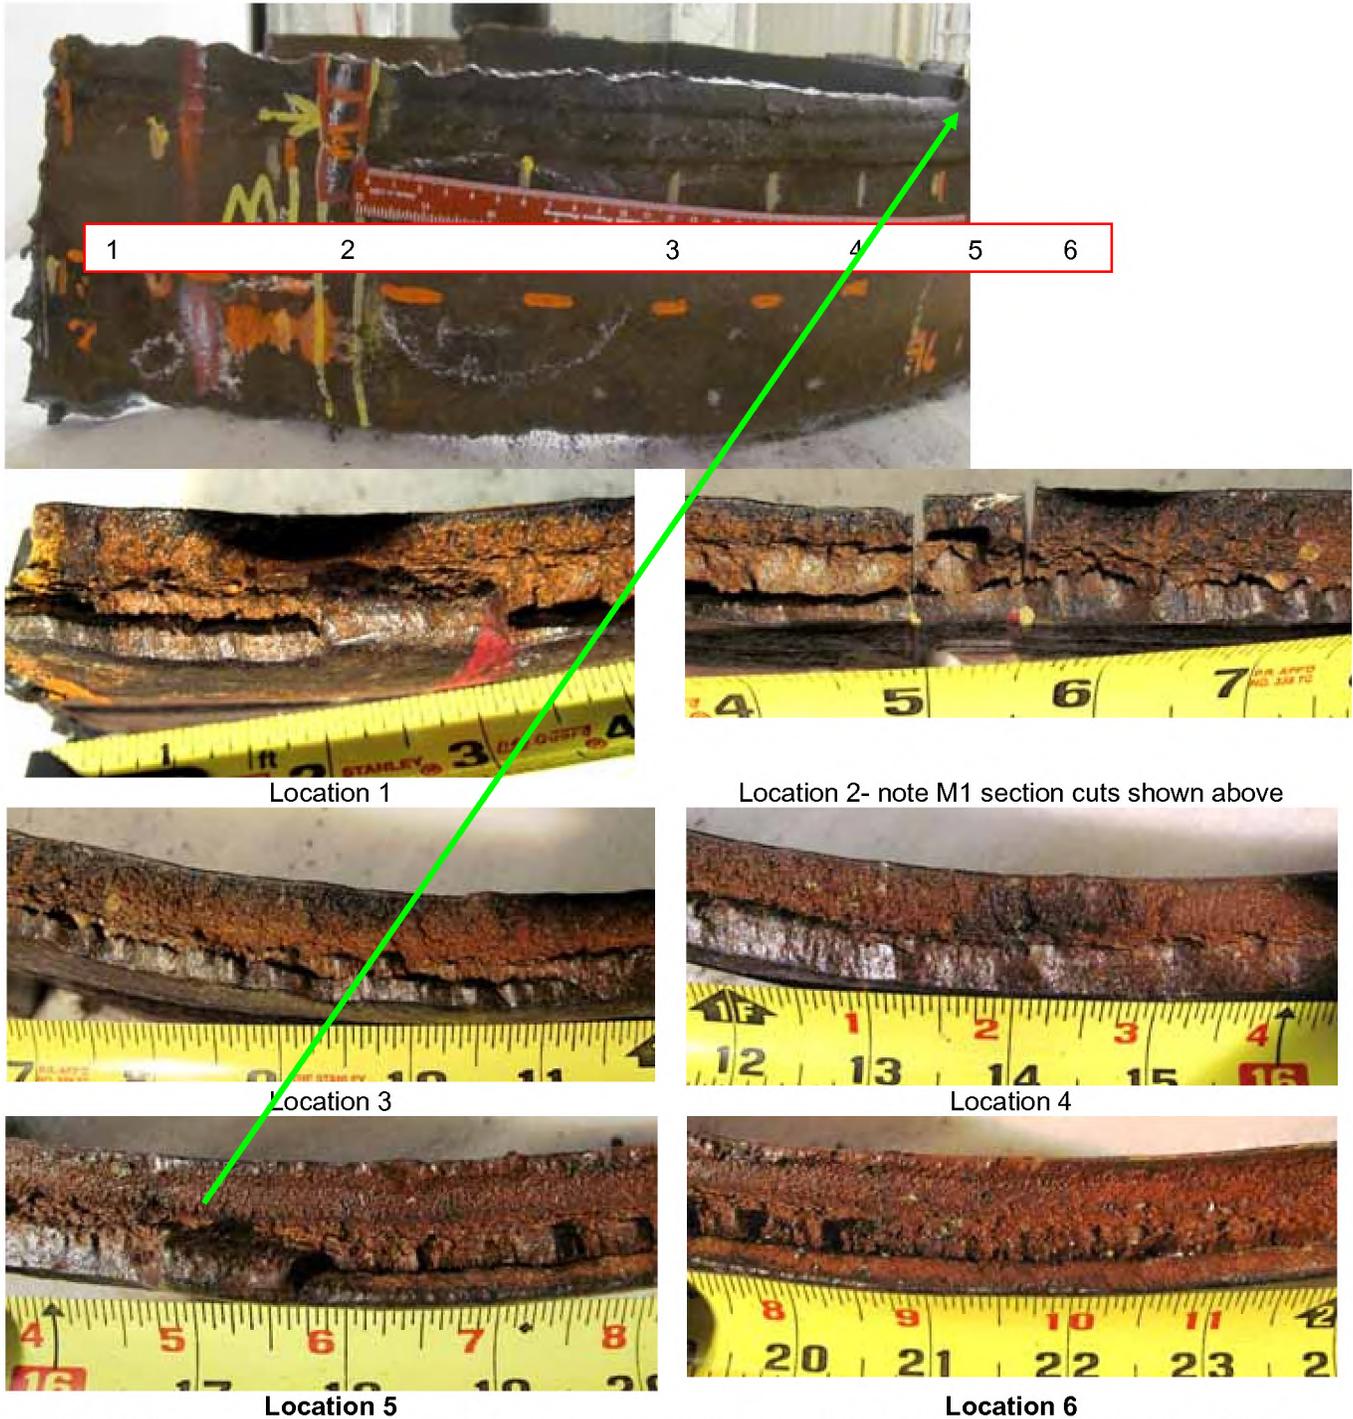
FIGURE 3 Photos of the fracture along CS4 with the locations as shown in the upper left (ID on top)

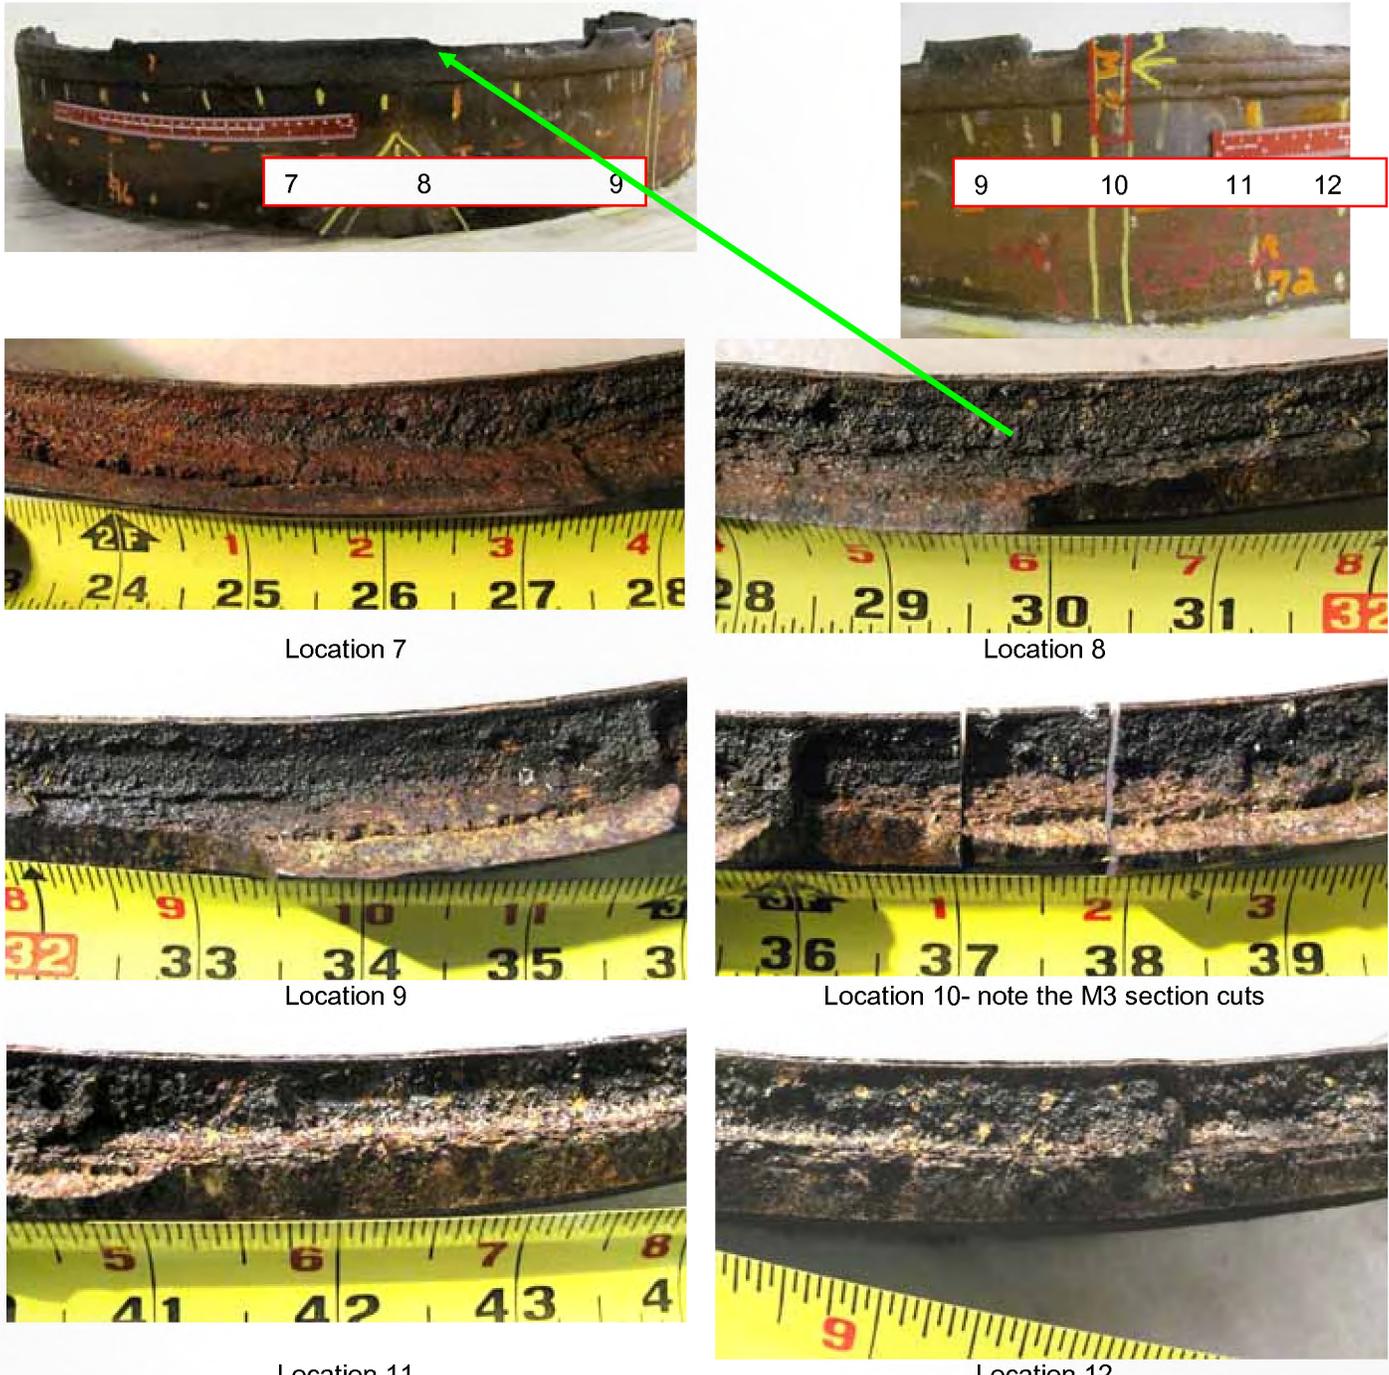
FIGURE 4 Photos of the fracture along CS4 with the locations as shown in the upper left (ID on top)

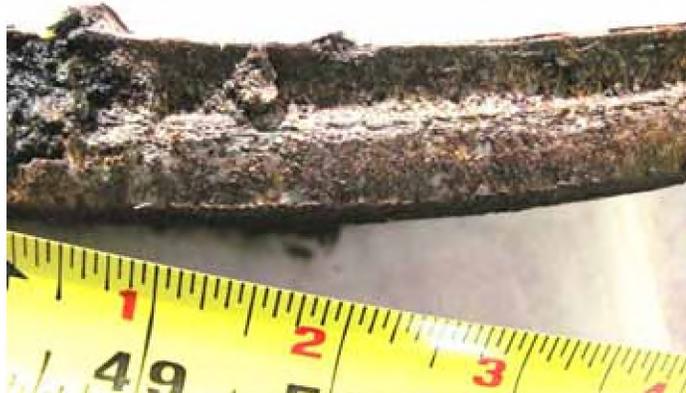
Location 13

FIGURE 5 Photos of the fracture along CS4 with the locations as shown in the upper left (ID on top)
