BETA LAB No.M10198- LS3 TOP	TESORO REFINING AND MARKETING COMPANY ANACORTES REFINERY 10200 W. MARCH POINT ROAD T91WA4428 ANACORTES, WA 98221	CUSTOMER P.O. No.: 4501667904
PART: 6600-E HEAT EXCHANGER LS 3 TOP PART 15		DATE: SEPTEMBER 20, 2010
PAGE 14 OF 53

LABORATORY REPORT-LS3 TOP

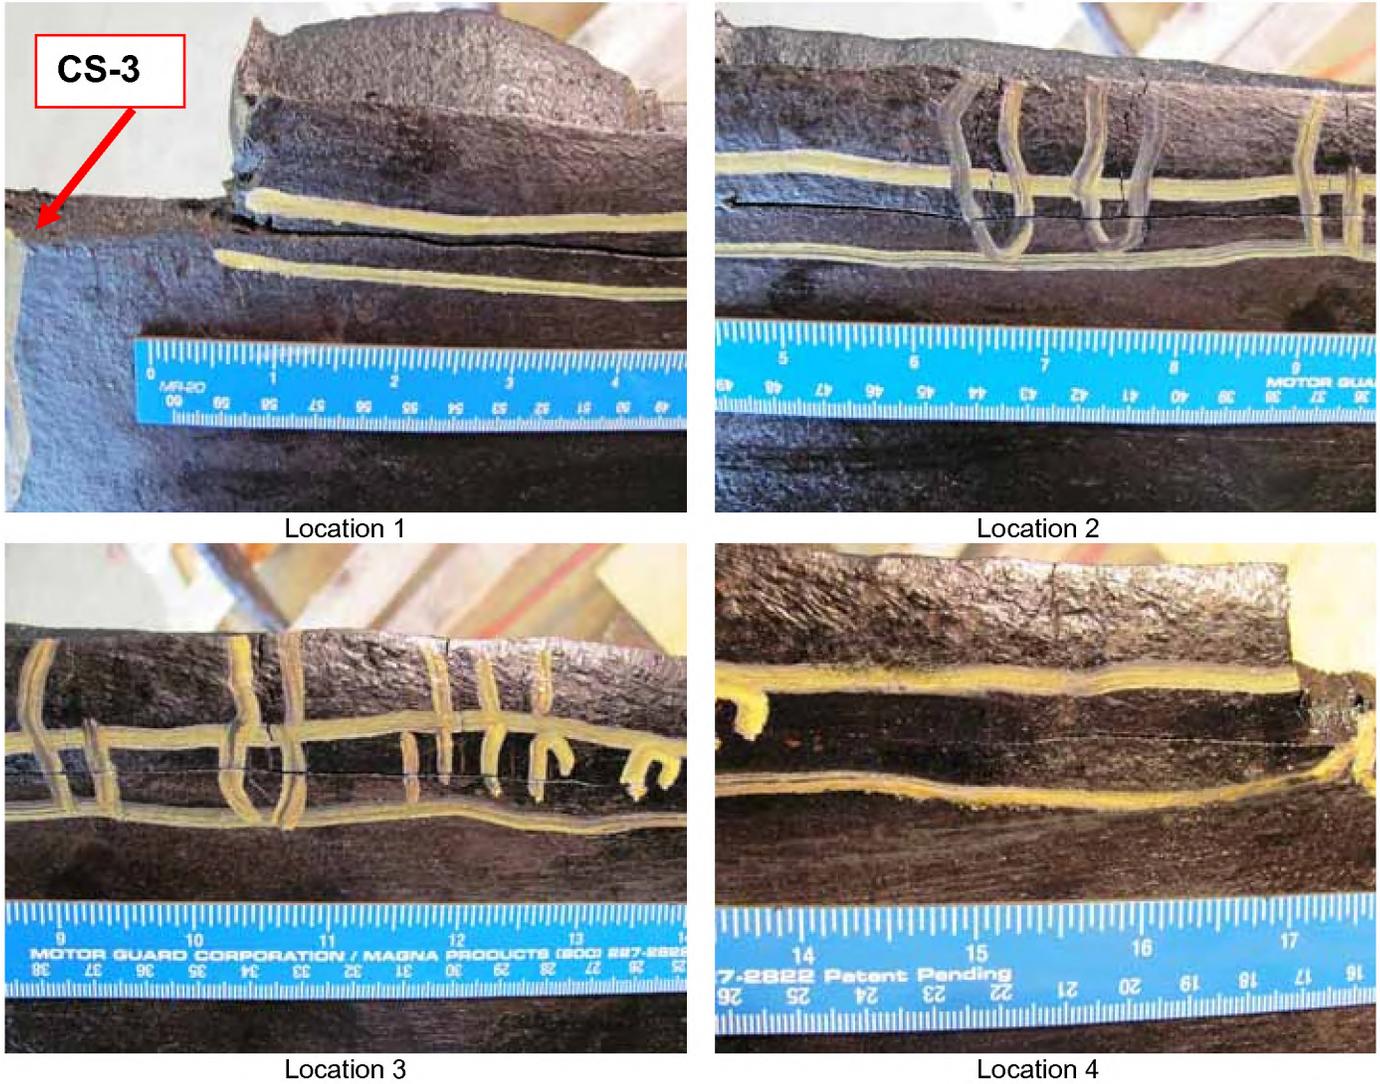
Figure 9. Magnetic Particle Inspection. Indications circled (fracture on top and looking at ID surface)

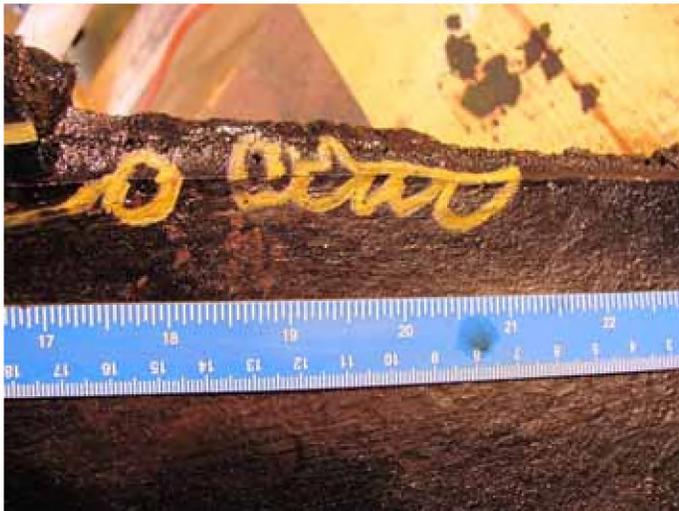
Location 5

Figure 10. Magnetic Particle inspection. Indications circled (fracture on top and looking at ID surface)

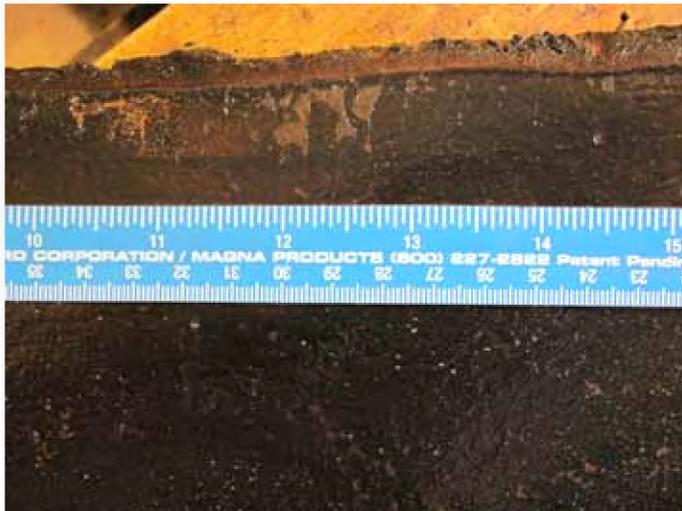
Location 9

Figure 11. Magnetic Particle inspection. Indications circled (fracture on top and looking at ID surface)

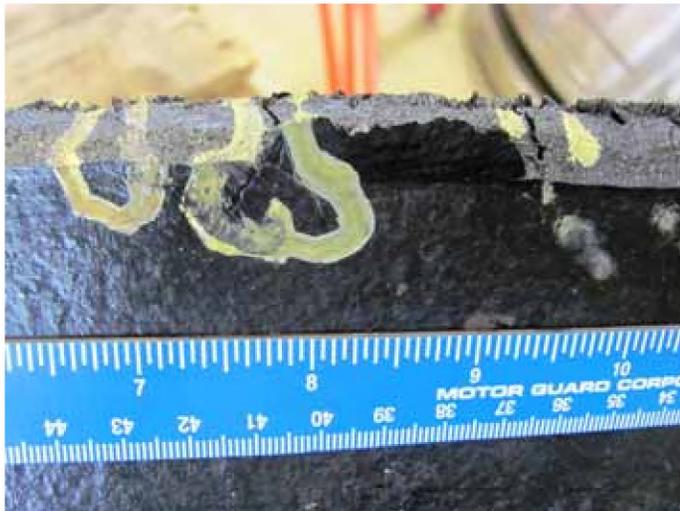
Location 13

Figure 12. Magnetic Particle inspection. Indications circled (fracture on top and looking at ID surface)

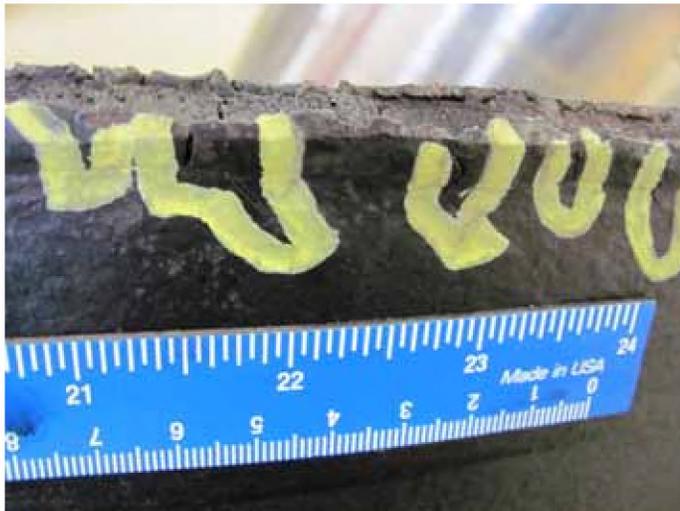
Location 17

Figure 13. Magnetic Particle inspection. Indications circled (fracture on top and looking at ID surface)

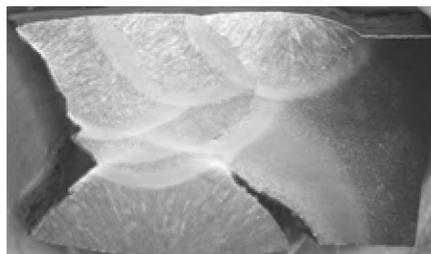
14 M-3- note fracture changed location in the distance of the saw curth and grinding

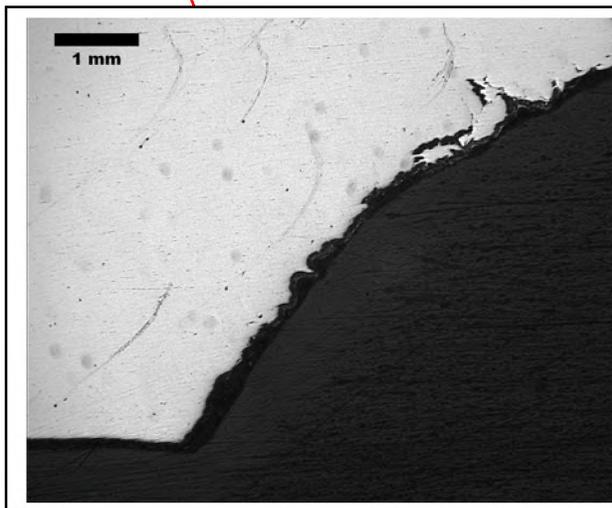
Fracture at ID corner, un-etched

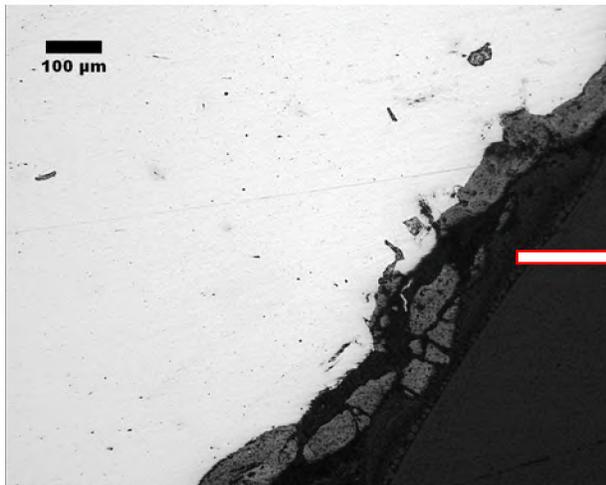
One field up from the ID corner along the fracture edge, un-etched

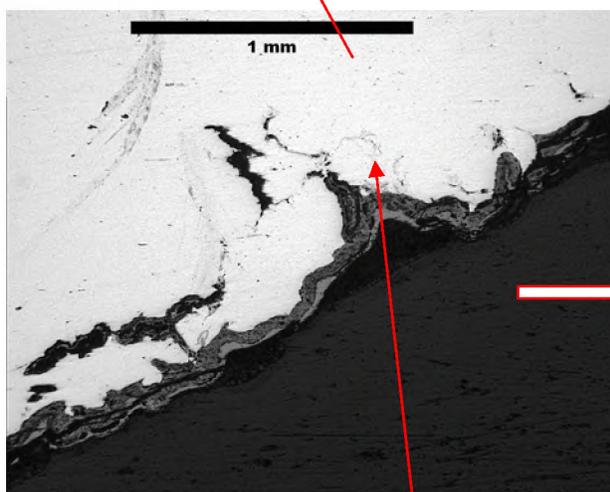
Two fields up from the ID corner along the fracture edge, un-etched

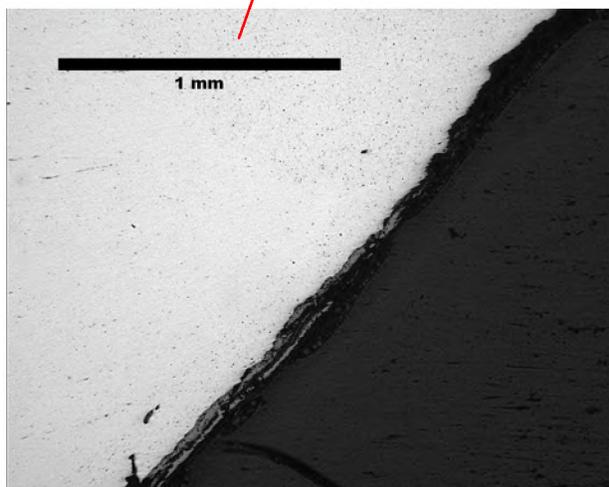
Area at HAZ and Weld Metal, un-etched

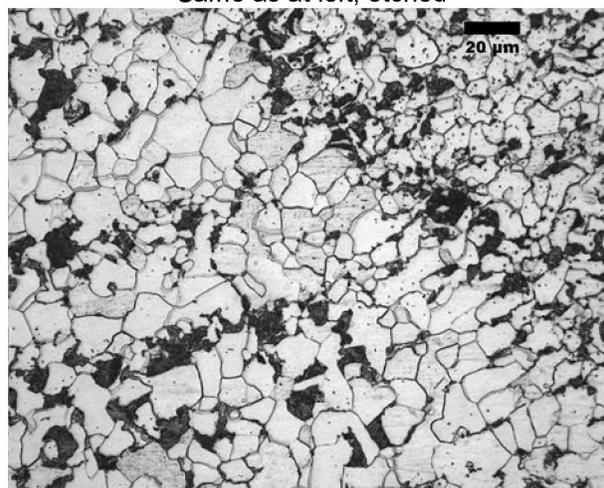
Area at HAZ-WM from the photo above at higher magnification, etched

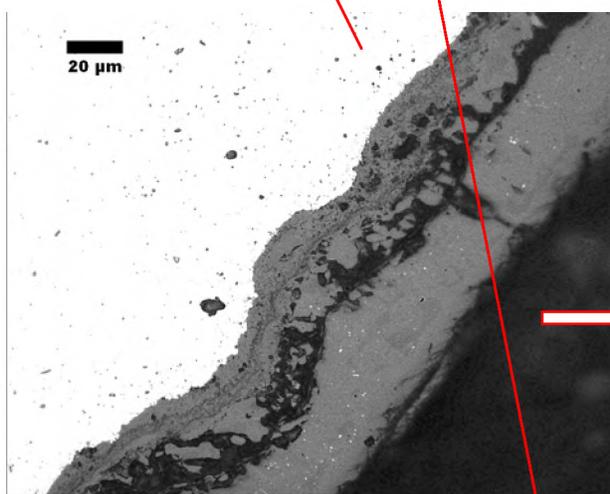
Approximately mid-wall along the fracture edge, un-etched

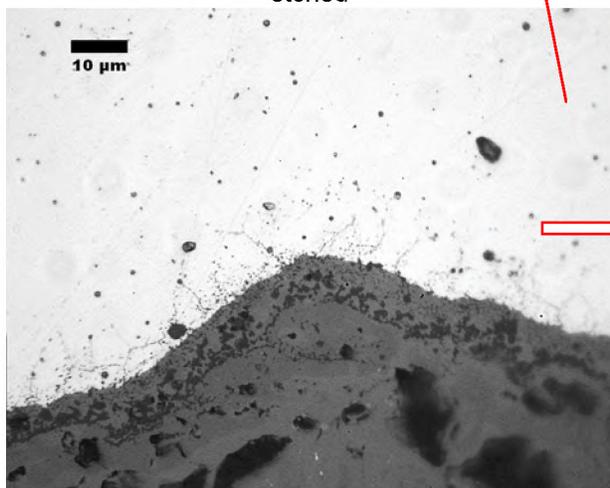
Area at fracture edge near OD, un-etched

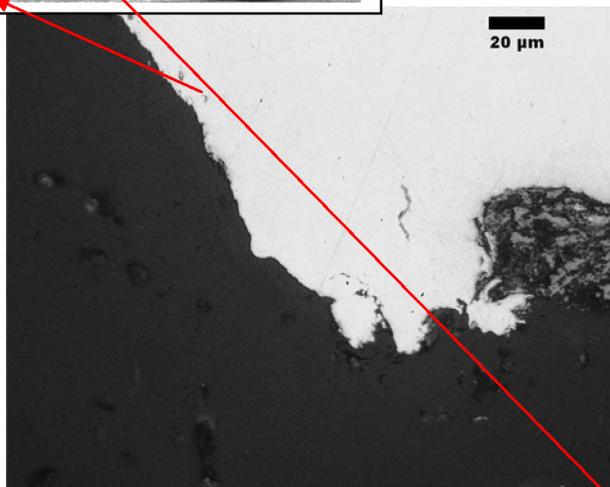
Base Metal at ID corner at the cut. Un-etched

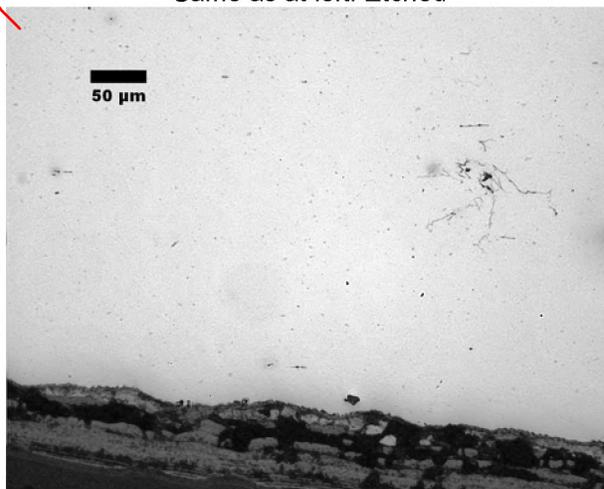
Area approximately 3 mm from the crack

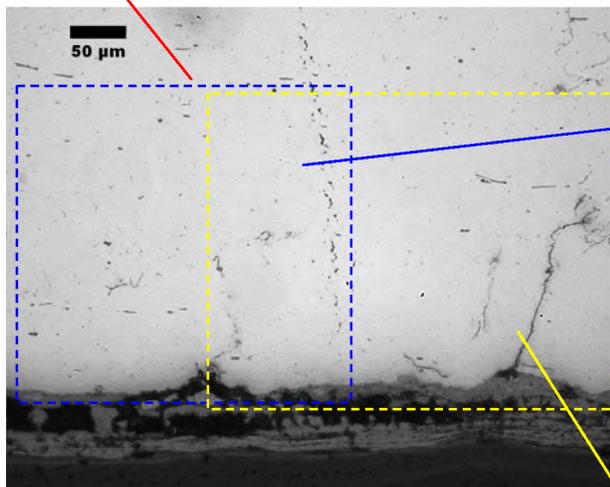
Area near the crack, un-etched
