U.S. CHEMICAL SAFETY AND HAZARD INVESTIGATION BOARD

INVESTIGATION REPORT

VAPOR CLOUD DEFLAGRATION AND FIRE

BLSR OPERATING, LTD.

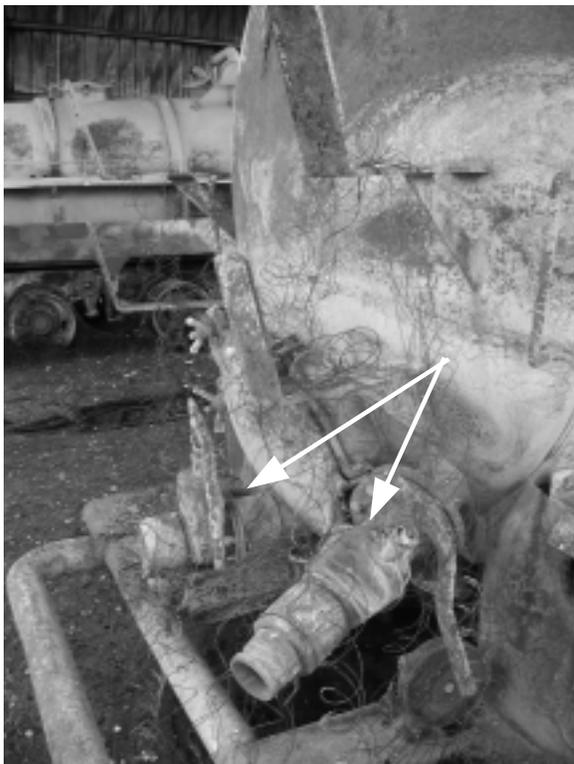
Figure 9. Truck tank drain valves in closed position.

The weight of the valve handle and internal components caused each of the drain valves to return to the closed position during the fire (Figure 9). However, even in the closed position, the fire-damaged valves allowed liquid to drain from the tanks. The sight glass was burned away, and the tanks were empty. All vacuum hoses were destroyed; only the coiled metal wire and connector fittings remained. Physical evidence also showed that the diesel fuel in the tanks did not spill to the pad area or contribute to the pool fire behind the trucks.

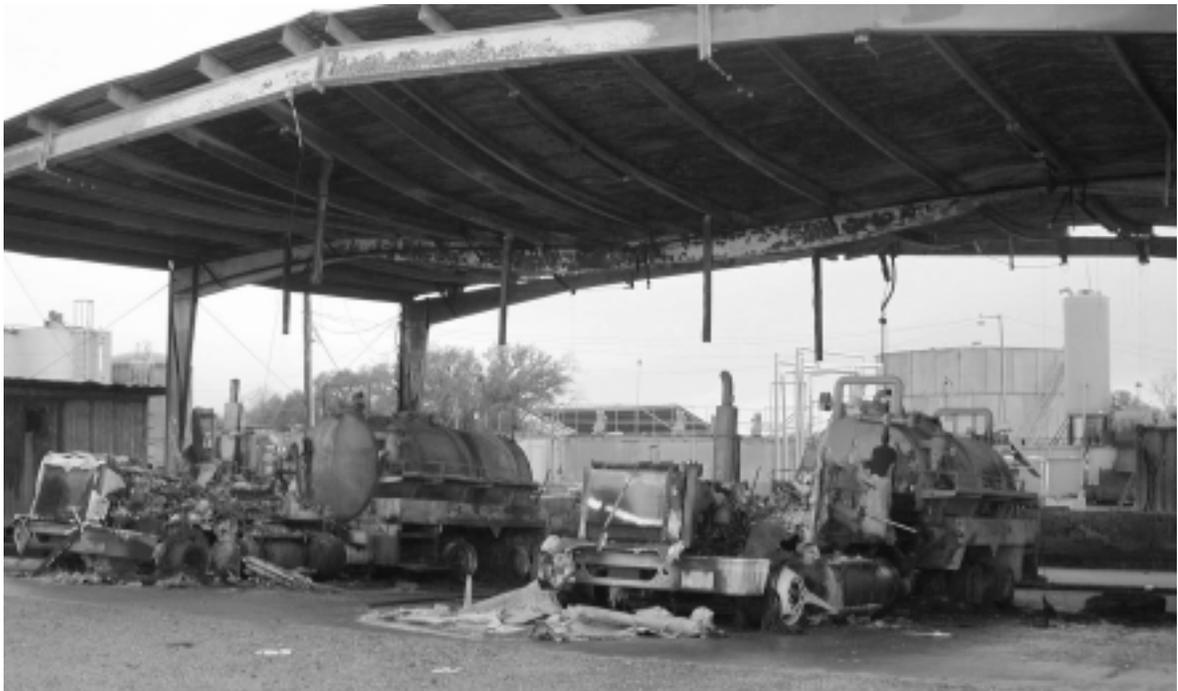
Figure 10. Mud disposal and washout pad, showing burned trucks and damaged canopy.

The canopy above the unloading pad sustained major heat damage (Figure 10). The electrical service line attached to the southwest canopy support column was severed, and all ceiling-mounted lighting and the vent fan were destroyed. The emergency eyewash station and shower next to the drivers' shed, the equipment switch panel on the northwest corner wall adjacent to the concrete pad, and equipment in the electrical shed sustained significant radiant heat damage. Fire and smoke damaged the storage room attached to the drivers' shed.

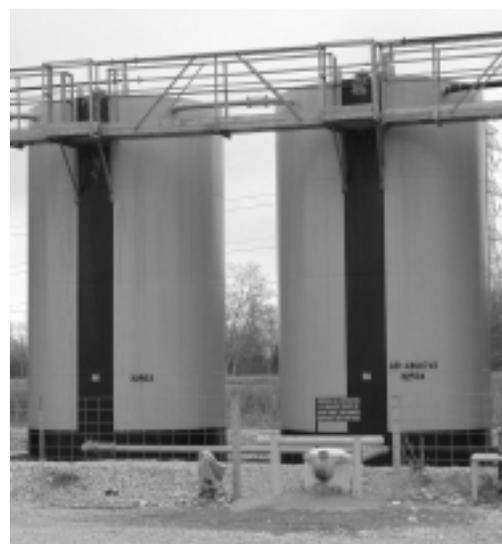
Figure 11. Unlabeled flammable condensate storage tanks, CJ Waller lease.

. . . The majority of those questioned during the investigation do not believe that BS&W exhibits a flammability hazard, even though it can originate from highly flammable condensate.

²¹Following the January 13, 2003, incident at BLSR, Noble Energy attached labels to product and waste storage tanks at the CJ Waller and Roberts well sites, identifying the contents as DOT Class 3 flammable liquids. However, the product and waste storage tanks at three other Noble Energy well sites did not have any hazard class labeling on February 11, 29 days after the incident.

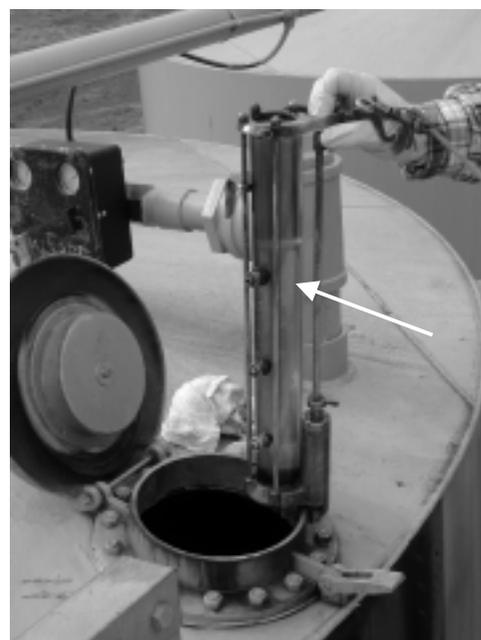
Figure 13. Gauge hatch and tank “thief” showing 13 inches of BS&W below condensate.

CSB analysis of nine tank BS&W samples from six production wells, including one of the wells involved in the BLSR incident, resulted in flashpoints below 30°F in eight of the samples. (For comparison, the flashpoint of condensate is about -36°F, and the flashpoint of gasoline is about -45°F.) Only one of the storage tank BS&W samples had a flashpoint above 141°F.²⁴ A tank bottom “thief” (Figure 13) was used to ensure that only BS&W was withdrawn from the tanks.

The measured flashpoint of BS&W is dependent on the amount of volatile hydrocarbons contained in the mixture.

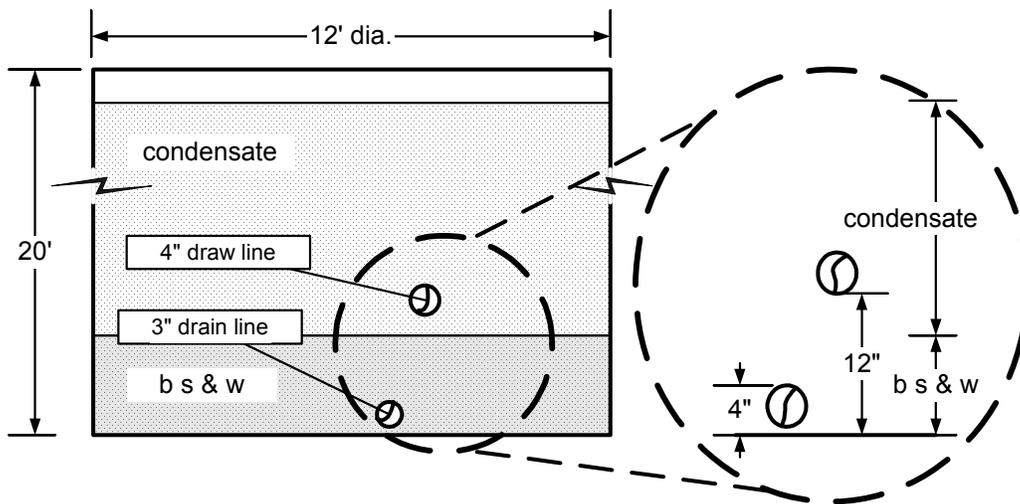
Figure 14. Vertical spacing of storage tank nozzles (180° apart around circumference of tank).

(presumably BS&W) through the drain nozzle, as much as 2 inches of condensate (140 gallons) is mixed with BS&W. The liquid “waste” in the truck tank is actually 25 percent highly flammable condensate.

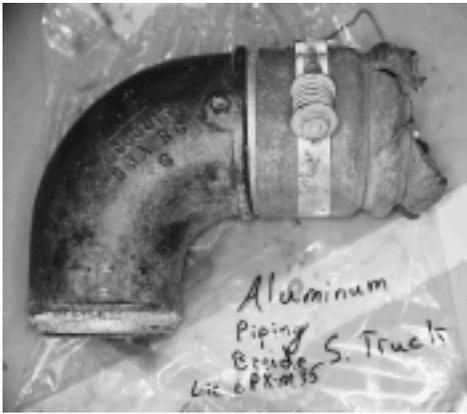
Figure 15. South truck diesel engine turbocharger discharge elbow.

One witness also reported that the hood on the south truck lurched up just before the vapor ignited, suggesting a high-pressure impulse around the engine. The elbow and attached short piece of flexible hose (dark arrow in Figure 16) were recovered and showed no fire damage, providing further evidence that the fitting had come off and fallen to the ground before the fire ignited and destroyed the engine.³²

³²For comparison, evidence suggests that either the north truck engine did not backfire, or the pressure wave from a backfire was not sufficient to blow the fitting off the turbocharger. A portion of the elbow was still attached to the turbocharger housing, and the remainder of the elbow and flexible hose was destroyed.

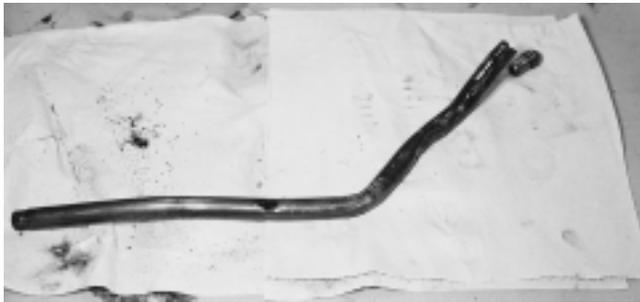
Figure 17. Bent exhaust valve pushtube, south truck diesel engine combustion chamber #2.

In April 2003, a diesel engine maintenance shop disassembled the two truck engines to determine if either had incurred internal damage caused by over-revving, which would support the backfire scenario. The north truck engine sustained no damage indicative of overspeed. However, the south truck engine clearly showed evidence of overspeed damage, including a severely bent exhaust valve pushtube (Figure 17) and bent exhaust valve. CSB determined that backfiring from the south engine is the most likely source of ignition of the flammable vapor cloud.

. . . The south truck engine clearly showed evidence of overspeed damage, including a severely bent exhaust valve pushtube and bent exhaust valve.

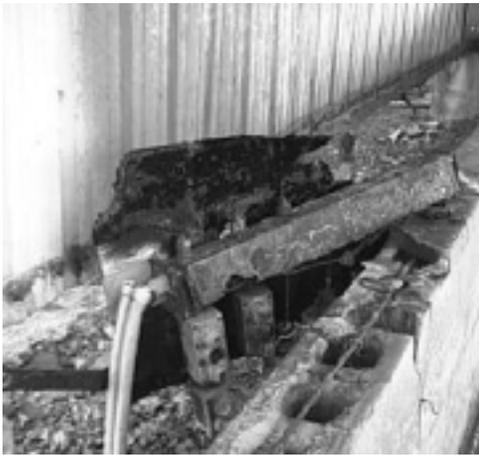
Figure 19. Remains of motor control switch panel.

None of these circuits were designed for operation in a flammable vapor environment.

Physical evidence and eyewitness testimony led CSB to conclude that the vapor cloud was not ignited by a facility electrical circuit.
