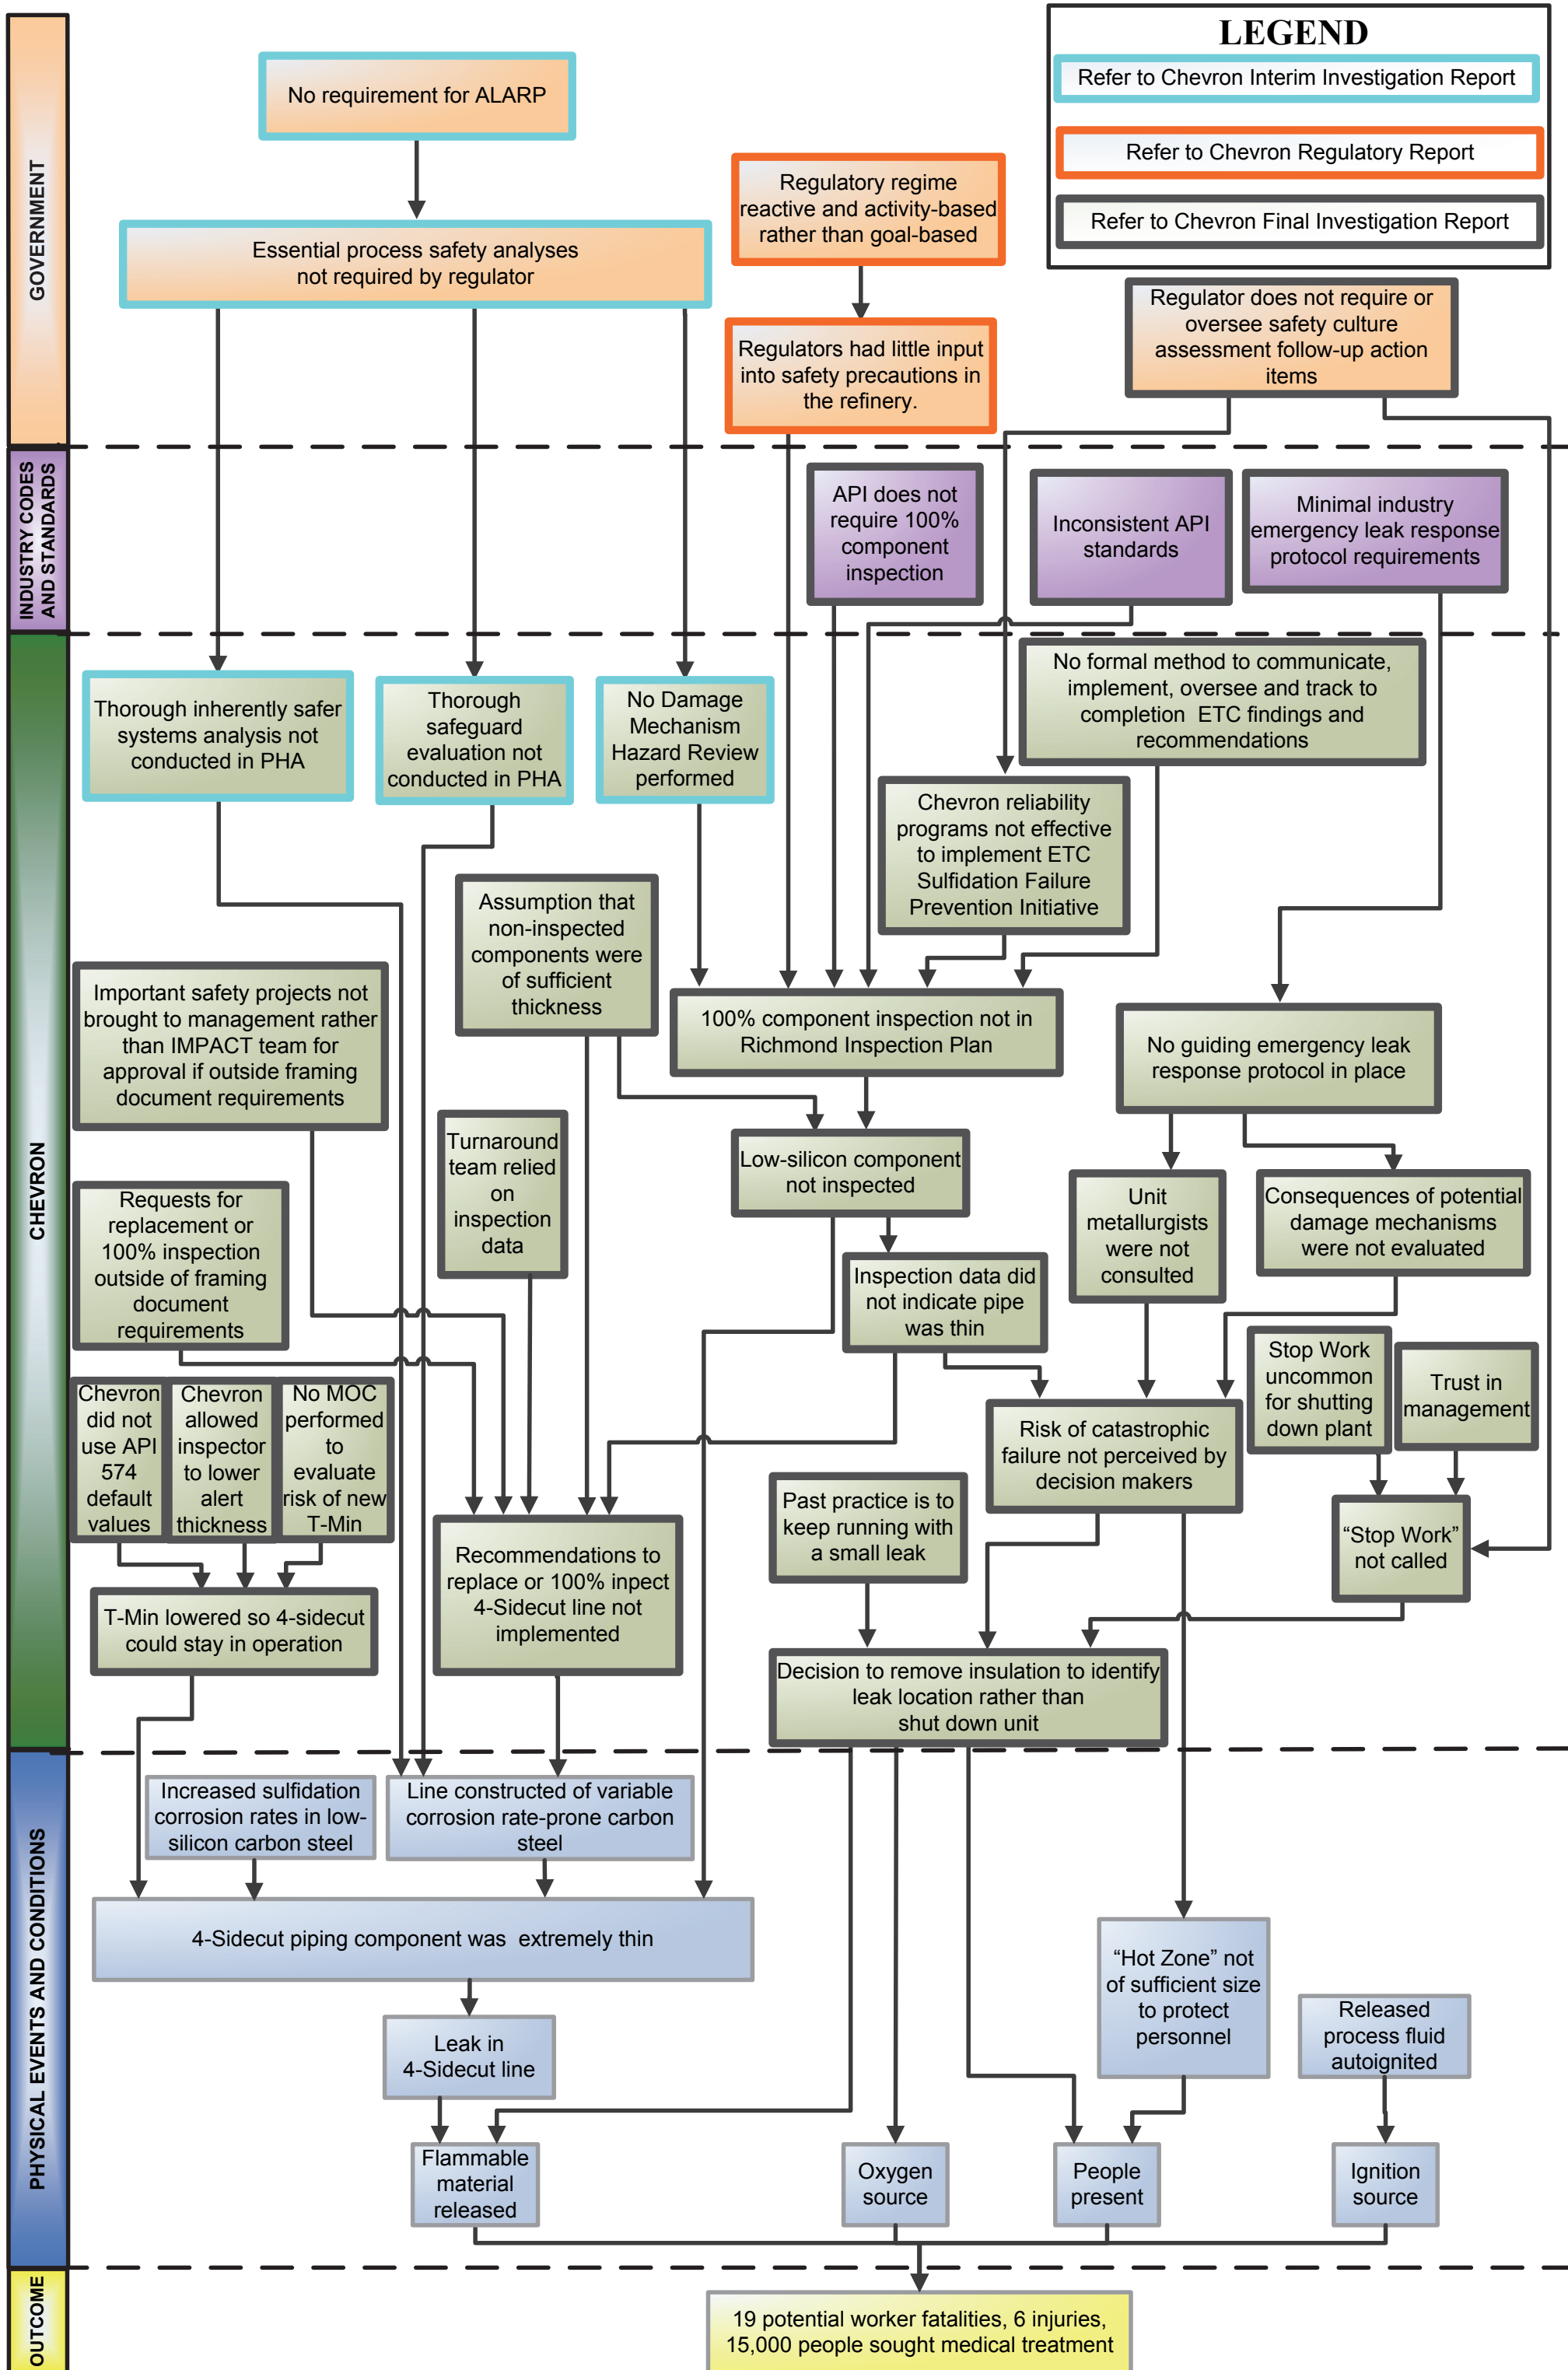
Assumption that non-inspected components were of sufficient thickness

Low-silicon component not inspected

Chevron did not use API 574 default values
Chevron allowed inspector to lower alert thickness
No MOC performed to evaluate risk of new T-Min

T-Min lowered so 4-sidecut could stay in operation

Increased sulfidation corrosion rates in low-silicon carbon steel

Line constructed of variable corrosion rate-prone carbon steel

4-Sidecut piping component was extremely thin

Leak in 4-Sidecut line

Released process fluid autoignited
