U.S. CHEMICAL SAFETY AND HAZARD INVESTIGATION BOARD

FINAL INVESTIGATION REPORT

CHEVRON RICHMOND REFINERY PIPE RUPTURE AND FIRE

CHEVRON RICHMOND REFINERY #4 CRUDE UNIT RICHMOND, CALIFORNIA

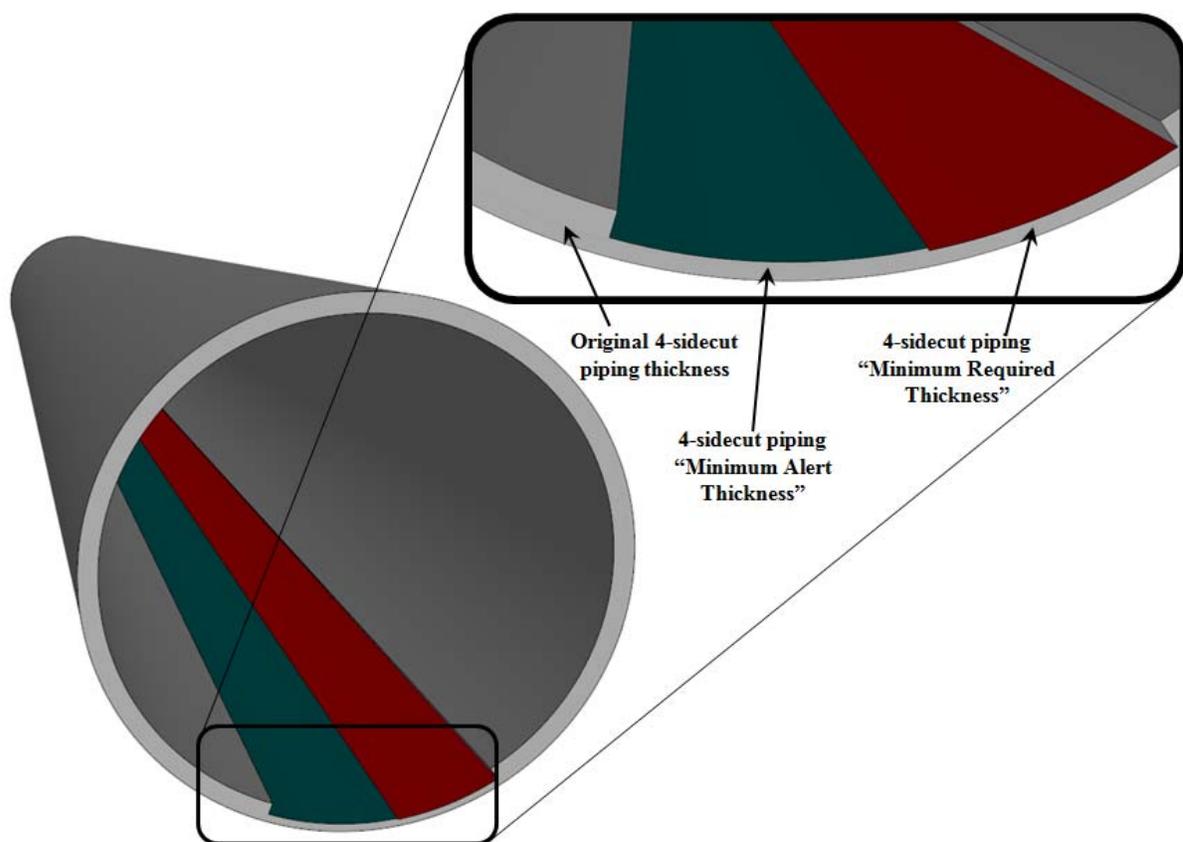
Figure 1. To-scale schematic of 4-sidecut piping identifying key wall thickness values. These include the original wall thickness (0.322-inch), “Minimum Alert Thickness” (0.13-inch), and “Minimum Required Thickness” (0.11-inch) using *API RP 574* default values.

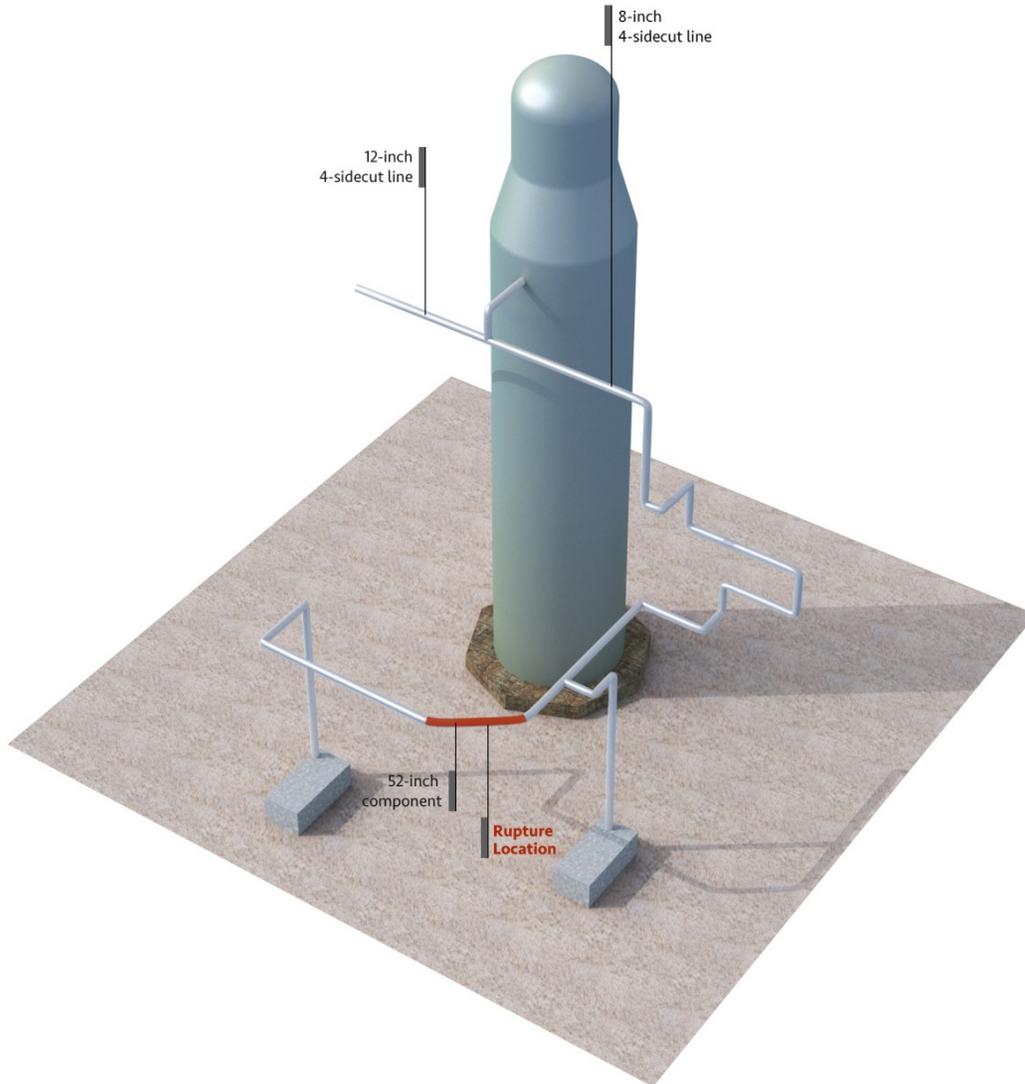
Figure 4. 4-sidecut line configuration and rupture location.

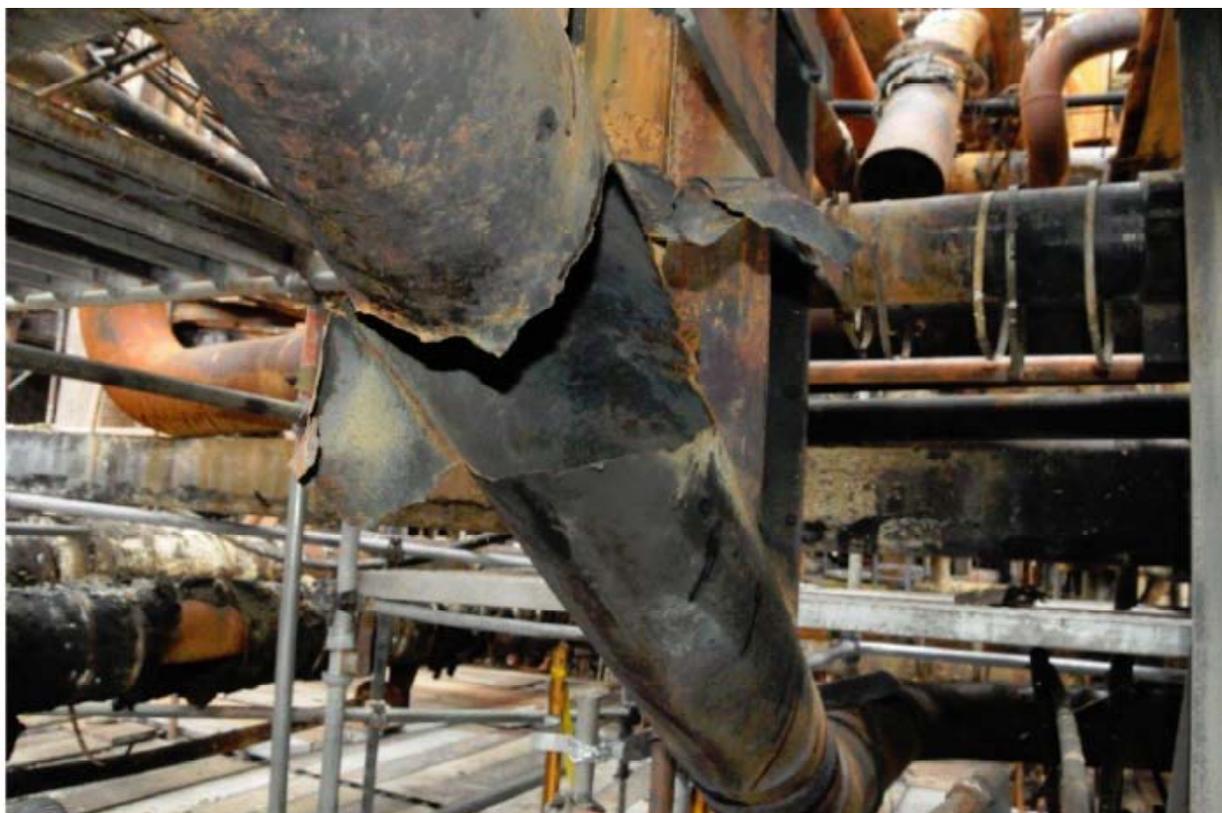
Figure 5. Photo of rupture on 4-sidecut 52-inch component.

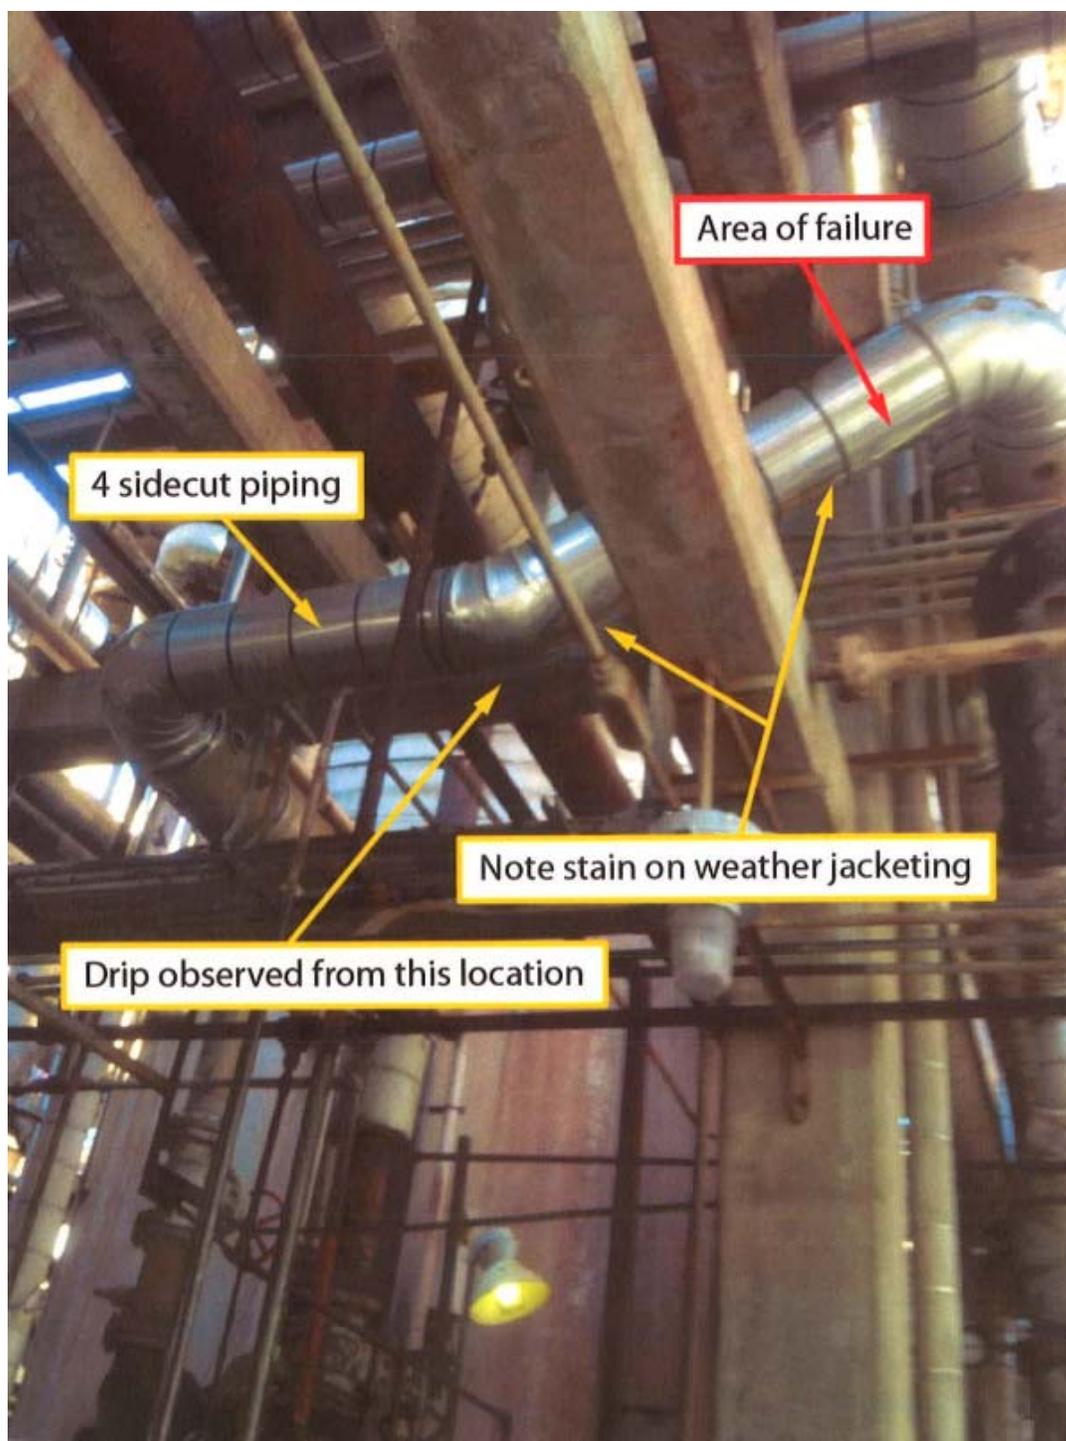
Figure 7. Photo taken of the leaking 4-sidecut pipe on August 6, 2012, at the Chevron Richmond Refinery.⁴⁹ Insulation obscured the actual leak location. Stain signifies where hydrocarbon process fluid was leaking from the 4-sidecut piping.

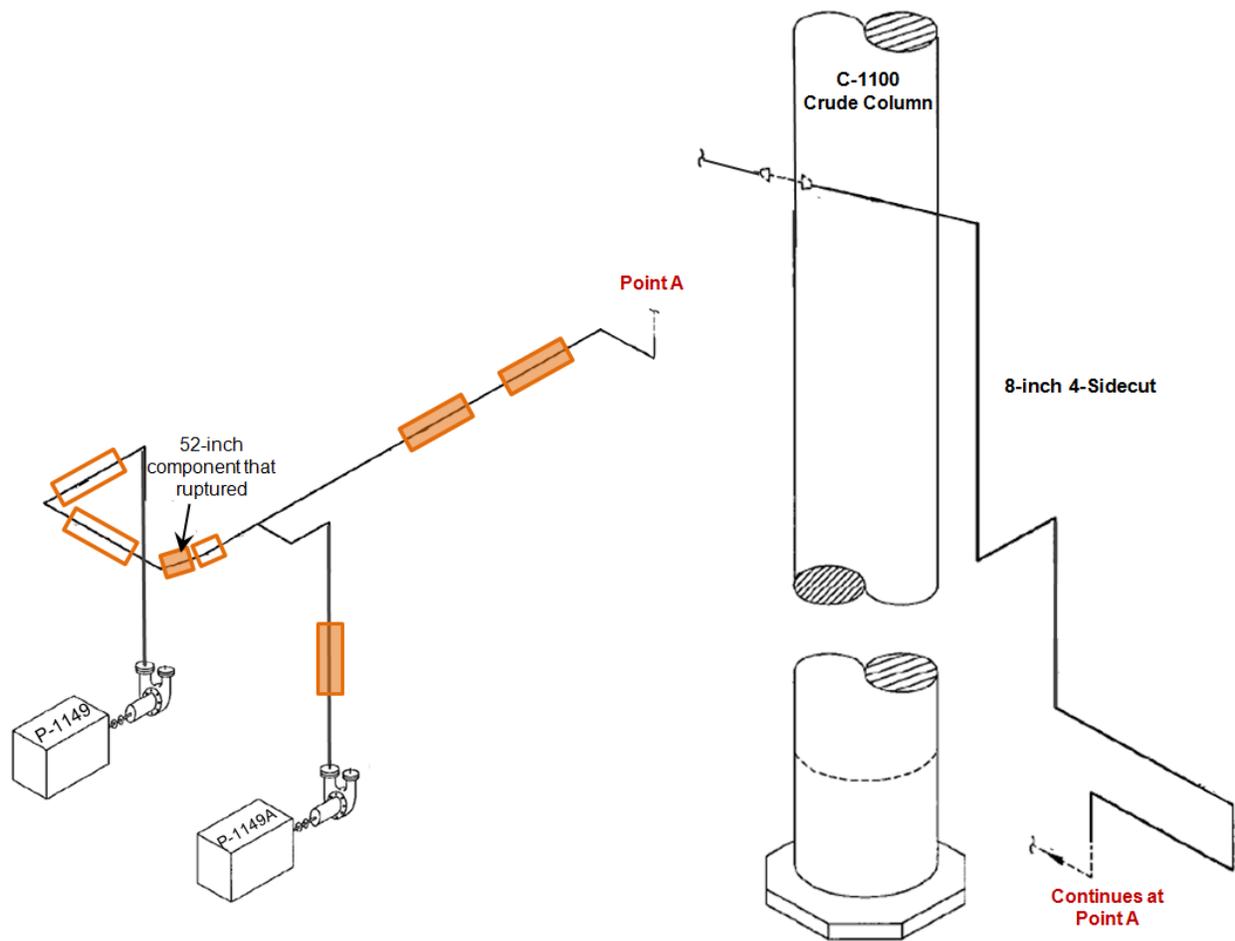
Figure 18. Locations of metallurgical samples taken from 8-inch 4-sidecut piping post-incident. The seven samples taken are boxed in orange. Four of the seven components sampled (shown with an orange fill) were found to have a silicon content less than 0.10 weight percent.

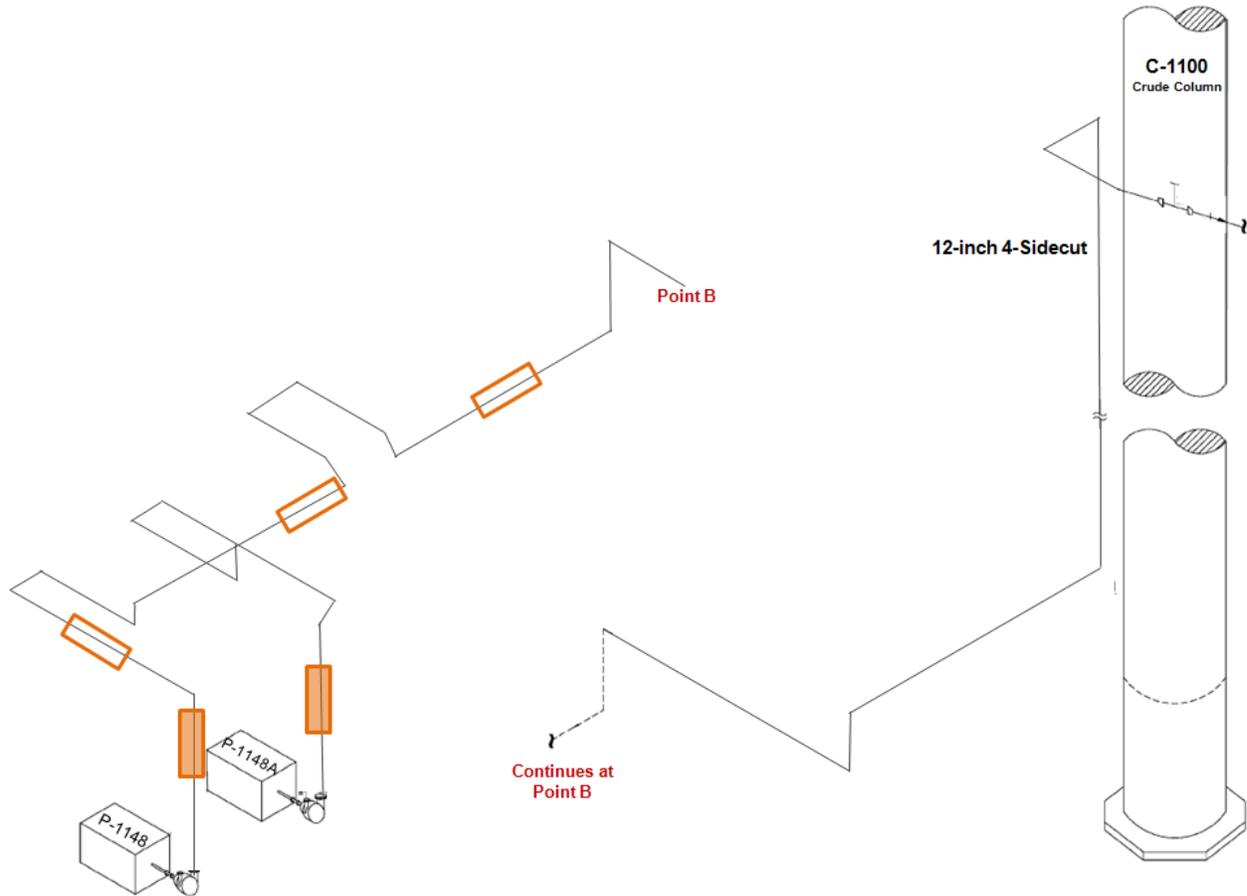
Figure 19. Locations of metallurgical samples taken from 12-inch 4-sidecut piping post-incident. The five samples taken are boxed in orange. Two of the five components sampled (shown with an orange fill) were found to have a silicon content less than 0.10 weight percent.

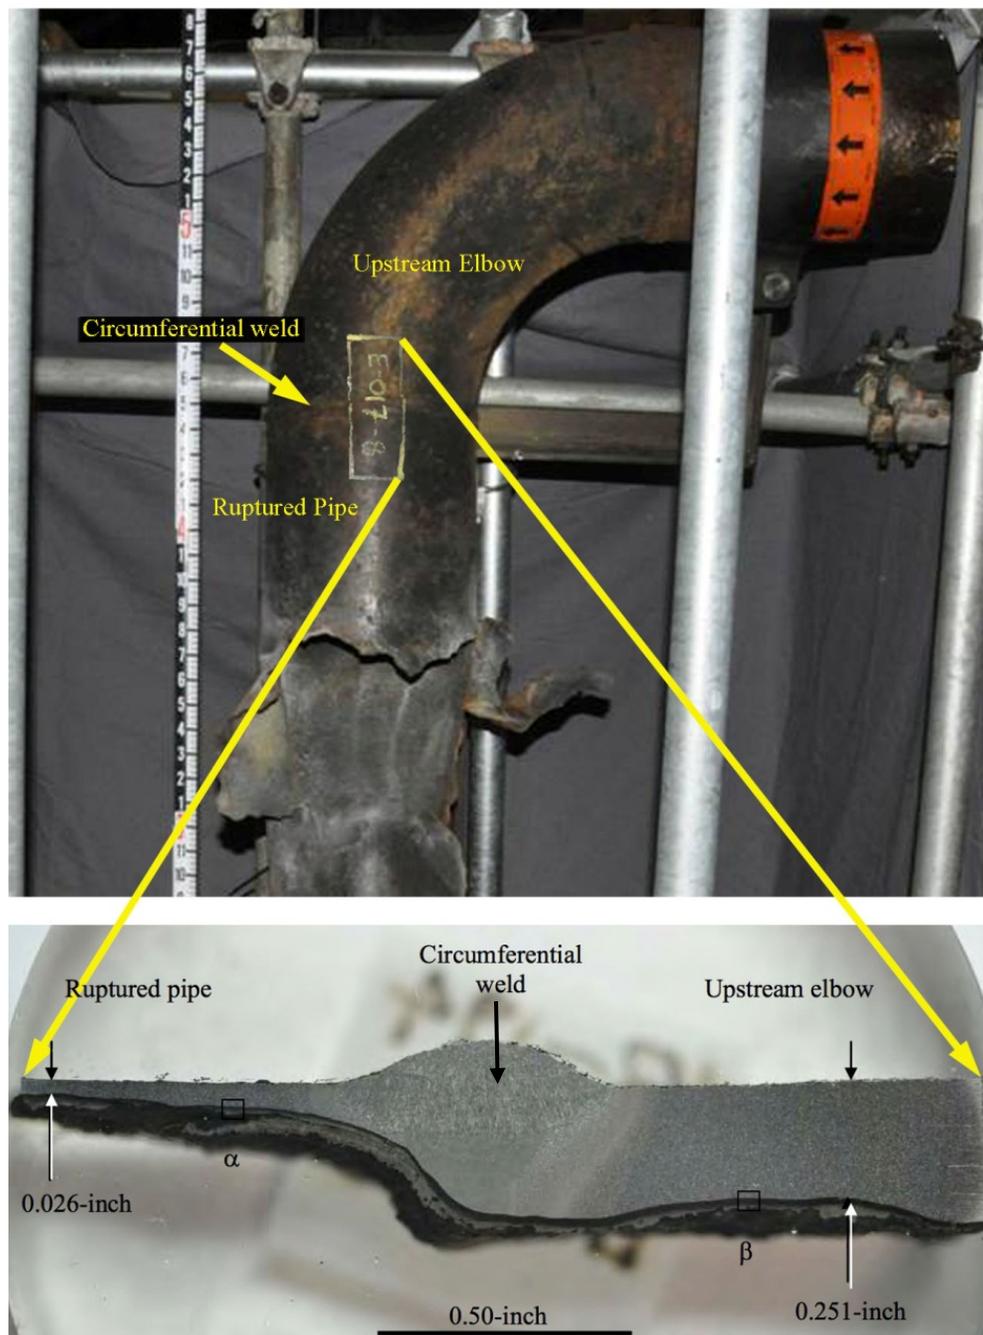
Figure 20. 4-sidecut piping sample (E-017-8) analyzed by Anamet Labs showing the relative thickness of low silicon piping on the left and the high silicon piping on the right. The ruptured 52-inch pipe component (left) contained 0.01 weight percent silicon, and the upstream elbow component (right) contained 0.16 weight percent silicon.⁷⁵ The initial nominal thickness of this piping was 0.322-inch.

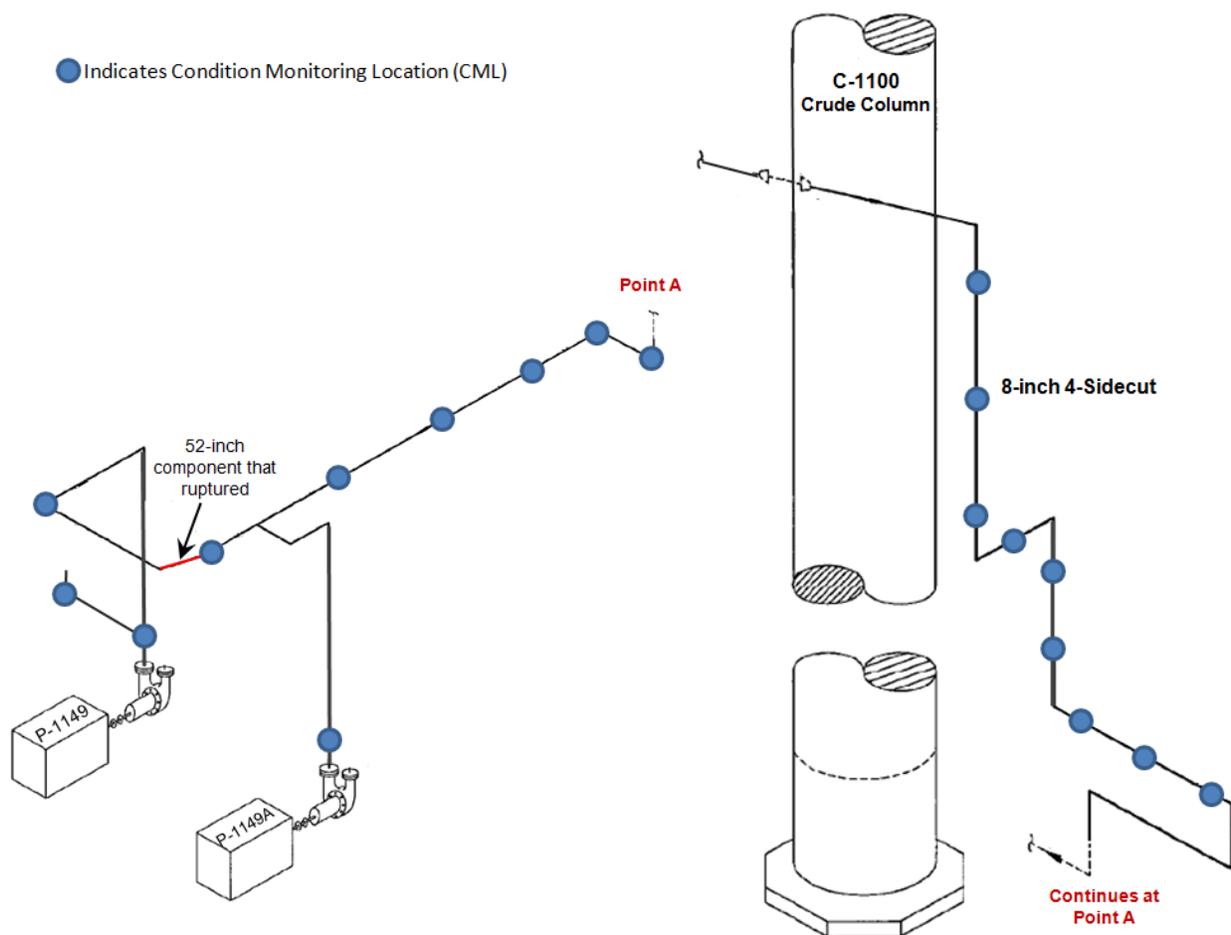
the 8-inch 4-sidecut piping circuit, although 100 percent component inspection was not performed. The CSB found that, although a CML was located on the adjacent upstream elbow, no CMLs were placed on the low silicon piping component that failed (Figure 21). Chevron identified corrosion in the 52-inch component during a supplemental 2002 inspection,⁸⁷ but the inspection results were not entered into the CML-tracking portion of the inspection database, and no new CML was required to be added to ensure future monitoring. As a result, the 52-inch component was never inspected again (Section 5.1.2.1.1).

Figure 21. CML placement on 8-inch 4-sidecut piping. Nineteen CMLs were used to monitor corrosion rates in the 8-inch 4-sidecut piping. A CML was not placed on the 52-inch component that ultimately failed. A CML was placed, however, on the upstream elbow adjacent to the 52-inch component.

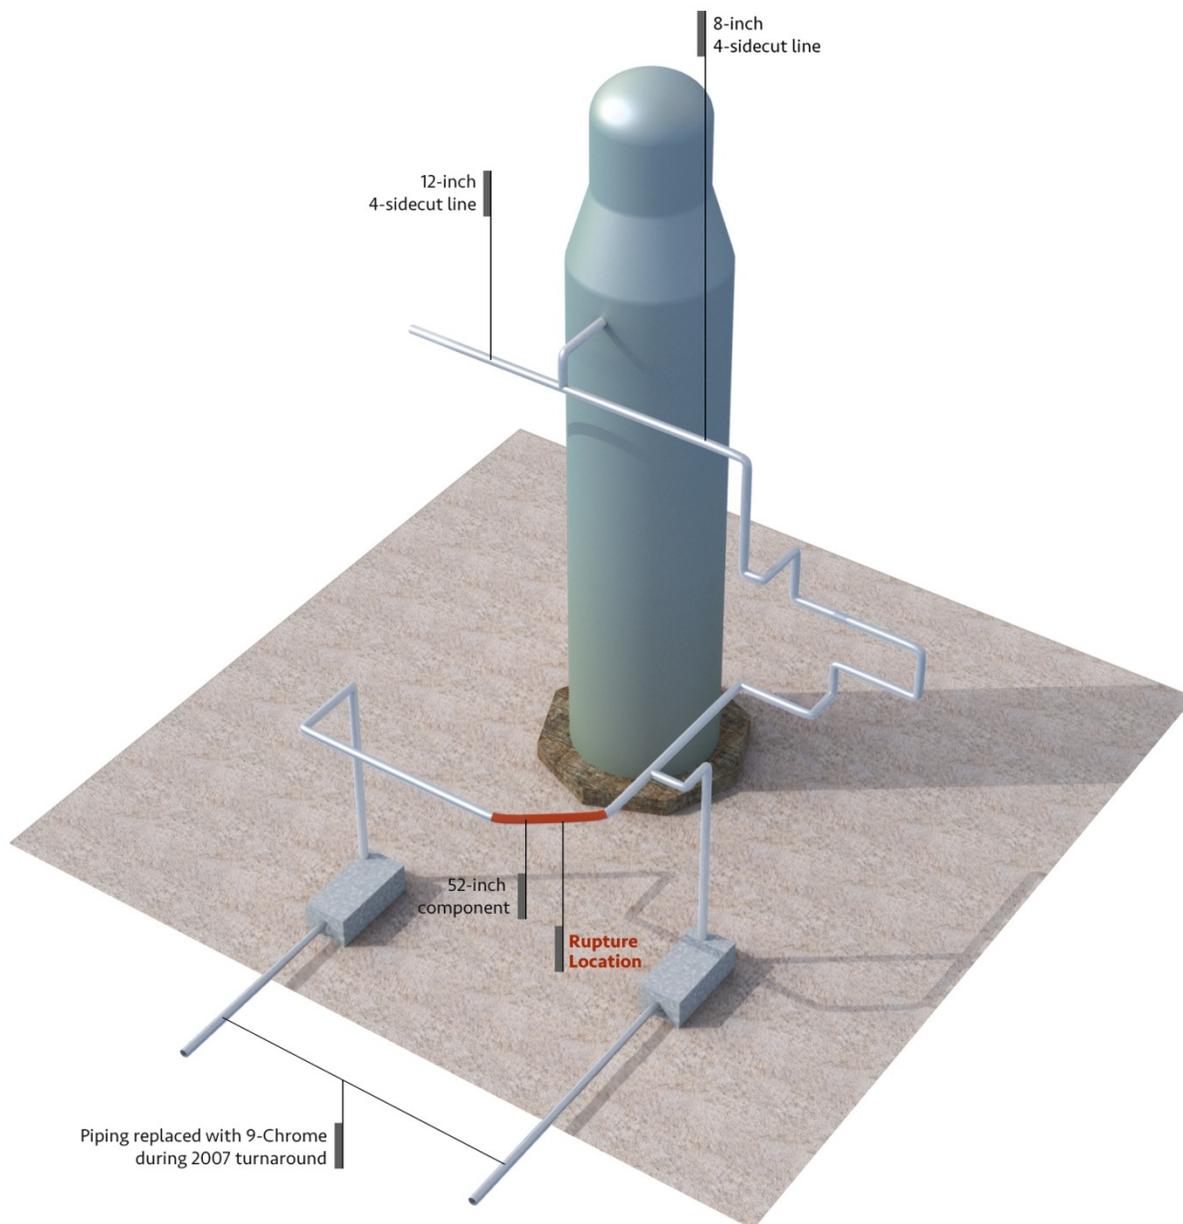
Figure 33. Crude column schematic indicating the piping downstream of the 4-sidecut pumps that was replaced during the 2007 Crude Unit turnaround. The portion of the carbon steel line containing the component that failed on August 6, 2012 was not replaced.

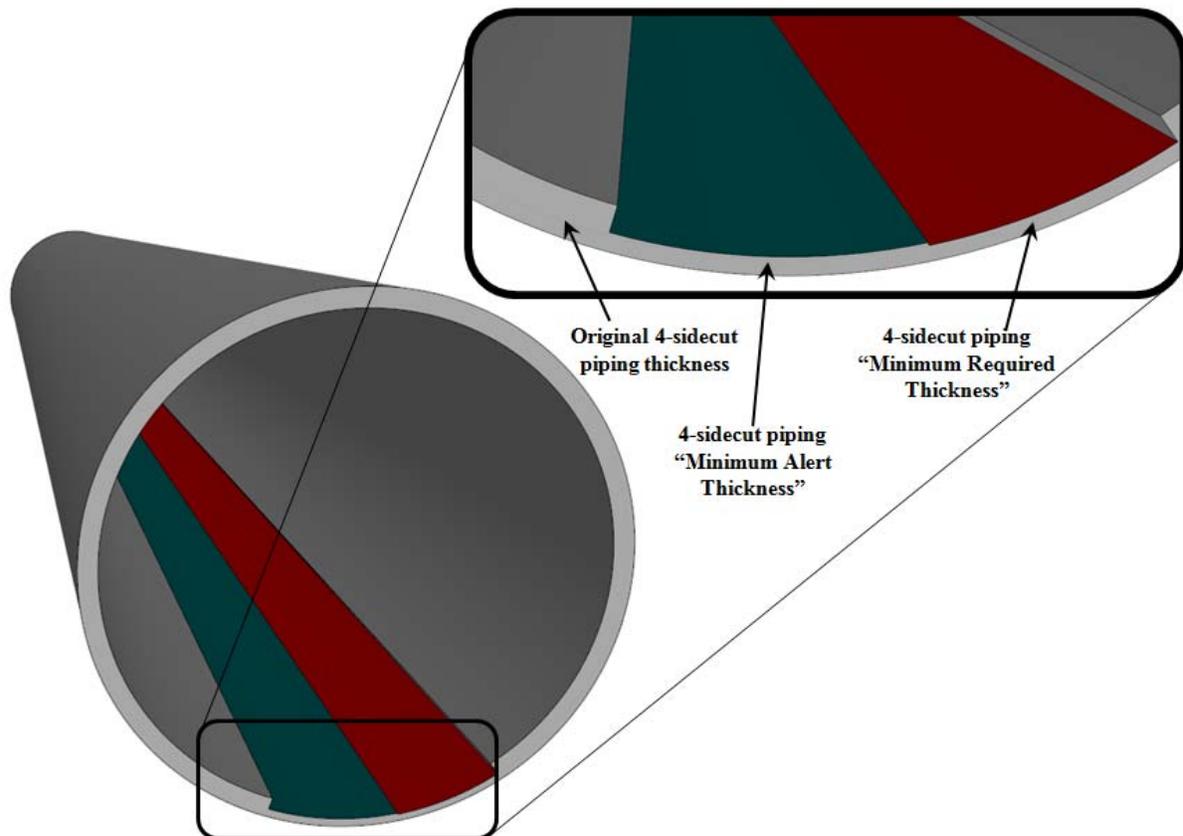
Figure 36. To-scale schematic of 4-sidecut piping original wall thickness (0.322-inch), Minimum Alert Thickness (0.13-inch), and Minimal Required Thickness (0.11-inch) using *API RP 574* default values.

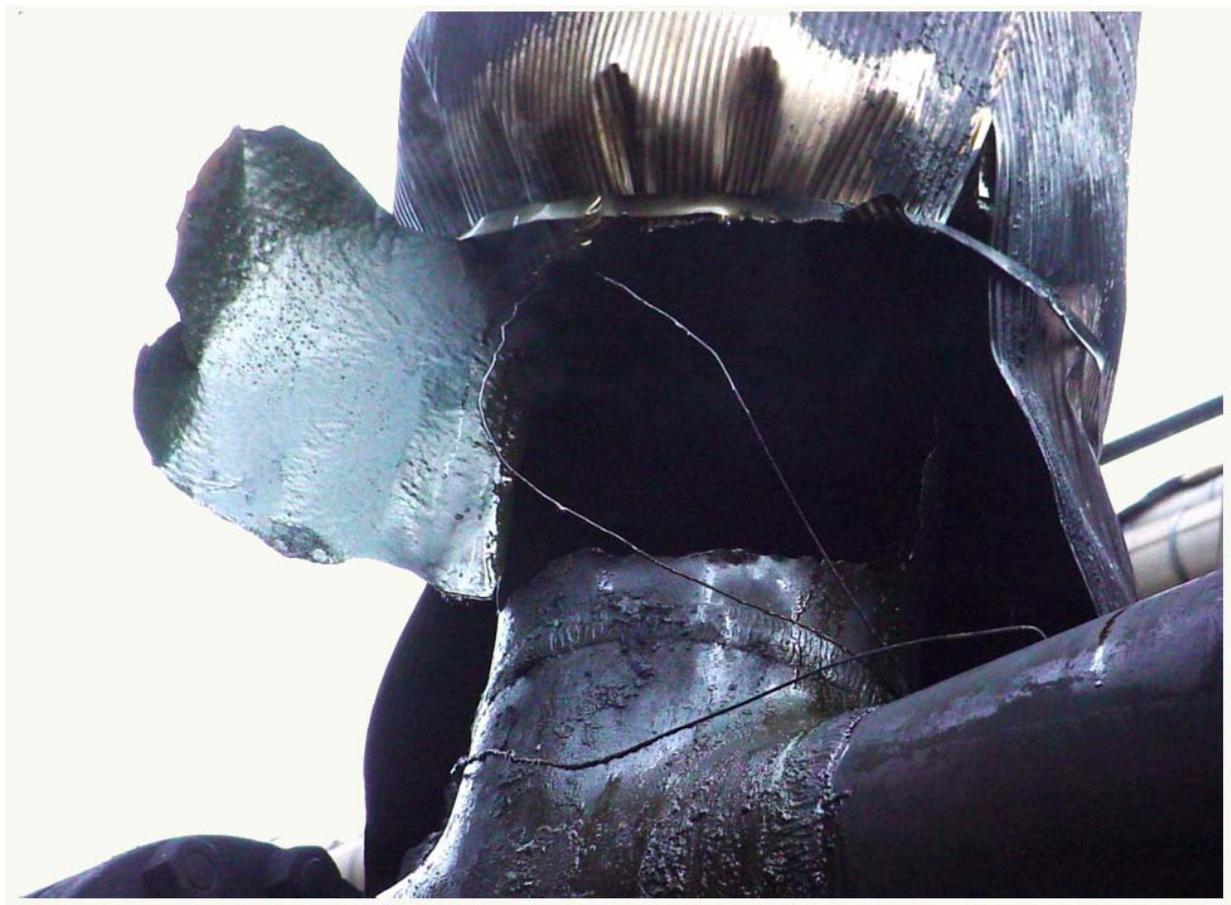
Figure 38. Photo from *API RP 939-C* of a low-silicon pup piece that ruptured at a BP refinery. The surrounding piping had higher silicon content, and the pup piece’s accelerated corrosion rate was unmonitored.

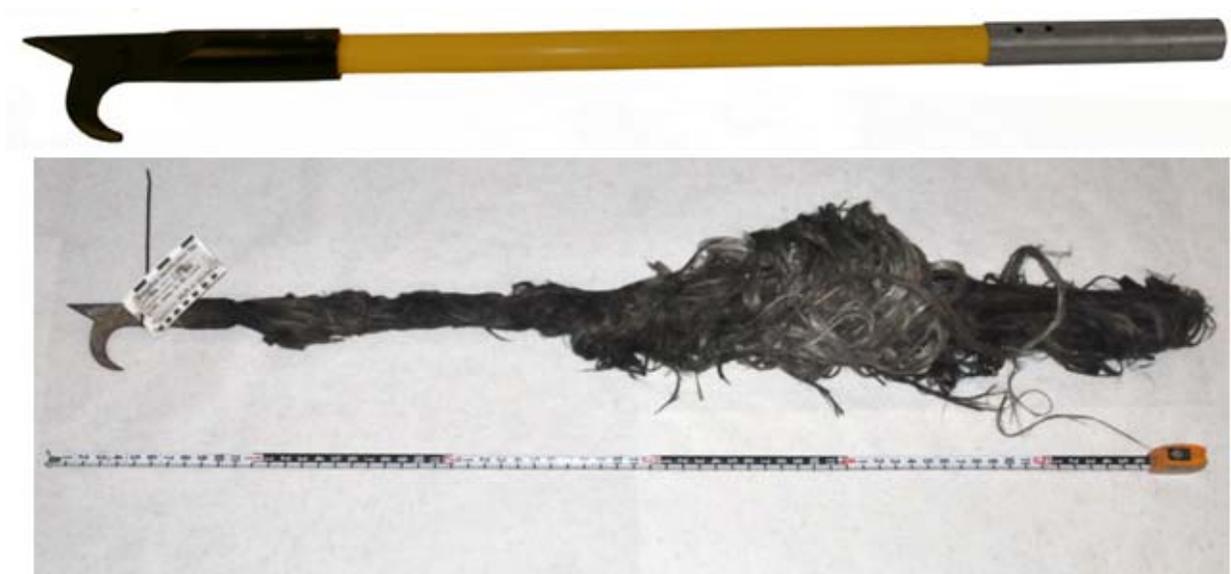
Figure 40. Photo of undamaged¹⁷⁹ (top) and burned during incident (bottom) pike pole used in early attempts to remove 4-sidecut insulation.

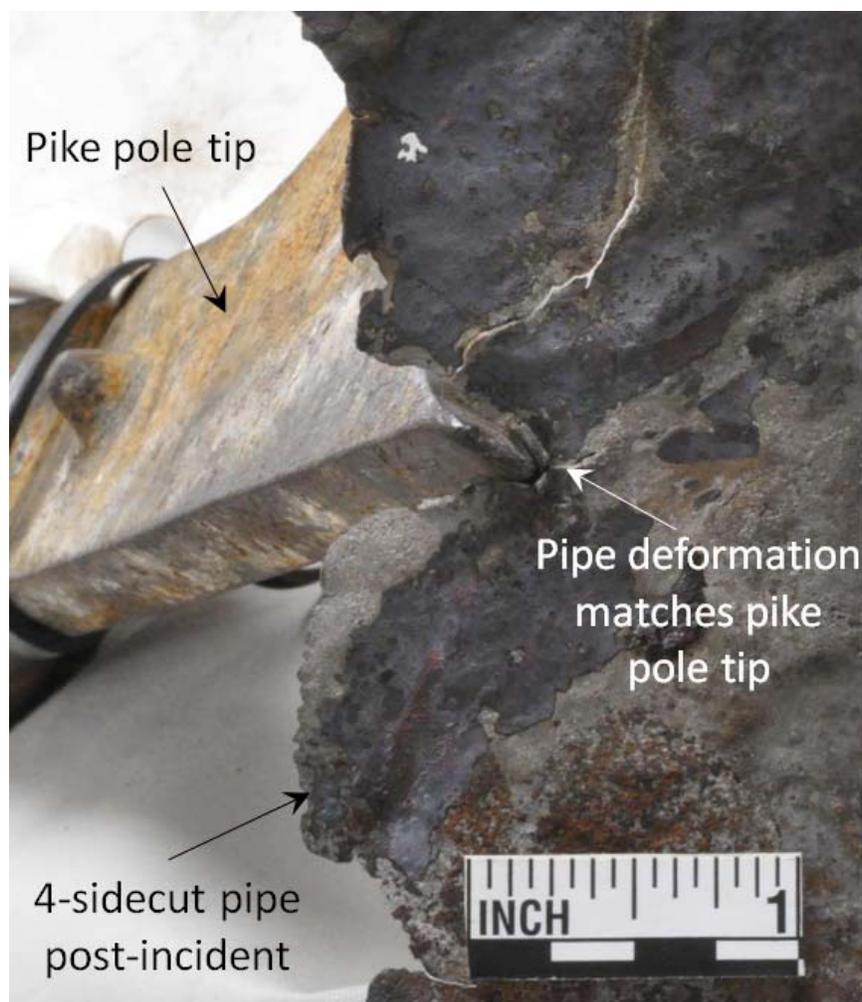
Figure 41. Photo showing that tip of fire pole matches apparent puncture location in failed 52-inch component of 4-sidecut piping.
