U.S. CHEMICAL SAFETY AND HAZARD INVESTIGATION BOARD

# INVESTIGATION REPORT

## E.I. DUPONT DE NEMOURS & Co., INC.

BELLE, WEST VIRGINIA

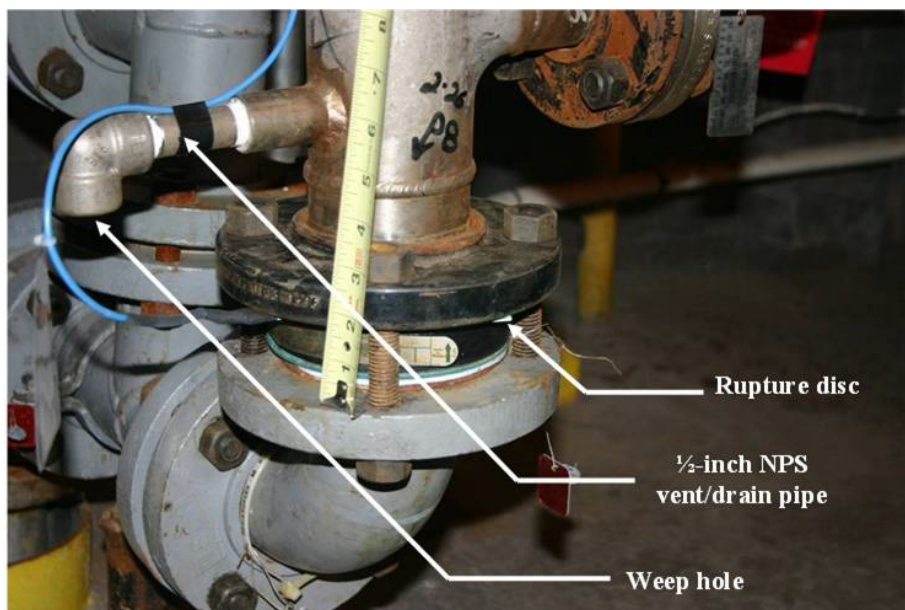
Figure 3. 0.5-inch NPS vent/drain pipe and rupture disc

weep hole (Figure 3). This connection was associated with a thermal oxidizer “vent stack,” that vents to the atmosphere on the roof of the building during a process upset. Operators notified the board operator at 5:19 a.m. when they found the source of the release.

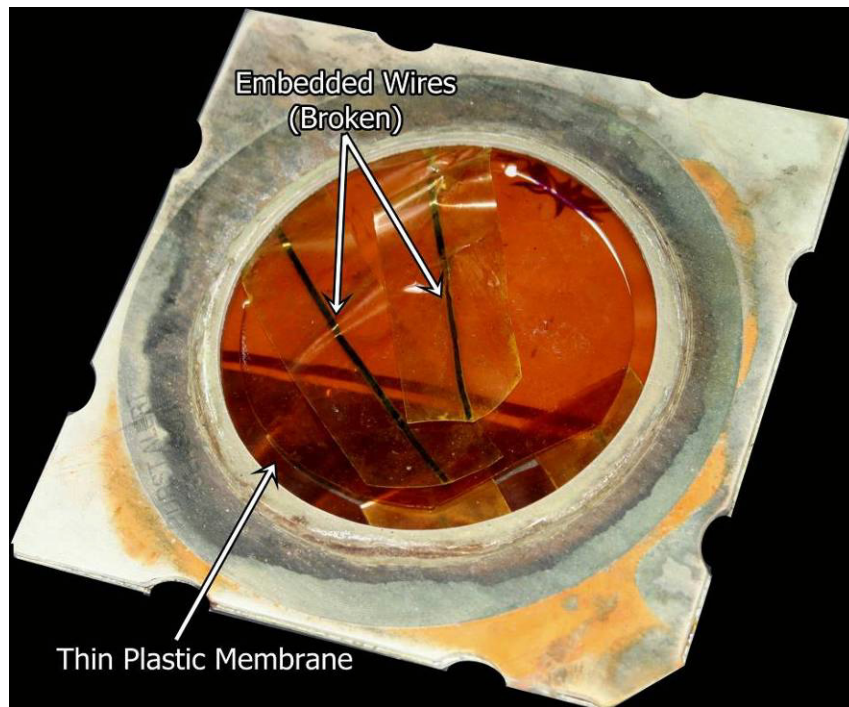
Figure 5. Rupture disc burst sensor post-incident

DuPont Belle used a “burst sensor” intended to notify the board operator that the rupture disk (Figure 5) activated. A burst sensor is a thin plastic membrane with embedded wires installed on top of the rupture disc. Small electrical current passes through the wires. When the rupture disc activates, the membrane and embedded wires break, triggering the alarm.

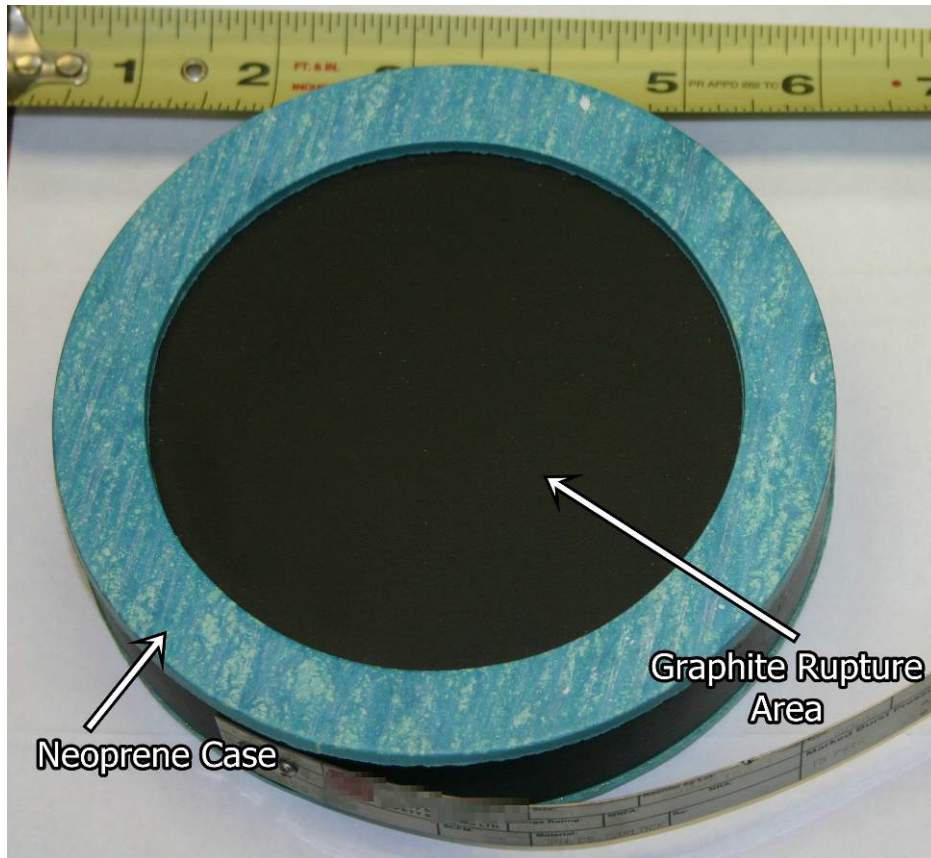
Figure 6. New rupture disc

The rupture disc involved in the incident was a 4-inch diameter graphite rupture disc, designed to rupture at 15 psig, and mounted in neoprene casing (Figure 6). While the rupture disc is on a preventive maintenance (PM) schedule, the annual inspection was so infrequent that the disc is replaced only when it has activated or is removed for certain processes. Operators told the CSB investigators that once removed, the rupture discs, intact or compromised, are discarded and replaced with new ones. Even without a burst

sensor, all overpressure protection devices, including rupture discs, should be routinely checked on an effective PM schedule as a layer of protection.<sup>16</sup>

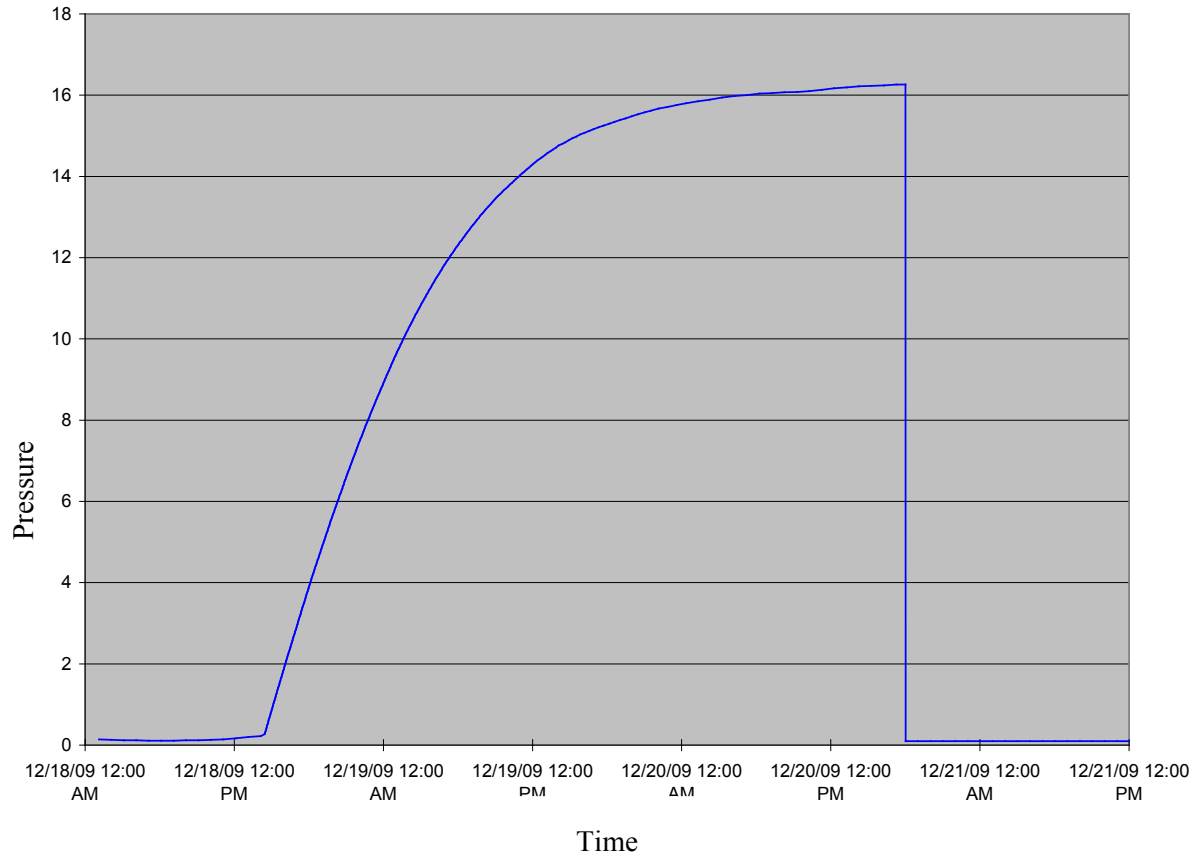
Figure 7. Process data showing sudden pressure decrease when rupture disc burst

The operators did not address the alarm when it triggered in December because they knew that work in the area was causing nuisance alarms; however, when the ECF alarm activated on January 22, 2010, operators responded. The board operator in the F3455 control room investigated and observed that the original alarm from December 21, 2009, was still displayed; the first item on the alarm screen had not been acknowledged because they had become accustomed to nuisance alarm conditions.<sup>21</sup>

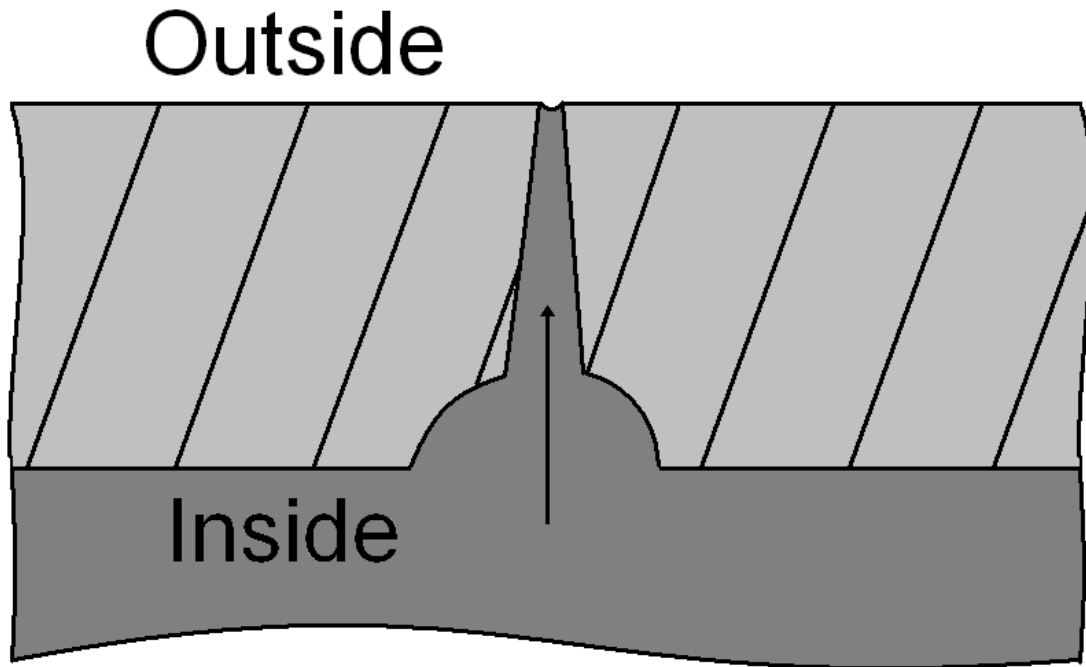
Figure 9. The pitting phenomena in the small initial hole of the oleum sample line wall

Caused by an unknown defect, oleum corroded through a small section of the pipe involved in the release on January 23, 2010. Starting as a pitting phenomena and finishing slightly larger than a pin hole, the corrosion penetrated the insulated stainless steel sample pipe (Figure 9).

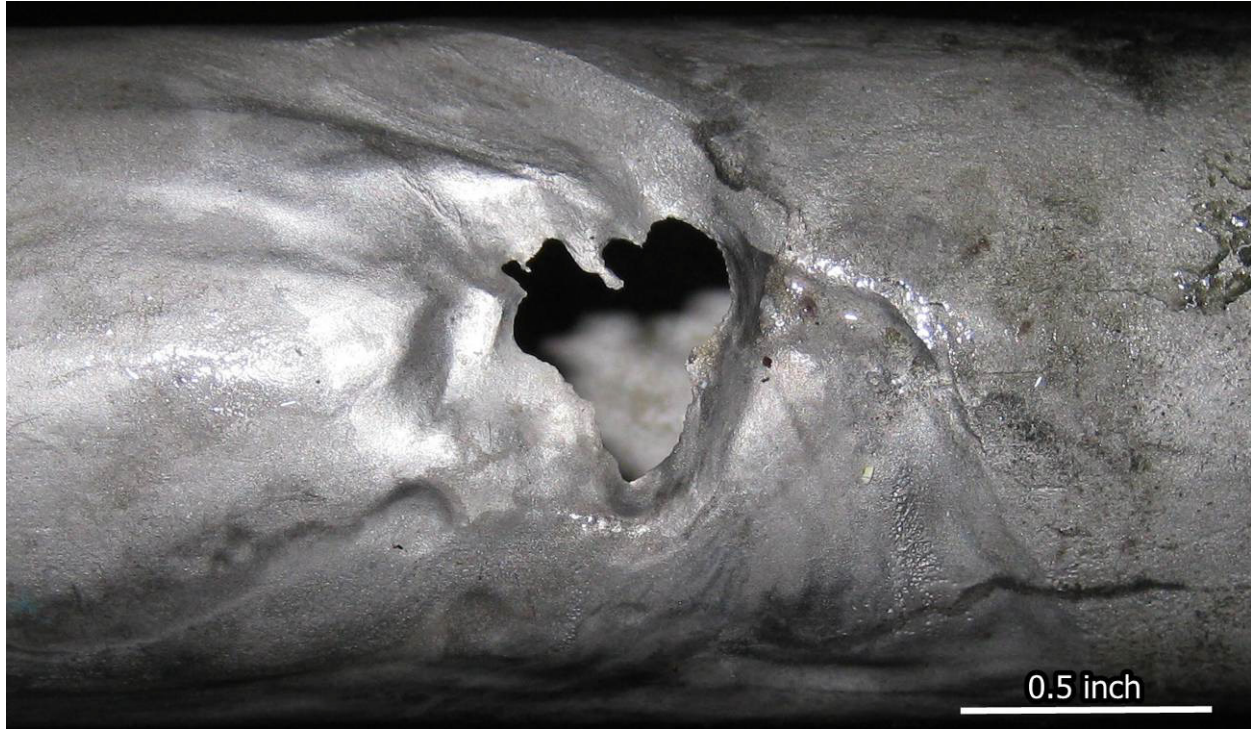
Figure 10. The larger hole eroded from the outside-in on the oleum sample line<sup>26</sup>

Once oleum was present on the exterior of the oleum pipe, it readily corroded the insulation and steam tracing line and then created a leak in the steam tracing, causing the steam and oleum to mix. This reaction created a strong solution of sulfuric acid that rapidly and effectively corroded the stainless steel sample line exterior, until a second larger hole developed at a location near the original small leak. The second hole clearly shows corrosion occurring from the outside-in (Figure 10).

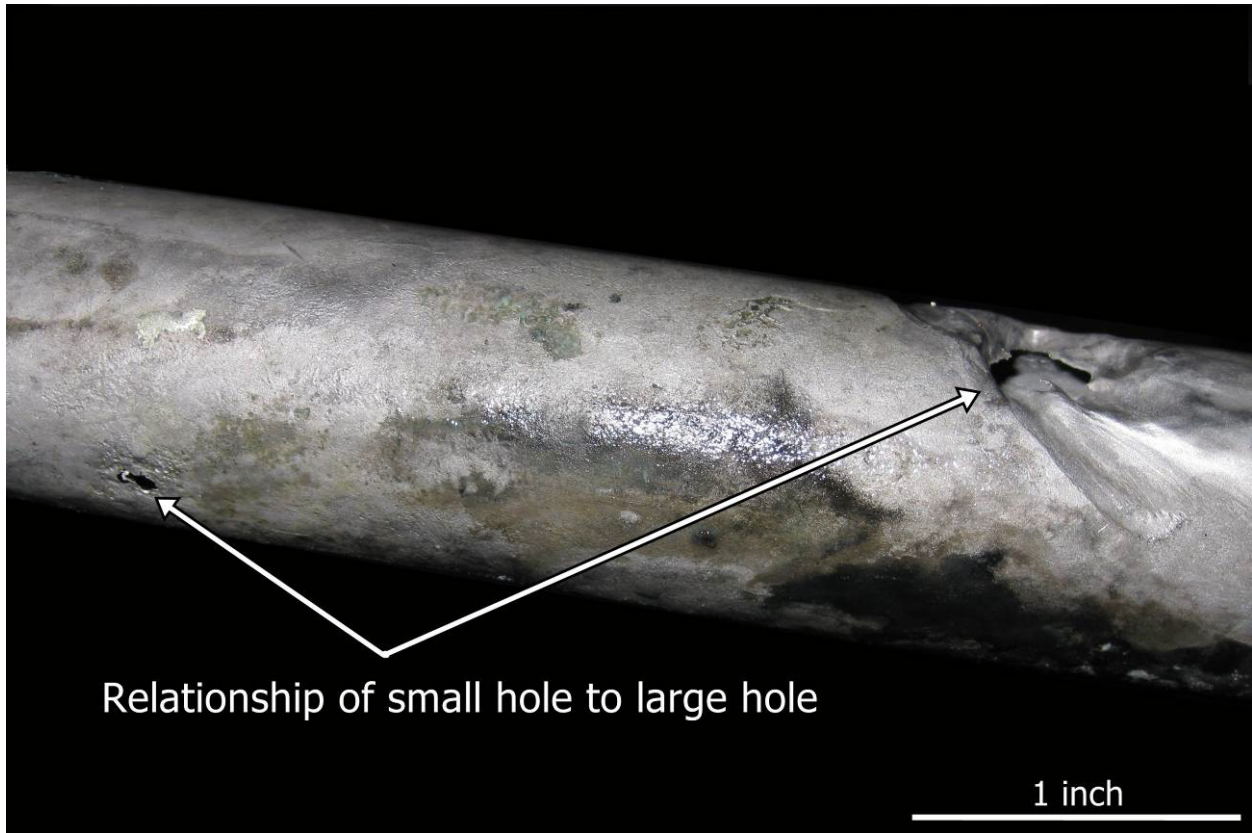
Figure 11. Photo showing the orientation of the small hole to the main hole

When DuPont removed the oleum-soaked insulation and cover, a larger hole was visible; the acid had also corroded a large amount of the steam tracing. When the sample line was properly cleaned, inspection revealed that the smaller hole was only a few inches away from the larger hole, and after thorough examination, metallurgists concluded that the small hole in the sample line initiated the oleum release (Figure 11).

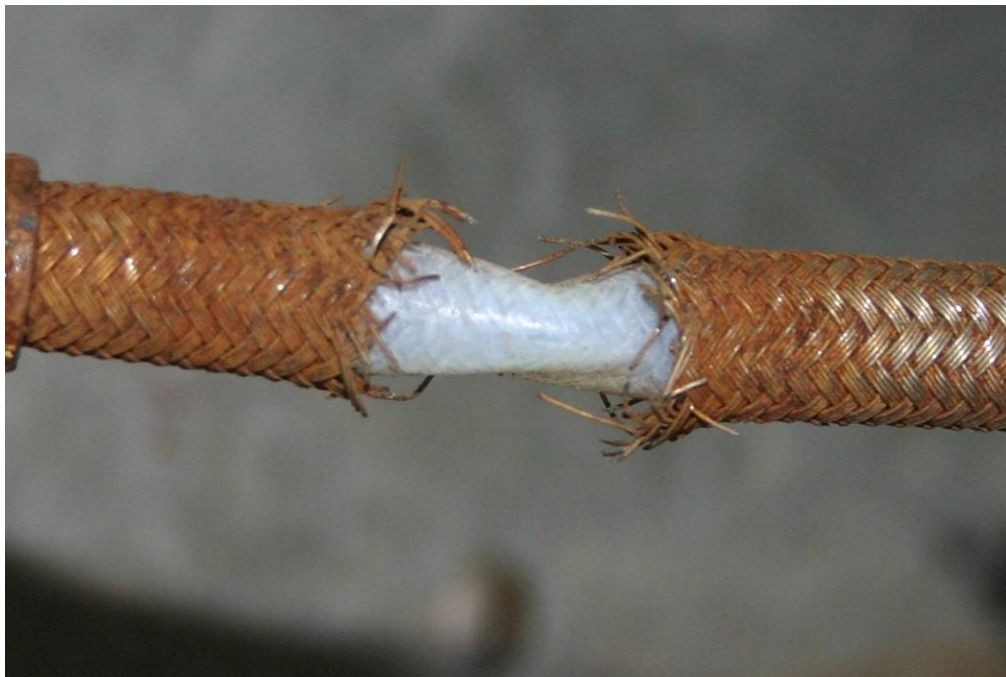
The hillside phosgene supply hose and valve assembly were removed and decontaminated in a water bath. When the hose was removed from the water, the white adhesive ID tag had fallen off, revealing a broken stainless steel braid and collapsed PTFE liner, a possible cause of the flow restriction (Figure 15).

Figure 15. Damaged hillside phosgene hose removed from phosgene cylinder. The plastic adhesive tag that covered the damaged section fell off during the hose decontamination procedure.

An operator stated during an interview that when he saw the physically defective section of the frayed hose, he told his coworkers, stressing that the hose was close to rupturing and that they were lucky to have found it and changed-out the hose in time. Unfortunately, this discovery was not captured as a near-miss, since supervisors were not made aware of the issue.

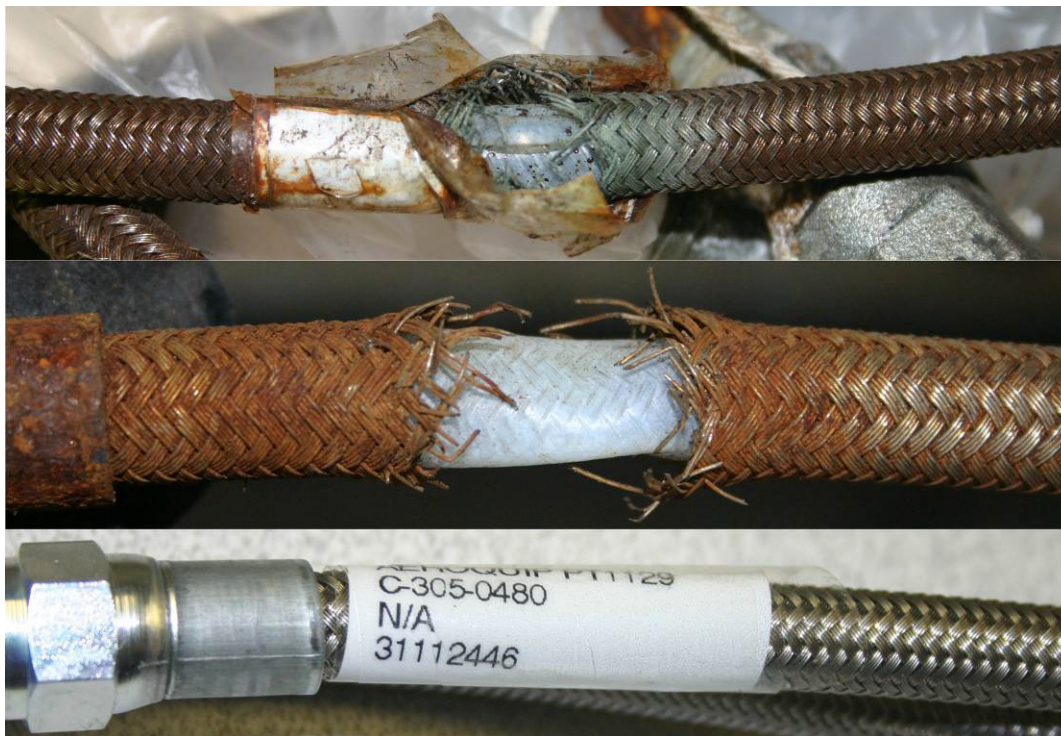
Figure 16. Flex hose comparison photographs: (top to bottom) ruptured riverside hose, flow restricted hillside hose, a new hose with attached ID tag

However, the PM schedule in SAP is actually set to a replacement frequency of 30 days. This procedure does not effectively communicate why the hoses must be replaced so frequently: if left on too long, the accepted corrosion condition poses a serious risk to the facility and the community.

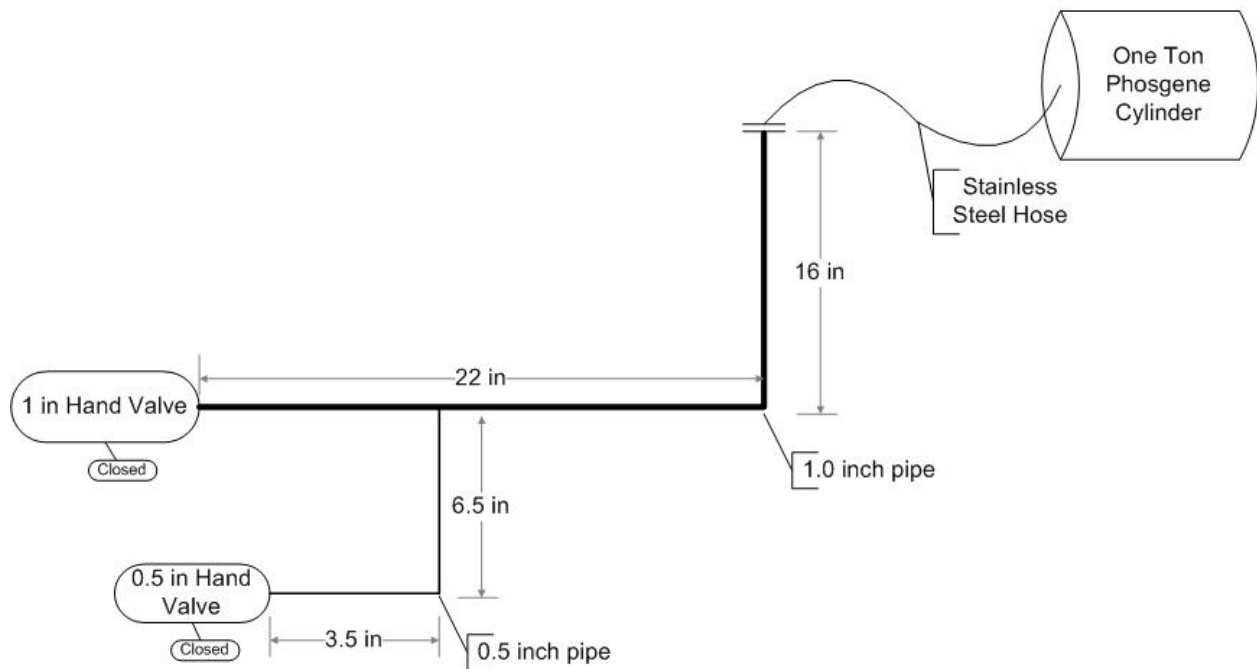
Figure 18. The hose and piping system that supplied phosgene for the release

Figure 18 shows the hose and piping dimensions and the maximum amount of phosgene present in the piping system associated with the hose failure.
