U.S. Chemical Safety and Hazard Investigation Board

US Ink/Sun Chemical Corporation

Ink Dust Explosion and Flash Fires in East Rutherford, New Jersey

No. 2013-01-I-NJ

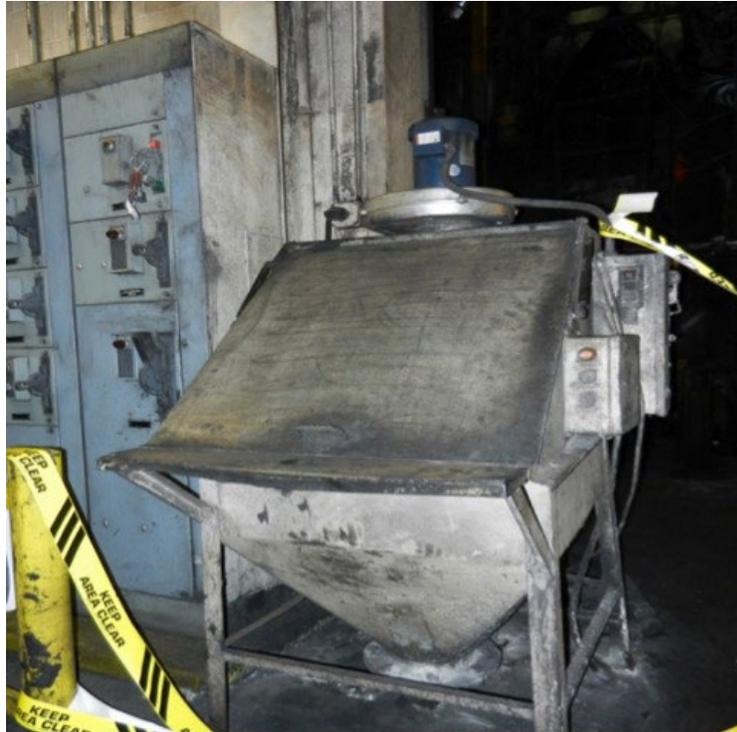
FIGURE 2

⁴ The bag dump station was positioned in the doorway of the pre-mix room. An overhead rollup service door was installed for access to the pre-mix room. At the time of the incident, the CSB found that the rollup service door was chained into a fixed rolled-up position to provide easier entry into the room. Witness accounts from plant employees and contractors indicated that Gilsonite dust generated from the bag dumping operation often accumulated around the facility but particularly on flat surfaces. US Ink did not provide an effective means of containing fugitive dust at the bag dumping station because emptied bags were often stacked alongside the bag dump, which in turn lofted dust into the air.

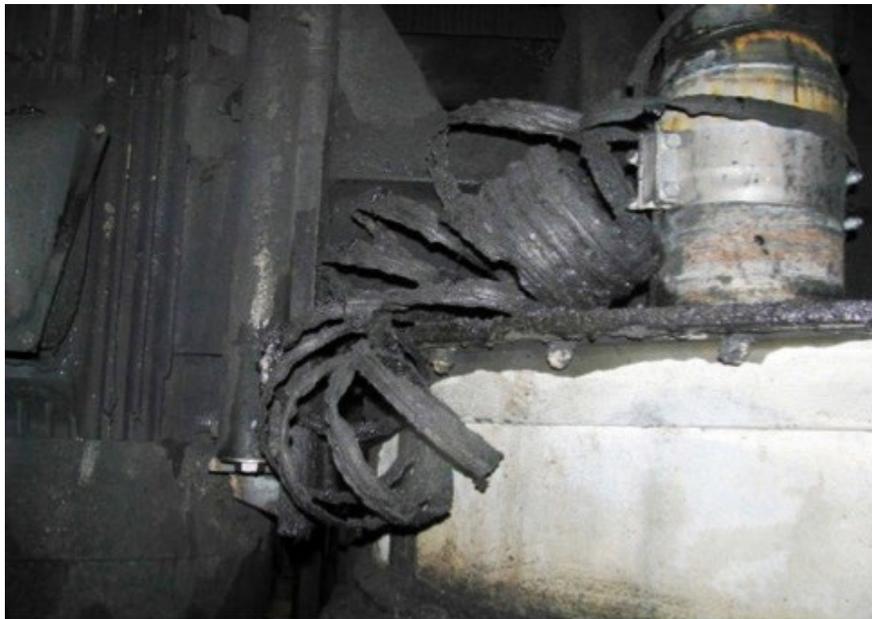
FIGURE 6

Burned ductwork over
T-306

The CSB investigated three possible points of origin of the fire: within the dust collector, within the ductwork above T-306, or within T-306. Chemical test results,³⁴ engineering design analysis,³⁵ physical evidence of excessive deformation, heat charring of the ductwork directly above T-306, and corroborated witness testimony all indicated that the fire originated within the ductwork of the dust collection system.

On the basis of all the test results, the CSB concluded that the incident probably started with the self-heating and spontaneous ignition of the accumulated sludge (mostly Gilsonite and carbon black mixed with hydrocarbon oils) in the ductwork of the dust collection system. Transport of the burning sludge to the dust collector caused the dust collection explosion. The explosibility of the accumulated sludge and powder deposits in various sections of the duct combined with the flame propagation back from the dust collector explosion to cause more extensive residual burning in the various duct sections. Dust deposits in and around the ducting, including deposits produced from the dust collector explosion, dispersed as the US Ink employee climbed the stairs,⁵¹ intending to suppress the visible flame in the detached flexible duct above Tank 306. The residual flame ignited the dispersed dust, and the subsequent fireball dislodged and lifted more dust so that an expanding fireball vented through the doorway into the corridor. This expanding fireball (or flash fire) was responsible for the multiple burn injuries.

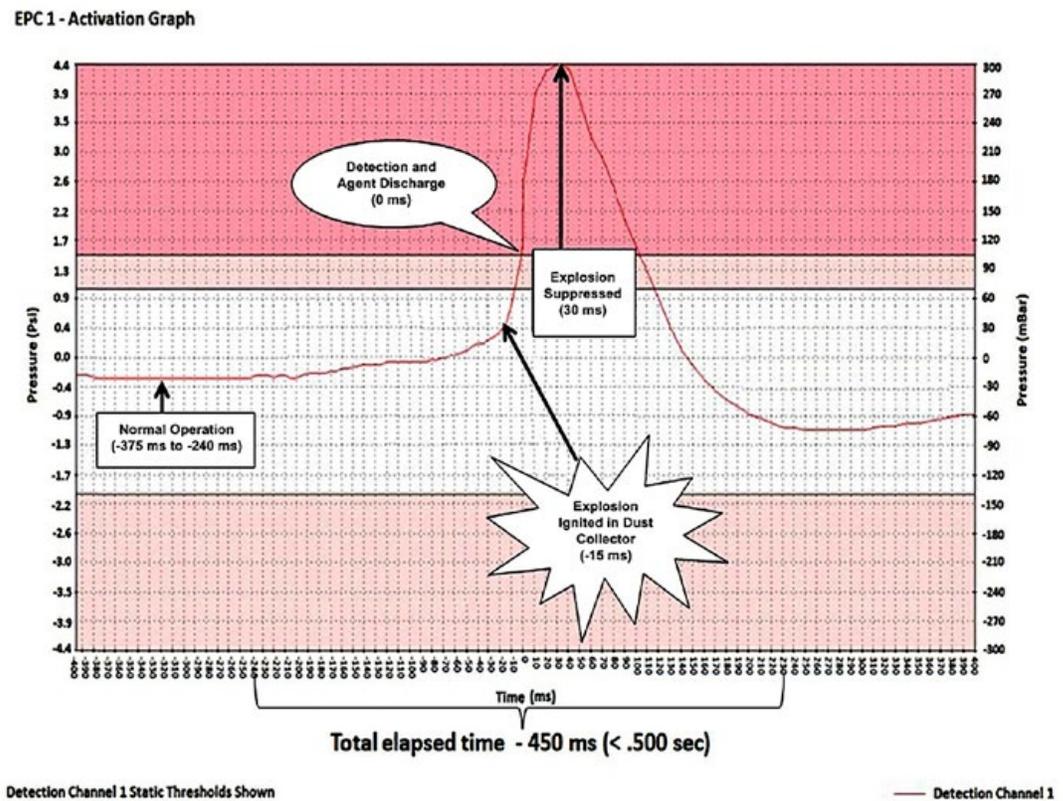
FIGURE 7

isolation canisters created a pressure spike of 4.4 pounds per square inch gauge (psig) in the dust collector and caused the flame front to propagate counter-current toward the mixing tanks. This rapid pressure rise (and the associated rapid flame propagation back through the ducting) triggered an initial flash fire at the bag dump station and within the rubberized ducts above T-306 (where the second and more volatile flash fire occurred). After the incident, the CSB learned that the design total suppression pressure (maximum design pressure for suppressed explosion) predicted for the dust collector was 3.8 psig. The increase in the total suppression pressure occurred because of the higher rate of pressure rise of the dust mixture compared to the expected design KST of 165 bar-meters per second (bar-m/sec).³⁷

Annotated Fike system pressure plot³⁹

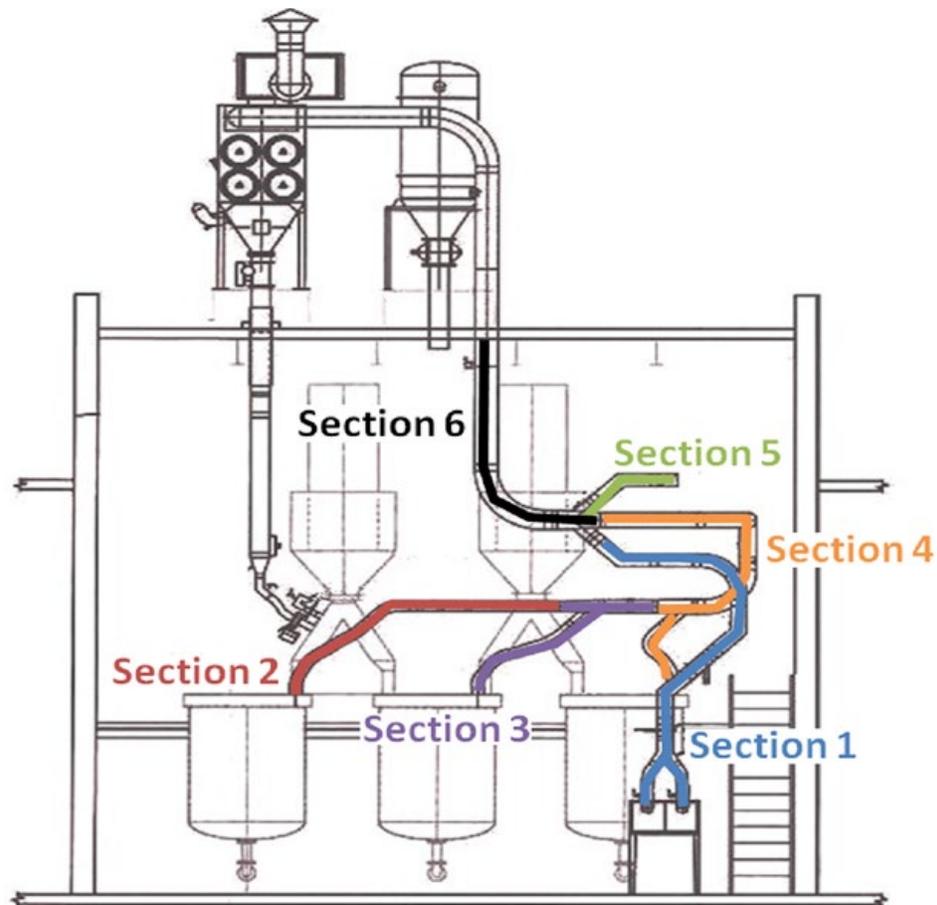
FIGURE 8

The CSB observed removal of the dust collection system ductwork in December 2012. Investigators collected residue samples from six sections of the entire ductwork system (shown in Figure 8). They inspected the interior of various ductwork sections and took material samples from inside the ducts. These inspections revealed large accumulations of black, burned, and unburned materials. Most of the accumulations appeared to be black sludge-like material. The CSB investigators collected samples of the sludge-like material for further chemical composition analysis and testing to develop possible ignition scenarios.

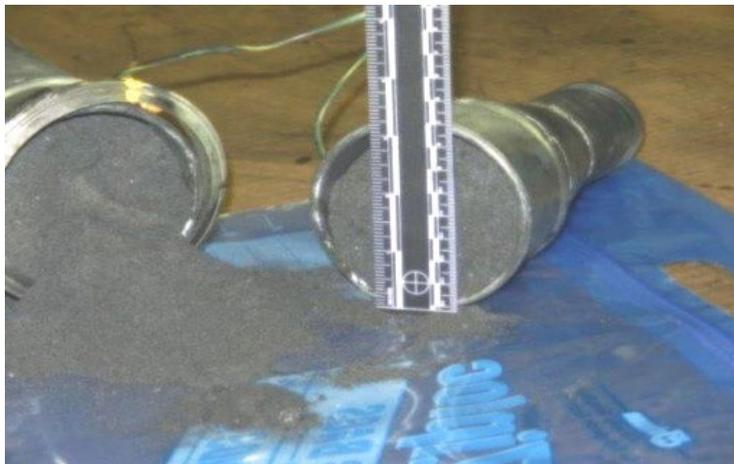
FIGURE 9

Vacuum cleaning ducts, plugged after less than 2 days of operation

The 3-inch ducts were disassembled during the investigation; they were plugged with free-flowing dust, a sign of insufficient conveying velocity (as illustrated in Figure 9). The connection of housekeeping hoses to a dust collection system is not a good practice because the pressure drop required to move air at 4,000 feet per minute (ft/

min) in the 1.5-inch hose (1.5 to 2.0 inches of mercury or 20 to 27 inches of water column) is much greater than the available system static pressure of 17 inches of water column. In addition, doubling the duct diameter reduced the air velocity to less than 25 percent of that available in the hose, plugging the 3-inch duct in less than 2 days of operation.
