Report No. 5005.0486A

**METALLURGICAL EVALUATION OF TANK COUPON T396-F/S9/10 FROM
FREEDOM INDUSTRIES, CHARLESTOWN, WEST VIRGINIA**

Customer Authorization: CSB2014-01-I-WV

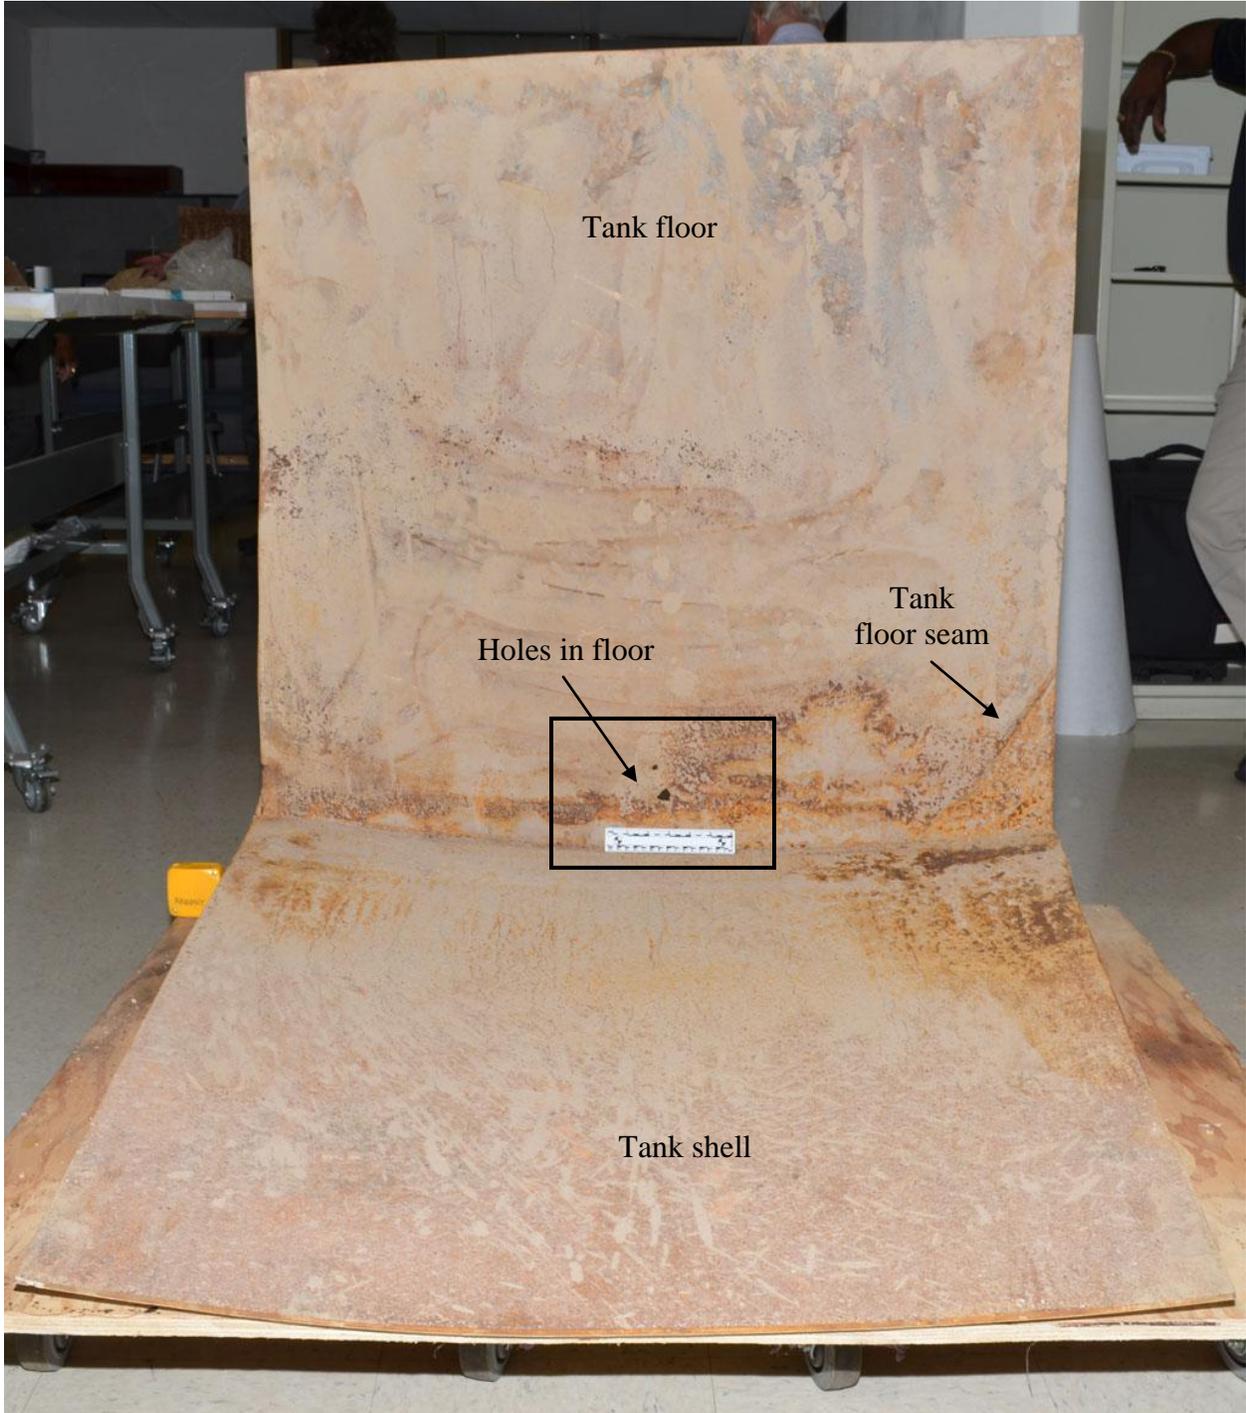
Figure 3 Photograph of the tank inside surface of the sample in the as-received condition after unpacking.

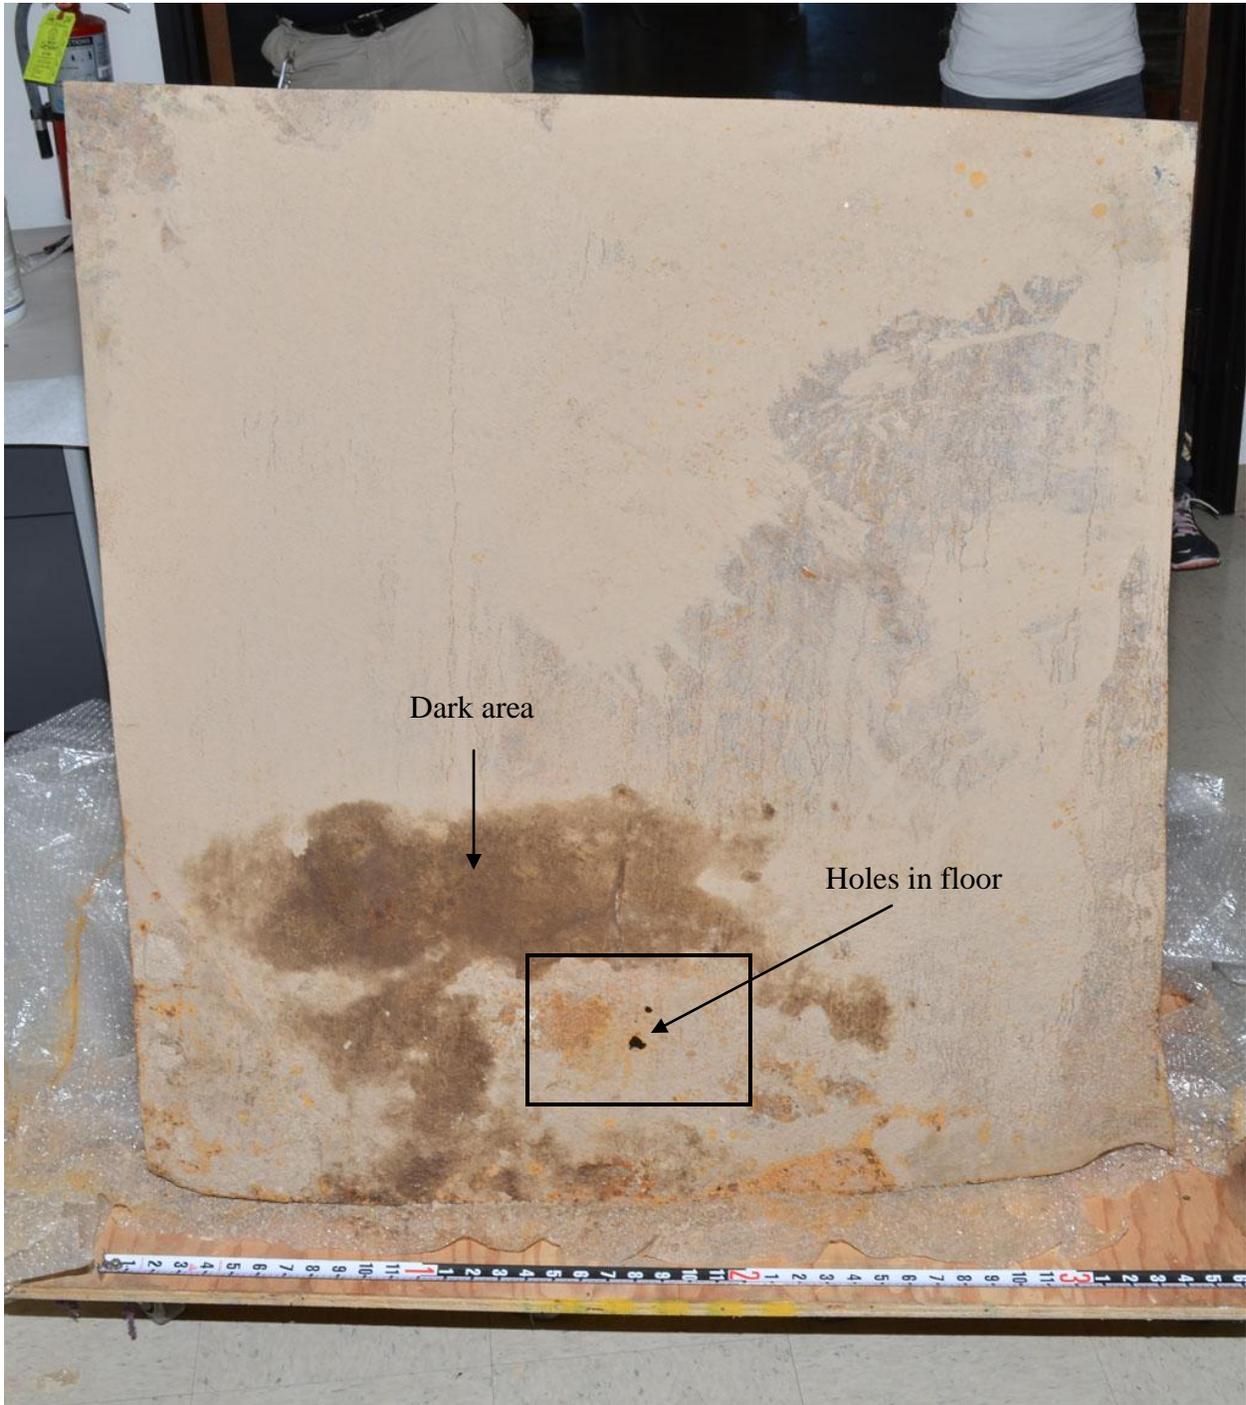
Figure 4 Photograph of floor soil side surface.

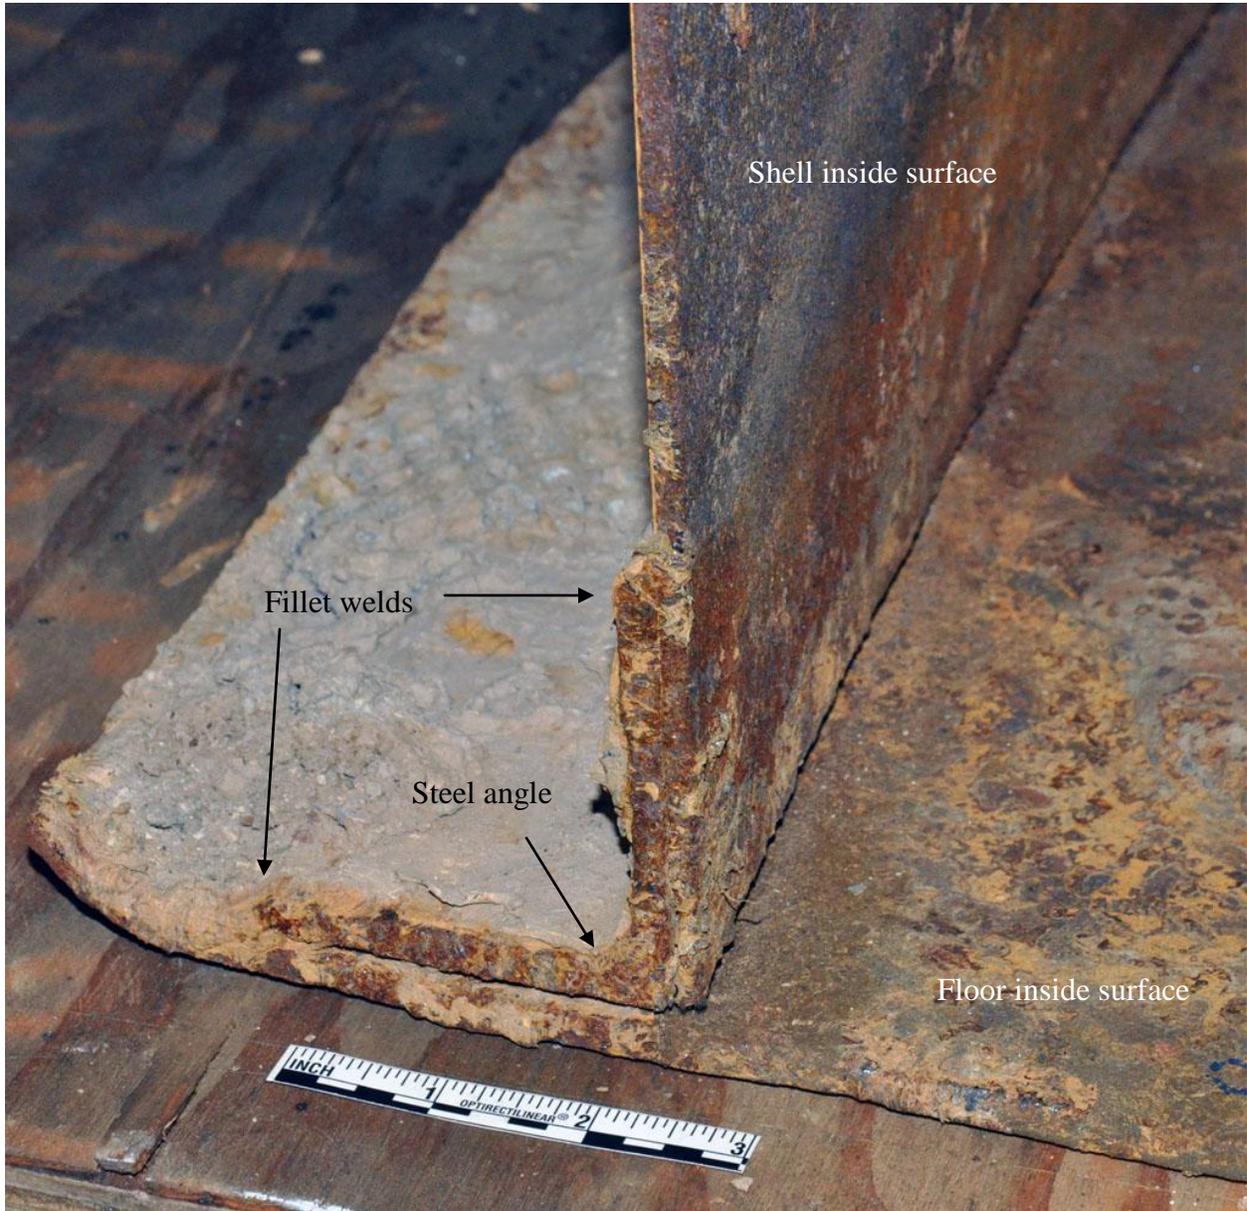
A light tan colored soil coated both the inside and outside surfaces of the sample as-received. It was reported that during water jet cutting of the tank, the local soil was unavoidably spread onto the sample. A photograph of the shell to floor joint is shown in Figure 5. The joint was completed with fillet welds along the top and outer edge of a steel angle as shown. A small section of welded lap joint between floor plates was present, but in this sample the majority of the floor was from a single plate, and all of the shell was from a single plate.

Figure 5 Photograph of the floor to wall welded joint.

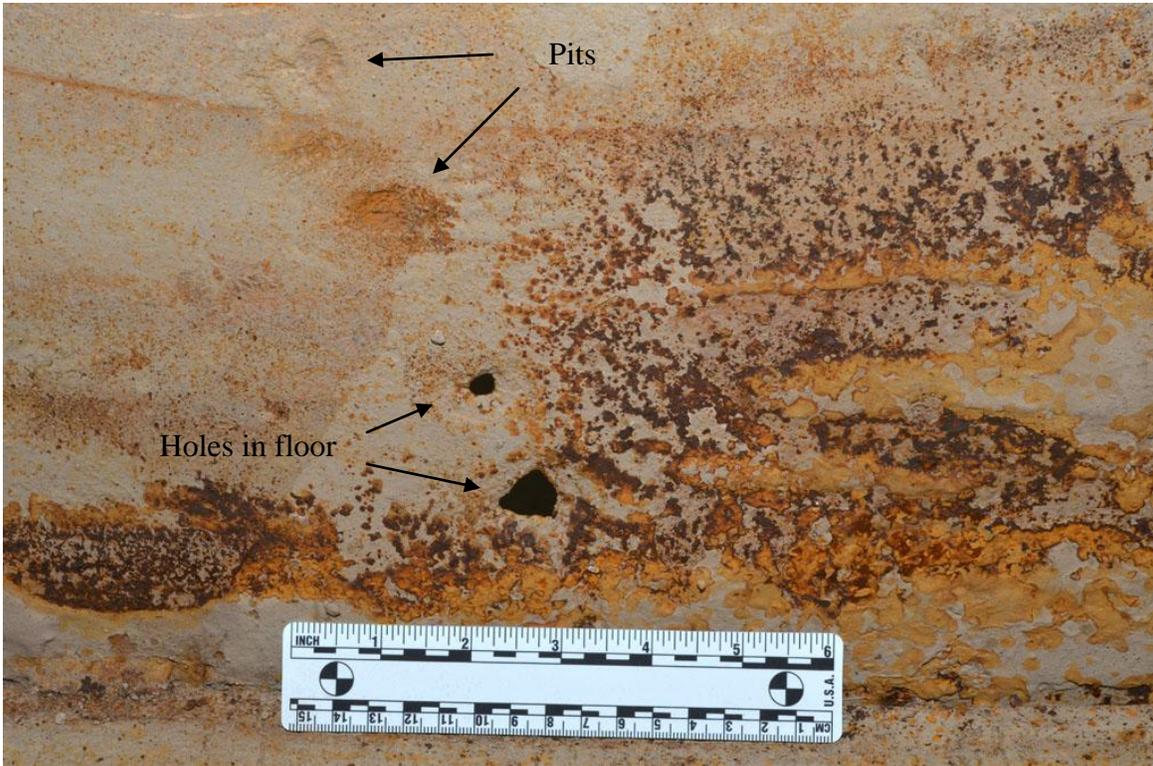
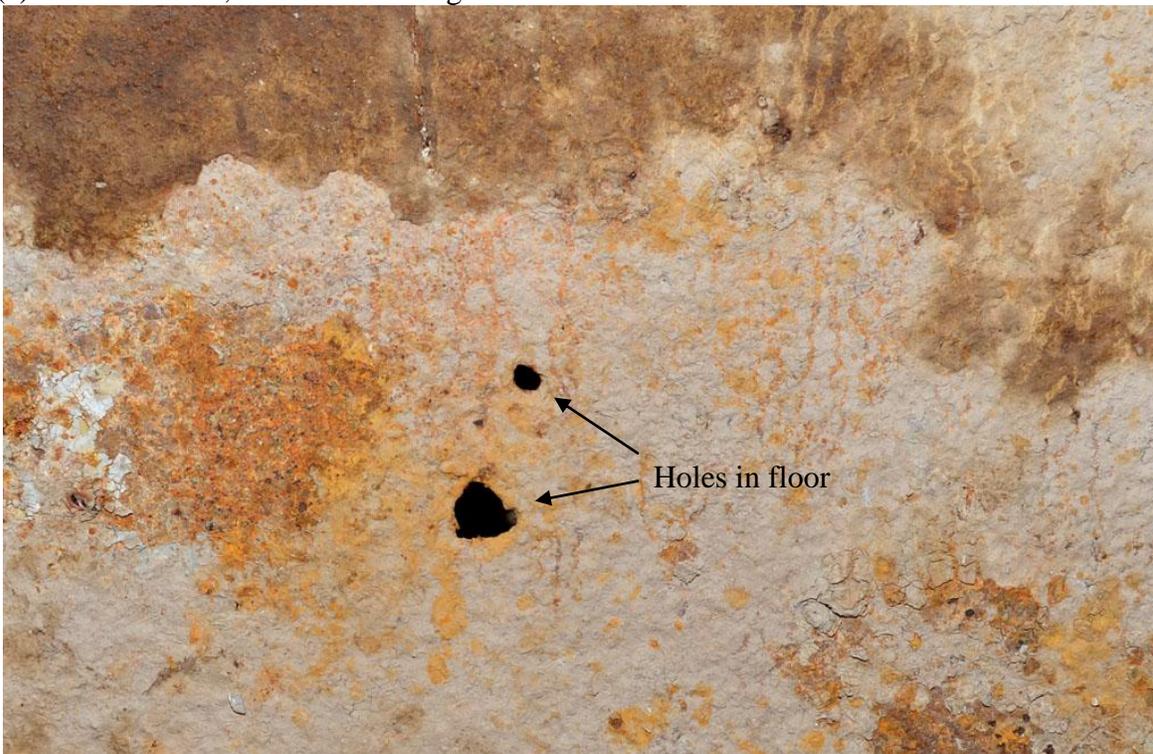
Holes in the floor are shown in Figure 6. On the inside surface, broad pits were visible next to the holes. Specimens of corrosion product and soil were extracted from the two larger pits onto carbon tape. A dark area was present on the floor soil side adjacent to the holes. The appearance of the dark area suggested the soil was saturated by a substance other than water.

(a) Inside surface, boxed area in Figure 3

(b) Soil side surface, boxed area in Figure 4

Figure 6 Photographs of the boxed areas in Figure 3 and Figure 4.

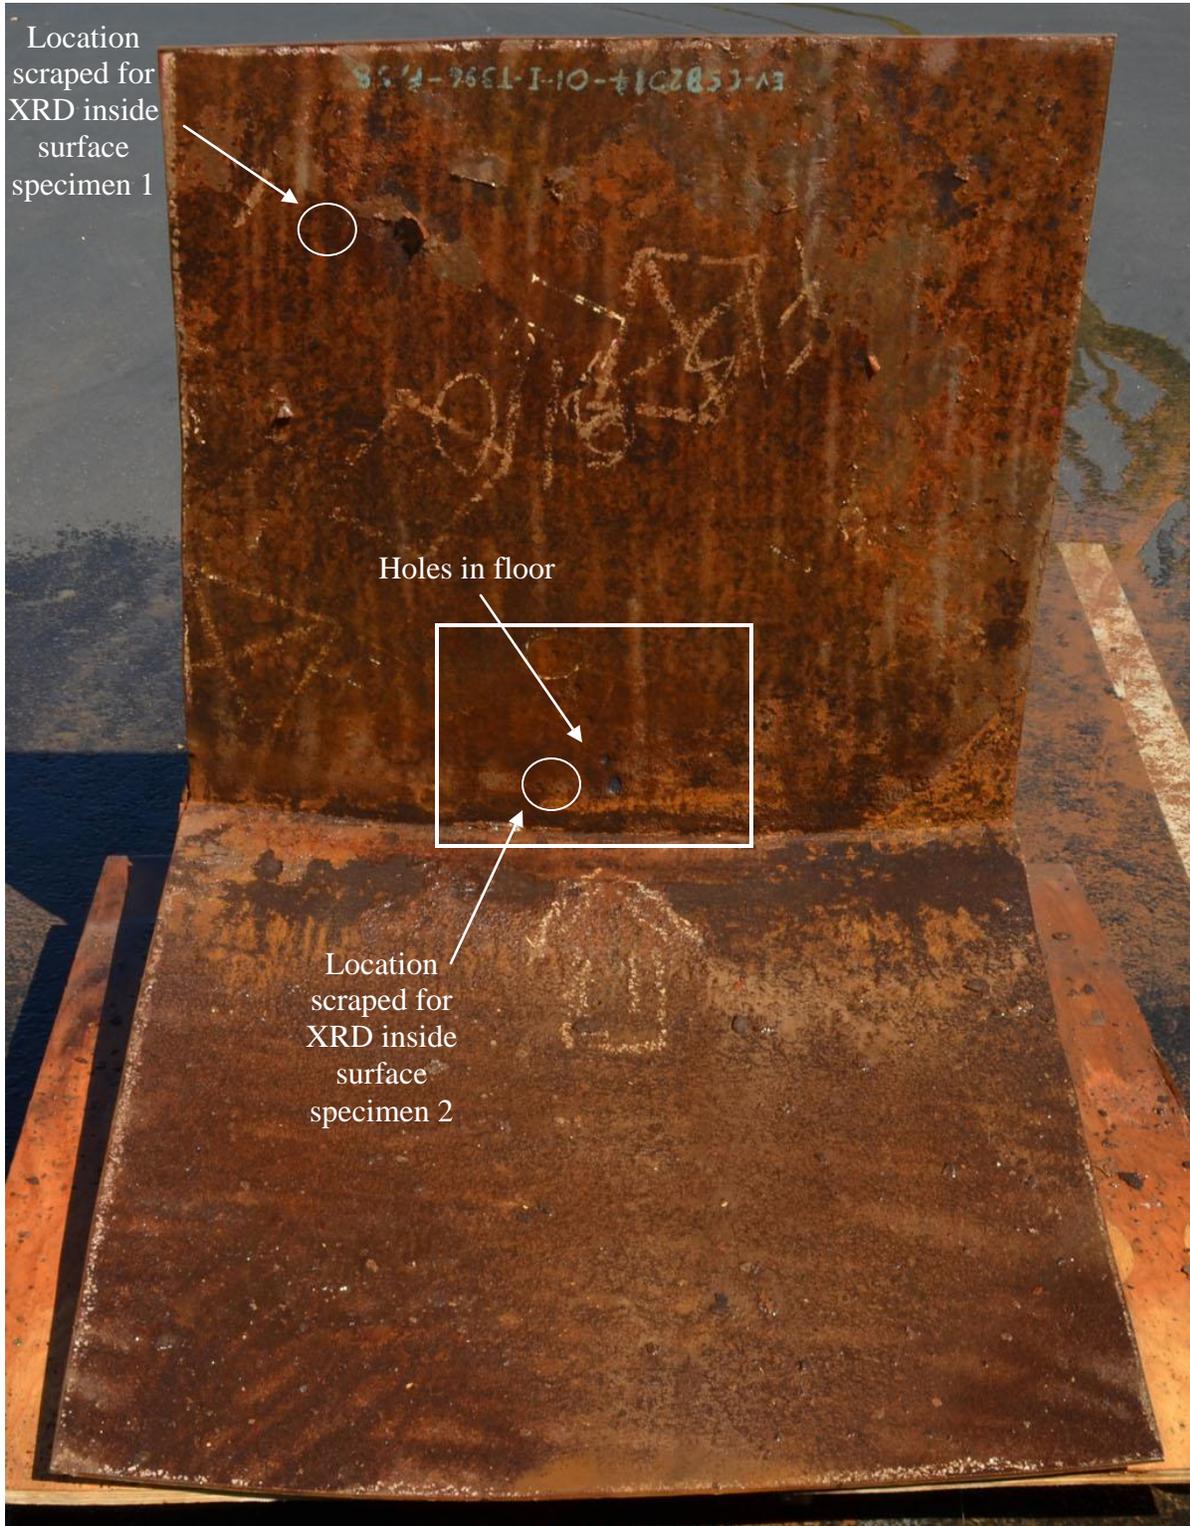
The sample was cleaned with tap water sprayed from a household pressure washer rated at 1900-psi. Care was taken to remove soil and loose rust, but retain corrosion product, particularly within pits. The sample is shown after washing in Figure 7 through Figure 10. Cleaning revealed shallow pits on the floor inside surface that had been obscured by dried soil, examples are indicated in Figure 9a. Three pits were located along an arc extending from the largest hole to the shallowest pit. The cause of this spatial relationship was not apparent based on the available evidence, although the arc was roughly aligned with the plate rolling direction, described in Section 2.6. Therefore, it is possible that the pits initiated along inclusion stringers at or near the steel surface. Based on the contour of the hole edges, the holes initiated on the inside surface as corrosion pits and grew toward the soil side. In general, the corrosion morphology was different on the inside and soil side surfaces. Inside surface morphology was characterized by fields of small pits that created a surface roughness similar to that found within the broad pits adjacent to and within the holes in the floor. Small areas of mill scale were present toward the sample side away from the shell. The soil side morphology was characteristic of general corrosion of carbon steel, with shallow pits and patches of mill scale away from the shell wall.

Figure 7 Photograph of the inside surface of the sample after cleaning. Notations written directly on the surface were made at the Freedom Industries incident site.

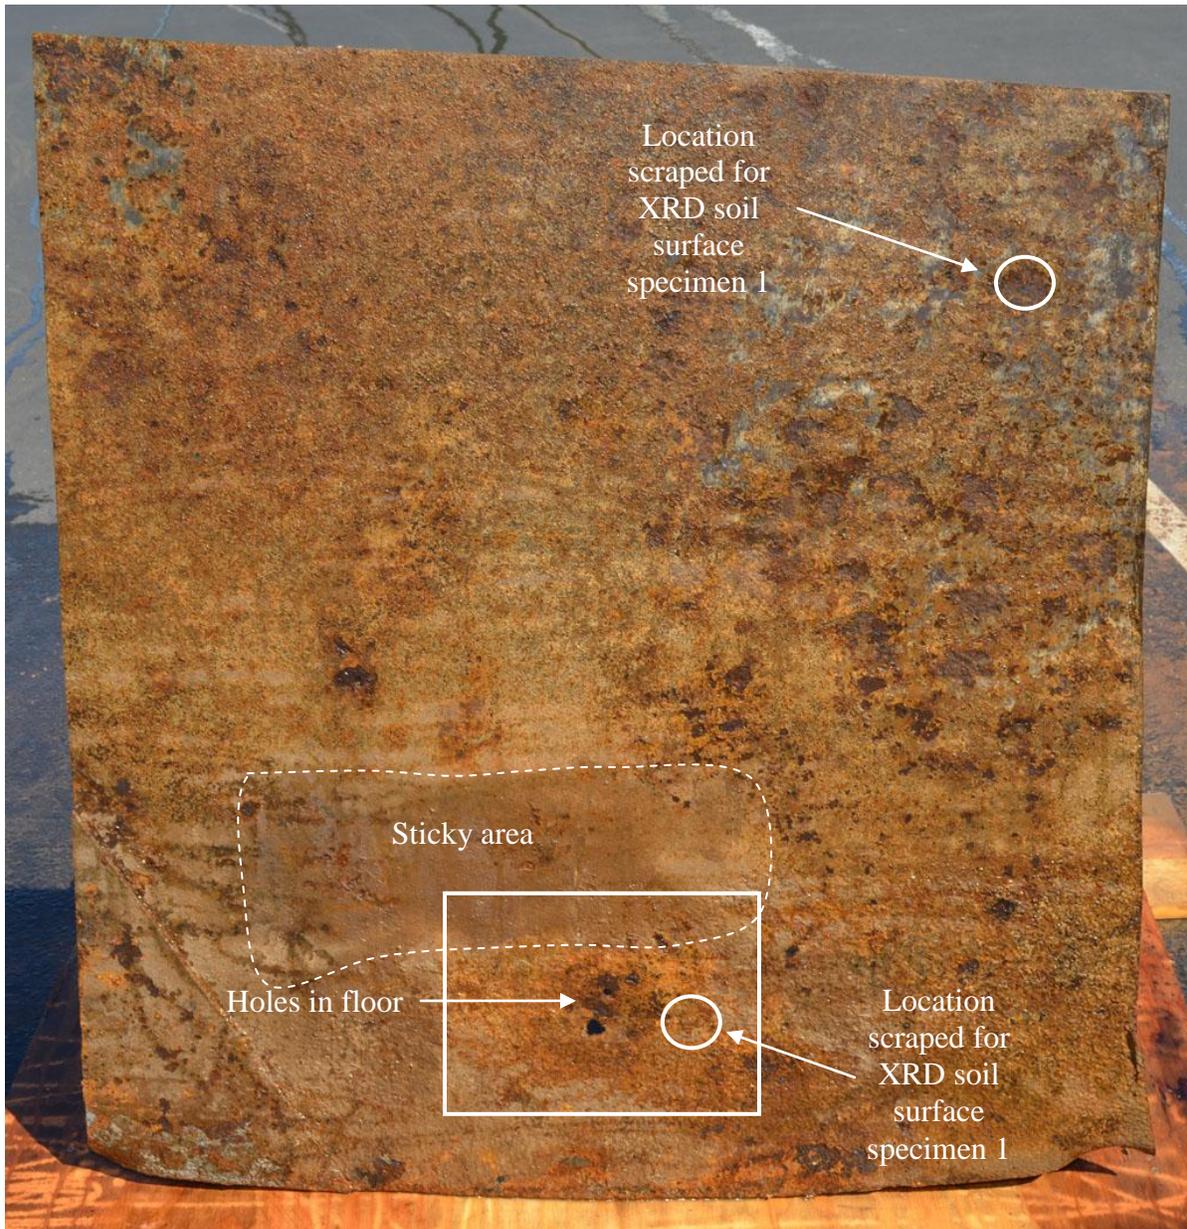
Figure 8 Photograph of the soil side surface of the sample after cleaning.

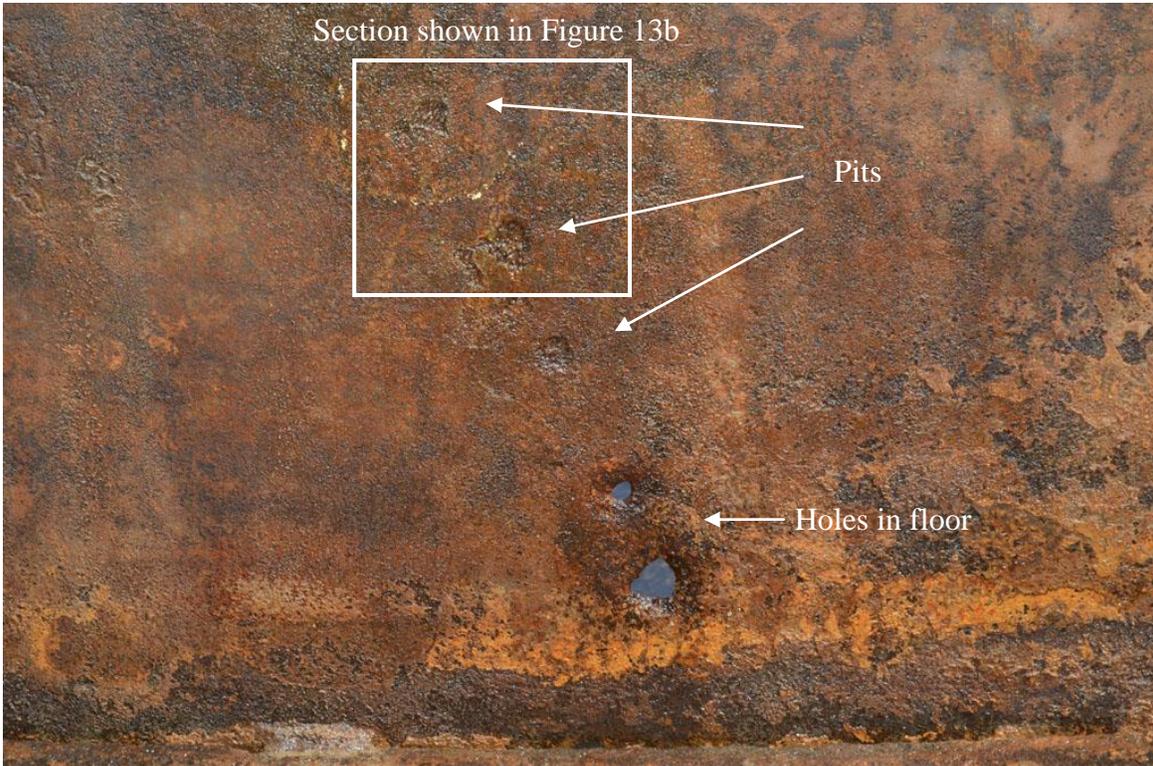
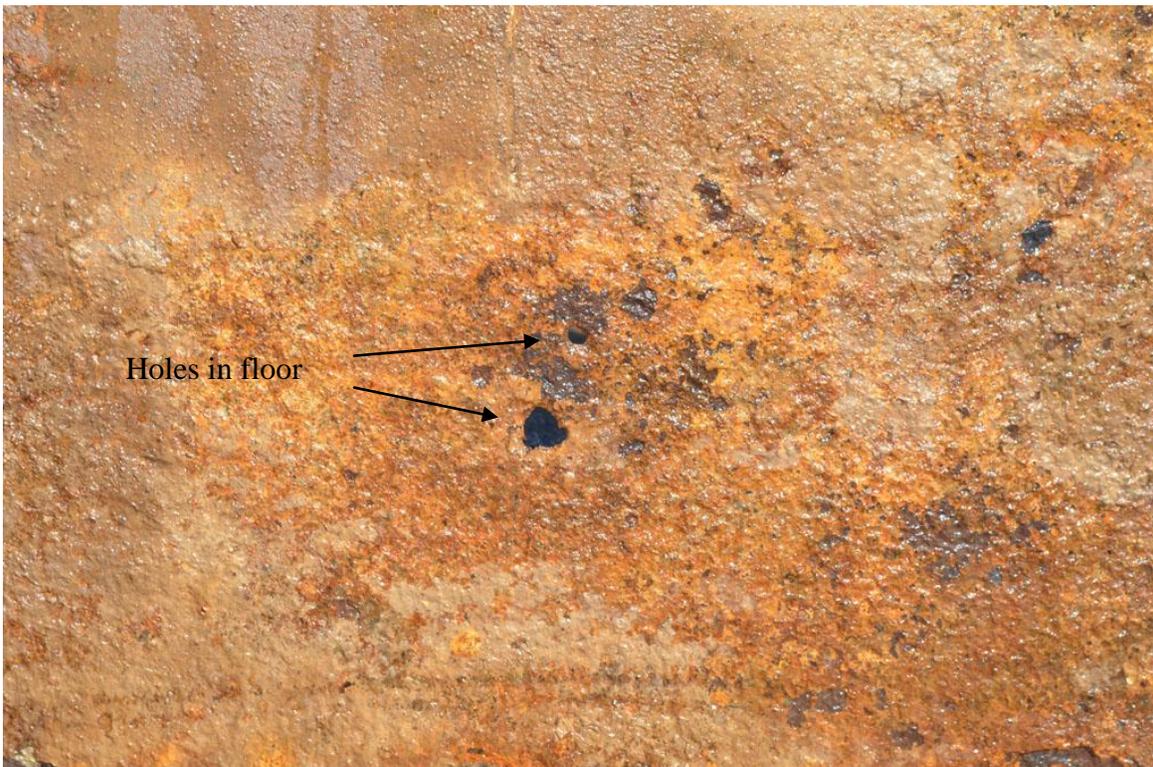
Figure 9 Photographs of the boxed areas in Figure 7 and Figure 8.

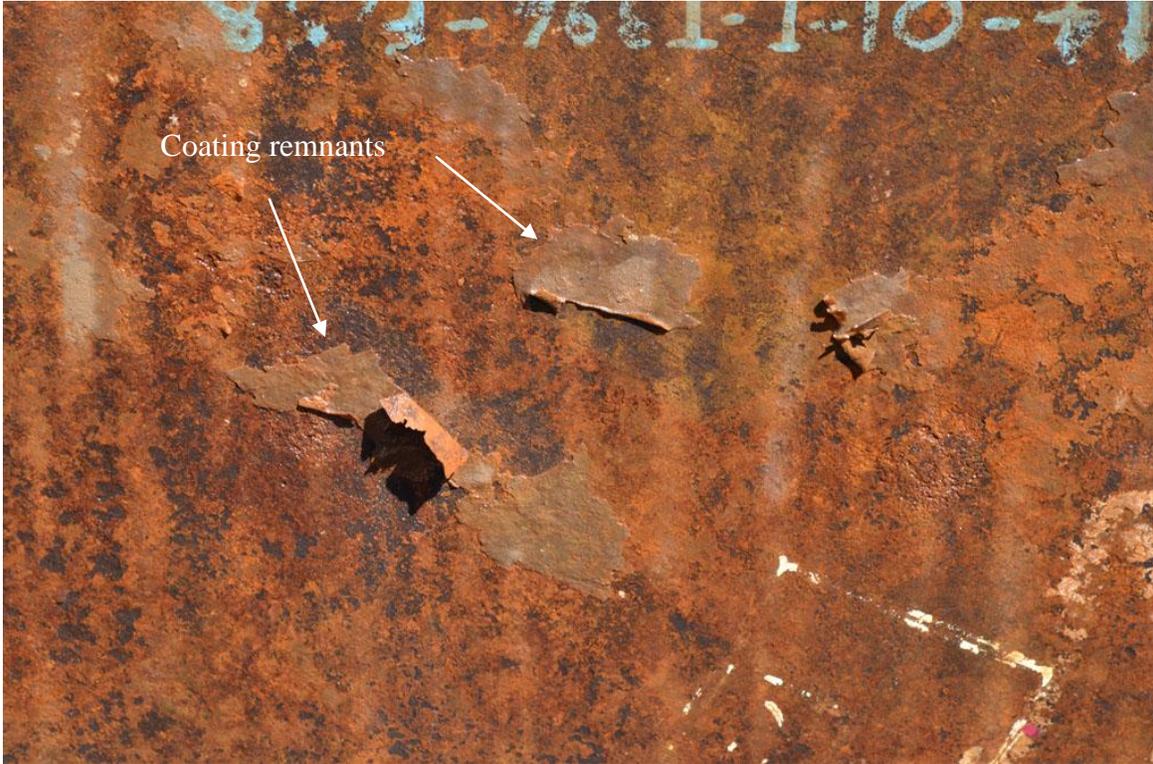
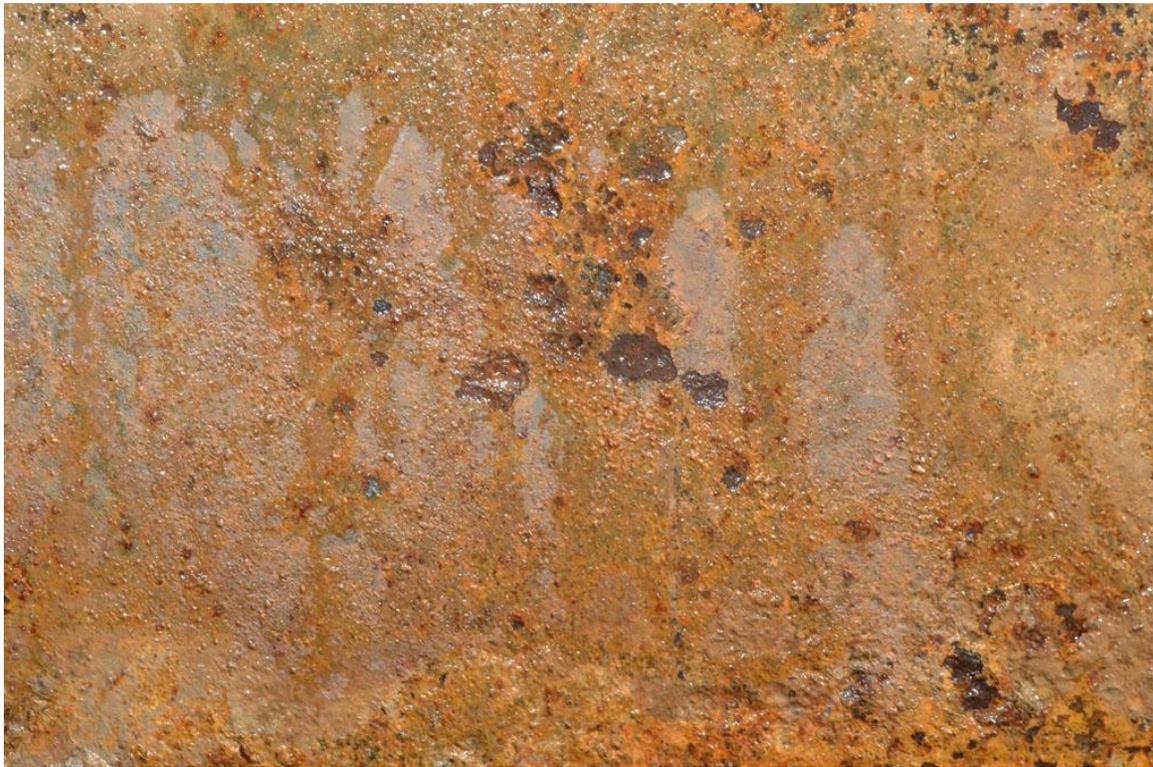
Remnants of a flexible organic coating were present on the floor inside surface, as shown in Figure 10a. Water was beading on the soil side dark area adjacent to the floor holes, and the surface of this area had a greasy, sticky feel. Specimens of the sticky surface and the organic coating were collected for chemical analysis. Analysis by infrared spectroscopy, described in Section 2.5, determined the inside surface coating to be a vinyl acetate and several possible matches were found for the sticky soil side specimen.

Figure 10 Photographs of (a) coating remnants on the floor inside surface and (b) sticky deposits on the floor soil side surface.

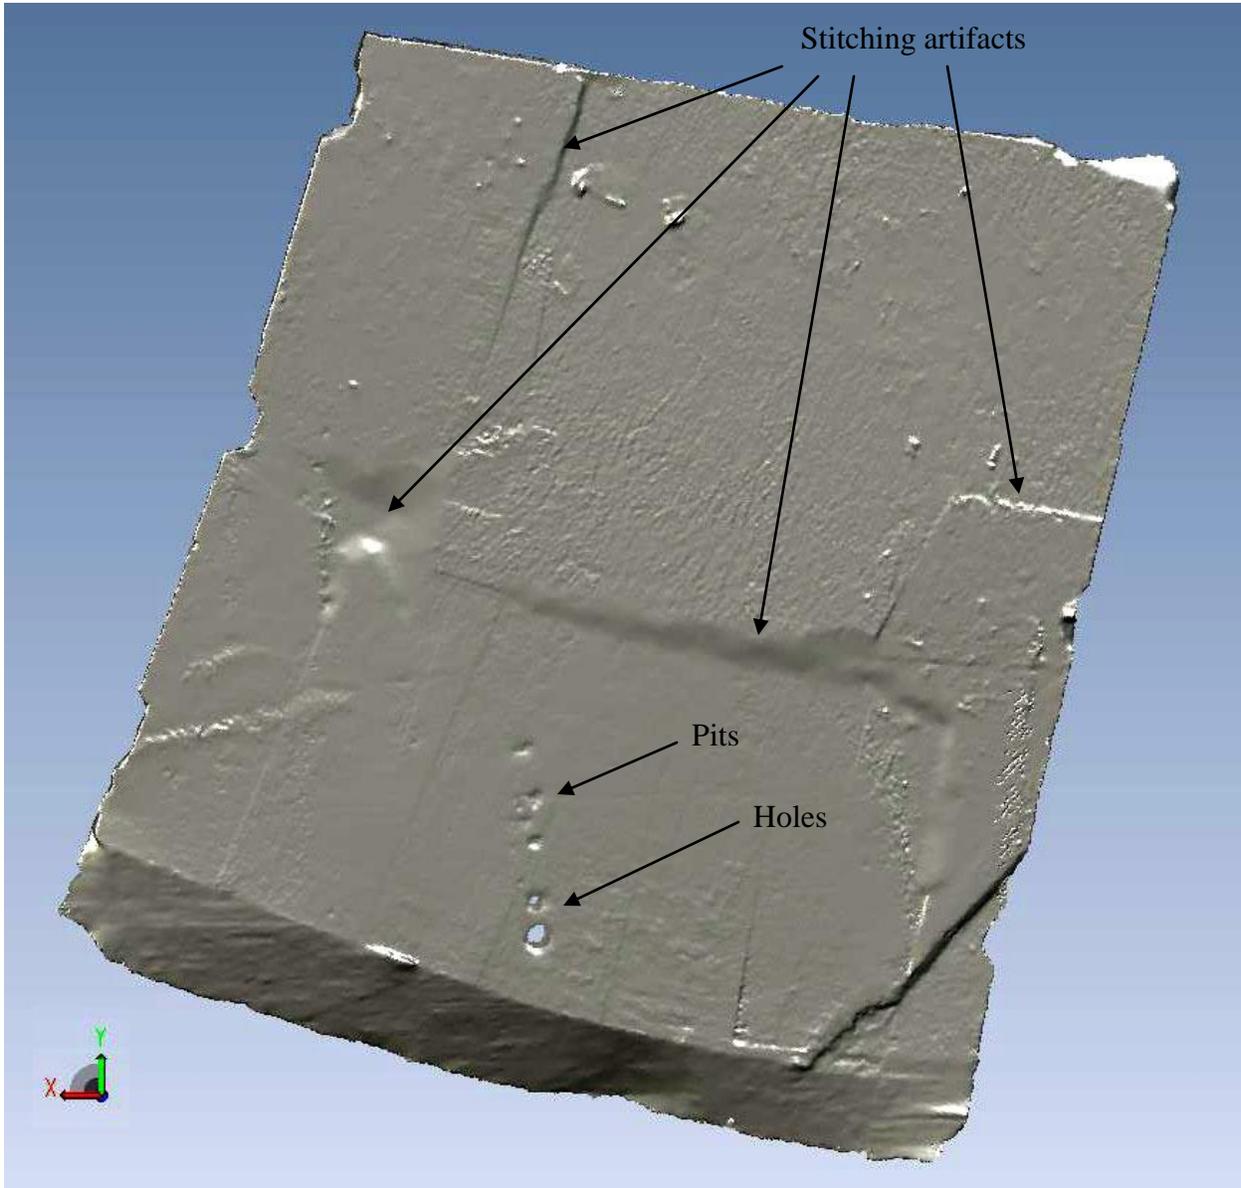
Laser scanning was performed on the washed sample to capture a point-cloud model of the floor geometry and surface features prior to sectioning. The laser scanning subcontractor was prepared to scan samples 10-inches by 10-inches in size, as described in the protocol, on a rotating stage. However, upon request, the subcontractor agreed to scan the entire floor section, with the understanding that digital stitching would be required to represent the entire floor portion of the sample because it was too large to fit on the rotating stage. A view of the three dimensional model of the floor inside surface is shown in Figure 11. Although some stitching artifacts were introduced, the general geometry and local detail around the holes and pits was captured.

Figure 11 Three dimensional model of the inside surface of the floor obtained from laser scanning.

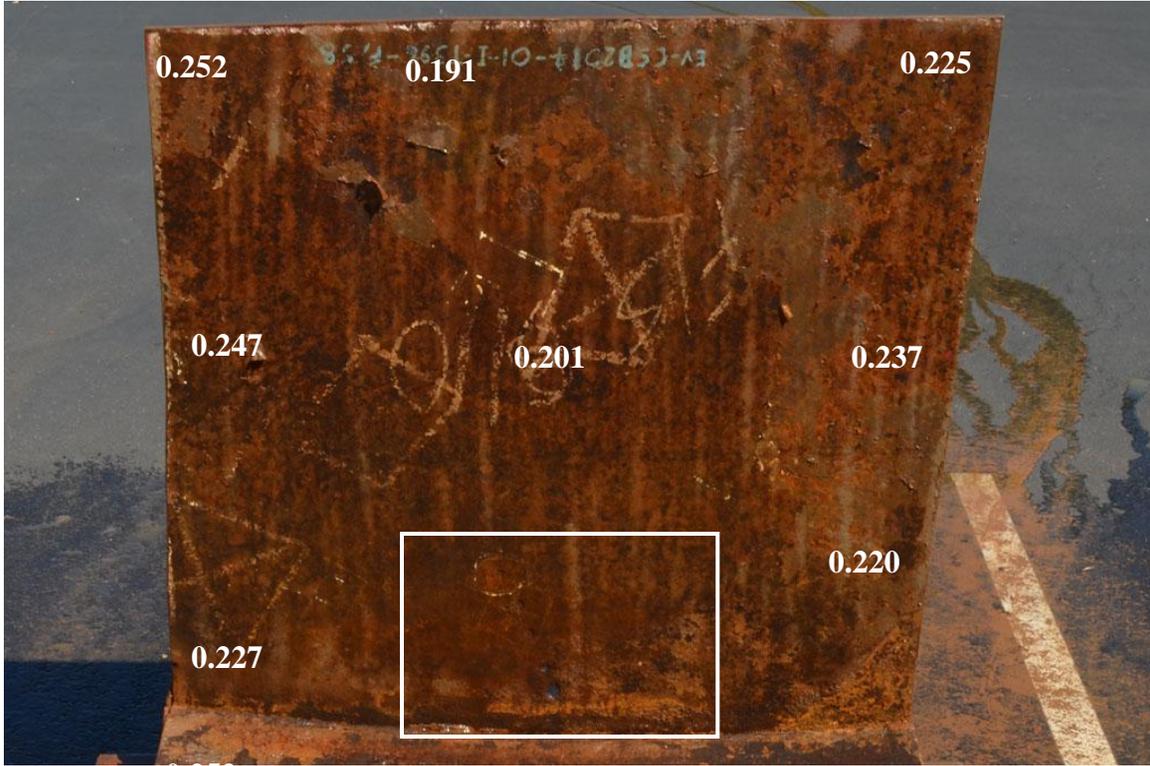
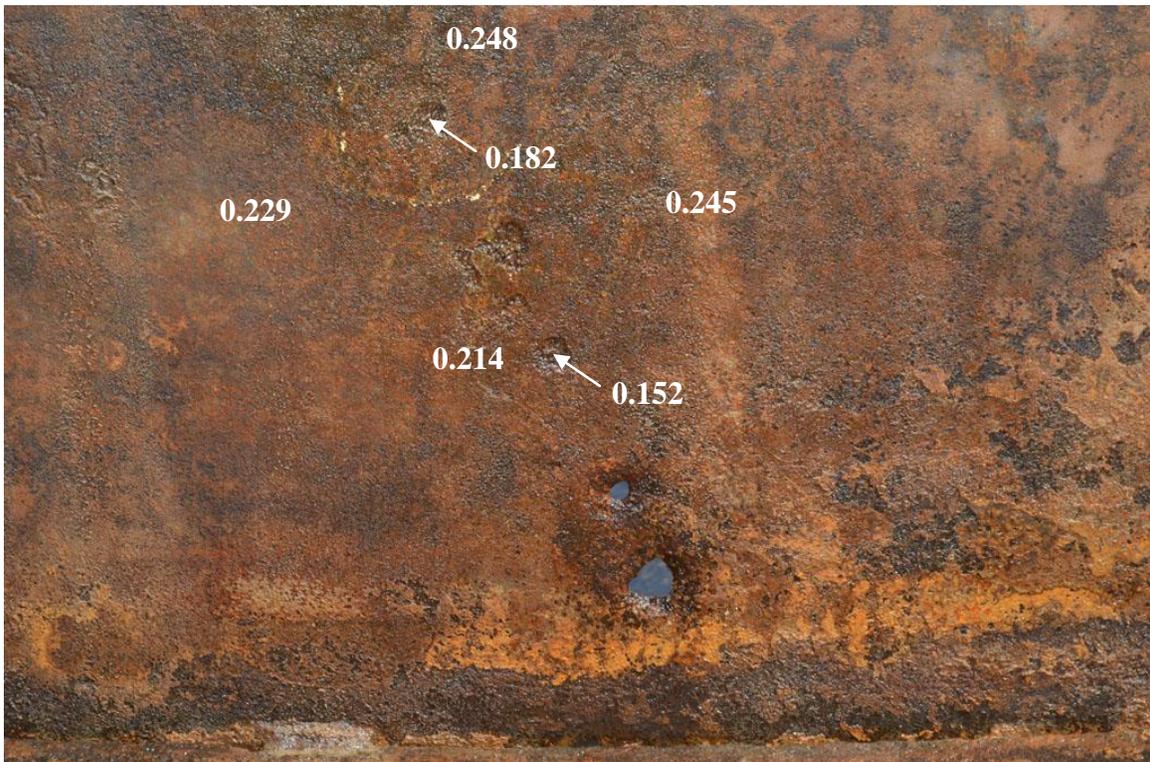
Thickness measurements were performed on the sample floor section using a pointed anvil micrometer after the floor had been sectioned. Measured thickness and general locations are indicated in Figure 12.

Figure 12 Photographs of the floor with thickness measurements annotated. The measurements were made after the sample had been sectioned as shown in Figure 13a.

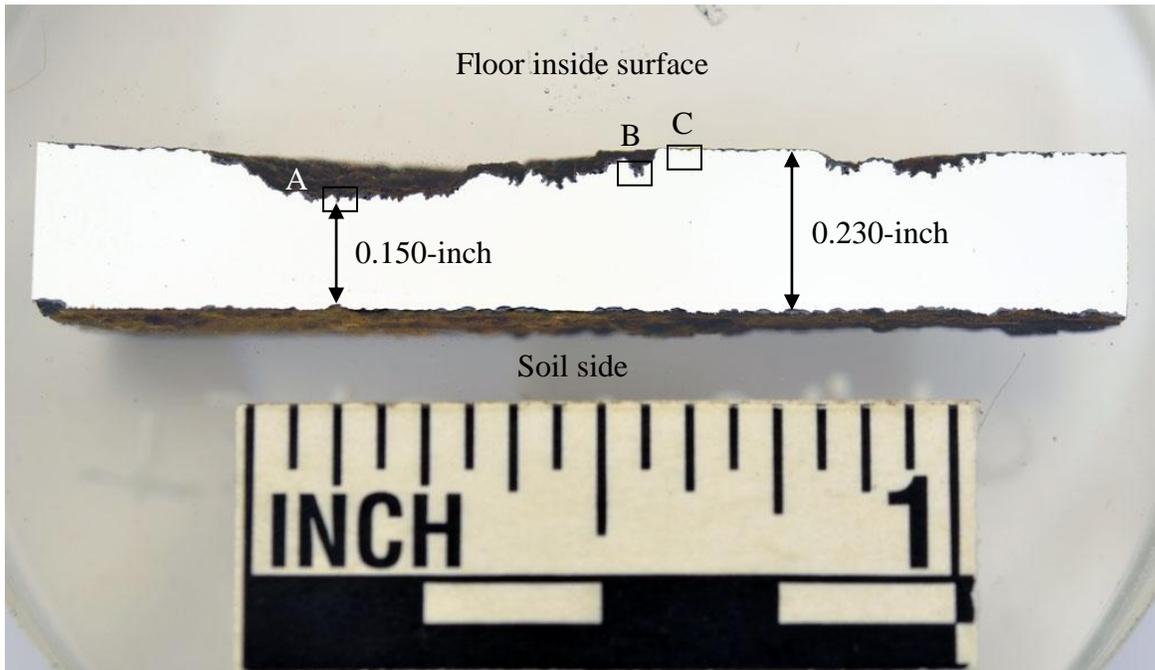
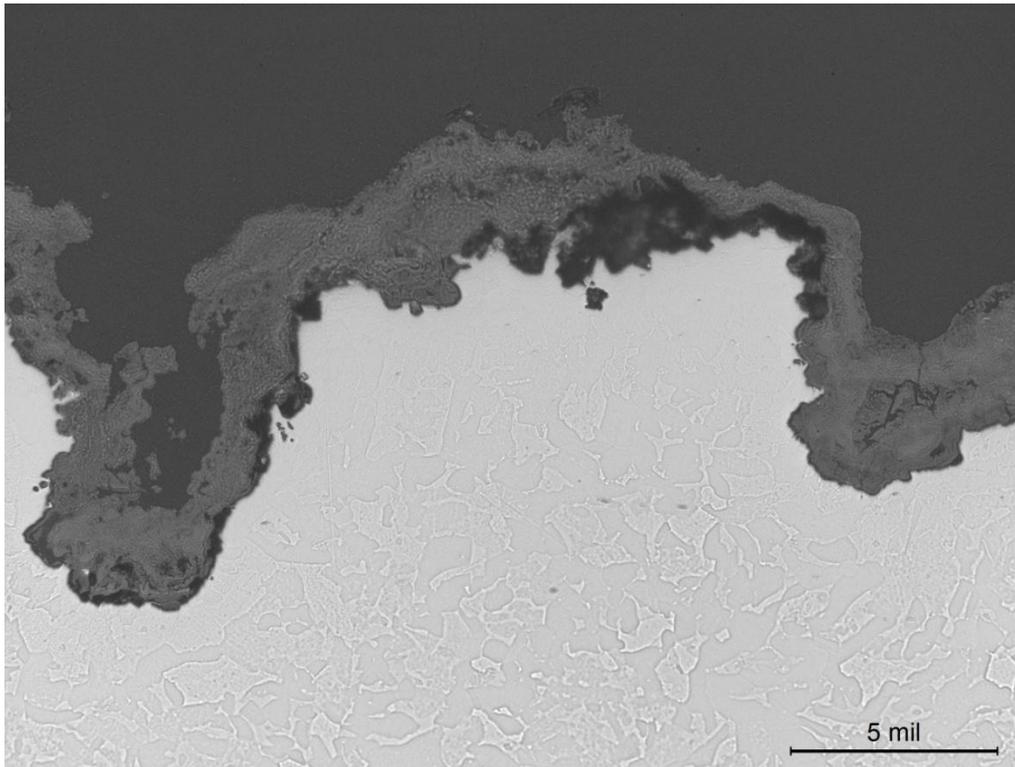
Specimens were prepared for metallography from the floor sections indicated in Figure 13. The specimen labeled floor pit is shown as-polished in Figure 14. This sample illustrated the general differences between inside surface and soil side surface corrosion morphology. Within the broad pits on the inside surface, corrosion advanced in cells of localized attack, as shown in Figure 14 and Figure 15.

1. Holes in the floor of Tank 396 were caused by pitting corrosion that initiated on the inside surface and propagated toward the soil side.
2. Remnants of a vinyl acetate coating were present on the inside surface of the floor of Tank 396.
3. The floor of Tank 396 met the chemical composition requirements of a range of carbon steels commonly used for welded steel storage tanks.
4. The floor of Tank 396 met the tensile requirements of a range of carbon steels commonly used for welded steel storage tanks.

(a) Specimen floor pit

(b) Boxed area A in (a)

Figure 14 Photograph and micrograph of the floor pit specimen, as-polished.

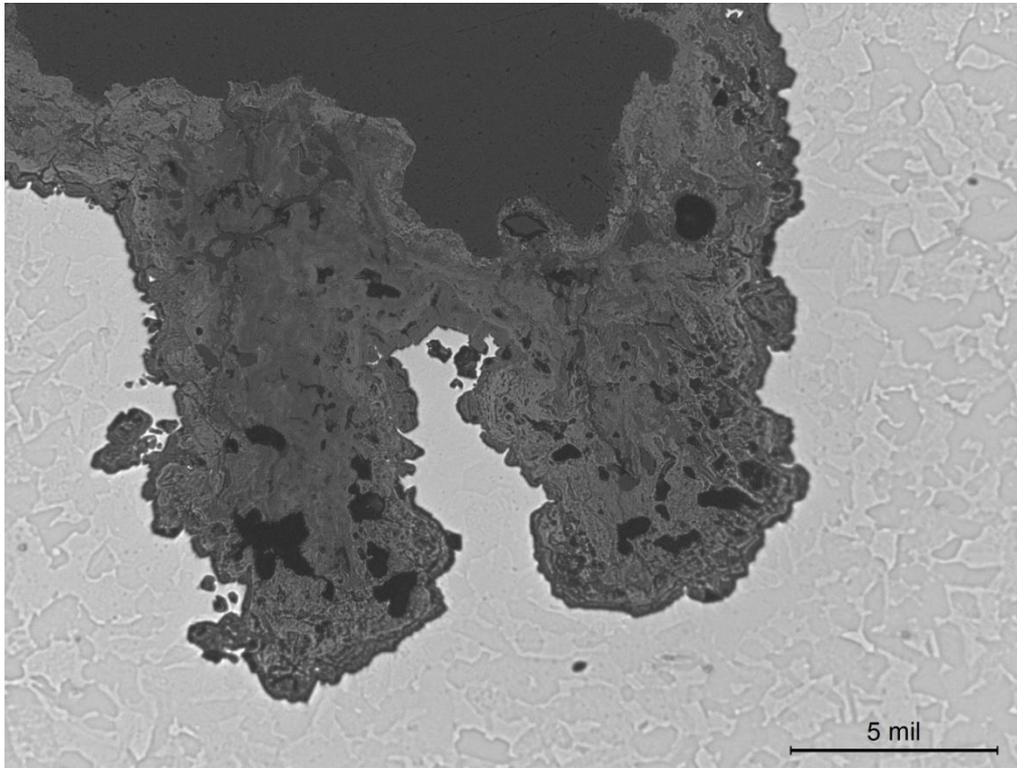
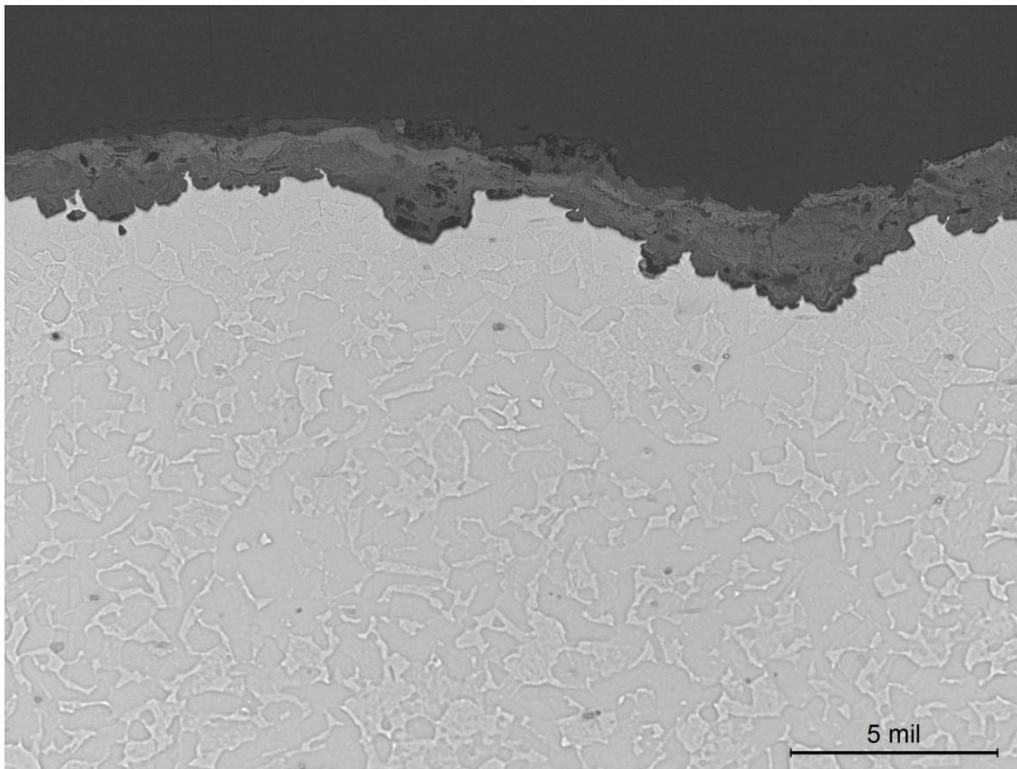
Figure 15 Optical micrographs of the floor pit specimen.
