Report No. 5005.0486A

**METALLURGICAL EVALUATION OF TANK COUPON T396-F/S9/10 FROM
FREEDOM INDUSTRIES, CHARLESTOWN, WEST VIRGINIA**

Customer Authorization: CSB2014-01-I-WV

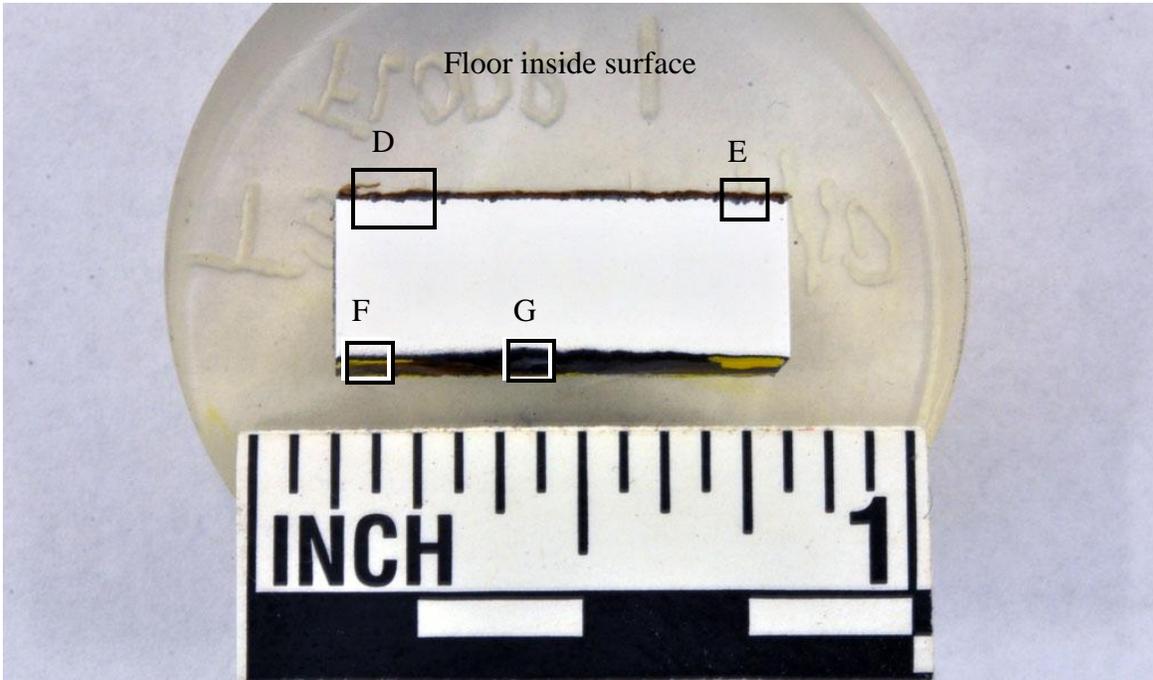
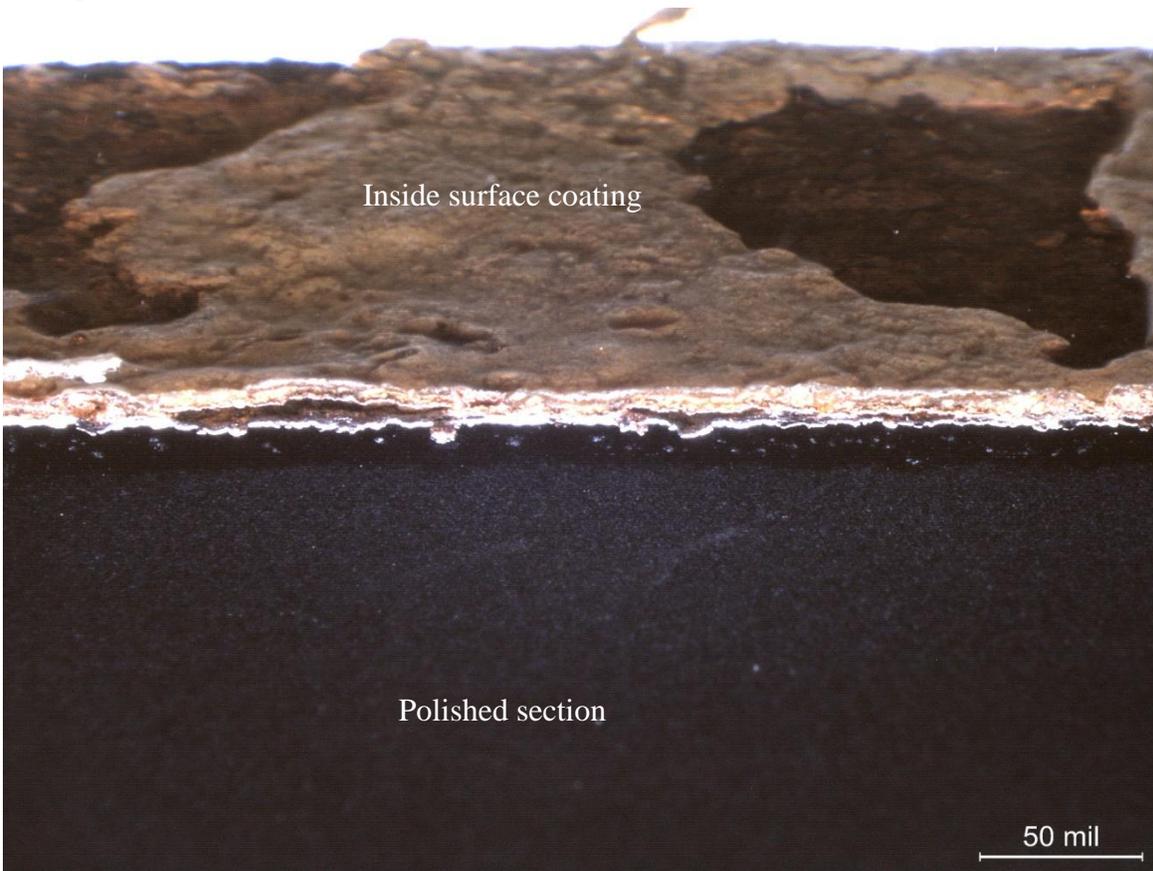
A specimen labeled floor 1, shown in Figure 16, was prepared from a section through an area of remnant inside surface coating. In cross section, the outer layers of the coating were an opaque light tan color and an inner layer was a translucent amber color, shown in Figure 17a. Significant erosion of the outer layer during polishing indicated water solubility, consistent with the flexibility of specimens pulled from the surface immediately after washing and subsequent stiffness of the specimens after drying. Corrosion product was present beneath the coating, shown in Figure 17b. Examples of mill scale on the floor 1 specimen soil side surface are shown in Figure 18 and Figure 19. In some regions, mill scale was closely adhered to the soil side, and in others, under scale corrosion had separated the scale from the steel surface.

Figure 16 Photograph and macrograph of specimen floor 1. In (b) the specimen is viewed at an oblique angle to show the inside surface and the as-polished section.

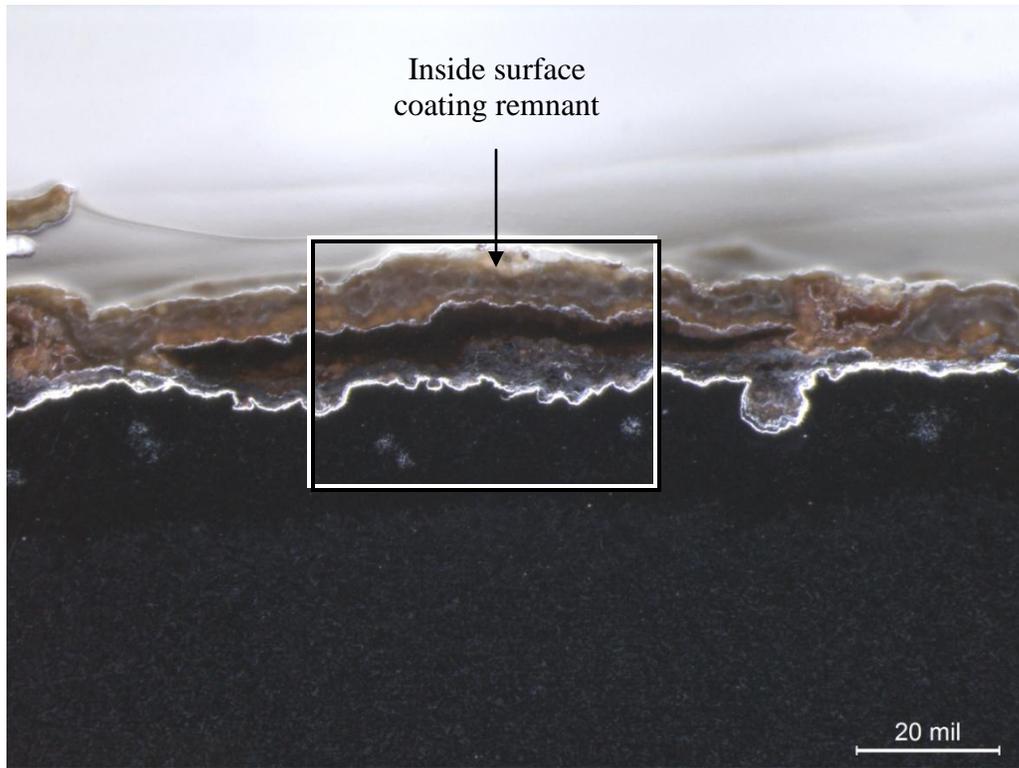
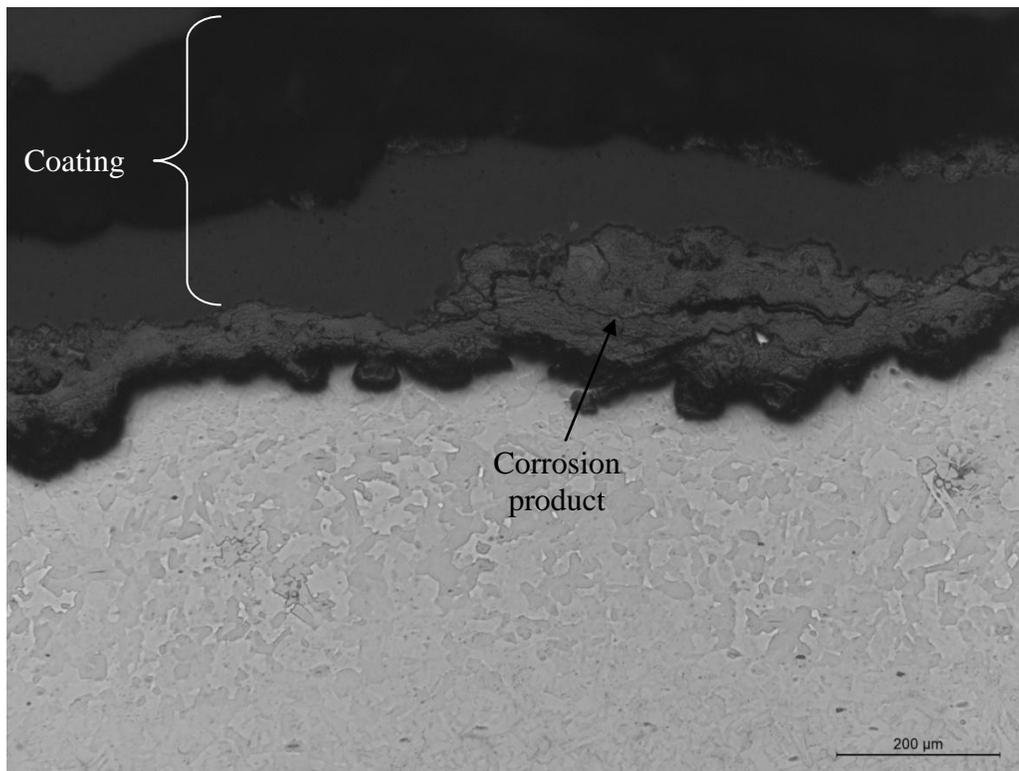
Figure 17 Macrograph and micrograph of specimen floor1 from the boxed area E in Figure 16a.

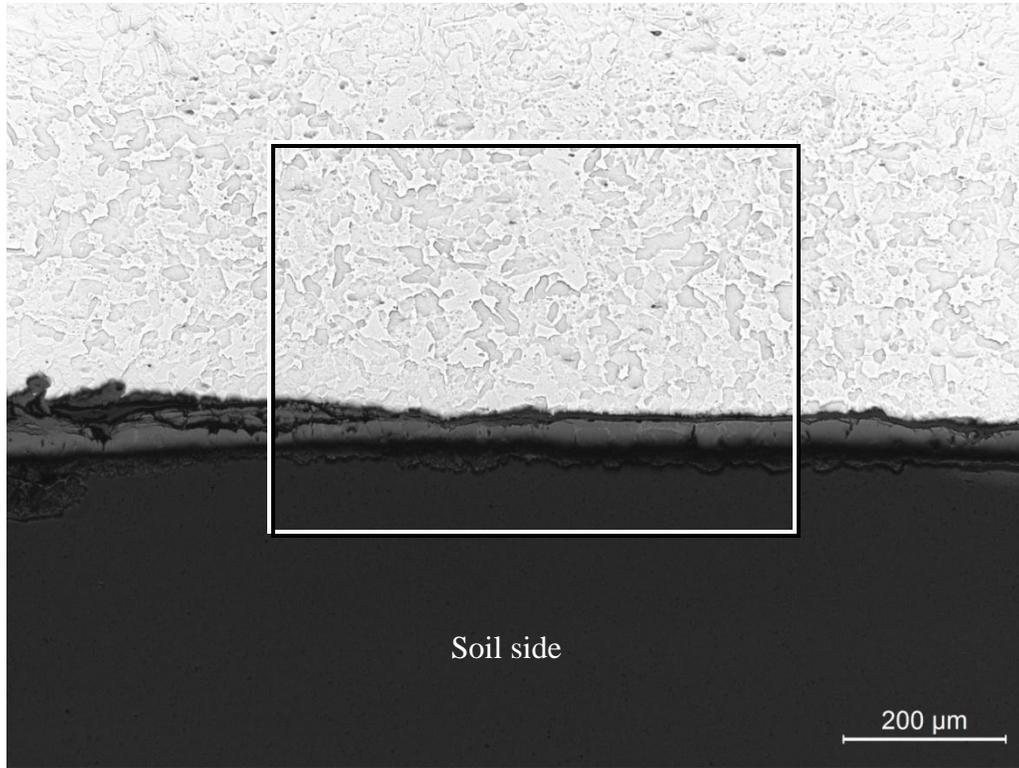
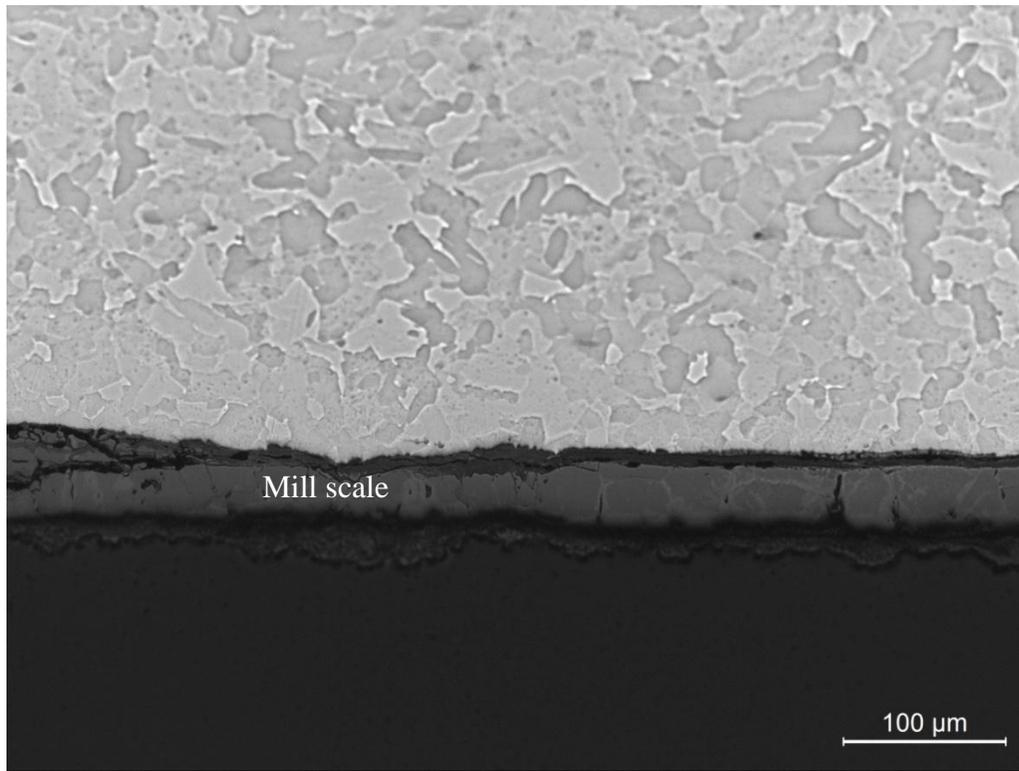
Figure 18 Optical micrographs of the floor 1 specimen from the boxed area F in Figure 16a.

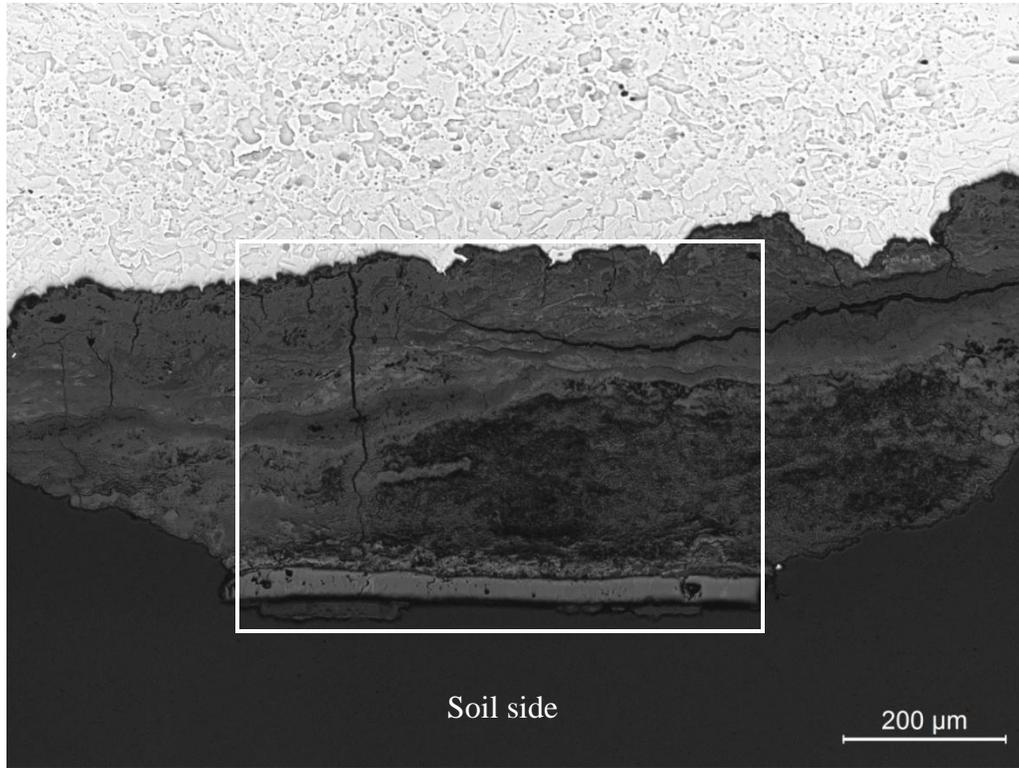
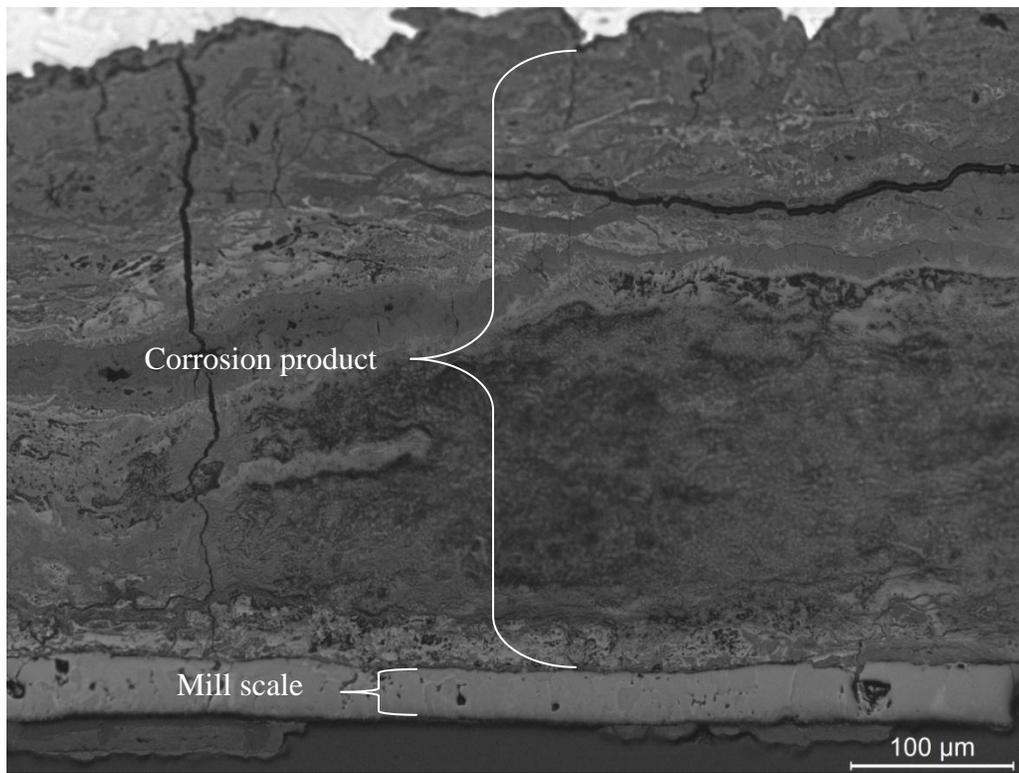
Figure 19 Optical micrographs of the floor 1 specimen the boxed area G in Figure 16a.

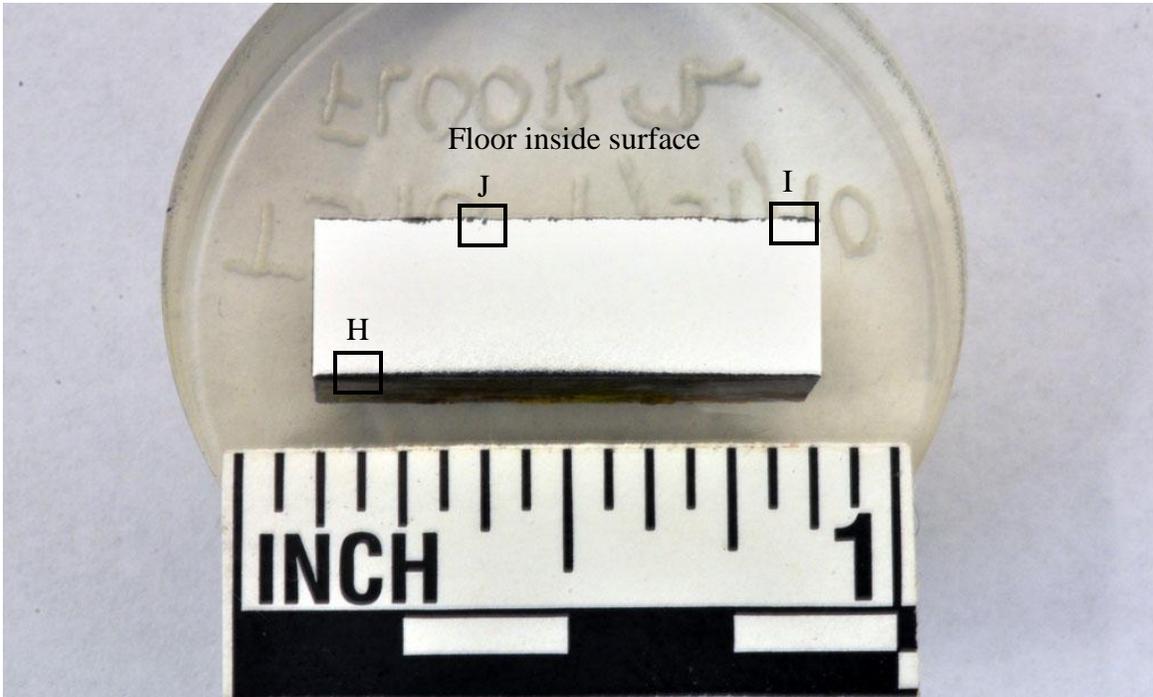
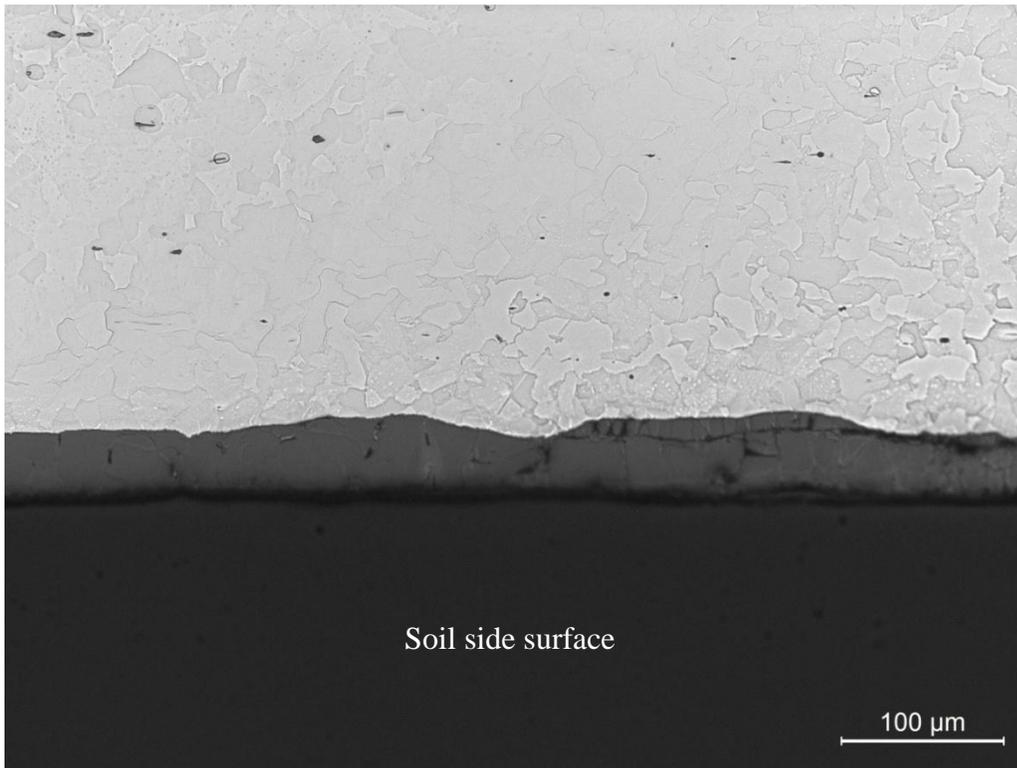
A specimen labeled floor 2, shown in Figure 20a, was prepared through a section through mill scale on the soil side surface. As shown in Figure 20b, some regions of tightly adhered mill scale were present. Examples of inside surface corrosion similar to other areas of the floor are shown in Figure 21.

Figure 20 Photograph and optical micrograph of specimen floor 2, as-polished.

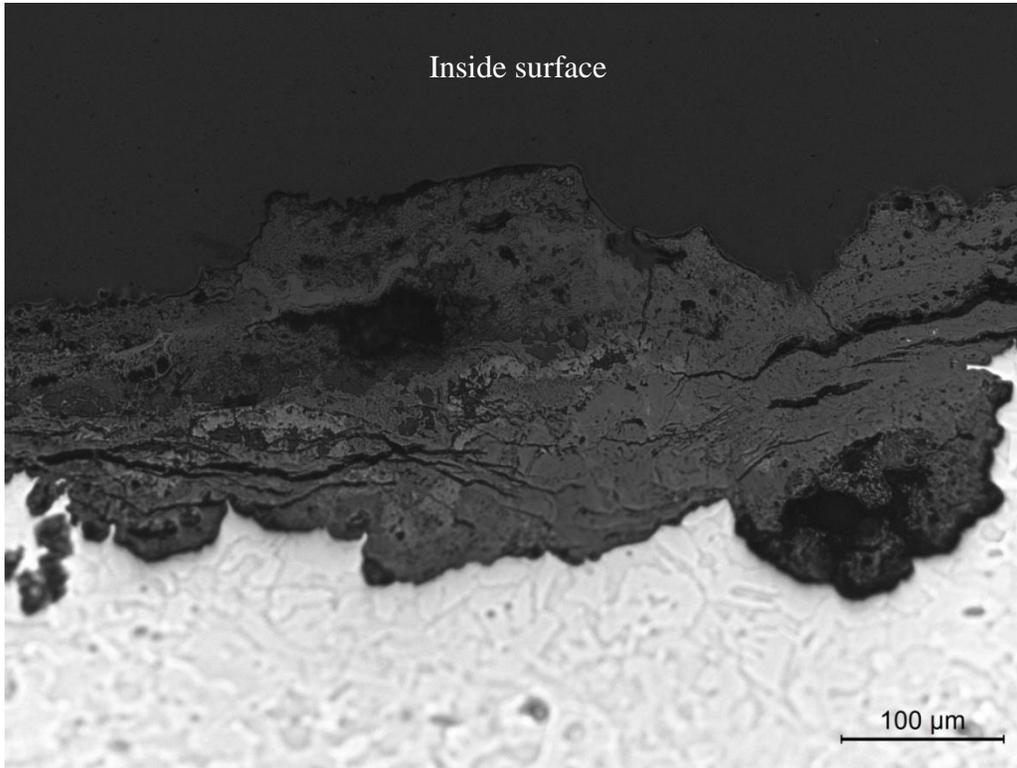
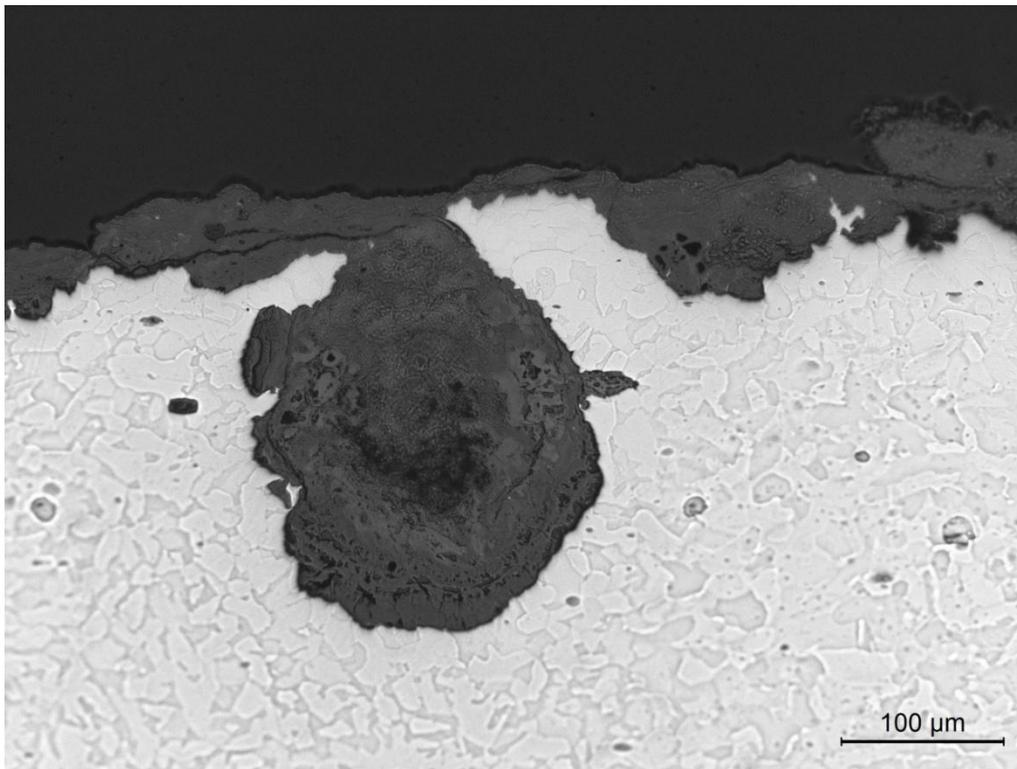
Figure 21 Optical micrographs of specimen floor 2 from the boxed areas I and J in Figure 20a.

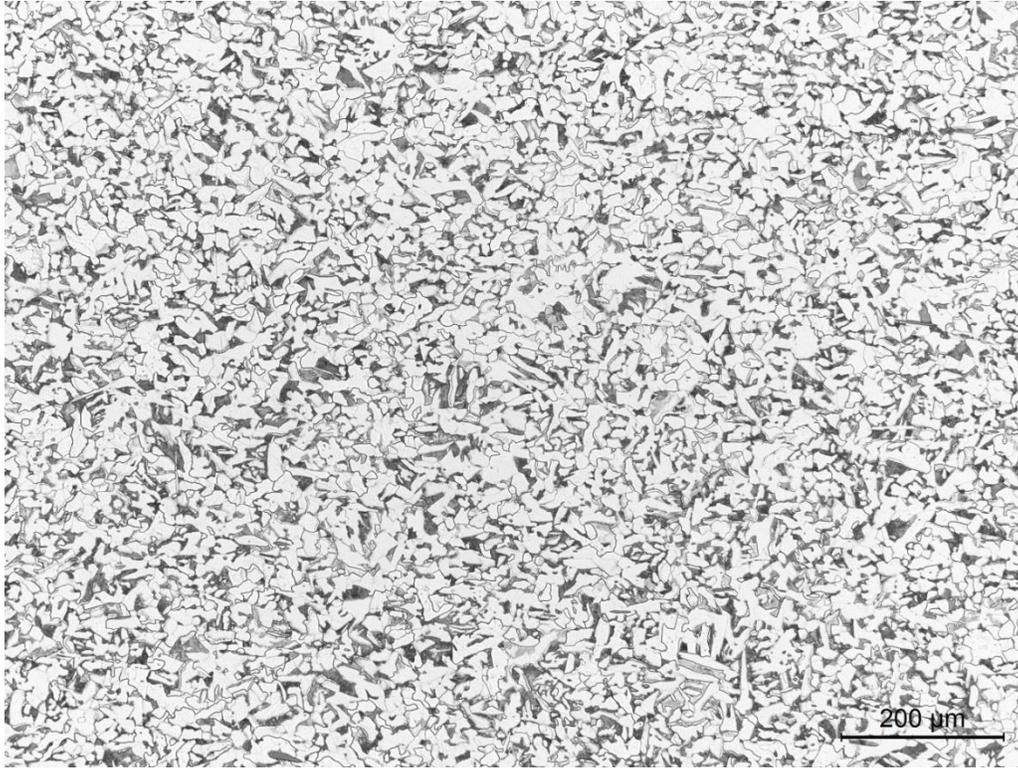
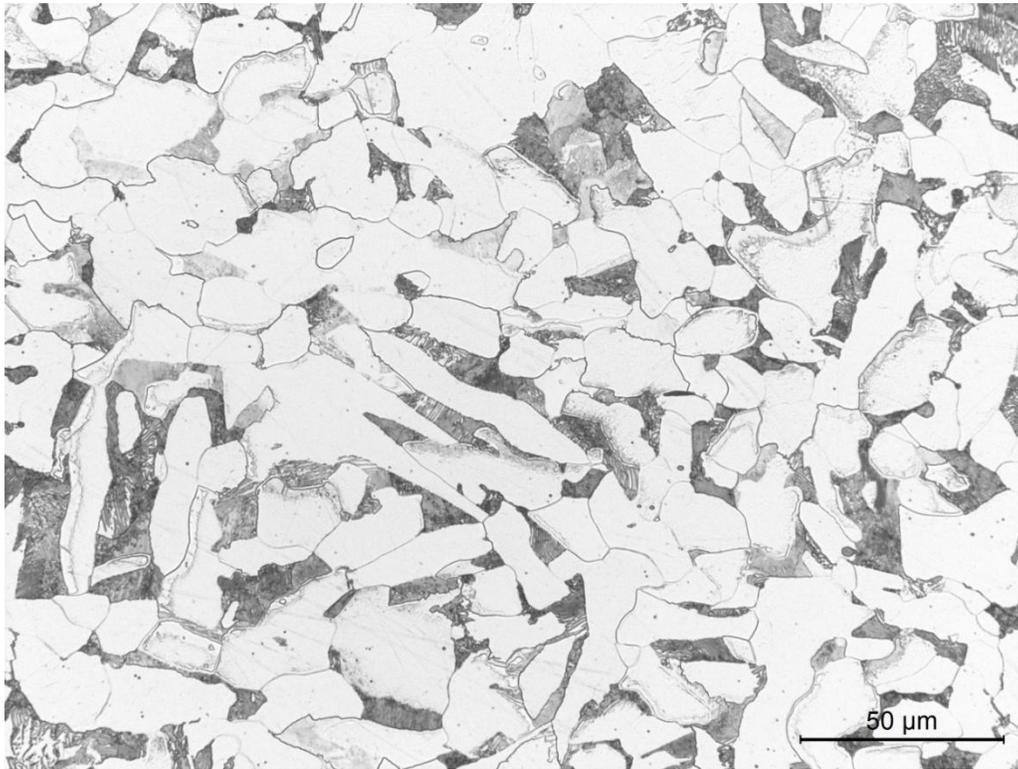
The general microstructure of the floor, shown in Figure 22, was consistent with low and medium carbon hot finished steels.

Figure 22 Optical micrographs of specimen floor 2, etched with 2% nital.
