U.S. CHEMICAL SAFETY AND HAZARD INVESTIGATION BOARD

# INVESTIGATION REPORT

## LPG FIRE AT VALERO – MCKEE REFINERY

REPORT NO. 2007-05-I-TX

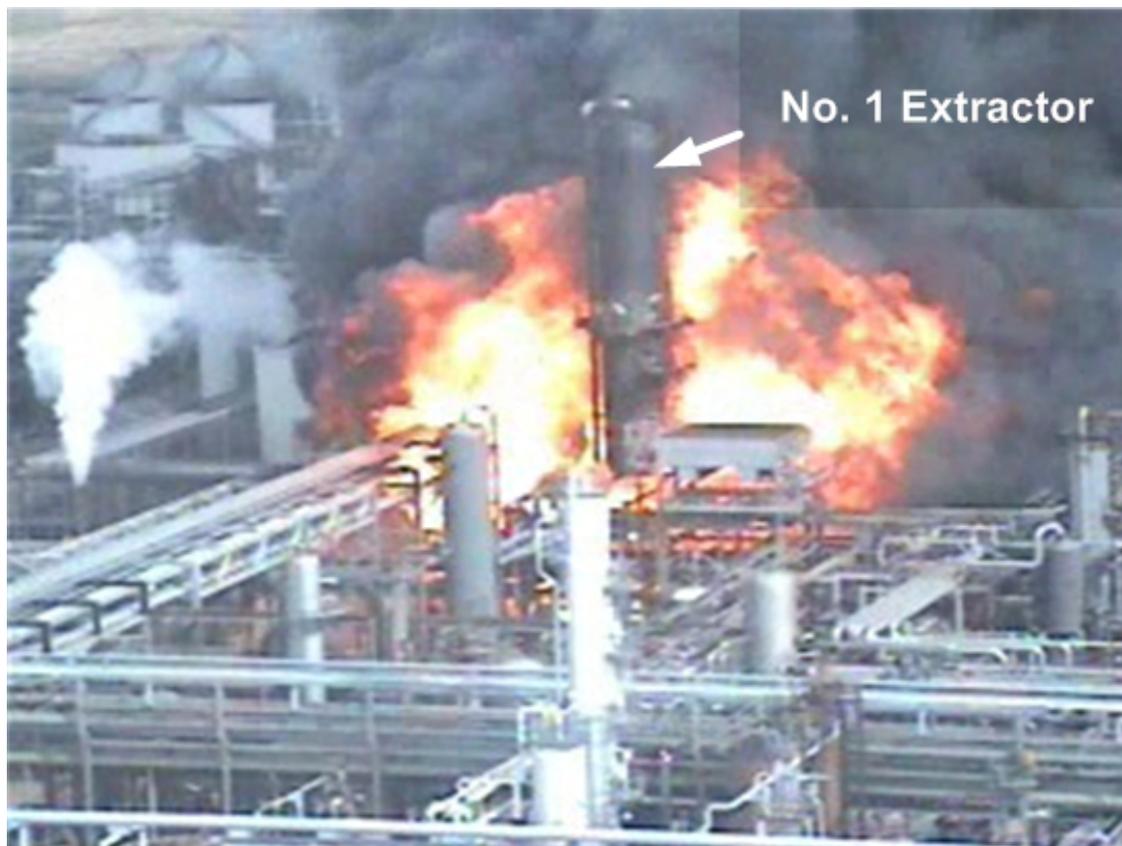
Figure 3. Approximately 90 seconds after ignition (from surveillance video)

The propane escaping from the high-pressure system formed a vapor cloud that traveled downwind toward the boiler house, where it likely ignited.<sup>11</sup> The flames flashed back to the leak source.

A steel support column on the east/west (E-W) pipe rack was impacted by a high-pressure propane jet fire. The column, which was not protected by fireproofing insulation, buckled, collapsing the rack and causing multiple pipe failures. Liquid petroleum products discharged from the damaged pipes, contributing to the rapid spread of the fire and the damage caused to surrounding equipment, such as the No. 2 Cooling Tower and No. 4 Naphtha Column.

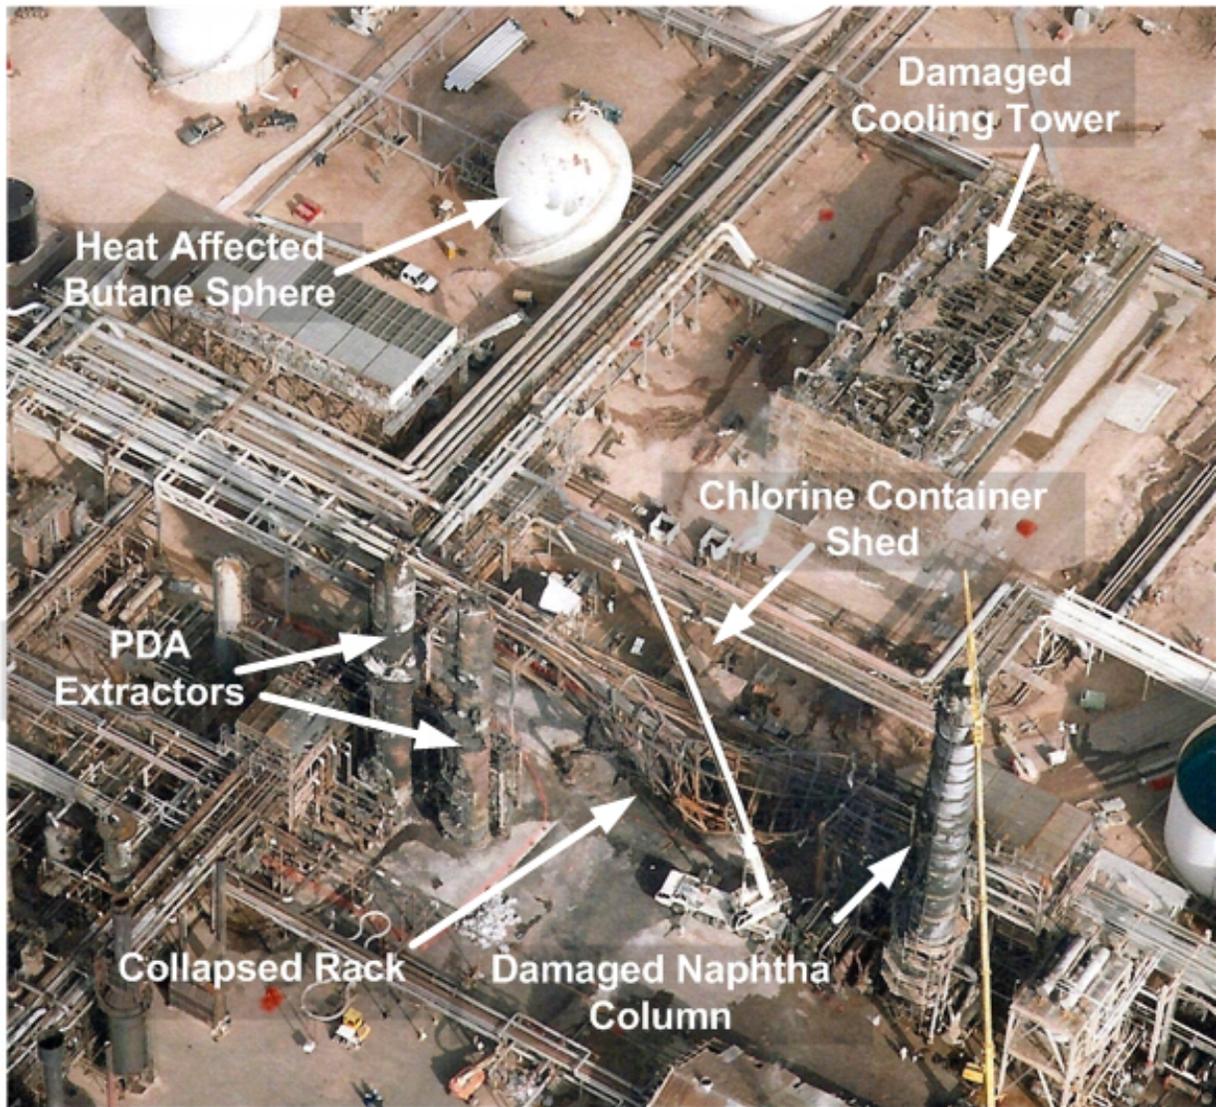
Figure 4. Aerial photograph of damage from the PDA unit fire

The PDA unit was heavily damaged (Figure 4). Much of the piping, control wiring, and heat exchange equipment in the area of the extractors was destroyed and major equipment items, including the extractor towers, required extensive evaluation to determine if they were safe for continued use. Valero restarted the rebuilt PDA unit in January 2008, nearly one year after the fire, restoring the refinery to full production capacity.

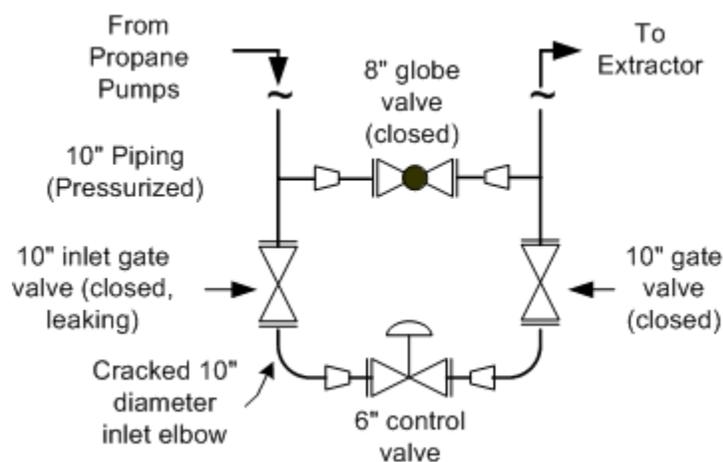
Figure 5. Propane mix control station schematic (not to scale)

In this incident, water settling out of a propane stream likely leaked through a 10" NPS<sup>20</sup> (250 DN) inlet block valve and accumulated in the low point formed by a control station (Figure 5). The control station was connected to the process, but had not been used for approximately 15 years. A period of cold weather likely froze the water, fracturing the pipe elbow upstream of the control valve. Warmer weather then melted the ice, resulting in a release of highly pressurized liquid propane through the fractured elbow. Appendix B contains a detailed time line of the incident.

The station's configuration made it a dead-leg: a section of piping connected to the process with no flow through it. Water in the propane likely sank into the dead-leg, leaked by the inlet block valve, and accumulated in the control station piping.<sup>24</sup>

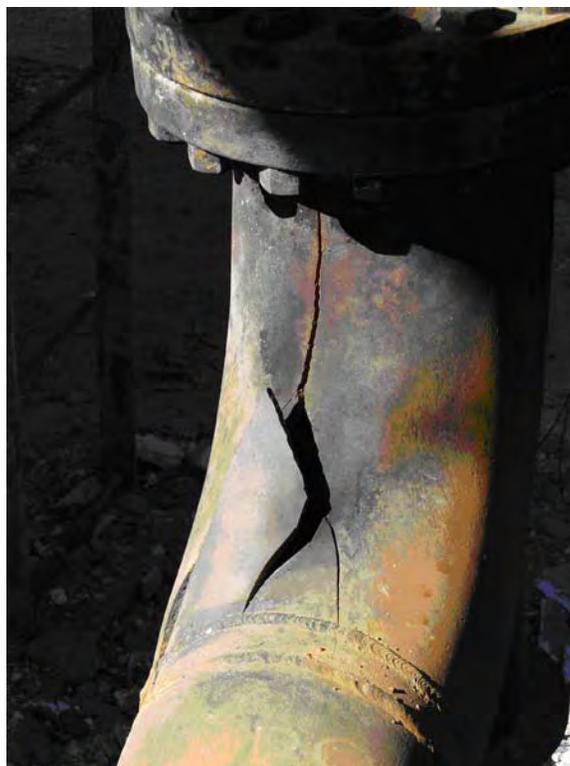
Figure 6. Crack in the 10" diameter propane mix control station inlet elbow

The extended period of cold weather and the lack of freeze protection on the control station allowed the water to freeze and expand, cracking the elbow upstream of the control valve. The crack propagated along the inner radius of the elbow, the line of highest stress (Timoshenko, 1958), opening wider as it developed (Figure 6). Appendix C contains a more detailed discussion of the CSB's analysis of crack formation and propagation. The damage to the inlet elbow and the post-incident leak rate determined for the inlet block valve are consistent with the estimated initial propane release rate during the incident.

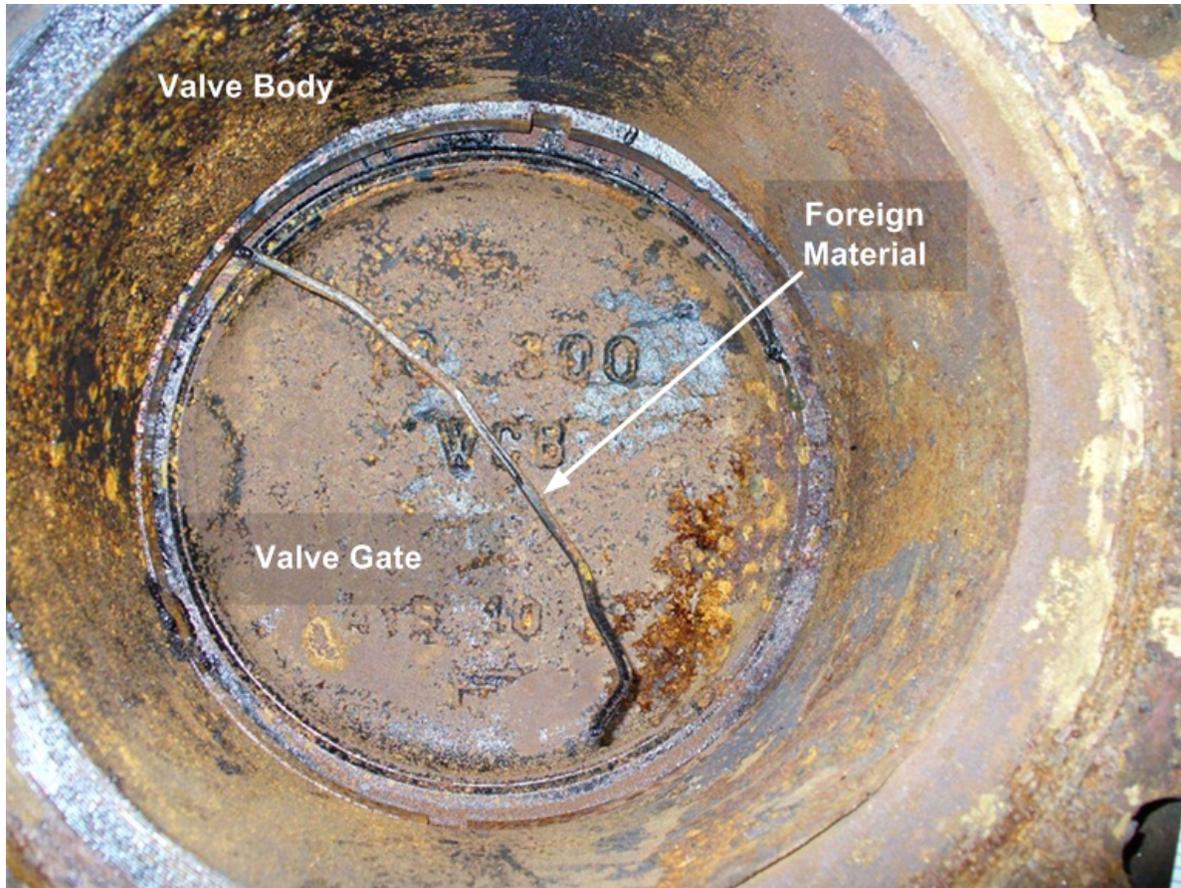
Figure 7. Downstream view of propane mix control station inlet block valve

On February 16, 2007, shortly after 9:00 a.m., ambient temperatures rose above freezing and the ice inside the elbow began to thaw. Post-incident examination of the control station inlet block valve (Figure 7) revealed that a foreign object was jamming the valve,<sup>25</sup> creating a leak path. When tested in a laboratory after the incident, this valve allowed over 1,025 gpm (233 m<sup>3</sup>/hour) of water to leak through at process pressure. At approximately 2:09 p.m., melting ice opened the leak path, releasing liquid propane at 500 psig (3,447 kPa) pressure through the cracked elbow. A flammable vapor cloud rapidly formed. Based on recorded data from the PDA unit's computerized control system, the CSB estimated an initial propane leak rate of 4,500 pounds (2,040 kg) per minute (Appendix D describes the propane mass balance calculations used to develop this figure).

<sup>25</sup> In gate valves, a circular gate slides against metallic seat rings, providing a leak-tight seal when the valve is closed. The foreign object in the inlet gate valve prevented a tight fit between the gate and the seat rings.

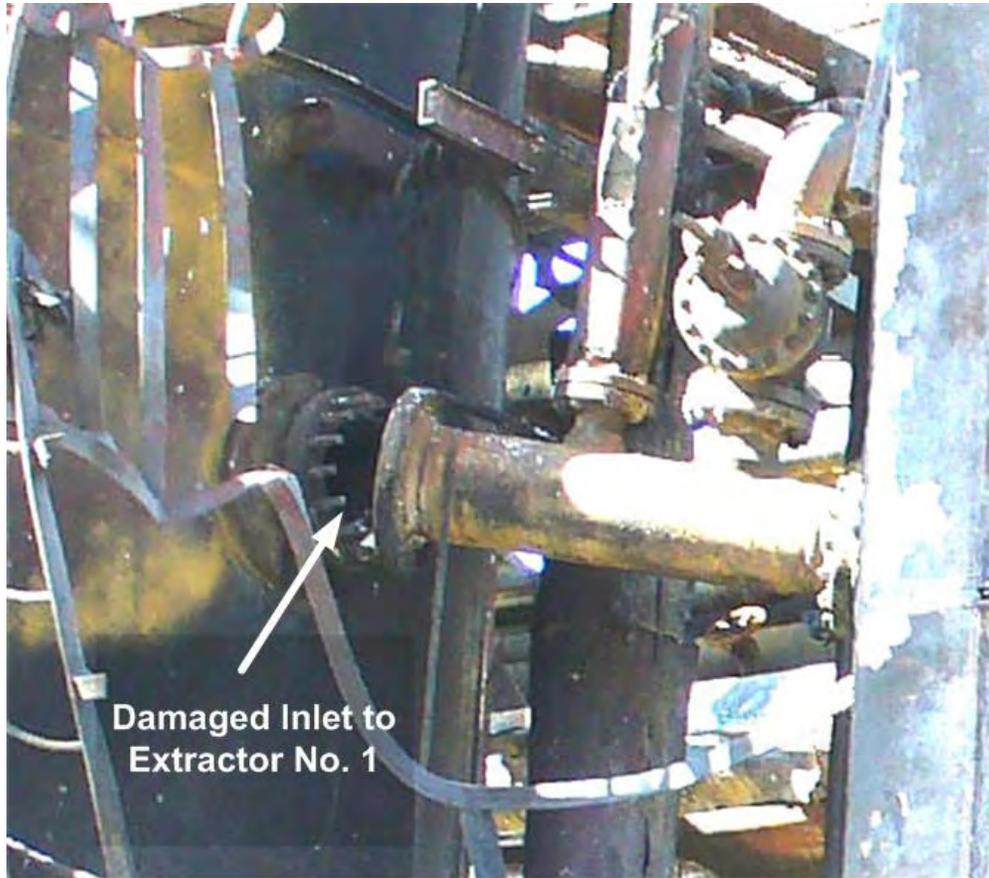
Figure 8. Damaged 10" propane inlet on Extractor No. 1

The wind blew the propane cloud toward the boiler house, where it likely ignited.<sup>26</sup> The flames flashed back to the release point. The size and intensity of the resulting fire blocked access to manual shut-off valves and pump on-off switches that might otherwise have been used to control the propane discharge. Within minutes, the fire damaged piping and pipe rack supports, spreading the fire (Figures 4, 8, 9).

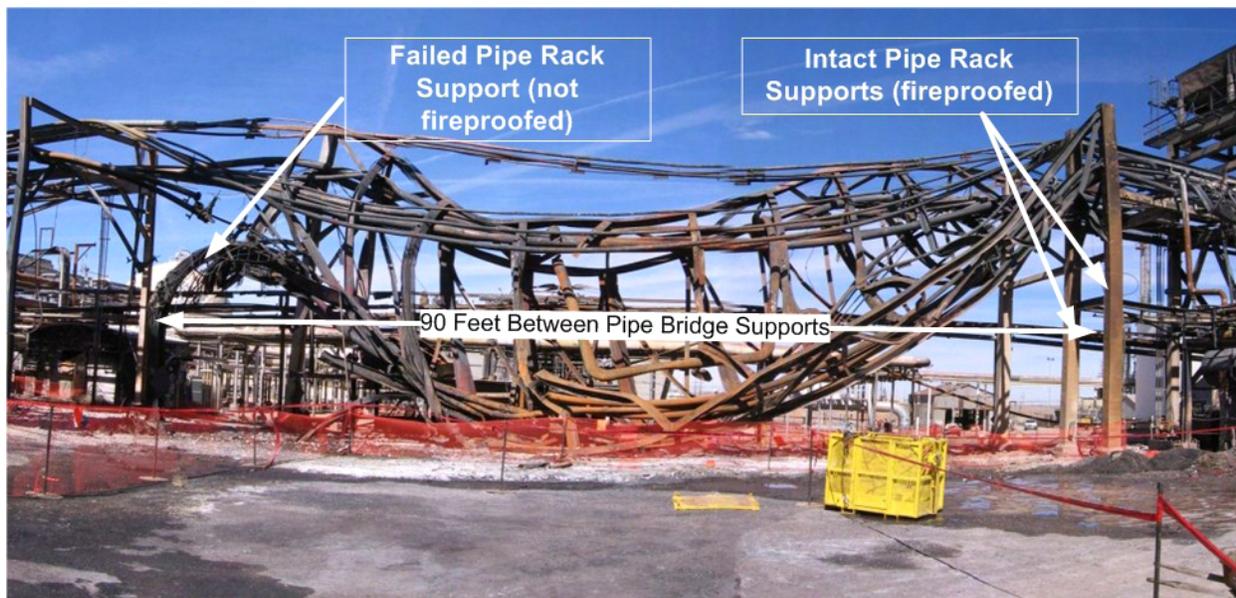
Figure 9. Pipe bridge support fireproofing

Valero Energy Corporation's SP-00-04, *Fire Proofing Specifications*, calls for fireproofing pipe racks within 30 feet of equipment with the potential to cause a serious fire, but makes no special provisions for processes handling LPG. A loss-prevention report produced for the McKee Refinery listed fireproofing of pipe rack support steel, including the E-W pipe rack north of the PDA unit, as a top priority for the site fireproofing program, but the rack had not been fireproofed at the time of the incident.

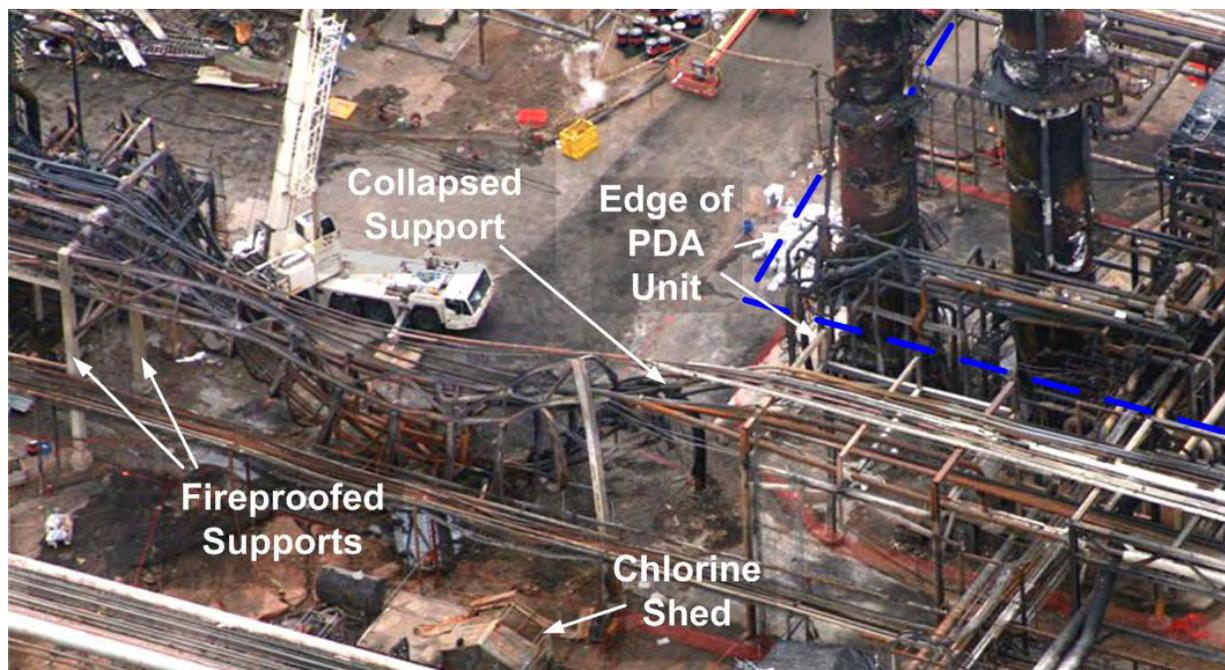
Figure 10. Extractor towers (upper right) and collapsed pipe rack

A failed inlet flange to the No.1 Extractor, located 77 feet away from the buckled pipe bridge support, was the most likely source of the jet fire that collapsed the pipe bridge (Figure 11). The closest major process vessel (the No. 2 Extractor) was 51 feet away from the support. These distances exceed both API's and Valero's recommended fireproofing distances.

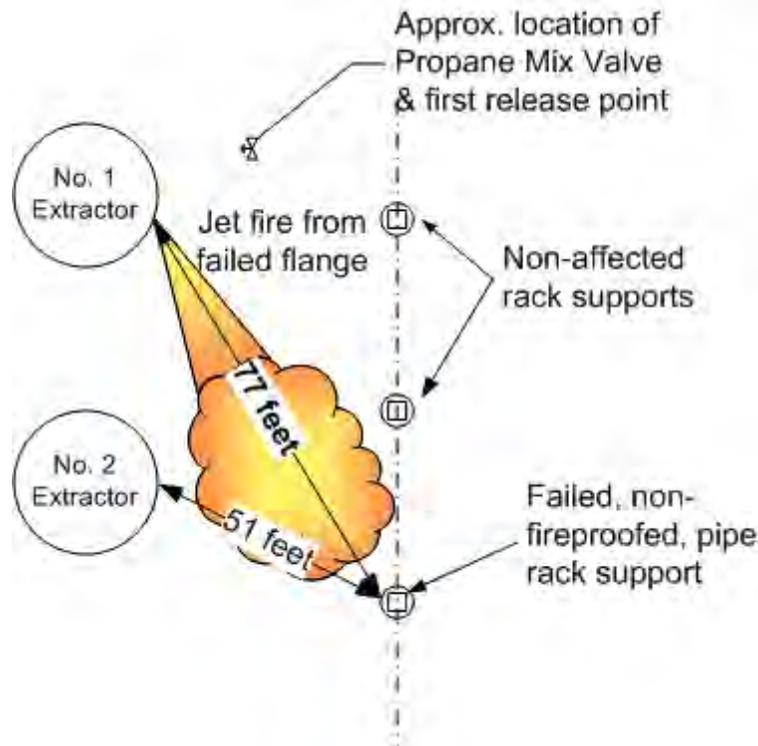
Figure 11. Distances between the E-W pipe rack supports and the extractors

API 2218 references the API 2210/2210A LPG fireproofing distance of 50 feet, developed for pool fires in LPG storage units. Neither standard addresses fireproofing for LPG processes or jet fire scenarios, even though process unit conditions, including pressure, can be more extreme than those found in storage facilities. In this incident, the high operating pressure of the extractors (500 psig, 3,447 kPa) likely produced a jet fire with a range and intensity beyond that anticipated in the API standards for LPG storage releases.

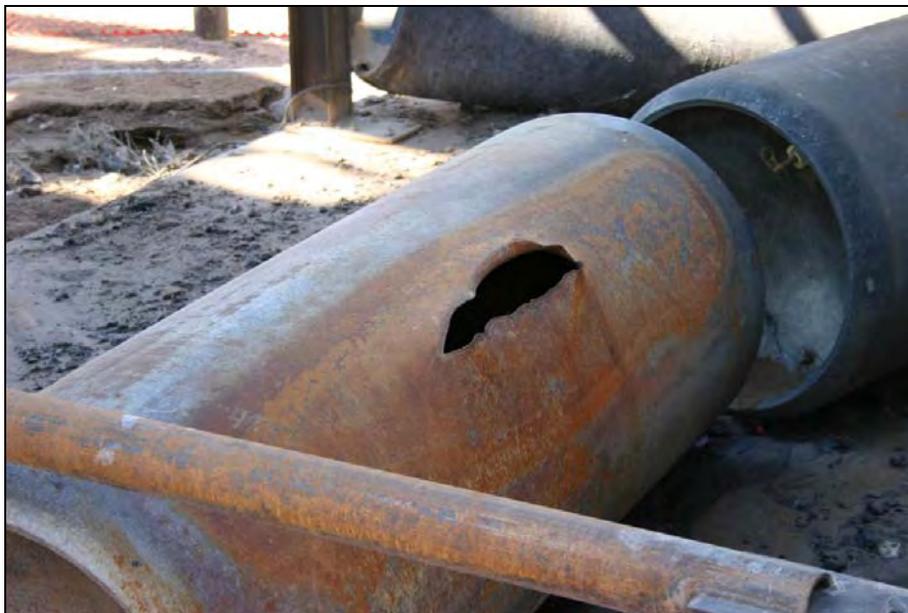
Figure 13. Ruptured one-ton chlorine container

Post-incident examination revealed that three one-ton chlorine containers in a cooling tower water treatment shed were subjected to radiant heating due to their proximity to the PDA unit (100 feet to No. 2 Extractor) and pipe rack (20 feet). All three containers vented when their fusible plugs, installed to prevent container rupture, melted as designed. One container ruptured despite the operation of its fusible plugs, and another vented completely. The third developed a leak through a partially melted plug that was repaired by emergency responders using self-contained breathing equipment for protection against the toxic vapor. More than 2.5 tons of chlorine, an extremely toxic material, were released.<sup>18</sup>

Safer materials for controlling biological growth in cooling towers are available, and Valero has identified replacing chlorine in cooling water treatment at all its refineries as a safety goal in its 2008-2012 Strategic Plan. The plan noted that 10 of its 18 refineries (as of May 2007) used ton container quantities of gaseous chlorine as a cooling water biocide. The McKee Refinery substituted sodium hypochlorite (bleach) for chlorine in its No. 2 Cooling Tower during PDA unit reconstruction. Bleach essentially stores chlorine in a form that presents a much lower inhalation hazard, an example of the inherently safer principal of attenuation (Kletz, 1998).<sup>49, 50</sup>

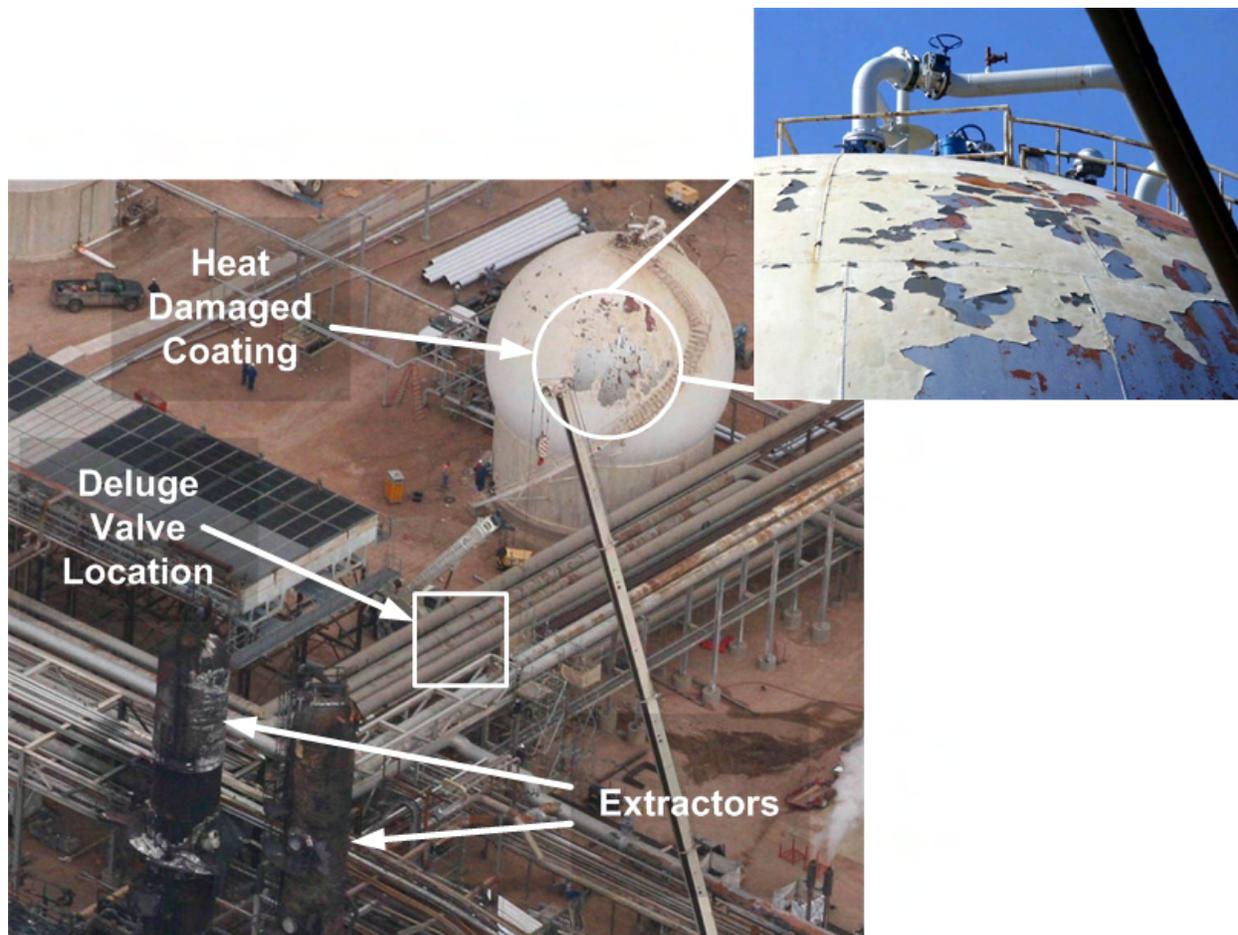
Figure 14. Heat-damaged coating on sphere and location of sphere deluge valves

approximately 3,600 barrels (151,000 gallons, 572 m<sup>3</sup>) of liquid butane under pressure, and was exposed to radiant heat from the fire. Figure 14 shows heat damage to the white protective coating on the tank's exterior.

Analysis of the overall effects of the fire revealed significant vessel damage as far as several hundred feet away from the PDA unit, generally downwind from the initial release, and including the insulated No. 4 Naphtha Column. Although the wind shifted several times during the fire, it never blew strongly from the southeast, which would have directed the flames toward the uninsulated butane sphere. Exposure to direct flame impingement or to significant heating over a prolonged period might have resulted in a vessel failure with potentially catastrophic consequences.

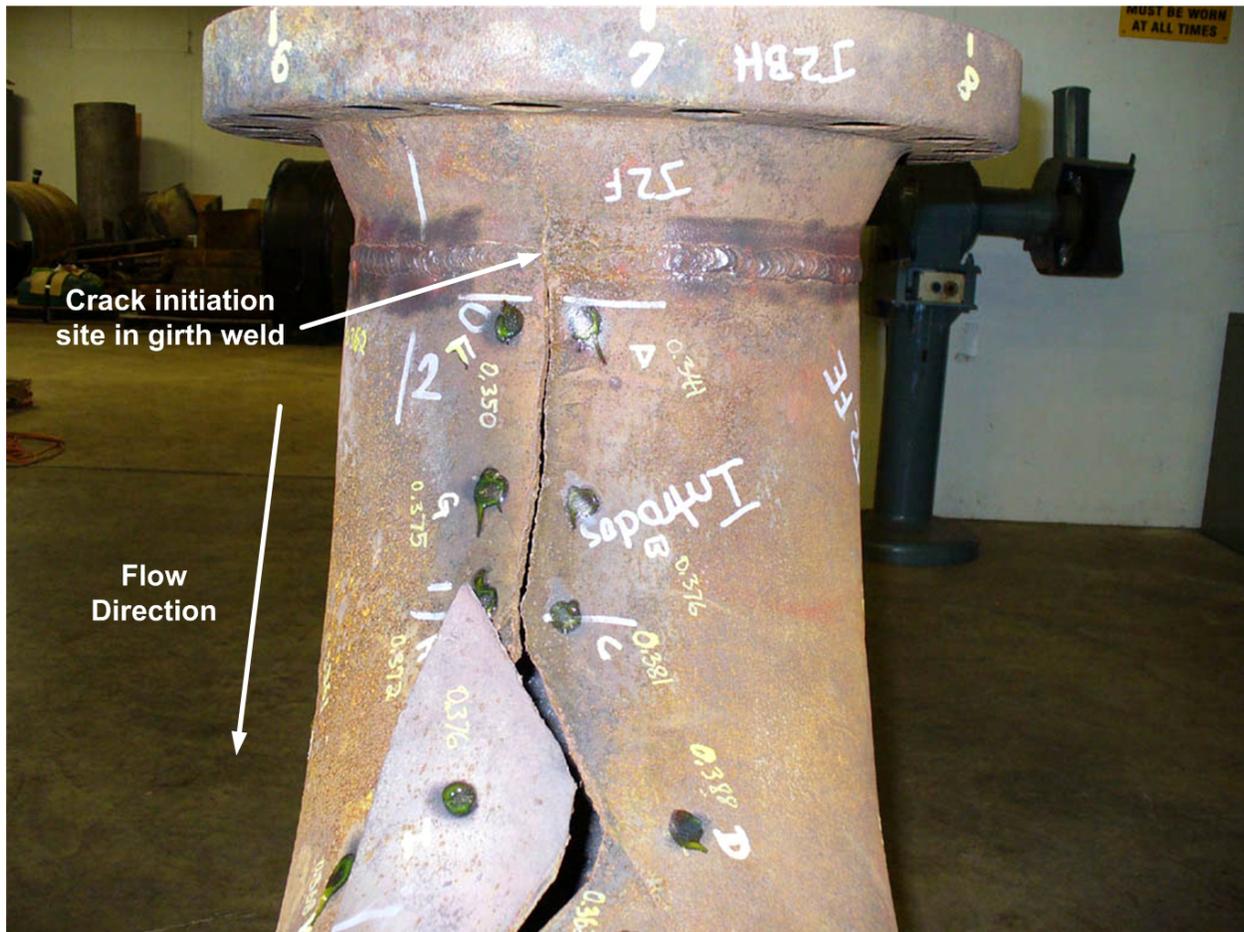
Figure C- 1. Fractured inlet elbow

The fracture in the inlet elbow of the No. 1 Extractor propane mix control station initiated in the exterior surface (cap) welding pass of the girth weld that joined the 10" NPS inlet flange to the 10" elbow, on the intrados (the inner radius) of the elbow (Figure C- 1). No flaw was observed at the initiating site, and the elbow and flange materials were within specification for tensile properties and chemical composition.<sup>1</sup>

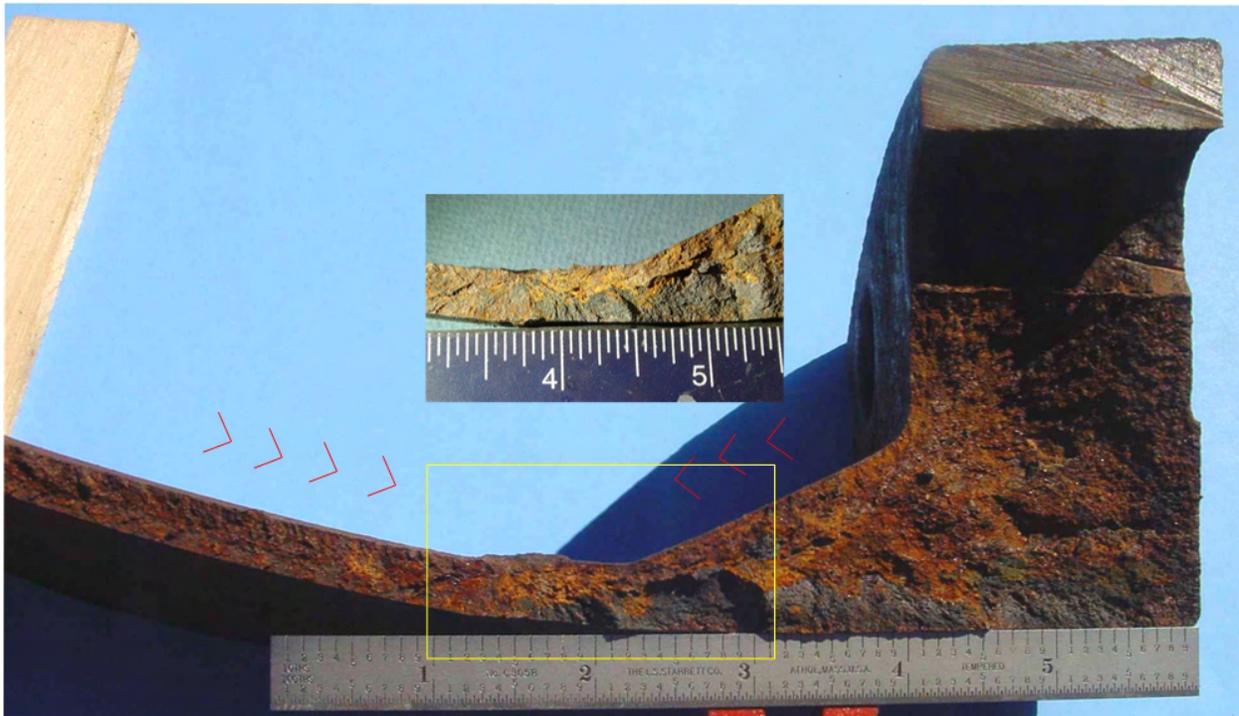
Figure C- 2. Origin and brittle propagation markers

The fracture propagated parallel to the pipe axis in both directions, with the surface exhibiting brittle fracture propagation features (Figure C-2).

Charpy V-notch (CVN) toughness tests were performed on the elbow and flange materials. Based on a 50 percent shear-area appearance, ductile to brittle transition temperatures were determined to be 95°F and 70°F (35°C and 21°C), respectively. Given that this piping was exposed to temperatures as low as 6°F (-14°C), brittle propagation behavior could be expected in these components.
