Statement of CSB Lead Investigator Don Holmstrom Updating the Status of the Board's BP Texas City Refinery Investigation

[The following statement was issued to update the public in Houston, Texas, June 28, 2005, 10 a.m. For further information contact Daniel Horowitz, CSB Director of Public Affairs, at (202) 261-7613 / (202) 441-6074.]

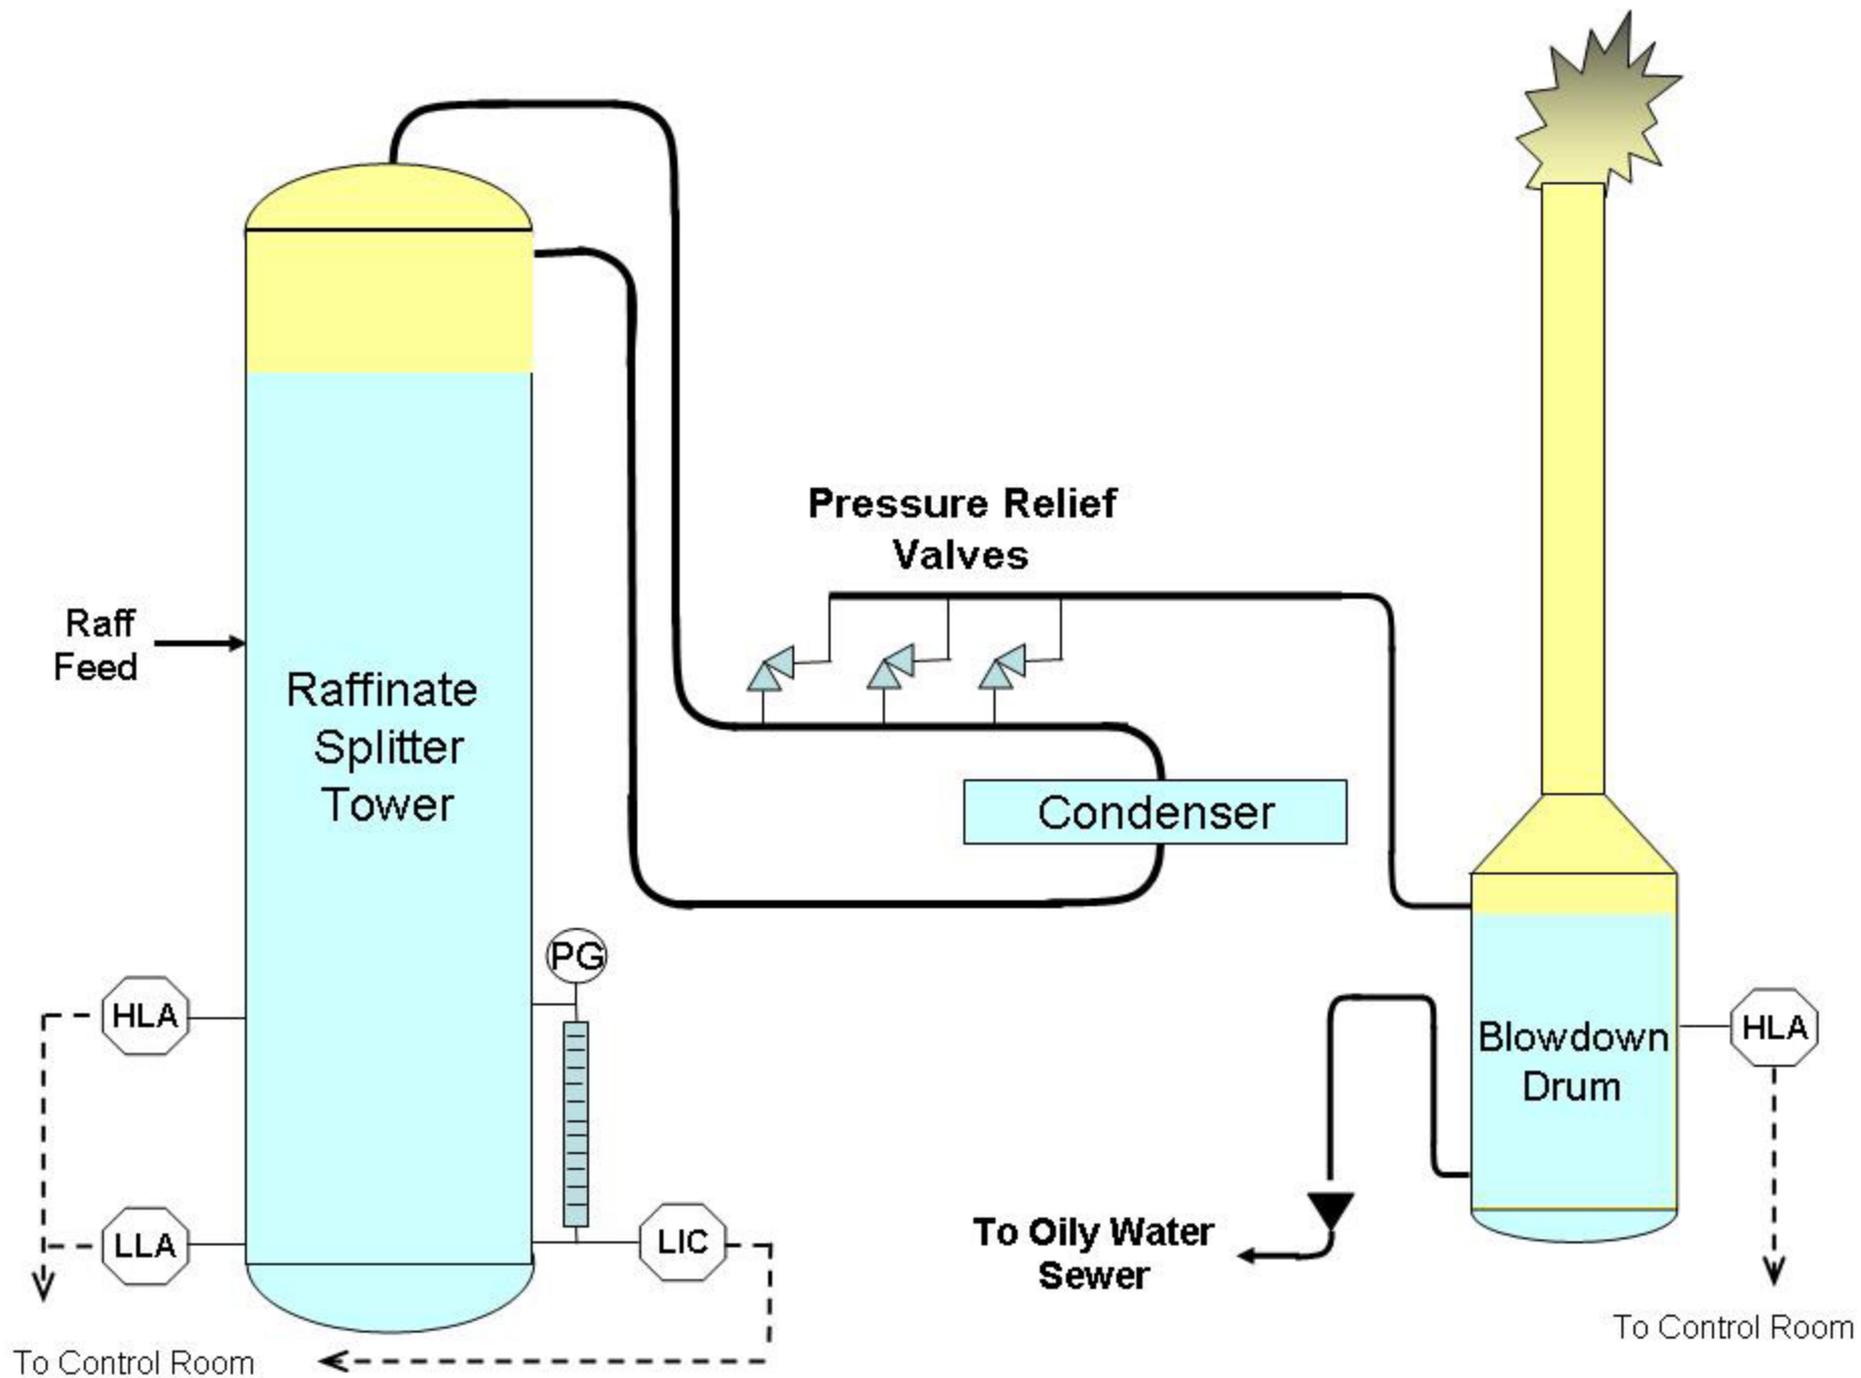
I will now describe some of the key equipment involved in the accident, using the diagram here on the easel. This diagram is not drawn to exact scale, and it does not show all the equipment in the process.

On the morning of March 23, the raffinate splitter was being restarted after a maintenance turnaround. The raffinate splitter is the 164-foot tall distillation tower shown here on the left. This tower distills highly flammable hydrocarbons, such as pentane and hexane. When the tower is operating normally, vapor flows from the top of the tower into the condenser, condenses to a liquid, and is returned to the tower via a reflux drum, which is not shown.

If tower experiences excess pressure above 40 pounds per square inch, there are three emergency pressure-relief valves designed to vent the pressure. Material vented through the pressure-relief valves flows to a blowdown drum – a vertical tank shown here. The blowdown drum vents directly to the atmosphere through a 114-foot-tall stack shown here.

As we reported back in April, the March 23rd start-up was abnormal, and the tower became flooded with liquid hydrocarbons. Our current estimate is that the liquid inside the tower ultimately reached a height of 120 feet or more. Normally this tower operates with less than 10 feet of liquid at the bottom. The flood of liquid inside the tower is shown here in blue.

When the relief valves opened, a large volume of liquid and vapor flowed rapidly to the blowdown drum. Accumulating liquid in the blowdown drum is shown here in blue. As we noted at the last briefing, some hydrocarbon flowed through a so-called “goose-neck” drain, shown here, and entered the process sewer, where it later caused a fire downstream.

I now draw your attention to some key instrumentation located on the tower and the blowdown drum. First, the raffinate splitter level indicator, shown here, is a sensor instrument that is supposed to measure the liquid level inside the tower. On our diagram, it is referred to as an LIC or level indicator control.

The blowdown drum was also equipped with a high-level alarm, shown here in the diagram. If functioning properly, this switch would trigger an emergency alarm if liquid approached the height of the goose-neck drain and was therefore in danger of draining into the sewer system. This alarm would sound in the control room and alert operators to a potentially dangerous condition inside the blowdown drum.
