U.S. CHEMICAL SAFETY AND HAZARD INVESTIGATION BOARD

## CHLORINE RELEASE

**DPC ENTERPRISES, L.P.**

REPORT NO. 2004-02-I-AZ

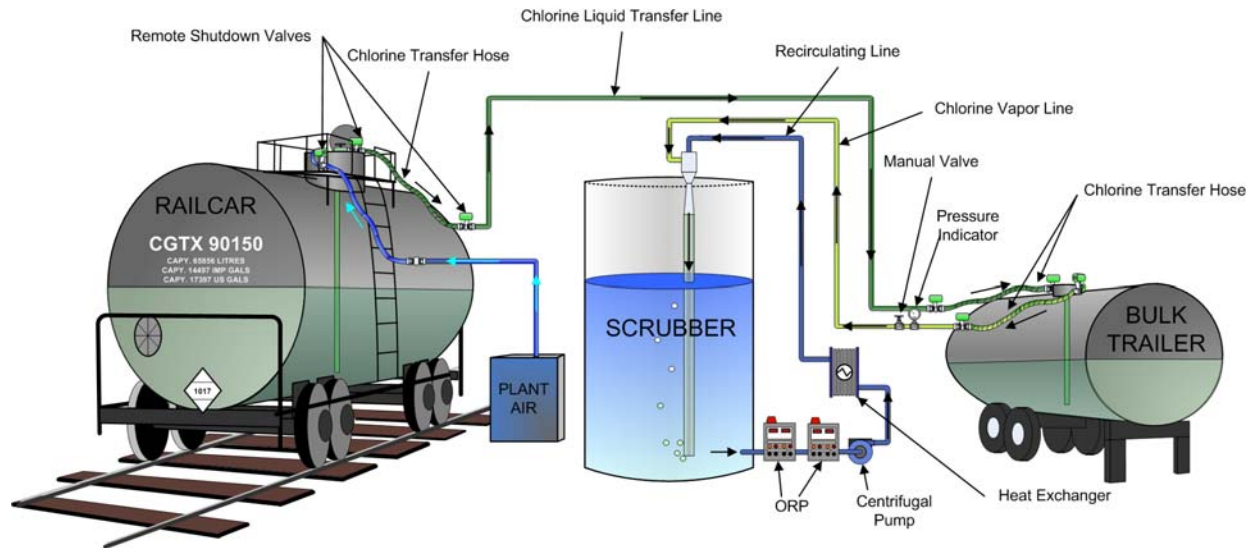
Figure 3. Chlorine bulk road trailer loading and caustic scrubber systems

Compressed air from the plant air supply pressurizes the headspace of the railcar and forces liquid chlorine to flow through the chlorine liquid transfer hoses and line into the bulk road trailer. As the bulk trailer fills, displaced chlorine vapors and air vent to one of two scrubbers.

As Figure 3 shows, a centrifugal pump circulates the scrubber solution through monitoring equipment and a heat exchanger (cooler) to the top of the scrubber where it mixes with chlorine vapors.<sup>11</sup> The cleaned air vents through the top of the scrubber. Scrubber efficiency is normally close to 100 percent.

Two oxidation reduction potential (ORP)<sup>12</sup> meters located in the suction line to the pump (Figure 3) track the concentration of caustic in the scrubber liquid. The meter readings are displayed in millivolts (mV)
