U.S. CHEMICAL SAFETY AND HAZARD INVESTIGATION BOARD

CHLORINE RELEASE

DPC ENTERPRISES, L.P.

REPORT NO. 2004-02-I-AZ

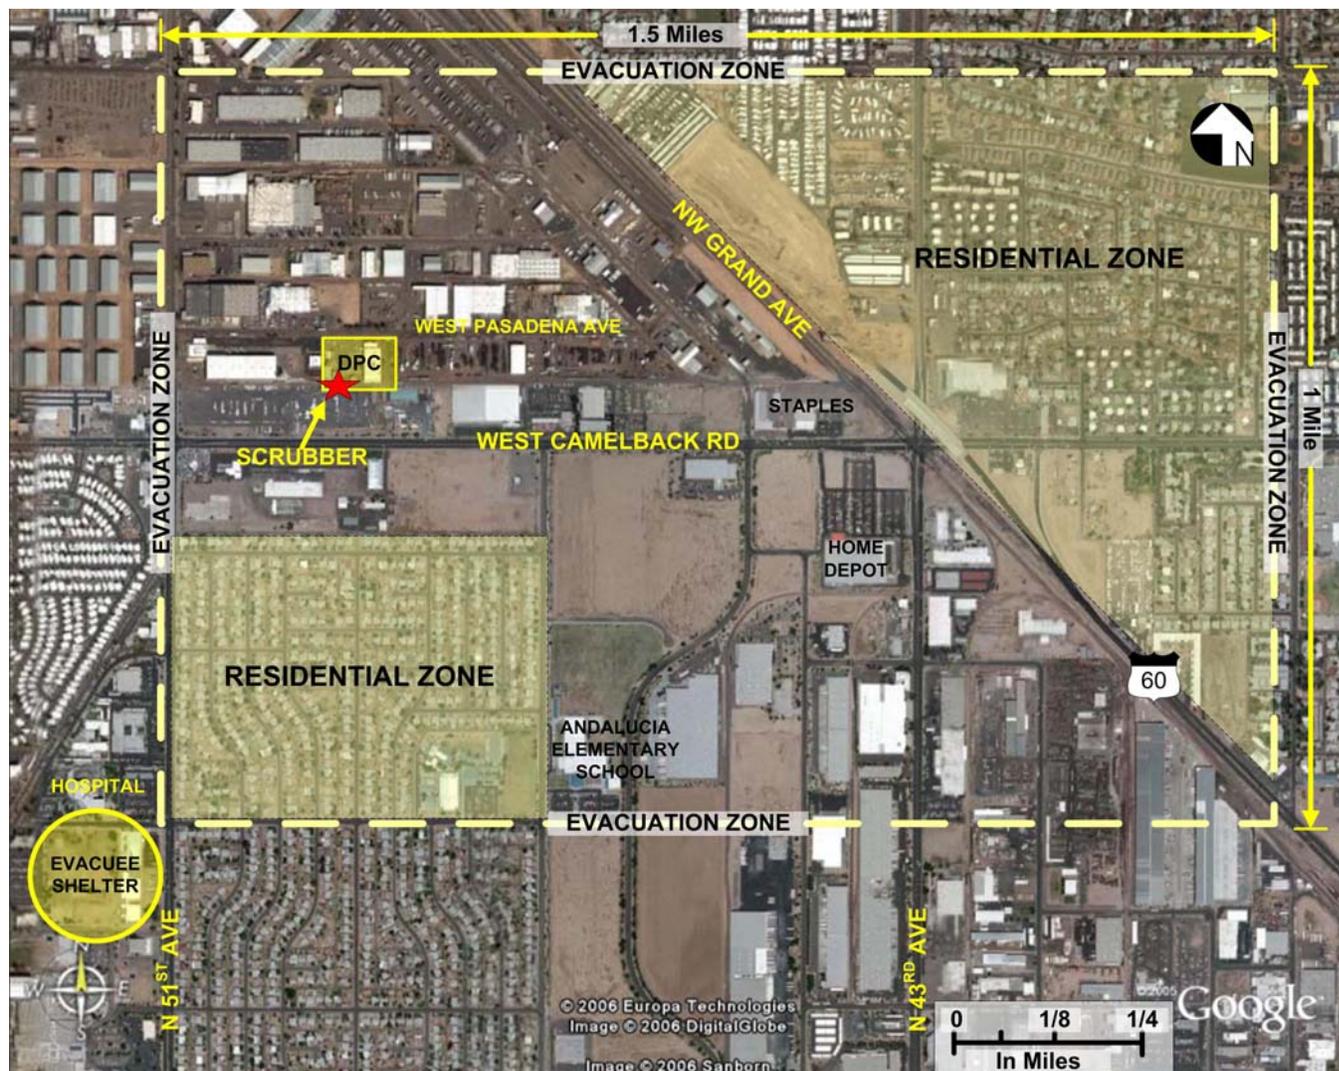
Figure 1. Surrounding community (Glendale and Phoenix, Arizona)

The incident commander established an initial isolation zone covering roughly two city blocks, based on the *DOT Emergency Response Guidebook's* recommendations for chlorine releases, and excluded traffic from a segment of Camelback Road (a major east-west roadway). Based on dispersion modeling by the Tempe Fire Department,³⁰ the incident commander expanded the isolation zone to a 1 by 1.5 mile rectangle extending downwind from the DPC site (Figure 1).

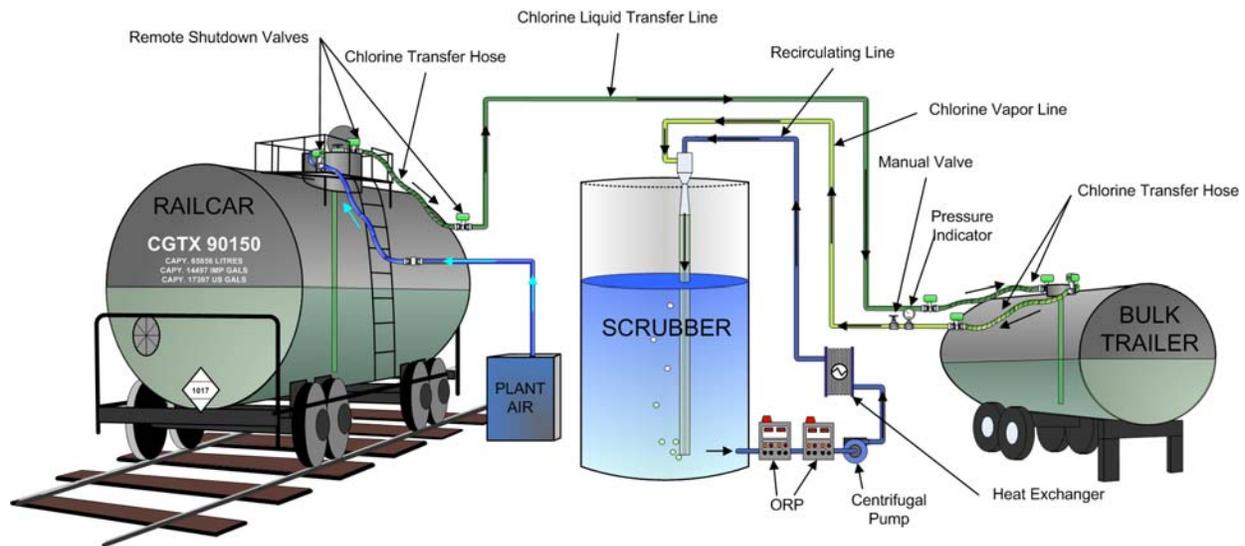
Figure 3. Chlorine bulk road trailer loading and caustic scrubber systems

As Figure 3 shows, a centrifugal pump circulates the scrubber solution through monitoring equipment and a heat exchanger (cooler) to the top of the scrubber where it mixes with chlorine vapors.¹¹ The cleaned air vents through the top of the scrubber. Scrubber efficiency is normally close to 100 percent.

Two oxidation reduction potential (ORP)¹² meters located in the suction line to the pump (Figure 3) track the concentration of caustic in the scrubber liquid. The meter readings are displayed in millivolts (mV)

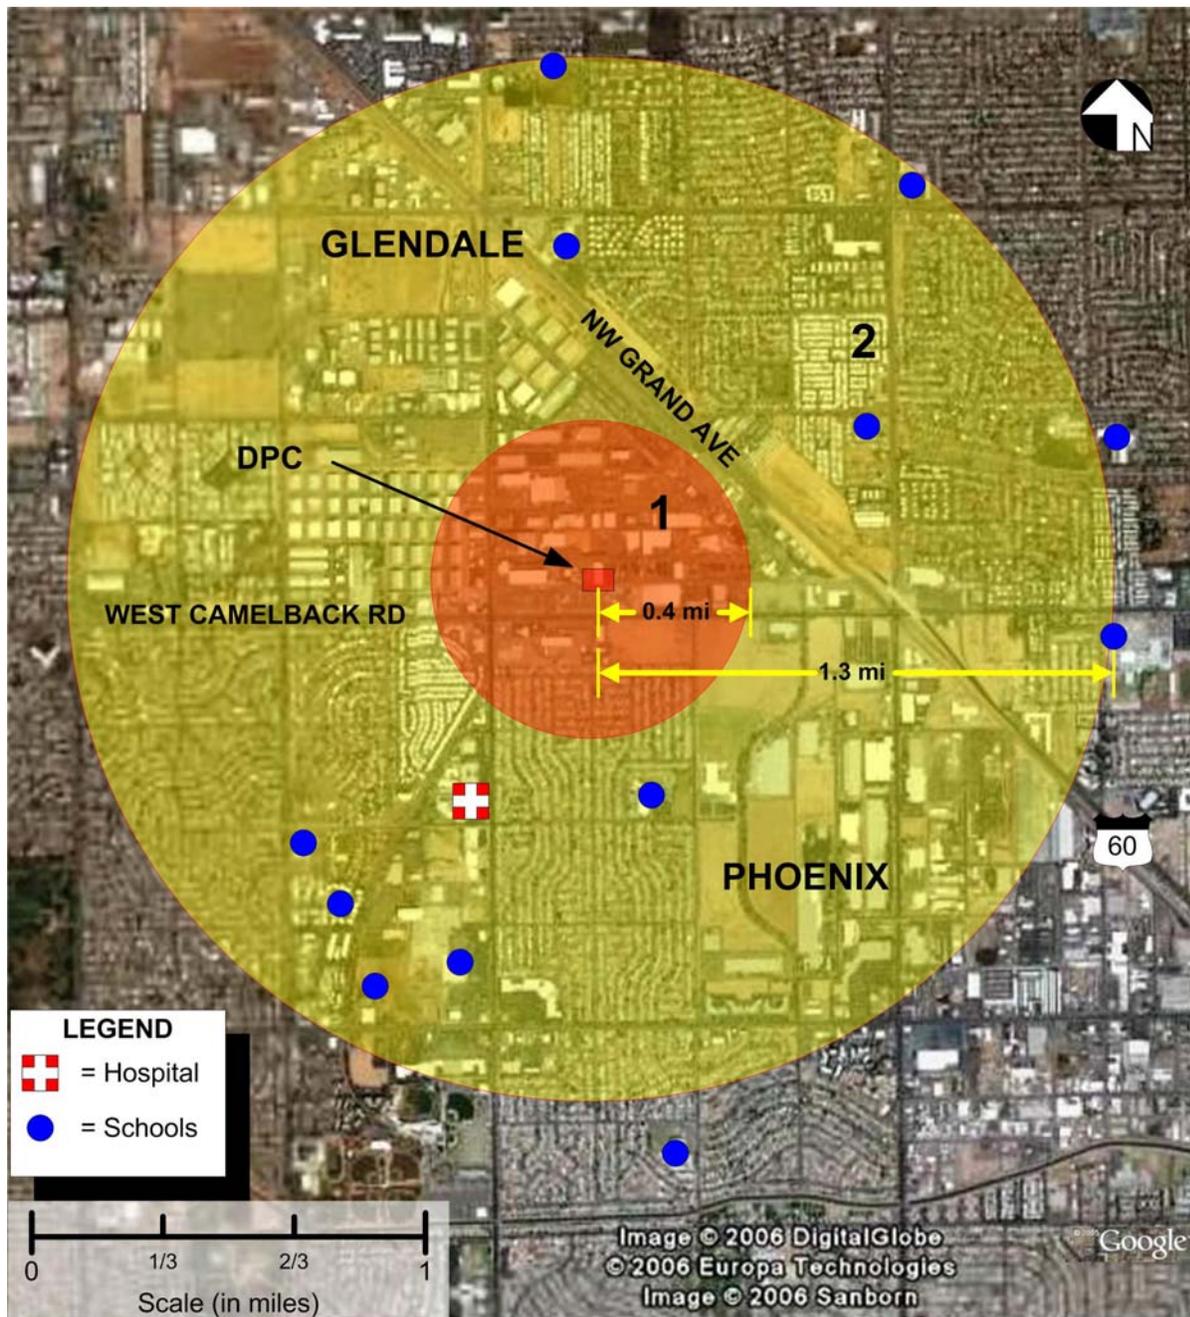
Figure 6. Hazardous chlorine concentration distances

The November 17 chlorine release was serious, and had the potential to significantly harm workers and the community. The CSB investigators estimate that the scrubber could have released up to 1,920 pounds of chlorine (Appendix B). Fortunately, the weather conditions during the incident were favorable for dissipation of the release. Under these conditions, the CSB estimates that hazardous concentrations²⁰ of chlorine likely extended out as far as 0.4 miles from the site.²¹ A similar release under highly stable atmospheric conditions could produce toxic concentrations of chlorine up to 1.3 miles from the DPC site.

The areas of Glendale and Phoenix within these distances of DPC are shown in Figure 6. Approximately 750 people live inside the smaller (0.4 mile radius) circle (Region 1), while nearly 30,000 live inside the larger (1.3 mile radius) area (Region 2). Depending on the wind direction and atmospheric conditions, a 1,920 pound release in this densely populated area could place many people at risk.

²⁰ Based on reaching chlorine's Emergency Response Planning Guideline (ERPG)-2 concentration of 3 ppm at the distances given. Concentrations closer to the DPC site would have been higher. The ERPG-2 concentration is the maximum airborne concentration below which nearly all individuals could be exposed for up to 1 hour without experiencing irreversible or other serious health effects, or symptoms that could impair an individual's ability to take protective action (American Industrial Hygiene Association). The EPA and other organizations use ERPG-2 concentrations in emergency response planning. Exposure to lower concentrations of chlorine can still cause symptoms, see Table 1.
