U.S. CHEMICAL SAFETY AND HAZARD INVESTIGATION BOARD

# INVESTIGATION REPORT

## CHLORINE RELEASE

**DPC ENTERPRISES, L.P.**

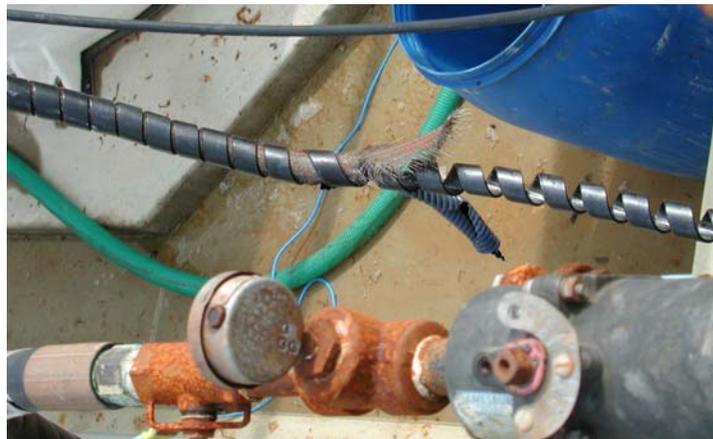
Figure 2. Failed stainless-steel transfer hose.

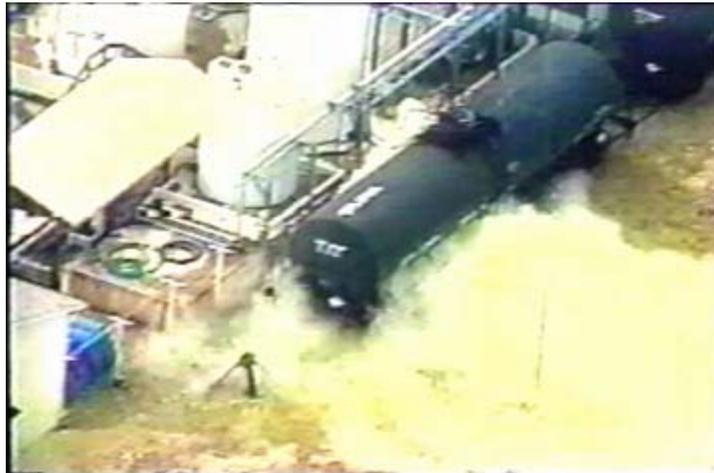
remained in the breakroom. At approximately 9:20 am, the three men outside heard a loud pop and observed a continuous release of chlorine at tank car station #3 (Figure 14). They immediately evacuated the area.

Figure 14. Chlorine release at tank car station #3.

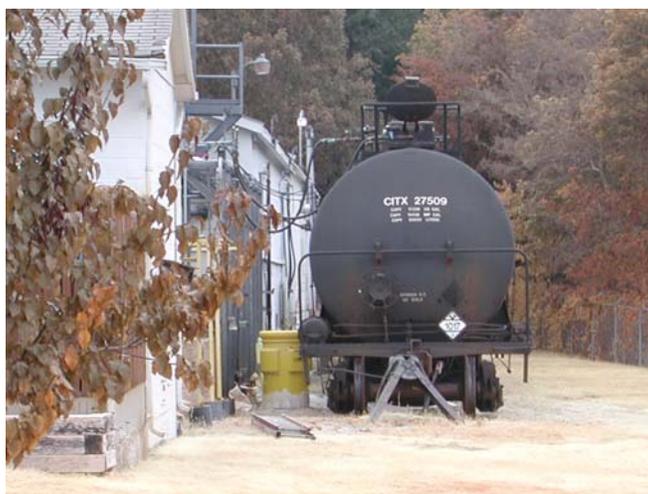
DPC began cleanup activities immediately after the R-7 fire department released the scene. Figure 18 shows the area of cleanup. Alarms were turned off, the chlorine piping system was evacuated and depressurized, and all fill stations were isolated.

Figure 18. Cleanup area around tank car station #3.

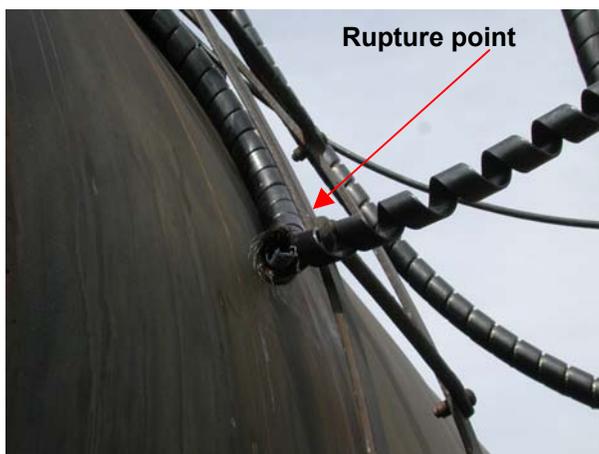
The catastrophic rupture of a 1-inch transfer hose attached at tank car station #3 initiated the chlorine release (Figure 19). Reconstructive analysis determined why the chlorine transfer hose ruptured and why the ESD valves failed to close. The excess flow valves were dismantled and inspected to determine if they should have closed.

Figure 19. Ruptured chlorine transfer hose at tank car station #3.

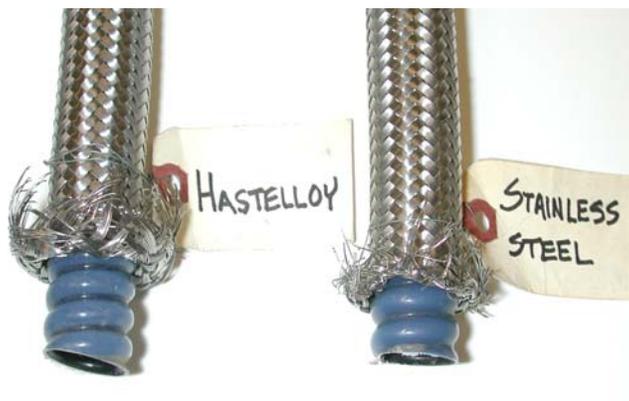
structural integrity, The Chlorine Institute (1998) recommends that hoses with such inner lining “have a structural layer braid of polyvinylidene fluoride (PVDF) monofilament material or a structural braid of Hastelloy C-276”<sup>13</sup> (Figure 20).

Figure 20. Structural braid layer pulled back to expose Teflon inner liner.

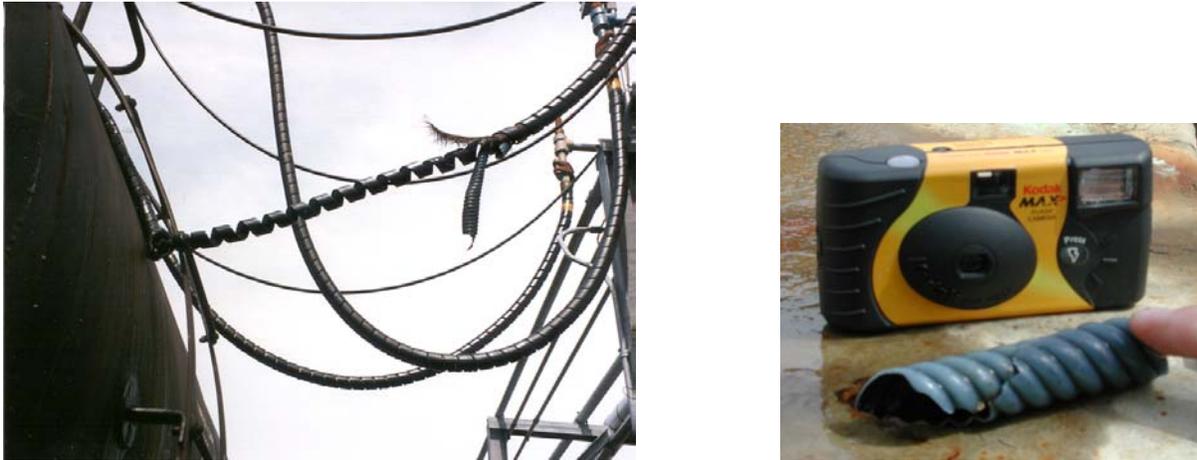
The rupture occurred in the chlorine transfer hose attached to tank car valve A, about 3.5 feet from its connection to the tank car (Figure 21). CSB investigators found a 2.5-inch-long segment of the hose inner liner and several pieces of the structural braiding scattered throughout the immediate area. The external spiral guard kept the ruptured hose attached to both the tank car and the plant piping.

Figure 21. Ruptured hose and piece of Teflon inner liner.

The HDPE spiral guards around each of the three hoses were cut off, and each hose was visually inspected. The structural braid layer of the intact hoses showed no signs of deterioration or discoloration; however, the structural braiding of the ruptured hose was significantly corroded, as evidenced by brown discoloration and granular flakes. The inner liner of the ruptured hose showed no sign of deterioration.

Materials testing of the structural braiding of both the ruptured hose and one of the intact hoses revealed that the ruptured hose braid layer was constructed of 316L stainless steel and the braid layer of the intact hose was constructed of Hastelloy C-276. As discussed in Section 4.1, nonmetallic inner liners (e.g., Teflon) must be reinforced with chlorine-resistant outer layers.

Once the hose was put into service at tank car station # 3, atmospheric moisture in combination with permeating chlorine molecules from the Teflon inner liner caused the 316L stainless-steel braid layer to corrode. Thus, CSB concludes that the hose ruptured because its stainless-steel structural braiding was inappropriate for chlorine transfer.

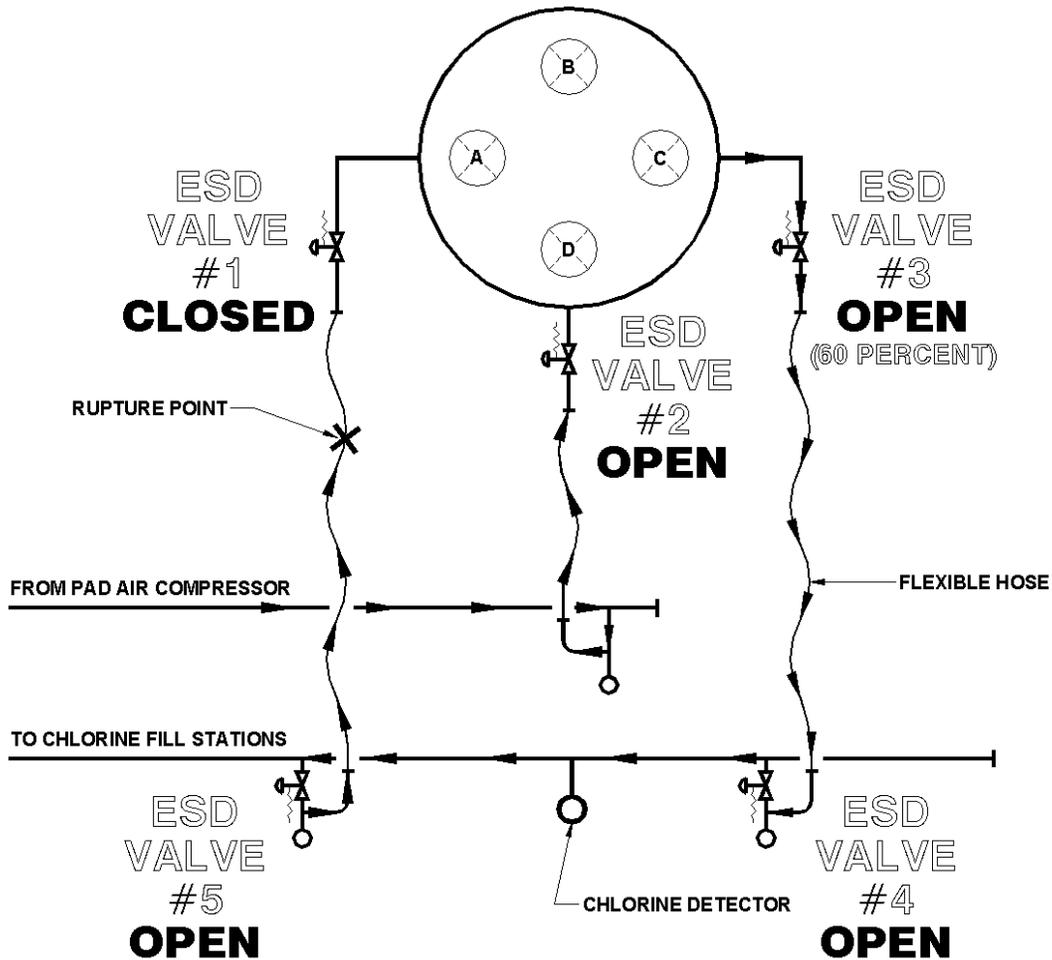
Section 2.4 describes the DPC Festus ESD system. CSB investigators checked the indicators on all five ESD valves at tank car station #3 after the incident.<sup>14</sup> Although both the automatic and manual ESD mechanisms were employed, four of the five valves failed to completely close and isolate the release (see Figure 22):

The one valve that did close was ESD valve #1, connected to the ruptured chlorine transfer hose.

Figure 22. Positioning of ESD valves at time of release.

The failure of ESD valve #2 to close and isolate the pad airflow supplied pressure to push chlorine out of the tank car during the release. DPC Festus had no other automatic mechanism to shut down the pad air system in an emergency. Such a mechanism may have slightly reduced the flow of chlorine from the tank

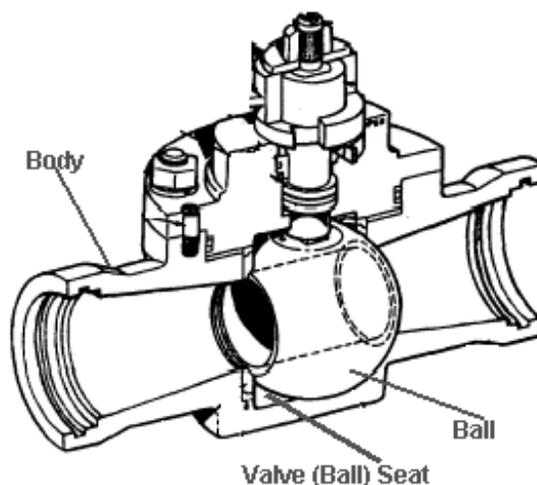
Testing of ESD valves # 3 and 4 revealed that the torque necessary to close the valves—in excess of 40 foot-pounds—far exceeded the 5 foot-pounds available from the actuators. Visual inspection of both valves revealed corrosion product buildup around the valve balls (Figure 23); these deposits were found to be ferric chloride. CSB investigators recognized that some corrosion within the repackaging system, including the unloading piping assemblies, occurred after the release. Therefore, a second set of piping assemblies—not in use at the time of the incident—was inspected and tested; these assemblies were also found to have corrosion, and they did not close properly when activated. It was concluded that corrosion products impeded motion of the ESD valves.

The valve balls were constructed of Monel, which is resistant to moisture-induced corrosion in chlorine service. The corrosion products were determined to have migrated to the valves from the pad air supply and tank car assemblies, as well as from parts of the plant liquid and pad air carbon steel piping.

Figure 23. Schematic of ESD valve.

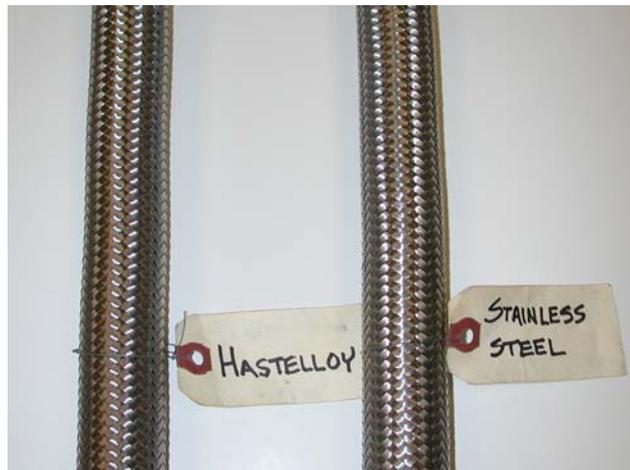
Hastelloy C-276 and 316L stainless-steel structural braiding appear to be identical (see Figure 24). CSB investigators believe that the inability to visually distinguish these two structural braid layer alloys facilitated installation of the incorrect hose at DPC Festus. In fact, throughout the hose supply chain, there was no adequate mechanism (e.g., color-coding, stenciling, or stamping) to help identify similar looking hoses.

Figure 24. Identical appearance of HastelloyC-276 and 316L stainless-steel structural braiding.

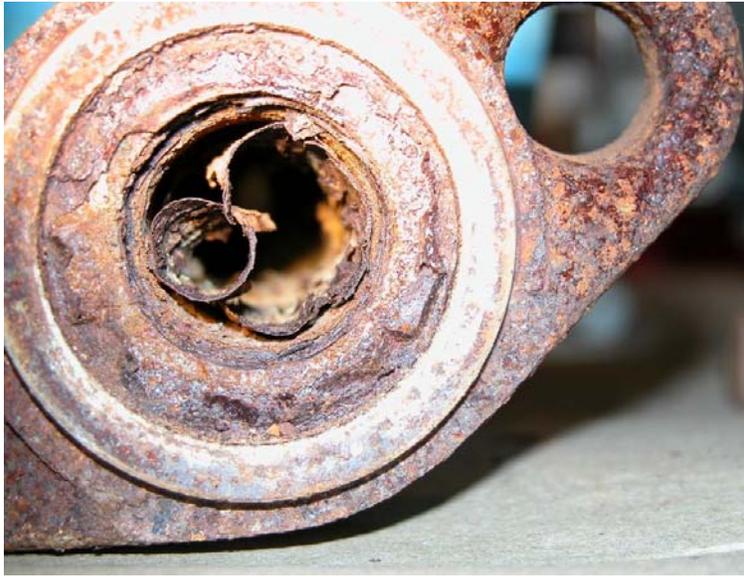
<sup>20</sup> The unloading assembly in use at tank car station #3 at the time of the incident and a second set of assemblies not in use were inspected; both exhibited corrosion.

Figure 25. Corrosion buildup in chlorine repackaging piping system.

The DPC Festus MI program was not successful in preventing corrosion within the chlorine repackaging system because it did not adequately address related supervision, procedures, and inspection.

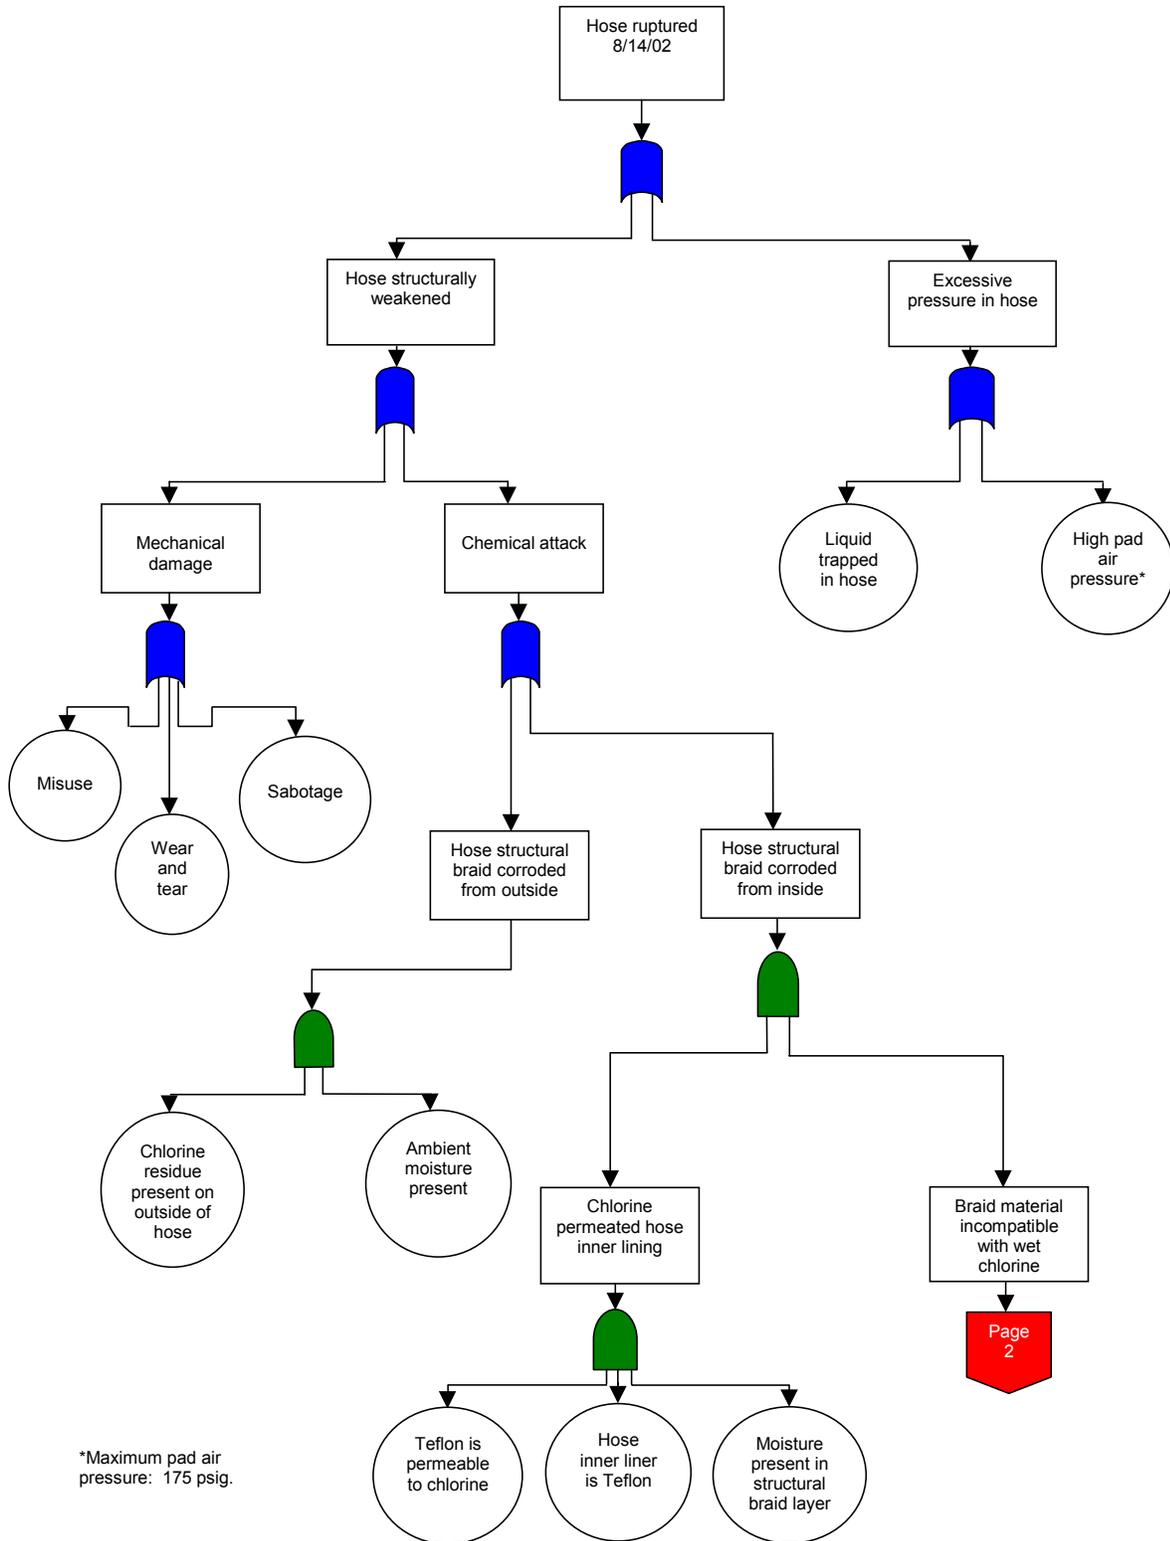
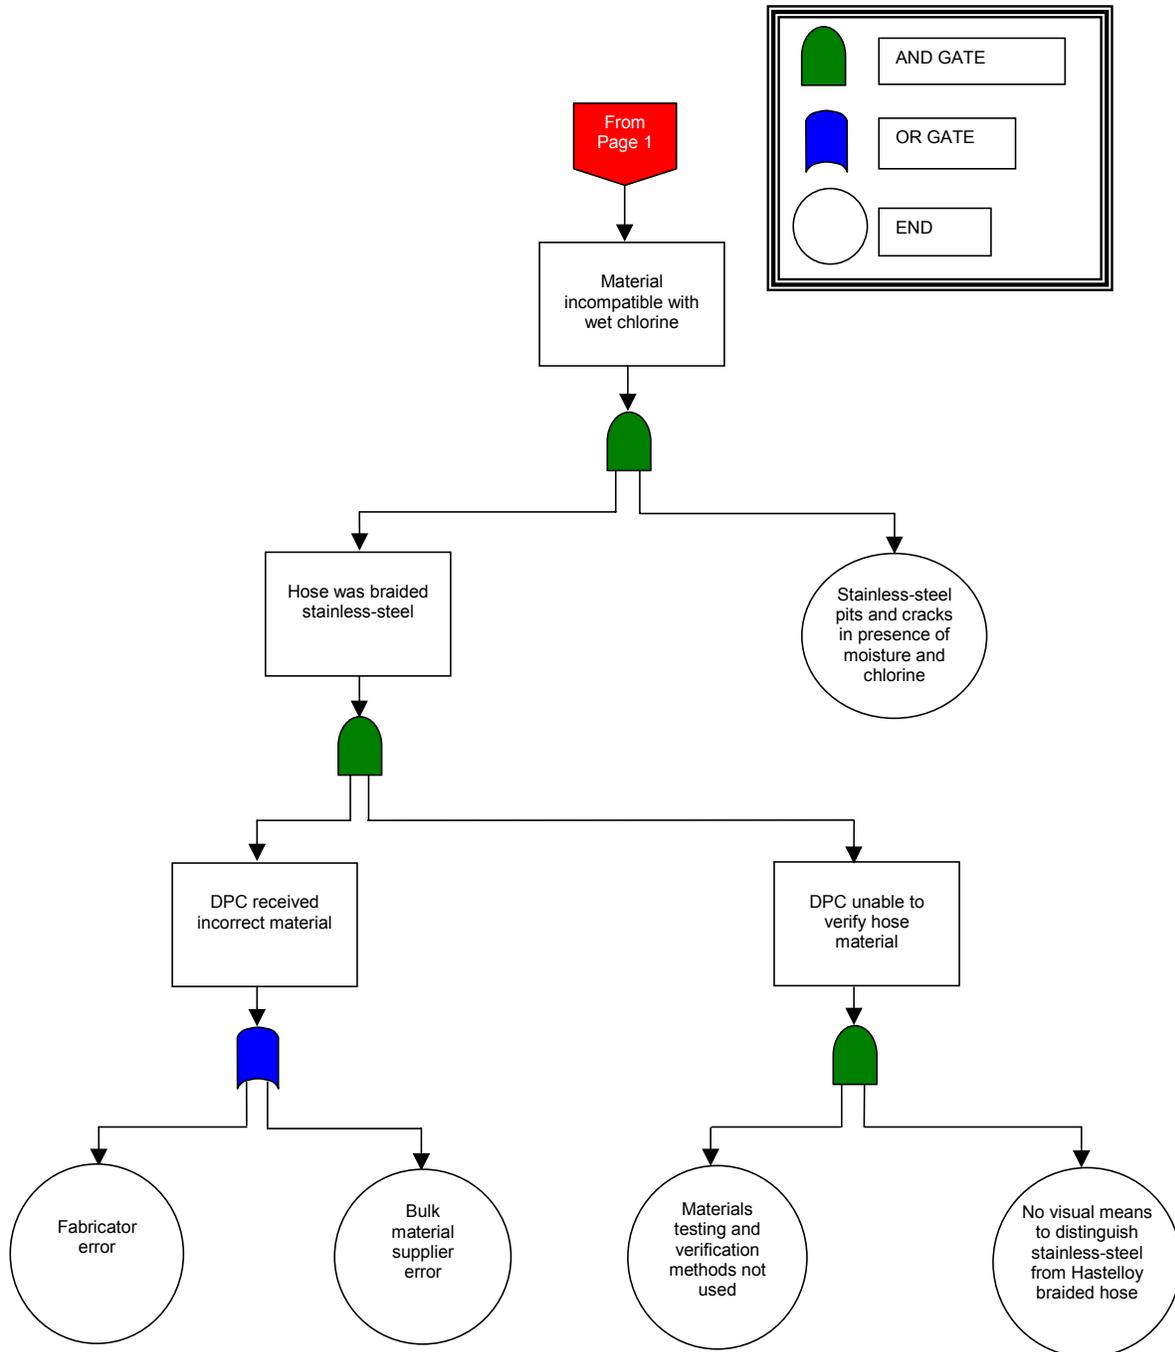
# APPENDIX E: Fault Tree Analysis, Hose Failure

During chlorine unloading operations, the transfer hose is subjected to maximum operating pressures of about 175 pounds per square inch gage (psig). The hose also encounters bending forces during each connection/disconnection to the tank car. CSB concludes that corrosion of the 316L braid layer weakened the structural integrity of the hose. Normal operating pressure, in combination with repetitive bending forces, caused the hose to rupture and release chlorine. (See fault tree analysis of hose rupture in Appendix E.)
