U.S. Chemical Safety and
Hazard Investigation Board

Fire During Hot Work at Evergreen Packaging Paper Mill

Canton, NC | Incident Date: September 21, 2020 | No. 2020-07-I-NC

Investigation Report

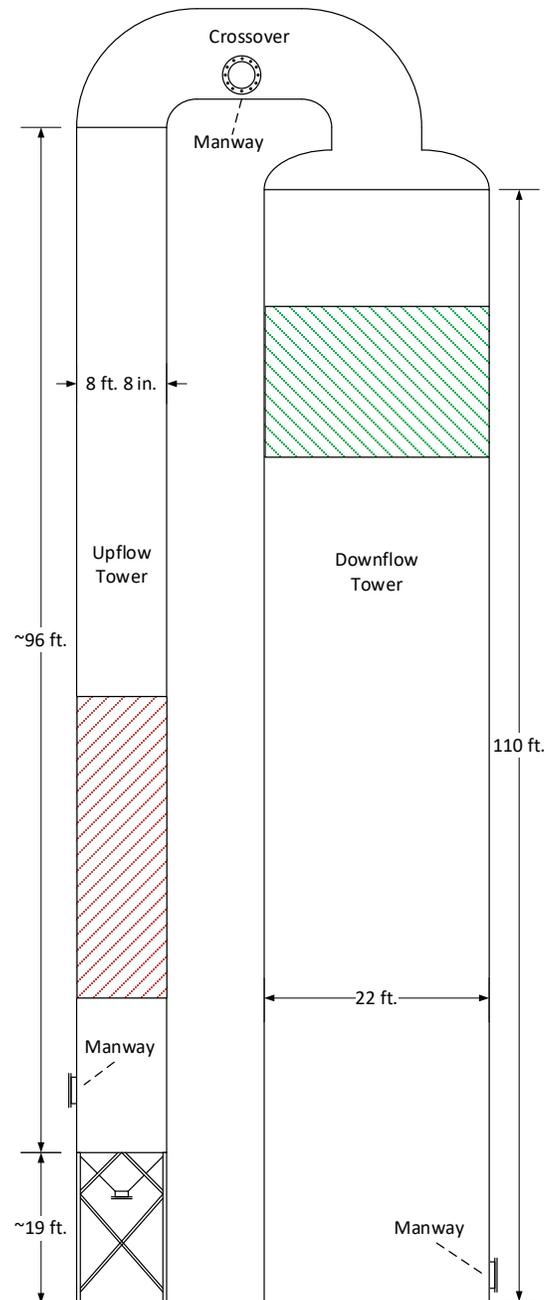
Blastco’s scope of work for the shutdown was, among other tasks, to perform FRP maintenance on four upflow towers in Evergreen’s bleaching units. For the #2 Fiber line D2 upflow tower, Blastco’s work scope was to repair approximately 30 feet of FRP, illustrated with red shading in **Figure 3**. This scope of work involved grinding away old material until acceptable base material was found, followed by applying alternating sheets of new fiberglass with layers of resin, until the desired thickness was reached. To accomplish this work, traditional scaffolding was built up from the ground to the entry manway of the upflow tower, which was located 23 feet above the ground. Inside the tower, additional scaffolding platforms were assembled so that workers could access the entire inside surface that was to be repaired.

Figure 3. Diagram of the #2 Fiber Line D2 towers. (Credit: CSB.)

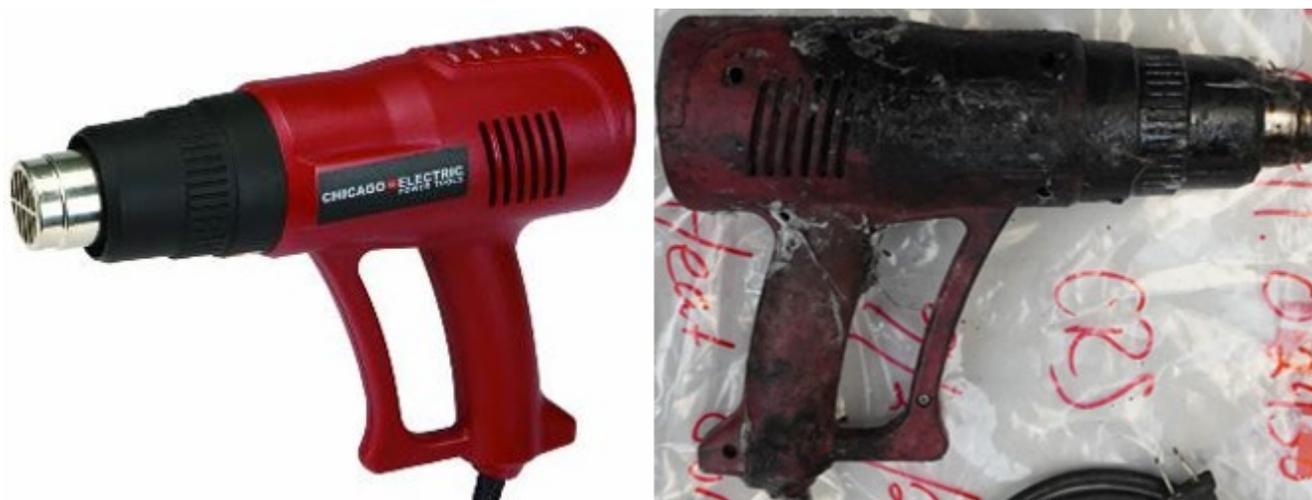
The heat gun Blastco used to warm the resin was a Chicago Electric model heat gun [5]. According to the tool’s manual, it had six different heat settings, each with a low and high sub-setting, for a total of 12 temperature settings. These settings ranged from a minimum of 430°F to a maximum of 1,160°F. One of the Blastco workers who used the heat gun could not recall the exact setting used leading up to the fire but told the CSB that it was set on the third or fourth setting, which corresponds with a temperature of between 650°F (the low temperature of the third setting) and 790°F (the high temperature of the fourth setting).

Figure 4. Exemplar heat gun (left). Heat gun recovered from scene (right). (Credit: Harbor Freight [6], CSB.)

Witnesses stated that at approximately 5:17 a.m., they saw the Blastco workers exit the upflow tower and throw a heat gun on the ground. The heat gun appeared to have been damaged by fire. One of the Blastco workers approached the Rimcor workers and alerted them to the fire. Two Rimcor employees looked up toward the upflow tower manway where Blastco had been working and could see fire inside the vessel. One Rimcor worker radioed the two Rimcor entrants inside the downflow tower to tell them to exit the tower, but received no response. The worker attempted to yell from the bottom manway and then went to the top of the D2 towers to attempt to make contact with the entrants from the upper manway. Black smoke was seen flowing out of the upper manway of the two towers and the Rimcor worker was unable to contact the two entrants. He then made his way back down.

The CSB recommends to Blastco to update its hot work policy and employee training program to specifically identify the use of heat guns as hot work. The policy and programs should make clear that hot work encompasses any method of work that can ignite a fire and not just spark- or flame-producing work methods.

In addition, there may be FRP applications in which the use of a heat gun is appropriate. The CSB concludes that Blastco should develop a policy, procedure, or guidance document on the correct use of heat guns in FRP operations. The CSB recommends that Blastco develop a policy and standard operating procedures for the proper use of heat guns in FRP operations.

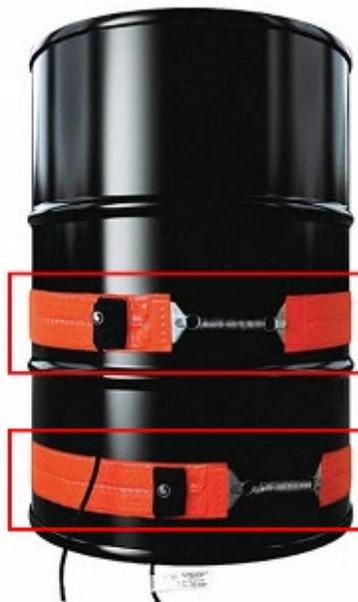
Third, Blastco employees told the CSB that on other jobs, to address the long gel times resulting from cold temperatures, they would apply heating bands to the 55-gallon resin drum to improve the cold weather performance of the resin (**Figure 7**).

Figure 7. Drum heaters. (Credit: Grainger [18].)

Blastco performed a post-incident inventory of its two job trailers and located two drum warmers. According to Blastco, the two drum heaters were located separately, one on each trailer. According to an employee, the company had recently begun renovating and reorganizing one of the trailers but was not yet finished at the time Blastco's work at Evergreen started. The employee stated that when he went to locate the heat bands on the night of the incident, the bands were not in their normal location and he could not locate them on the trailers.

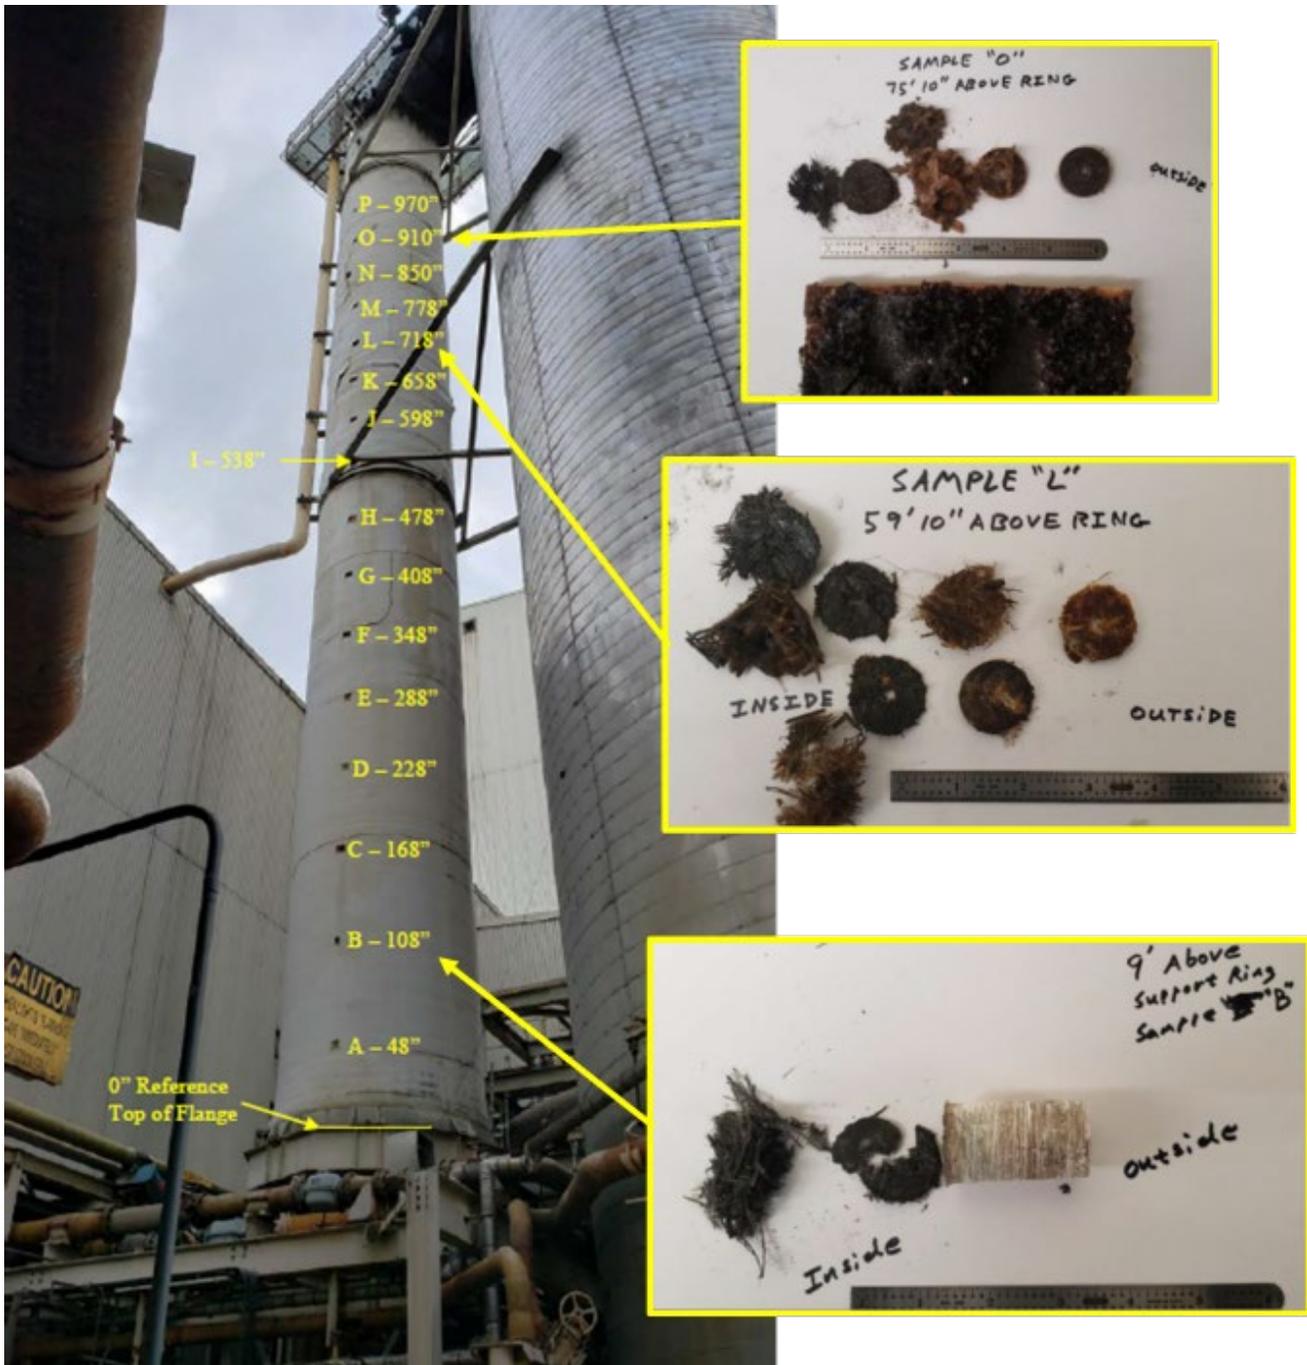
OSHA defines noncombustible materials as those materials which are not capable of burning or igniting. Since FRP is capable of burning in the presence of a flame, OSHA considers such material to be combustible[.] [9]

In order to determine the extent of the fire-induced damage sustained during the incident inside the upflow tower, 16 one- to two-inch circular core samples were removed from the side of the vessel (**Figure 10**). Blastco was working inside the tower from roughly the heights of sample "D" to sample "I." In the figure, the apostrophe symbol (') is used to notate feet and the quotation symbol (") is used to notate inches. During post-incident examination of the upflow tower, burn damage was found on the inside surface of the vessel's insulation near the top of the vessel.^a

Figure 10. Internal fire damage in the upflow tower. (Credit: Evergreen. Edited by CSB.)
