U.S. Chemical Safety and Hazard Investigation Board

Safety Bulletin

Key Lessons from the ExxonMobil Baton Rouge Refinery Isobutane Release and Fire

No. 2016-02-I-LA

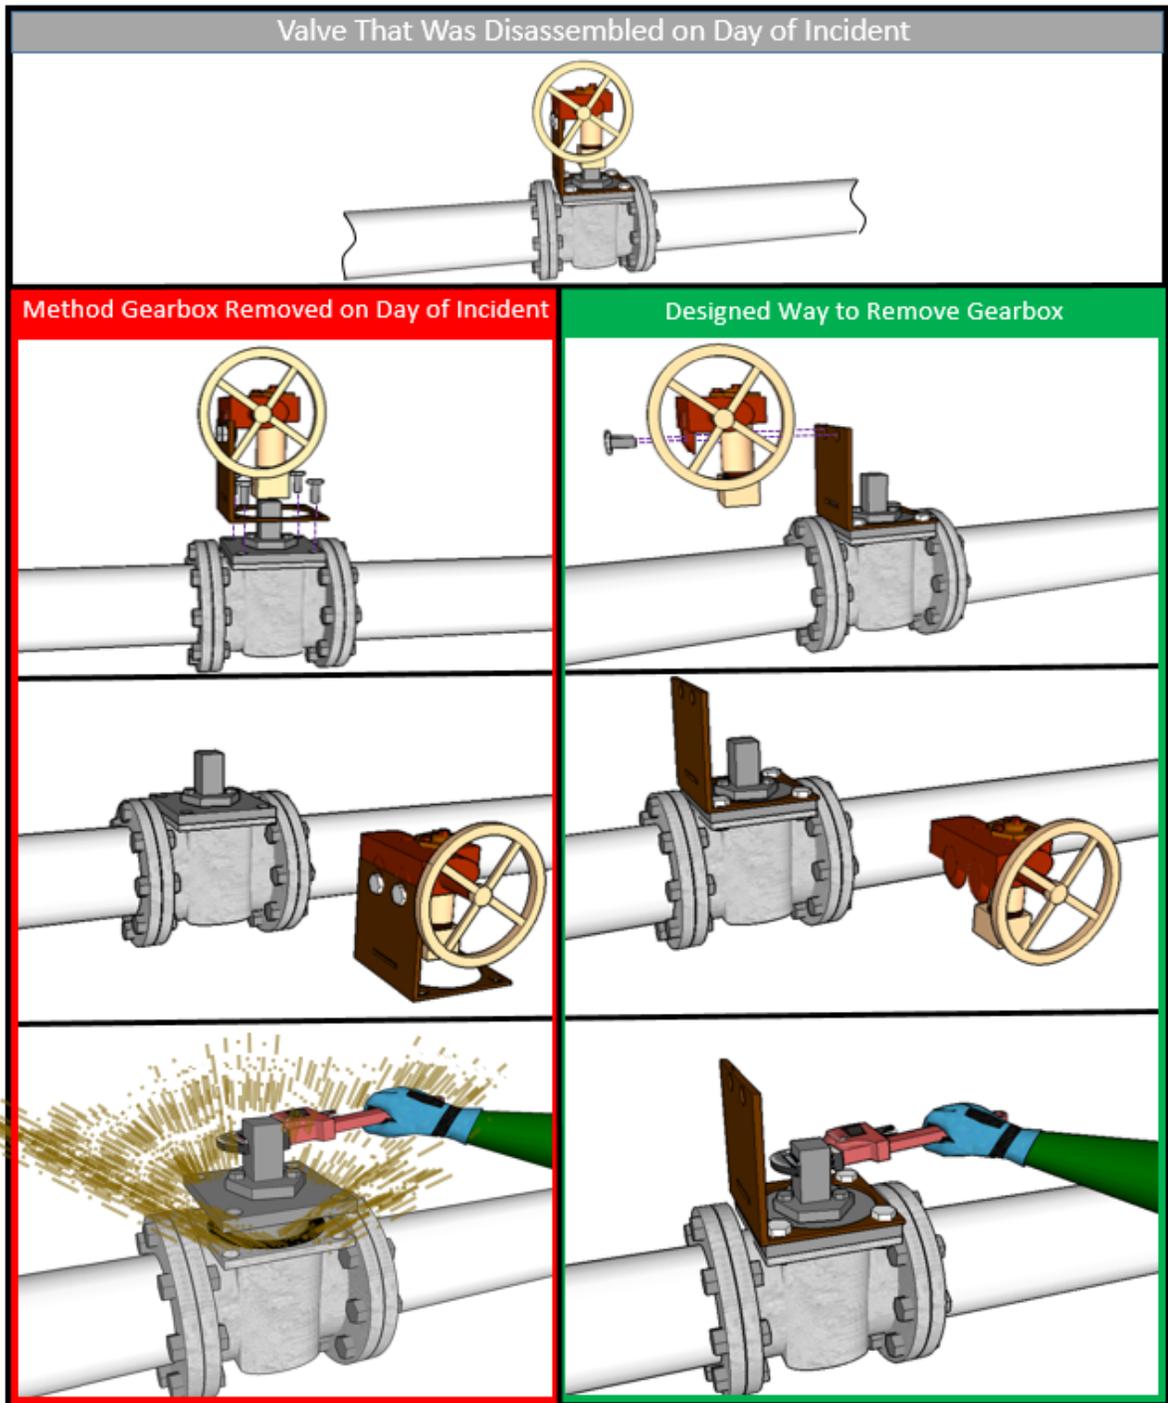
One of the operators removed the gearbox assembly so he could turn the valve stem with a pipe wrench to open the valve.¹⁰ Removing a malfunctioning gearbox from a plug valve is an accepted practice for alkylation unit operators.¹¹ To remove the gearbox, the operator removed the four vertical bolts that connected the gearbox support bracket to the valve body.¹² These four bolts, however, also secured the top-cap – a pressure-retaining component – to the valve body.¹³ The two horizontal bolts that could safely remove the gearbox from the support bracket remained in place. (Figure 3).

One of the operators then opened the valve by rotating the valve stem with a pipe wrench, while the other operator observed. With the four bolts removed from the top-cap, critical valve components were no longer held together. When the operator turned the valve stem, the plug valve loosened and came apart. Pressurized isobutane¹⁴ escaped from the valve body, forming a flammable white vapor cloud.

Figure 3. Gearbox removal. The left column illustrates how operators removed the plug valve gearbox on the day of the incident. It shows operators removed the entire support bracket. By design, removing the gearbox did not require removing the four vertical bolts that secured the pressure-retaining top-cap. The right column illustrates how the plug valve gearbox should be disassembled. The gearbox and handwheel could be disconnected from the support bracket by removing the two horizontal bolts on the side of the support bracket.

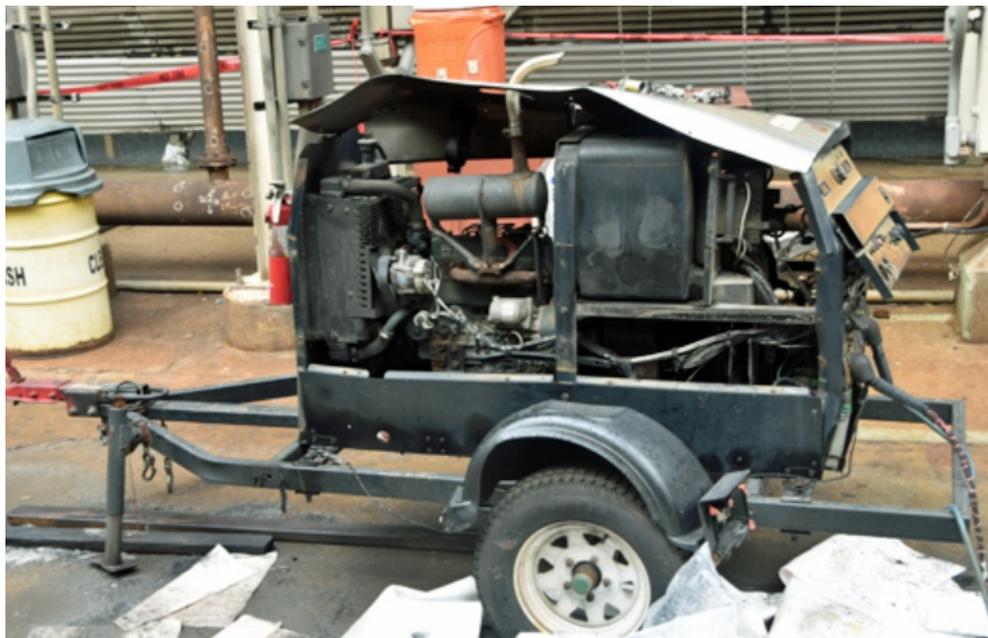
ExxonMobil estimated that 2,000 pounds of isobutane released into the atmosphere. Based on surveillance video, an energized welding machine located roughly 70 feet away likely ignited the vapor cloud. (Figure 4 and Figure 5). The resulting fire seriously injured one ExxonMobil employee and three contractors working in the vicinity of the release.¹⁵ Emergency responders isolated the release and extinguished the fire about 25 minutes after the initial ignition.

Figure 4. Welding machine that was the likely ignition source of the isobutane vapor cloud.

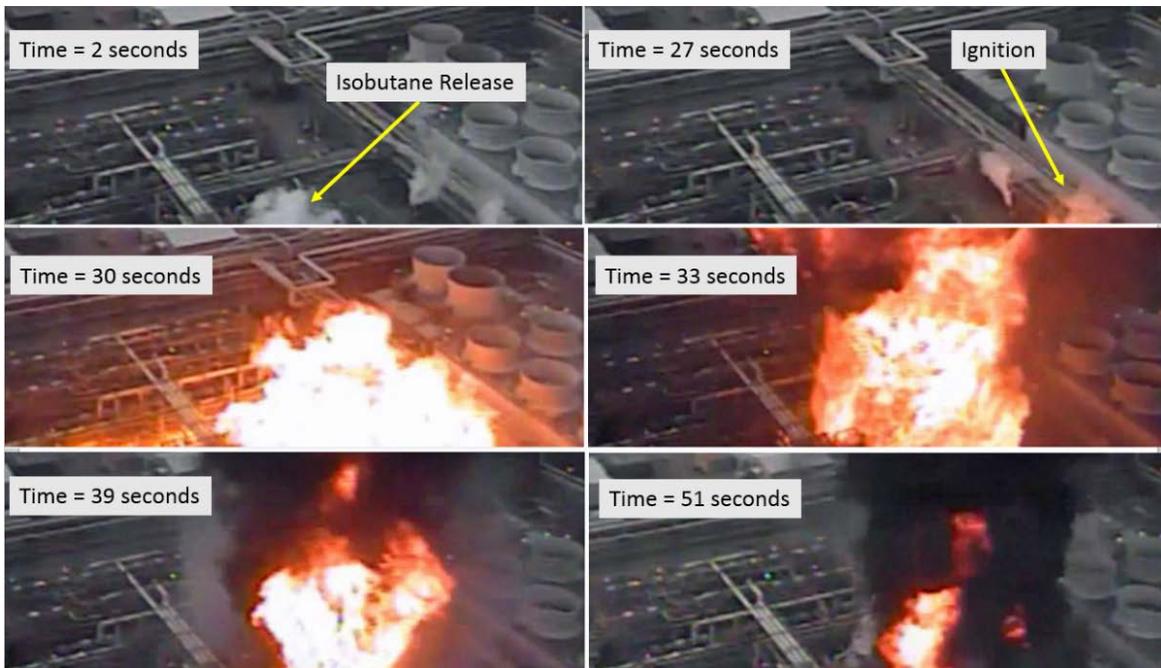
Figure 5. Sequence of events. Baton Rouge refinery security video clips showing the isobutane release and subsequent fire. This sequence does not show time zero – the first indication of the isobutane vapor cloud.

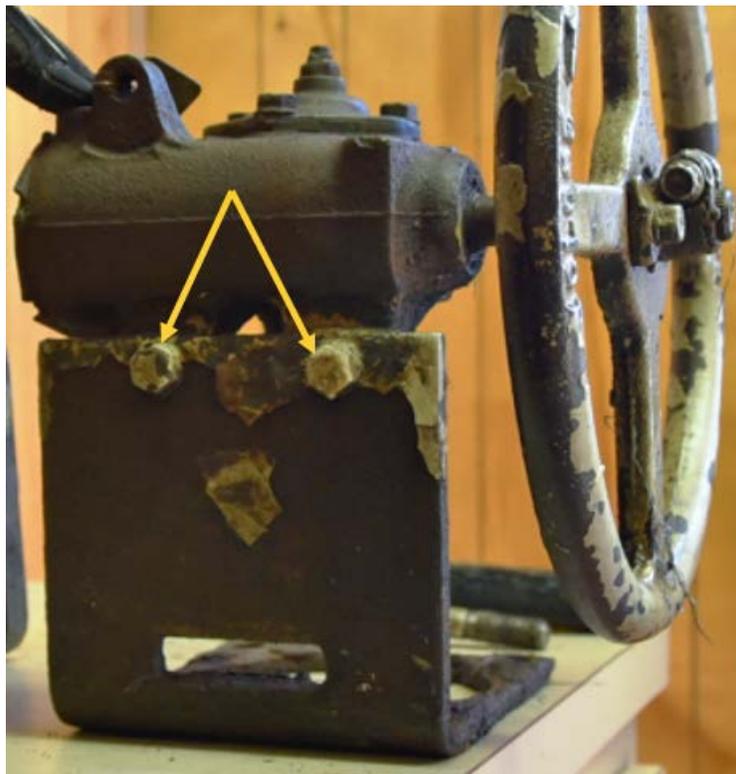
The gearbox involved in the incident conformed to this part of the standard because it *could* be removed without removing any pressure-retaining parts. The operator could have removed the two horizontal bolts that connect the support bracket directly to the gearbox, rather than the four vertical bolts that secure the support bracket to the pressure-retaining top-cap (as shown on the right side of Figure 3 and in Figure 6). But the operator did not remove these two horizontal bolts; instead, he removed the four vertical bolts, which he believed to be the correct bolts to remove.

Figure 6. Gearbox support bracket for the valve involved in the incident. The two horizontal bolts (yellow arrows) can be removed to take the gearbox off the support bracket and the valve without disturbing the top-cap bolts. By removing the gearbox in this manner, the pressure-retaining valve components are not disturbed.

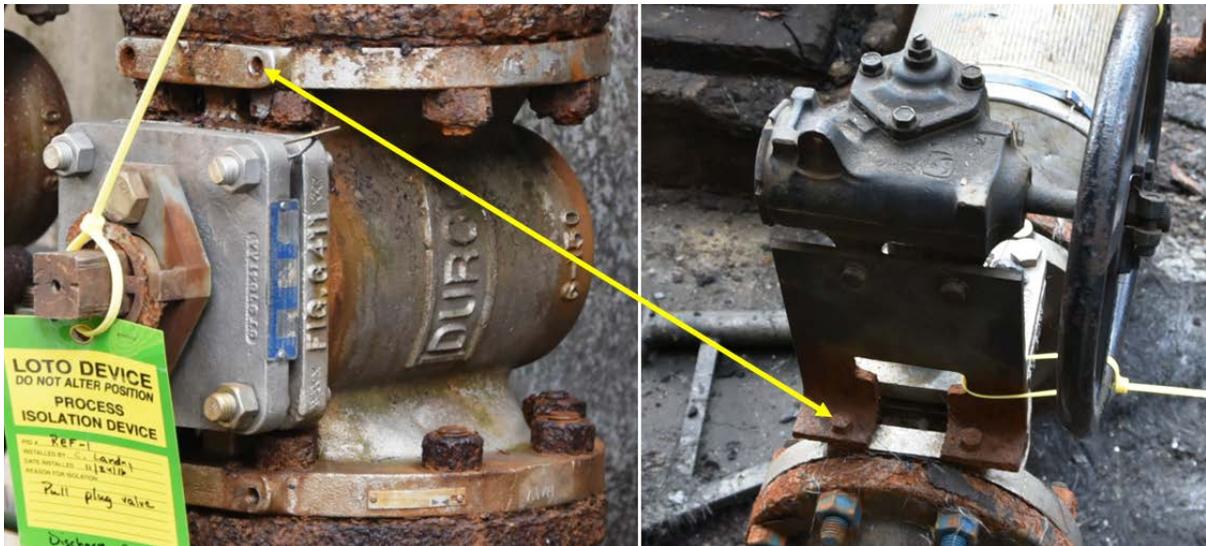
The CSB learned that the plug valve manufacturer (Durco) updated the plug valve design in 1984 so that the gearbox support bracket could be attached to the valve using different bolt connections than those that secure the pressure-retaining top-cap to the valve body. Approximately 97 percent of the plug valves located in the Baton Rouge refinery's alkylation unit are the more recent Durco plug valve design, which secures the gearbox assembly to the valve body flanges. (Figure 7 and Figure 8). With this improved design, the gearbox support bracket is unlikely to connect to the pressure-retaining top-cap, which can help prevent future incidents.

Figure 7. The improved plug valve design includes an additional four gearbox support bracket holes separate from the pressure-retaining top-cap (located on the valve body flanges) as seen at the yellow arrows. The photo on the right shows a gearbox support bracket attached to the valve body flange for a valve that was not involved in the incident. The photo on the left shows a different plug valve in the alkylation unit with its gearbox removed.

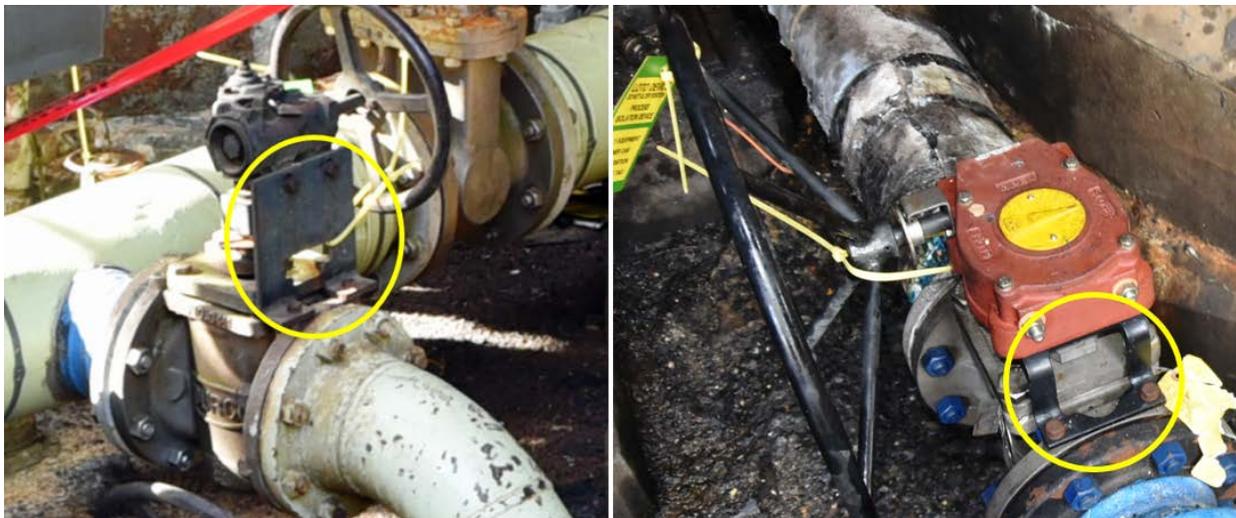
Figure 8. Two of several designs of gearbox support brackets (yellow circles) used at the Baton Rouge refinery. These specific brackets attach to the valve body flange – they are not among the approximately three percent of valves in the alkylation unit that attach the gearbox support bracket using the same four vertical bolts that secure the pressure-retaining top-cap.

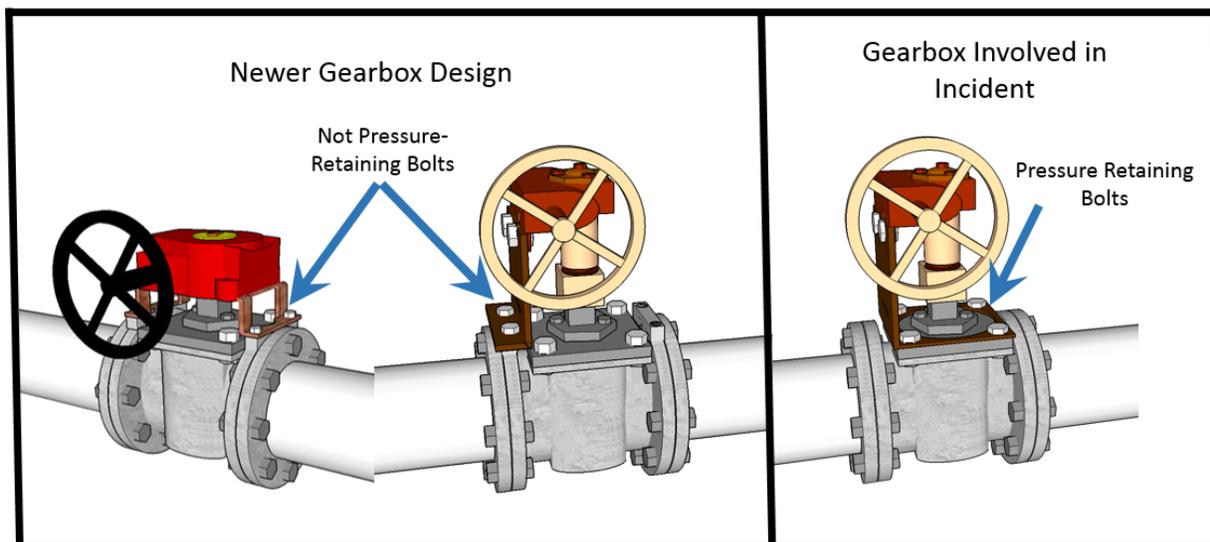
The location of the bolts on the newer valve design may have also contributed to the operator removing pressure-retaining bolts. On the newer design, the bolts connecting the support bracket to the valve are vertical, and are usually removed in order to remove the gearbox and handwheel. In describing how to remove a gearbox from this type of plug valve, an alkylation unit operator explained, “I would only have to pull those [vertical] bolts right there and the whole thing would come off.” Although another operator recognized that there were two different ways to remove the plug valve gearbox, there was not a preferred method. While looking at a photo of a plug valve to explain how to remove the gearbox, the operator said either the horizontal or the vertical bolts could be removed.

For the less common, older valve design, the vertical bolts were the pressure-retaining bolts and should not be removed; instead, the horizontal bolts should be removed to disassemble the gearbox and handwheel safely. (Figure 9 and Figure 10). It could appear as though these critical vertical bolts had to be removed to take the inoperable gearbox off the valve. Although other bolts allowed for gearbox removal without touching the critical pressure-retaining bolts, this design can lead to potentially

catastrophic consequences. The CSB concludes that poor equipment design was a significant factor that led to this incident.

Figure 10. Comparison of newer gearbox attachment designs, which are among the approximately 97 percent of the gearboxes in the alkylation unit, and the gearbox involved in the incident. Importantly, the improved valve design connects the gearbox support bracket to dedicated connection points on the valve flange as shown in the left illustration.

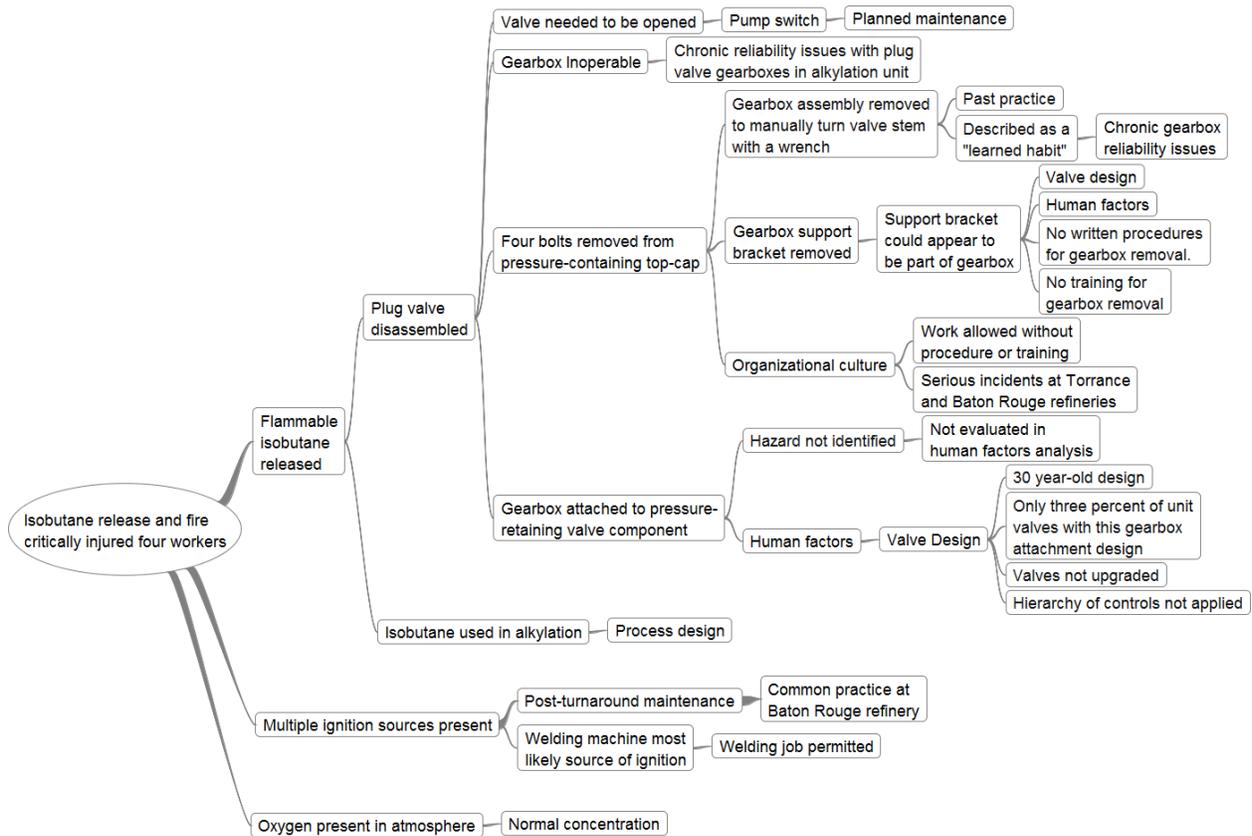
Figure 12. Simplified causal analysis of the November 22, 2016 incident at the Baton Rouge refinery.
