U.S. Chemical Safety and Hazard Investigation Board

ExxonMobil Torrance Refinery

Electrostatic Precipitator Explosion Torrance, California

No. 2015-02-I-CA

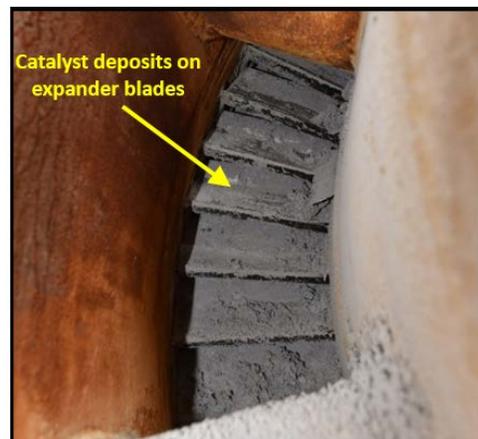
The gas that flows through the expander contains a small amount of catalyst particles that may, over time, build up on the expander blades (Figure 10). Uneven distribution of this buildup causes the expander to vibrate excessively, which can cause significant damage to the expander. Torrance refinery instrumentation monitored the vibration of the expander so that when the expander vibration increased to a certain level, operators could clean the catalyst buildup from the expander blades.

On the morning of Wednesday, February 11, 2015, the FCC expander started to experience increased vibration. On Thursday, February 12, 2015, workers cleaned the expander blades,²⁷ and this temporarily reduced the expander vibration. Three days later on Sunday, February 15, 2015, however, the expander again began to experience high vibration.

FIGURE 10
Catalyst buildup within expander. Photo was taken post-incident in 2015.

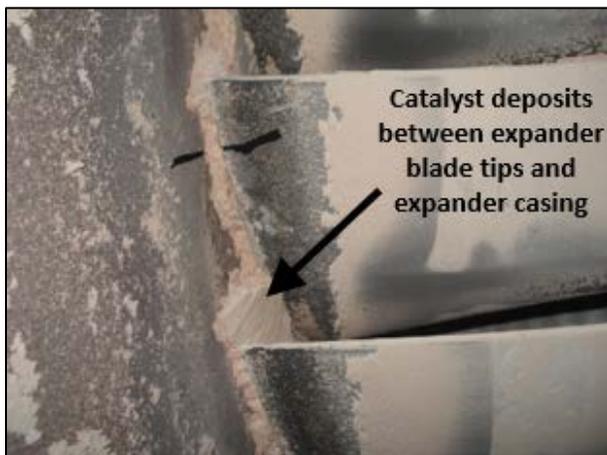
FIGURE 14

ExxonMobil personnel predicted the expander could not restart due to catalyst buildup between the expander blades and casing. Photo taken following expander outage in 2012.

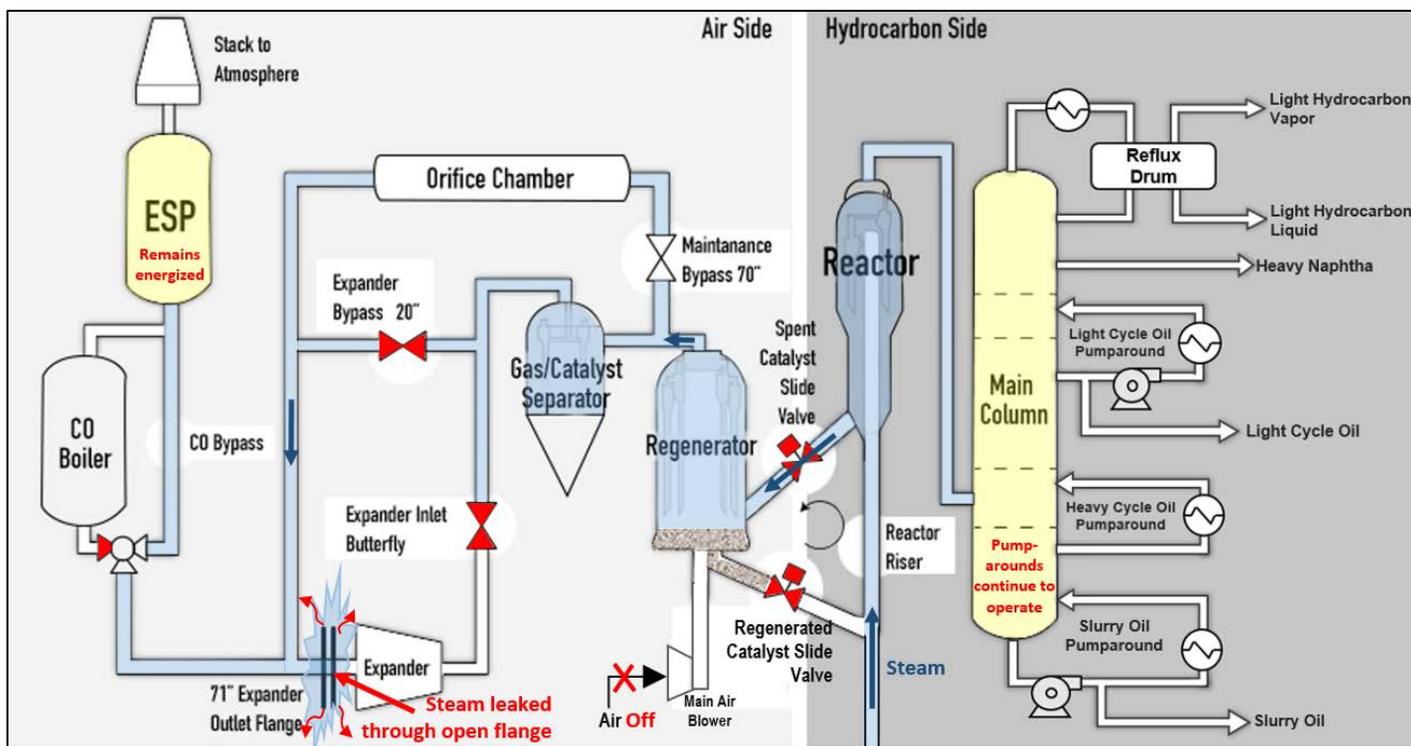
FIGURE 15

On the morning of Wednesday, February 18, 2015, ExxonMobil maintenance workers approached the open flange to install the blind. They did not install the blind, however, because at that time steam was escaping from the open flange, and they were concerned about their safety (Figure 15). Steam leaking from the flange indicated that the SCSV, one of the safeguards specified in the Variance, did not fully seal and there was no catalyst barrier present. Post-incident, the CSB identified meeting notes written on the Wednesday morning prior to the incident by an ExxonMobil manager overseeing the expander maintenance that questioned, “Does the leaking spent slide valve invalidate the Variance?” The sequence of events leading to the incident, discussed below, indicate that ExxonMobil management decided to continue isolating the expander while the unit remained in Safe Park even though it was known that the SCSV was leaking.

On the morning of the incident, steam leaked out of the open expander outlet flange. Steam from the reactor had leaked through the eroded SCSV, through the FCC unit air side piping and equipment, and out of the open flange.

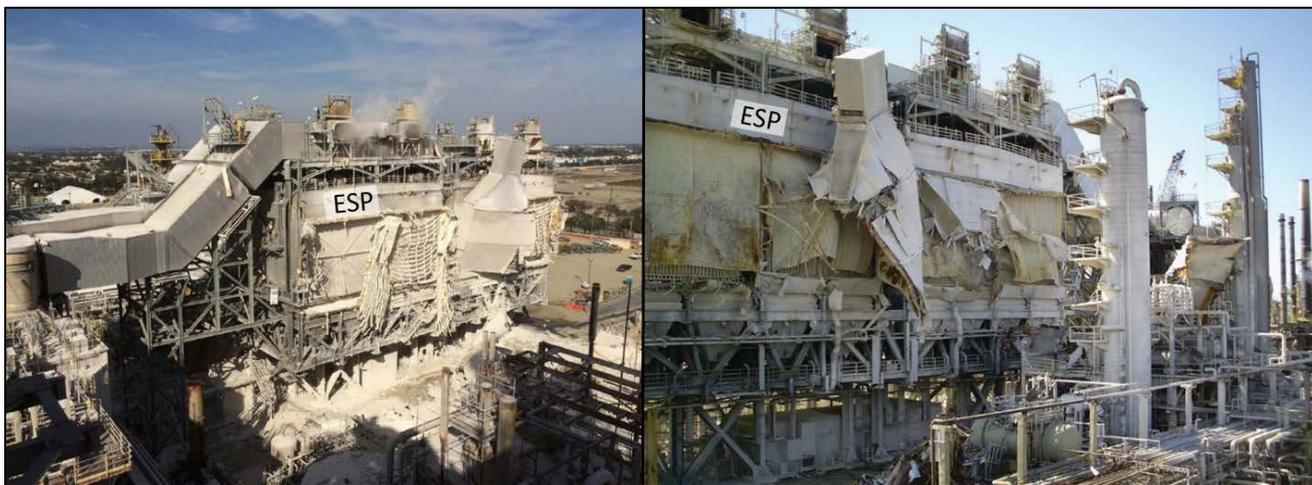
FIGURE 18

The explosion severely damaged the ESP (Figure 18). Debris from the explosion hit equipment near the ESP, causing two small fires and multiple leaks of flammable liquids. The explosion debris also punctured a heat exchanger that was out-of-service. Four contract employees who were working nearby sought first aid for injuries sustained while fleeing the area. Debris also fell on a building frequently used by operators, though was unoccupied at the time. In addition, catalyst dust was reported outside of the refinery property in the nearby community.^{36,37}

Damage to the ESP from the explosion. White catalyst dust from the ESP is visible on the ground in left photo.

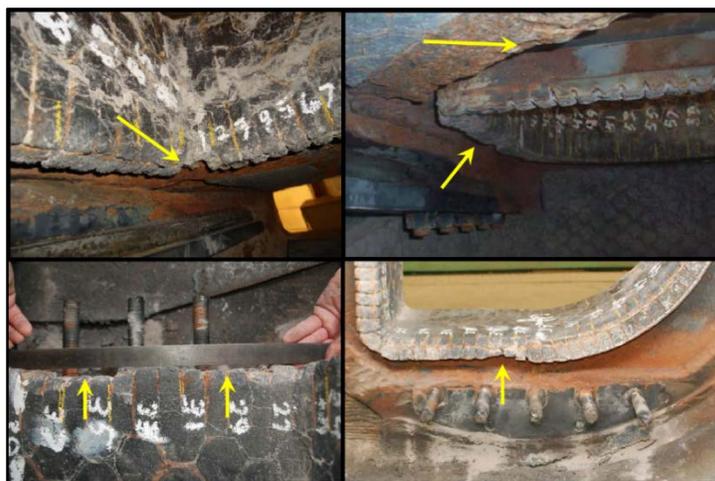
In Safe Park, the catalyst leaked through the closed SCSV, which was severely eroded from six years of operation and did not form a catalyst seal.

Following the February 18, 2015 incident, the CSB inspected the internal components of the SCSV. The inspection found the valve internals to be severely eroded to the point that the valve could not seal. An area of approximately 16 square inches eroded away during six years of operation, providing an open path for catalyst to flow through the valve even when in the fully closed position. The erosion prevented the closed SCSV from developing the necessary catalyst barrier on the day of the incident. Photos of the erosion identified in the SCSV are shown in Figure 23.

FIGURE 23
SCSV erosion identified post-incident

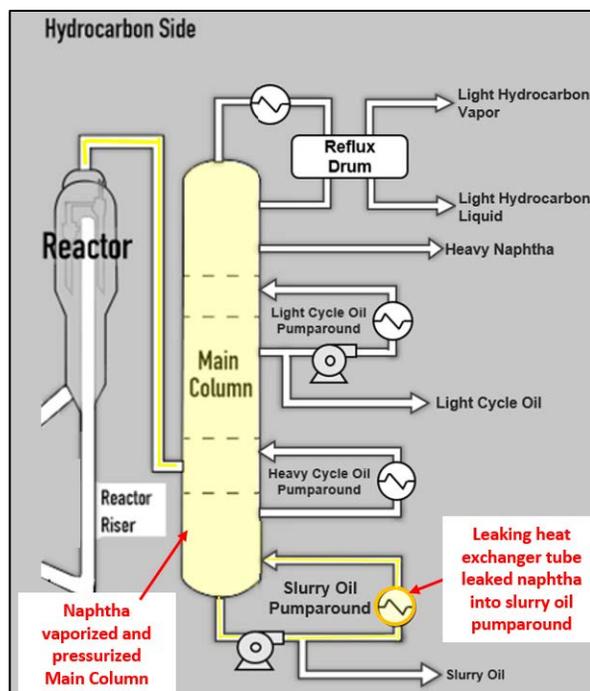
FIGURE 28

The heat exchanger that leaked naphtha into the slurry oil pumparound was one of two heat exchangers that provided heat to a distillation column in a neighboring unit. The heat exchangers were designed so that one heat exchanger could be operated while the second heat exchanger remained on standby. The standby exchanger was clean and ready for use when the operating heat exchanger had to be taken offline for cleaning, inspection, and maintenance.

Leaking heat exchanger tube allowed light naphtha to enter main column.

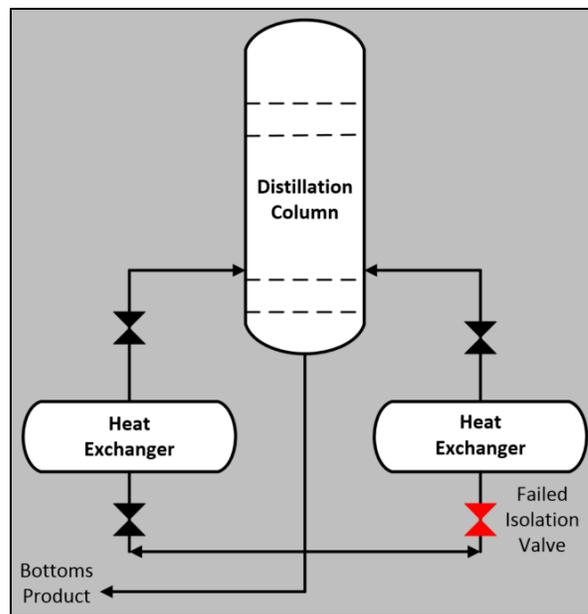
FIGURE 30
Heat exchanger shell-side path showing isolation block valve that would not close

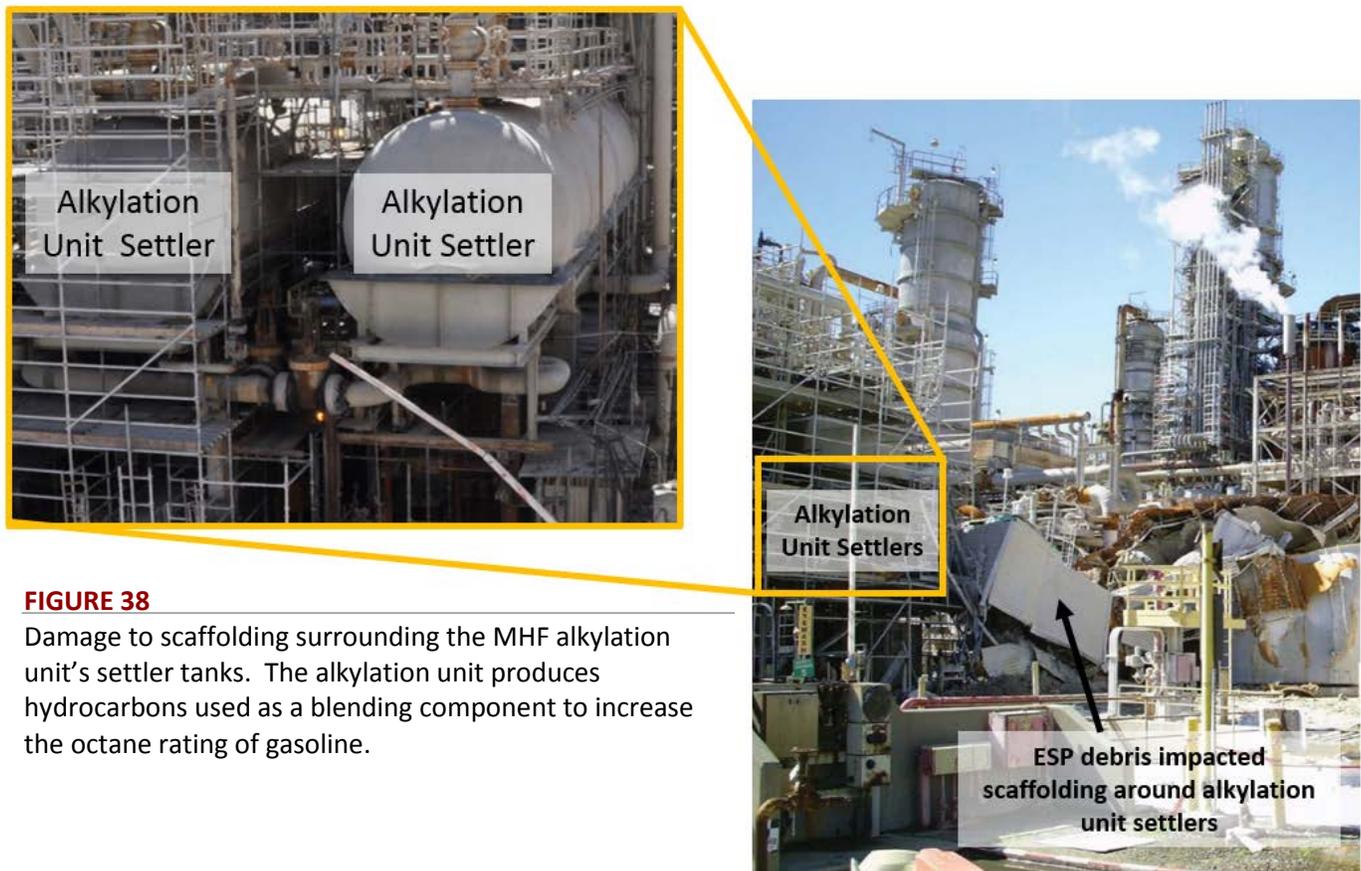
FIGURE 38

Following the ESP explosion, a portion of the ESP fell to the ground. A large fragment struck scaffolding⁵⁹ surrounding the MHF alkylation unit.⁶⁰ This scaffolding was located within a few feet of the alkylation unit's settler tanks⁶¹ (Figure 38), each containing hydrofluoric acid (HF), water, hydrocarbons, and a chemical additive intended to reduce the amount of HF vaporized during a loss of containment event.⁶² Discussed previously, the CSB has issued subpoenas for safety information pertaining to the potential release of HF in the event the tanks were struck by explosion debris, and is pursuing enforcement of the subpoenas in US Federal district court.⁶³

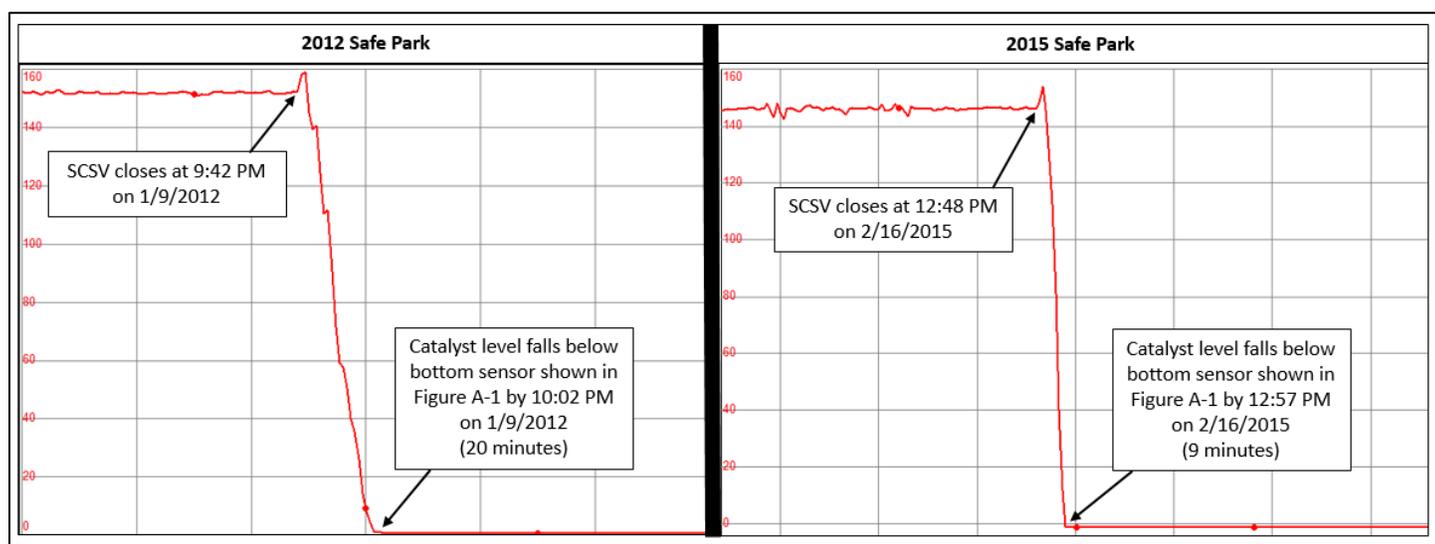
In both the 2012 and 2015 transitions to Safe Park, when the Spent Catalyst Slide Valve (SCSV) closed, the reactor catalyst level fell below the bottom sensor shown in Figure A-1. In 2012, it took 20 minutes for the catalyst level to fall below the bottom sensor, and in 2015 it took 9 minutes (see Figure A-2). This likely indicates that the fully closed SCSV was leaking both in 2012 and 2015. The leak rate in 2015 was likely faster due to the advanced erosion of the SCSV. Industry experts have informed the CSB that SCSVs may leak, even when the SCSV is new and has not been eroded by catalyst.

FIGURE A-2
In both 2012 and 2015, catalyst leaked past closed SCSV when unit entered Safe Park. In 2012, catalyst level fell below level sensors shown in Figure A-1 in 20 minutes. In 2015, catalyst level fell below level sensors shown in Figure A-1 in 9 minutes.

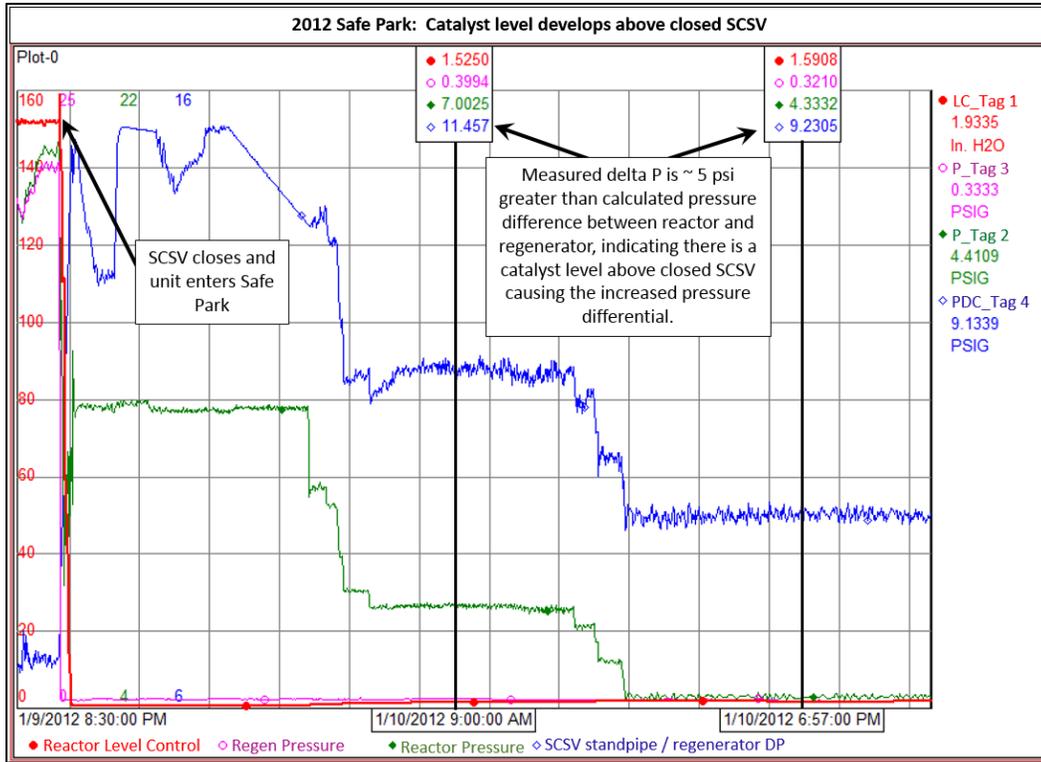
FIGURE A-4

In 2012, measured SCSV standpipe/regenerator differential pressure exceeded calculated reactor/regenerator differential pressure, indicating that catalyst had accumulated above the closed SCSV.
