U.S. Chemical Safety and Hazard Investigation Board

## E.I. DuPont de Nemours & Co Inc.

### Flammable Vapor Explosion

Welding on Tank Containing Vinyl Fluoride (1 Killed, 1 injured)

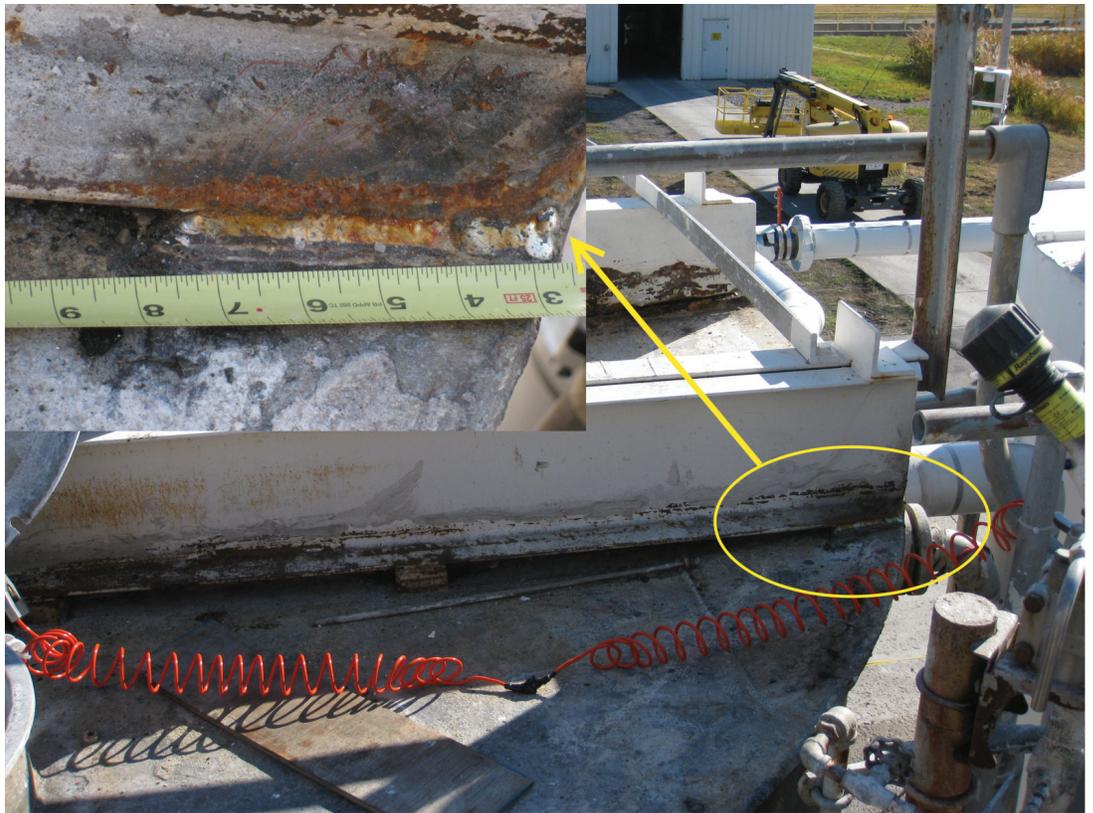
**FIGURE 4.**

Repair weld on agitator support beam to the slurry tank 2 top plate

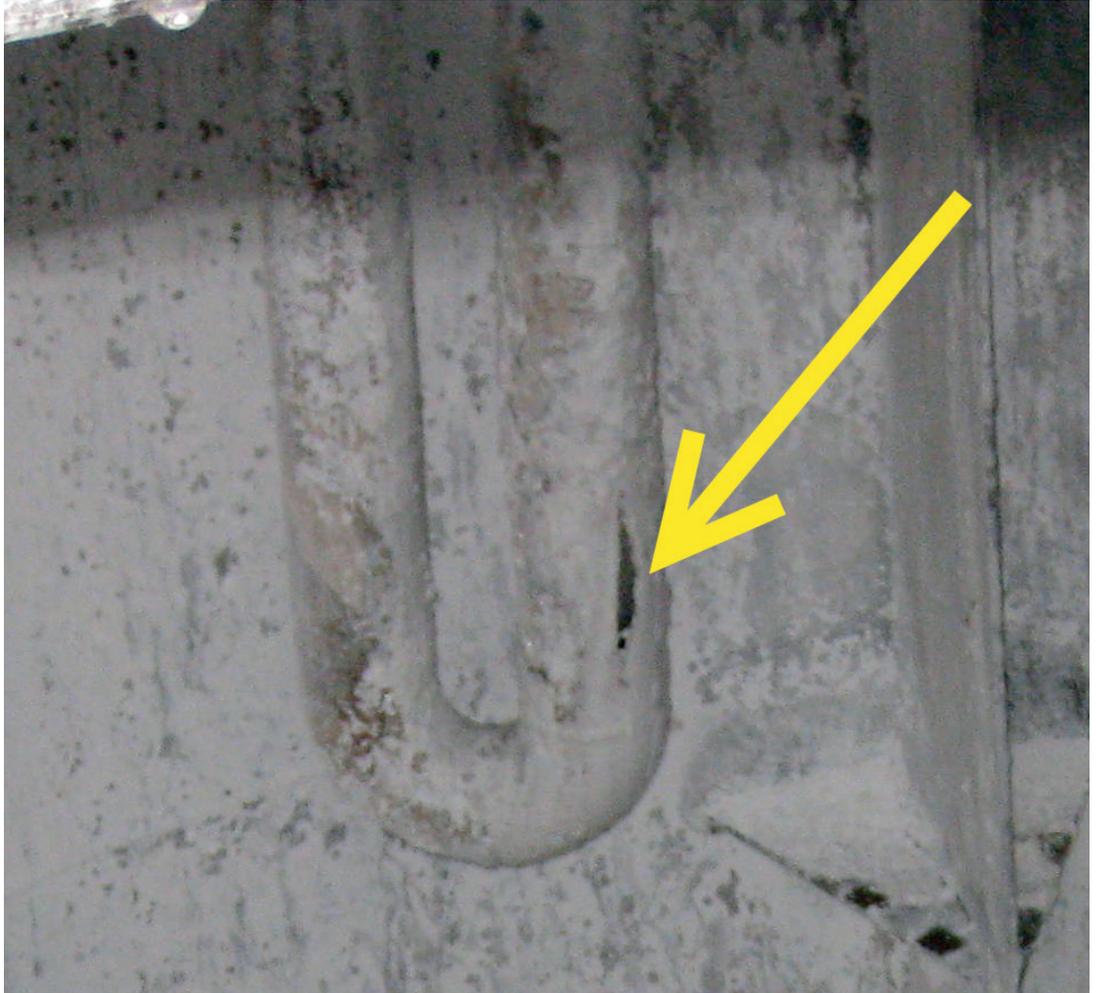
**FIGURE 5.**

During the tank 2 internal inspection on November 3, DuPont engineers discovered that the U-leg seal loop on the flash tank overflow line had a “fishmouth” split in the pipe (Figure 5), likely the result of the PVF water slurry freezing in the line. The engineers concluded that the slurry tank could be returned to service without repairing the split. DuPont engineers who saw the broken seal loop concluded its likely purpose was to limit steam in the flash tank from flowing into the slurry tanks. They further concluded that the operation was safe and that the broken seal loop presented no hazards. No acknowledgement was given to the fact that flammable VF gas had a pathway into the slurry tanks, an area classified as “low hazard” and not expected to contain any flammable materials. DuPont engineers scheduled a repair on this seal loop during the next planned unit outage. No management of change (Section 4.7.2) was carried out for the process to continue with this compromised seal loop.

Fishmouth split on seal loop pipe inside tank 2

the flash tank had an open path to slurry tank 2 through the cracked seal loop. VF from the flash tank was the main source of flammables on the day of the incident.

After DuPont personnel noticed the cracked seal loop, DuPont technical engineers decided not to repair the loop until the next turn around. If DuPont had included the slurry tanks and slurry flash tank overflow line in their PSM program they would have been required to fix the cracked seal loop before restarting the unit or ensure that the cracked seal loop posed no safety hazard.
