ANALYSIS OF HORSEHEAD CORPORATION MONACA REFINERY FATAL EXPLOSION AND FIRE

JULY 22, 2010

Prepared for the US Chemical Safety Board (CSB)

By William H Hunter MA MIMMM CEng.
Metallurgical Consultant.

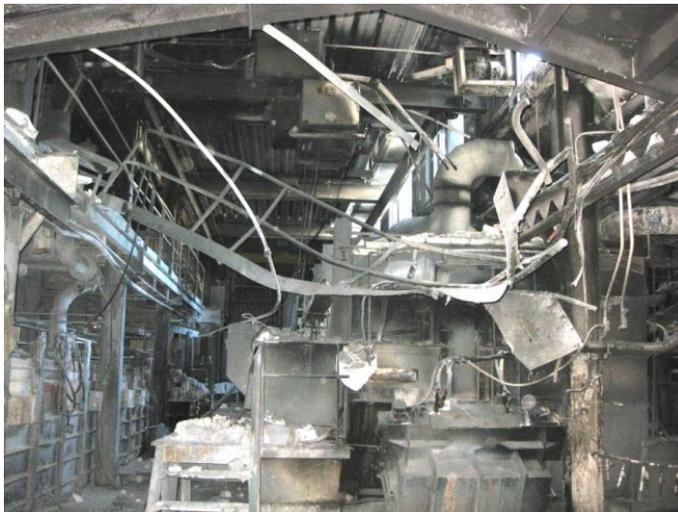
This photograph shows a typical scene within the plant after the explosion and fire. It is a general view showing damaged plant and equipment, all covered with a zinc oxide ash.

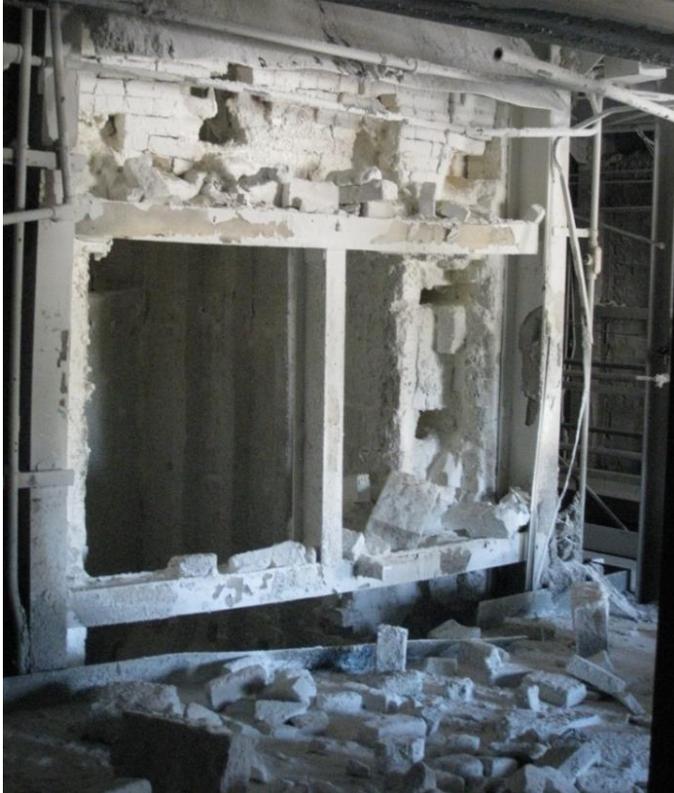
This photograph shows the combustion chamber wall of column B, and the site of the explosion, the pressure relief panels being blown out into the workplace.

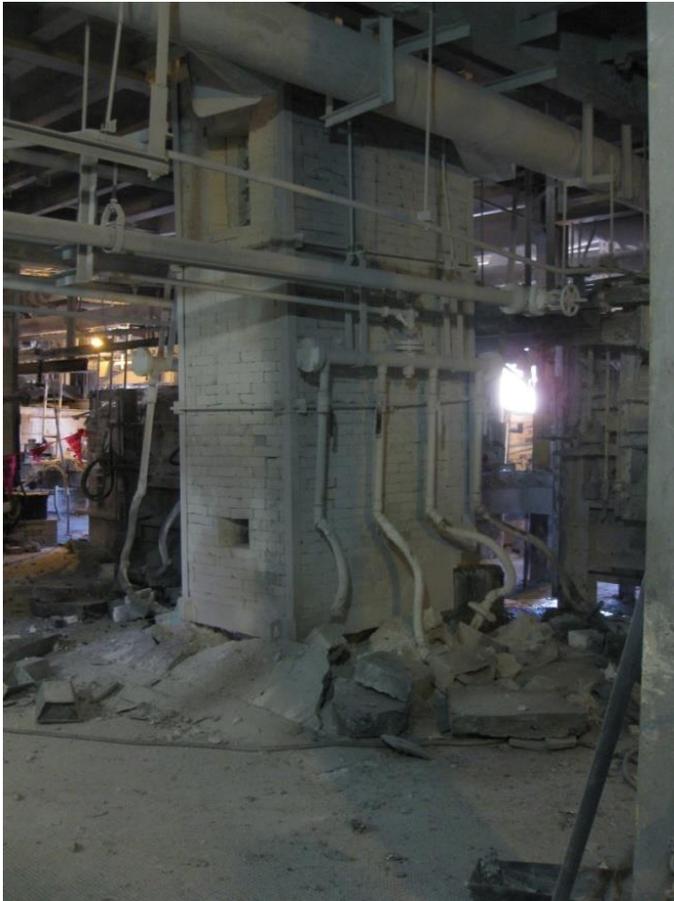
This photograph shows the reflux tower after the explosion. The trays in the combustion chamber have collapsed but the reflux tower is largely undamaged, having dropped a few feet such that the framework for the reflux section insulation was sitting on the combustion chamber roof.

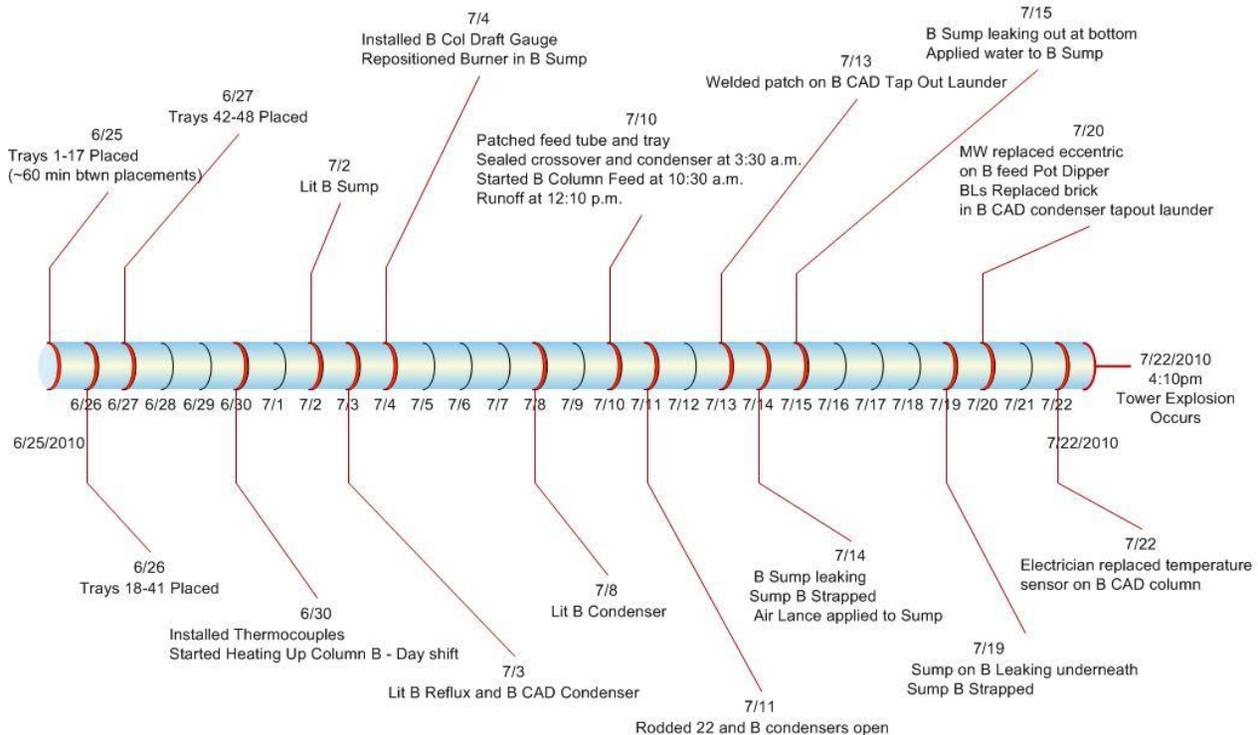
Horsehead Corporation B Column Timeline Juneⁿ 25, 2010 – July 22, 2010

July 22, 2010, 4:10pm, Tower Explosion Occurs

- Although the timeline shows the sump burner being lit on 2 July, the Column Heat-Up log [Ref: 6 and shown in Appendix I] shows the sump temperature well below target; this continued right through the warm-up with the highest temperature recorded being 380°C on 6 July; temperatures well below the target of 650°C continued for the last few days before feed. The sump burner is the means to warm the column from the *inside* and to dry any mortar in the sump or under tray #1.

- The timeline shows B sump leaking (suggesting blockage) being strapped on 14 July and an air

lance being applied to the sump. Leaks occurred again on 15 July. Further strapping took place on 19 July when the sump leaked. Clearly there were continuing problems with the sump. On the basis of the ladle logs, the feed rate to column B was being increased over this period; more feed means more run-off (strip metal) needing to exit the sump.

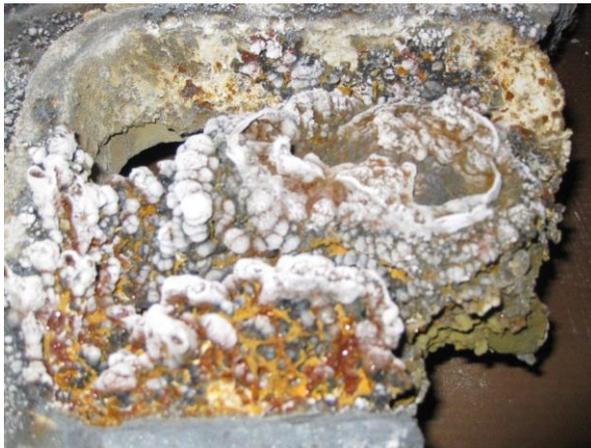
Photograph apparently of material in centre hole of tray #1 of B column. Assays were primarily in the range 95-99% ZnO (zinc oxide), balance mainly zinc, with one sub-sample at 77.6% ZnO, 11.1% zinc silicate, 7.3% Zn and 4% zinc aluminate (overall analysis 95.9% Zn, 3.1% Si and 1% Al.)

These are similar to those for material found in the sump throat of 26 column (exploded 1996), figures for two samples being 97.8% and 97.2% ZnO.

12. The analysis of material found in the bottom tray was primarily zinc oxide, with small traces of silicate and aluminate, which would have come from mortar or tray debris. It is most likely that this was formed *after* the explosion. The main sump blockage was, in my opinion, likely caused by a zinc oxide plug restricting the flow much lower down under the sump underflow.

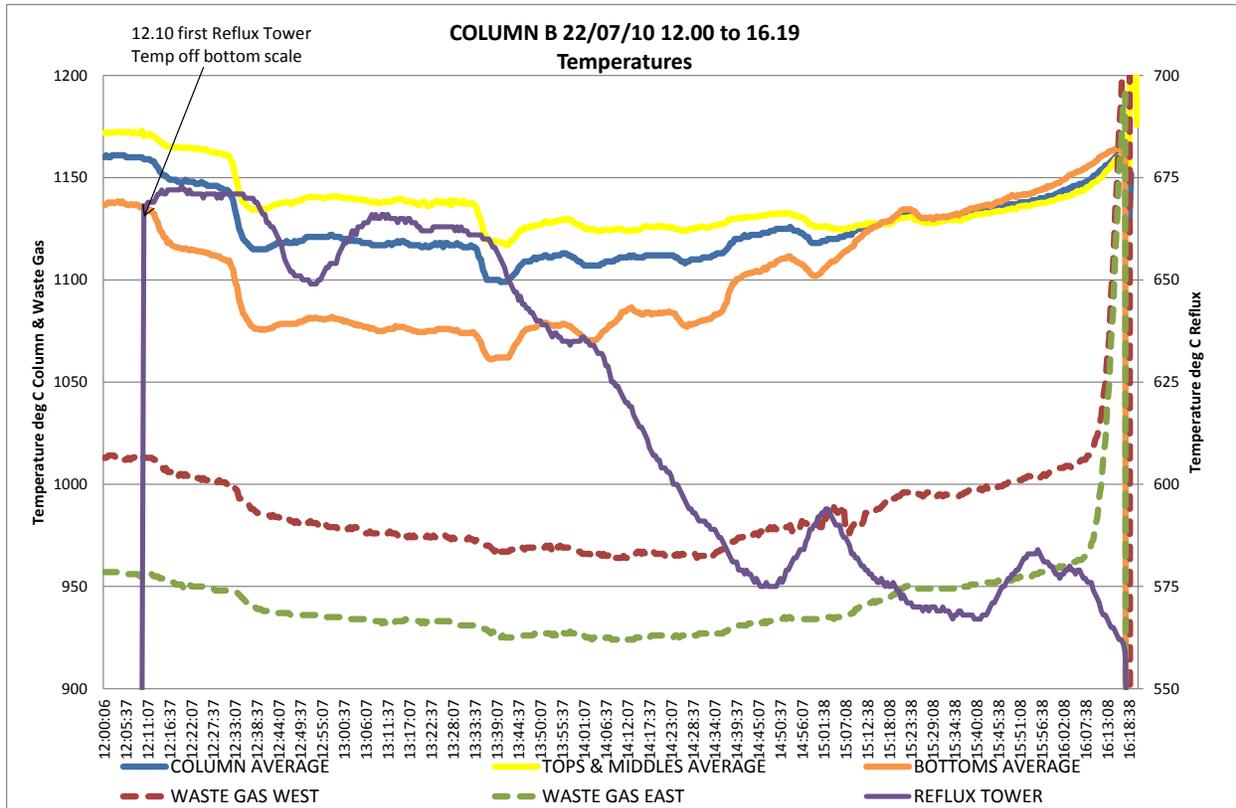
The points to note are:

- The first time that the reflux temperature (the control point for condensate) showed correctly in the life of the column was 12.10 on July 22 2010, just four hours before the explosion. In my professional opinion, for a key control thermocouple not to be available for a matter of days is not acceptable and is an example of inadequate attention to process control and safety. It contributed to the fact that condensate production had been far too high [Ref: Int. 11] up to this point, resulting in the operator reducing gas input (shown on the next chart).

- Temperatures are erratic, partly but not completely caused by changes to gas input.
- The reflux appears to have been lost, even with subsequent increases to gas input. This behaviour was noticed in the investigation [Ref: 1, p. 19] of the Noyelles-Godault explosion of January 1994. – to quote “The crossover temperature stops oscillating and initiates a long decrease (from 700°C to 500°C in 2 hours).”

- The final part of the chart shows the “alarm” period leading to the explosion.

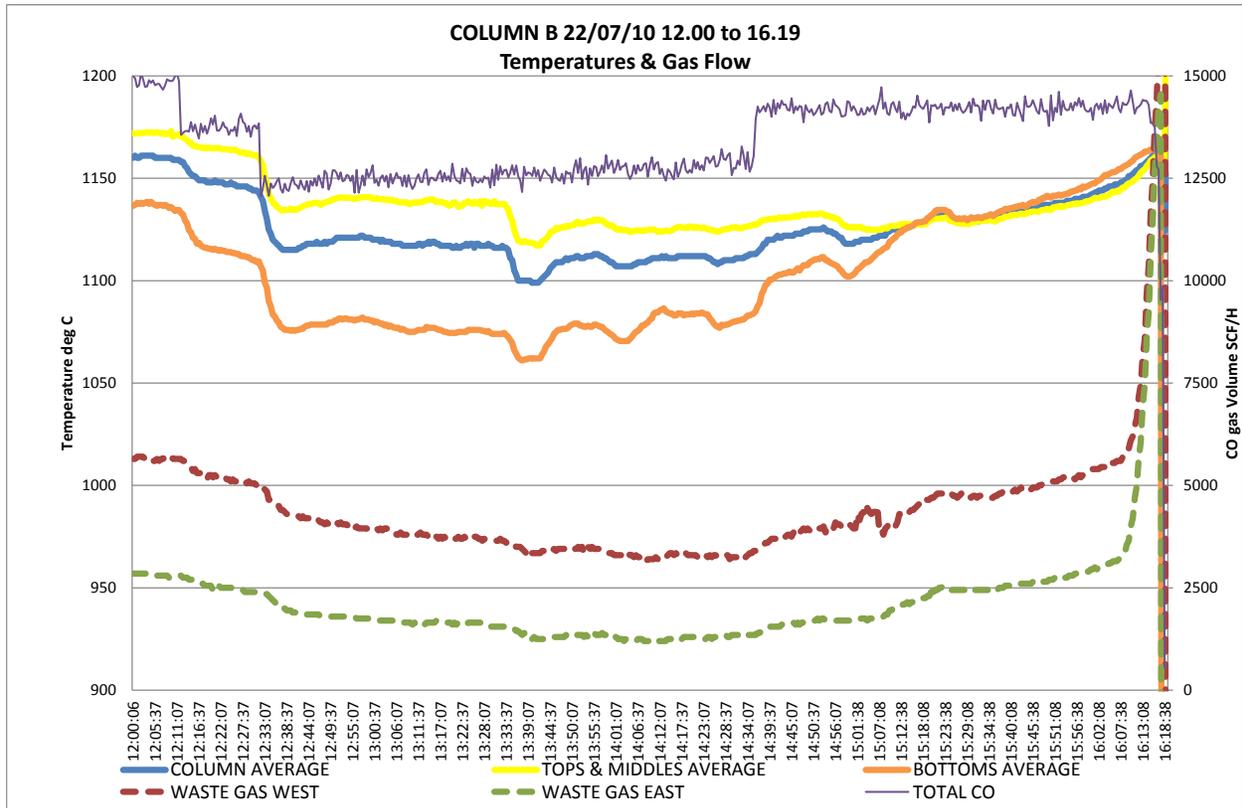
The second chart shows that the gas input changes will have influenced the temperature trends but, in my opinion, do not account for the rising *relative* trend of bottom and waste gas temperatures.

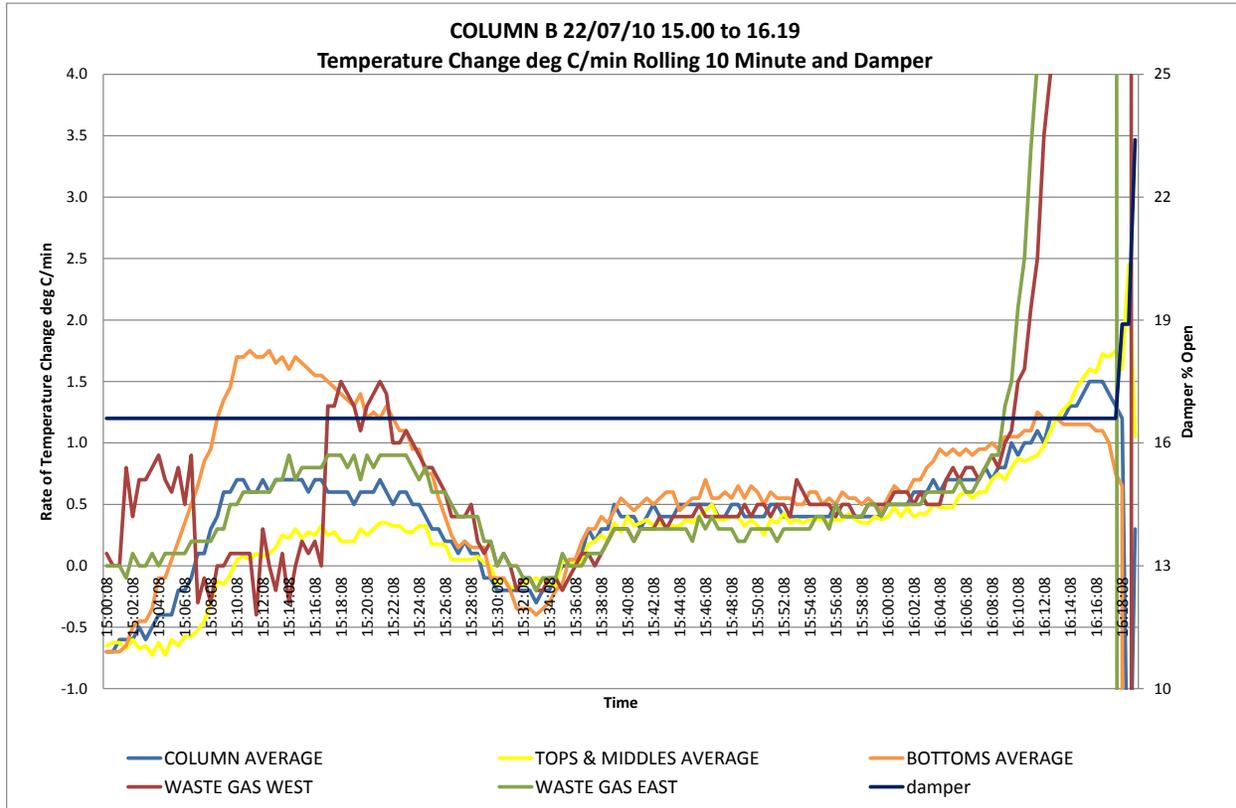
We can see that, leaving aside the final rapid rate of temperature rise (the alarm period), and a short period of relative stability around 15.30 to 15.36, all the column and waste gas temperatures

were rising for a prolonged period at a significant rate. The bottom temperatures were rising at a slightly faster rate than the other temperatures.

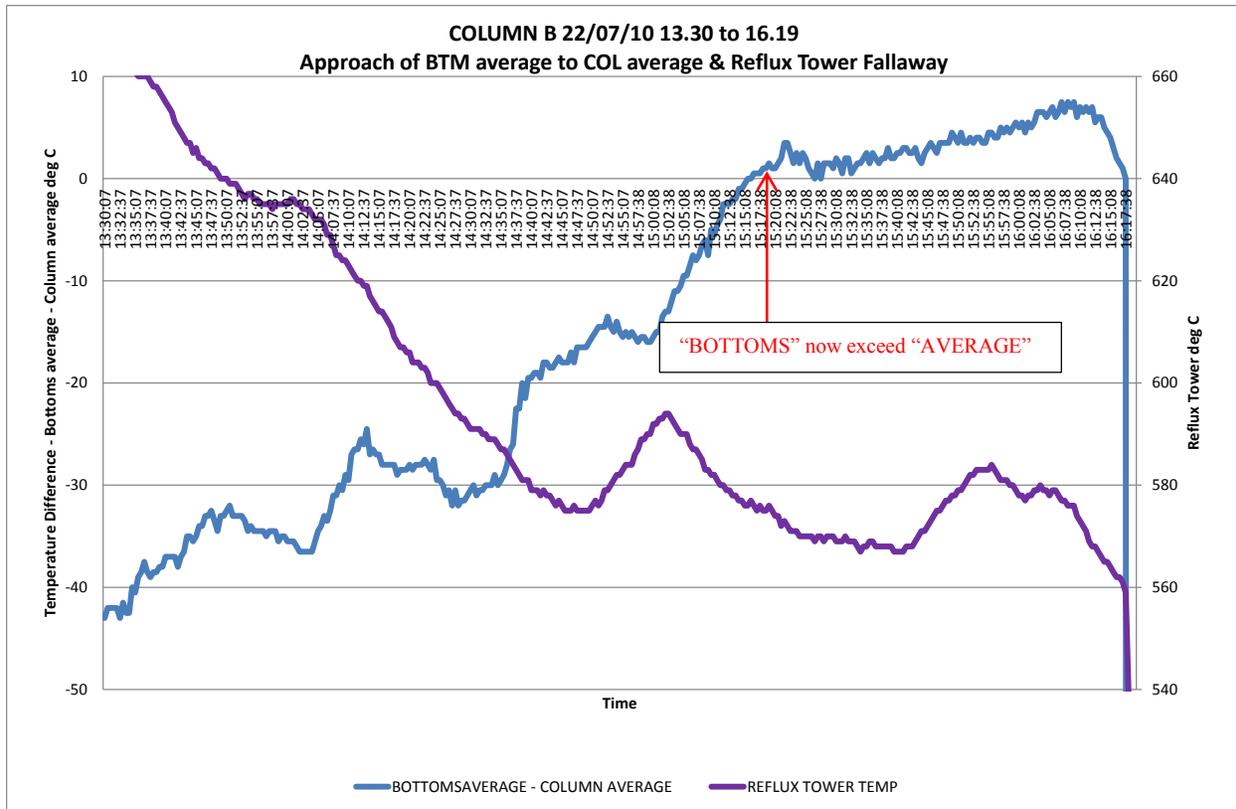
Because *all* column temperatures were rising slowly it is easier to see the worrying trend by examining the *relative* movement of bottom temperatures compared with the column average in the chart below. The timescale of this rising of bottom temperatures (starting at around 13.30) is similar to the start of the decline in the reflux temperature.

5. The temperature charts constructed from the DCS data show a clear anomaly with the B column temperatures from at least an hour before the explosion; bottom and waste gas temperatures were rising, the former to a point higher than the column average. This cannot be explained by variations in CO gas quality or the changes to gas input to B column. It is not clear as to why this was not observed on the control room computer screen – it is understood that the paper chart recorders for the main column temperatures no longer worked [Ref: Int. 17], but that the charts were on the bottom of the computer screen [Ref: Int. 18]. The number of individual combustion chamber thermocouples combined with their temperature movements due to gas quality changes would, however, have made it more difficult to see the clarity obtained from the penultimate chart in section IV.I.IV. This still raises the question as to what training operators had been given to recognise these temperature trends as indicating possible blockage and backfilling.

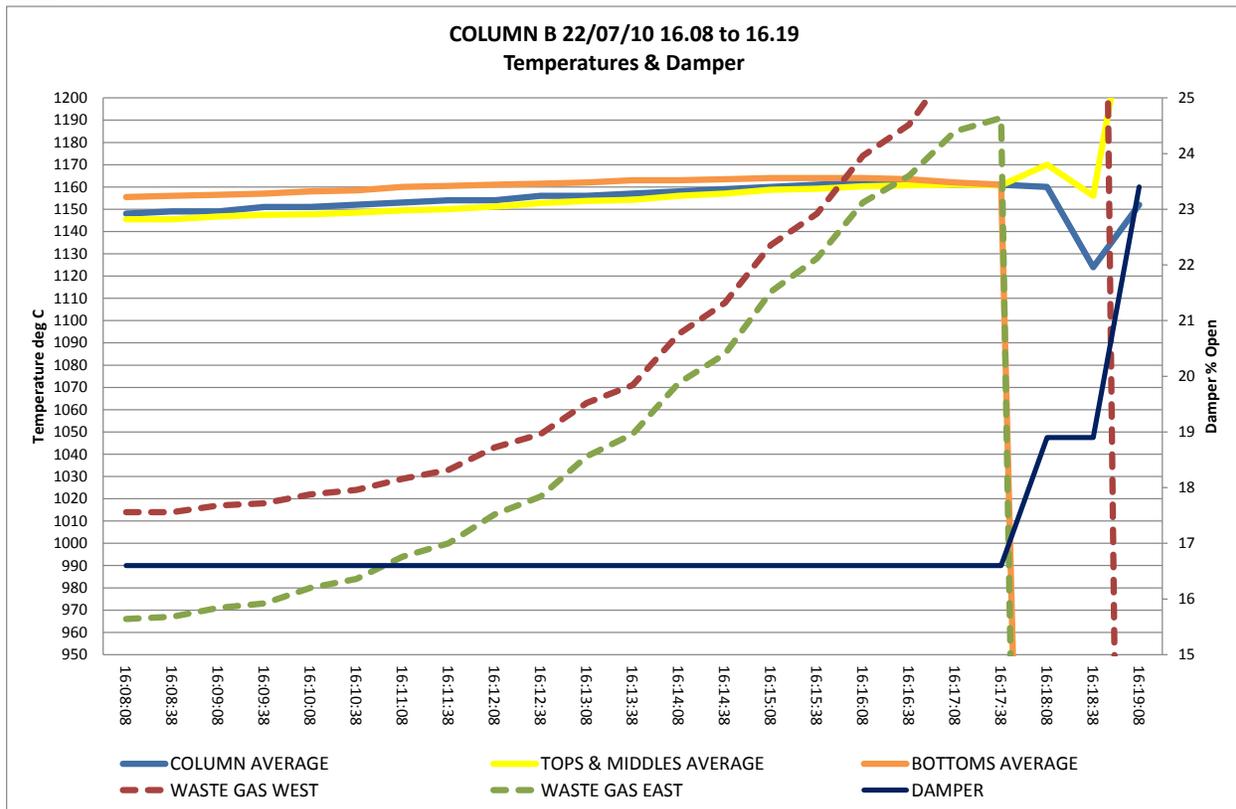
The final chart shows B column temperatures and column damper position over the final 10 minutes.

Here we can see that the position of the bottom combustion chamber average temperature continues above the column average until the final moments of the column. It can be seen that in the final moments the damper starts to open, probably as a result of the failure of the suction gauge in the combustion chamber. It is therefore a matter of speculation as to whether the damper opening influenced the final explosion or not.
