U.S. CHEMICAL SAFETY AND HAZARD INVESTIGATION BOARD

## Pesticide Chemical Runaway Reaction Pressure Vessel Explosion

**BAYER CROPSCIENCE, LP**

Report No. 2008-08-I-WV  
January 2011

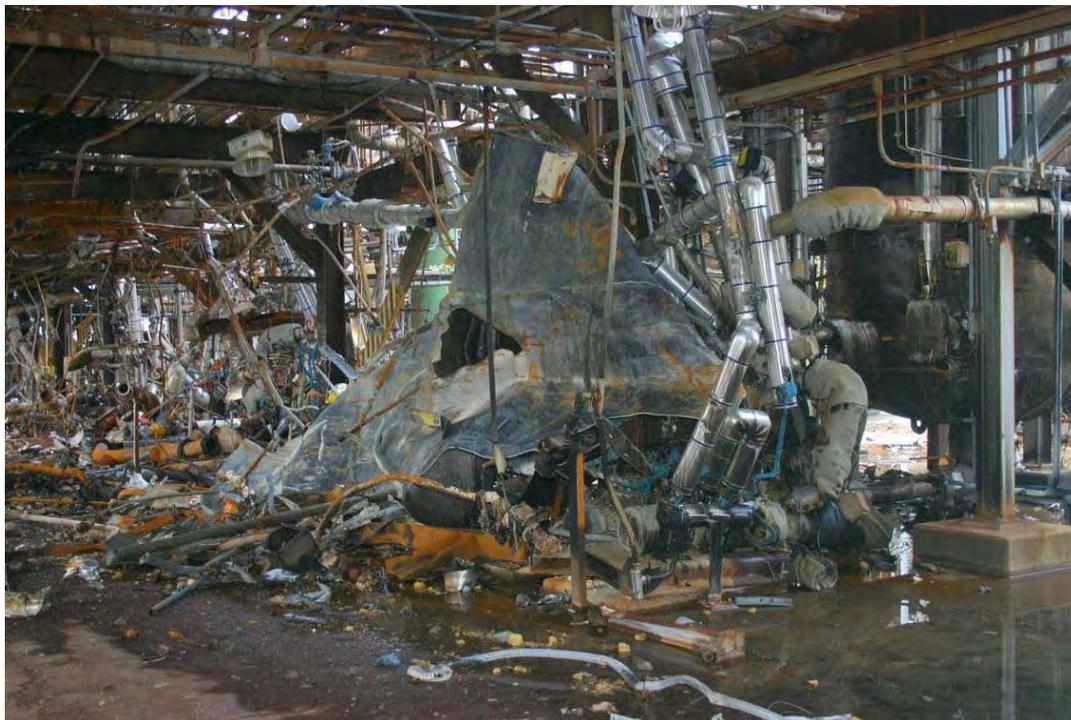
Debris was thrown in all directions, some hundreds of feet. The 5,700-pound residue treater ripped out piping, electrical conduit, and a structural steel support column as it split apart and careened northeast into the Methomyl-Larvin production unit structure (Figure 1). The blast overpressure moderately damaged the unit control building and other nearby structures. Flying debris struck the protective steel shield blanket surrounding a 6,700-gallon methyl isocyanate (MIC) “day tank” located about 70 feet southwest of the residue treater (Figure 2), but did not damage the day tank. The steel blanket also protected the MIC day tank from the radiant heat generated by the nearby fires that burned for more than 4 hours.

Figure 1. Residue treater came to rest inside the Methomyl-Larvin unit

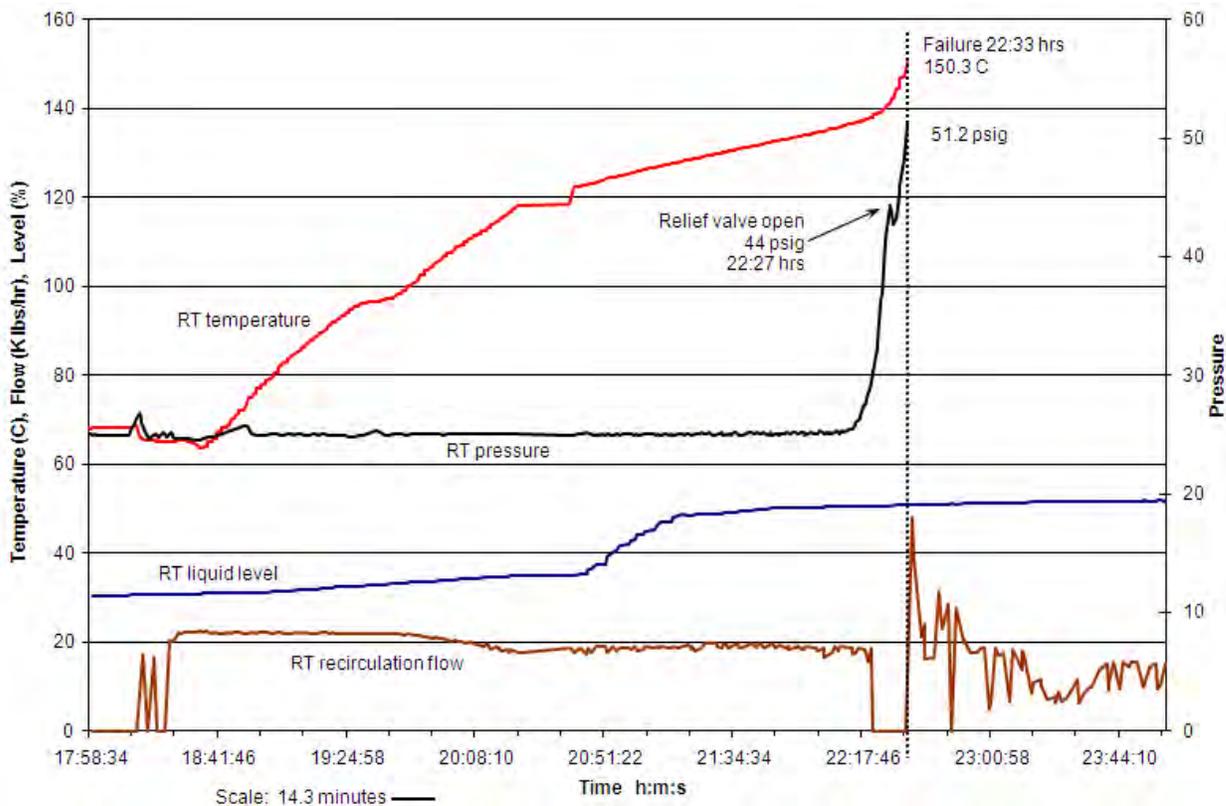
ranged between 60 and 65 °C (140-149 °F), still significantly below 135 °C (275 °F), the critical decomposition temperature. The pressure remained constant at 22 psig. At 6:38 p.m., the temperature began steadily rising about 0.6 degrees per minute (Figure 11). At 10:21 p.m., the level was 51 percent when the recirculation flow suddenly dropped to zero.<sup>30</sup> In less than 3 minutes, the temperature was at 141 °C (286 °F), rapidly approaching 155 °C (311 °F), the safe operating limit, and climbing at the rate of more than two degrees per minute.

Figure 11. Residue treater process variables before the explosion. Failure occurred at 22:33, as shown at vertical dotted line

<sup>30</sup> A Bayer review after the incident determined that the split-range temperature control was incorrectly programmed in the DCS. In the process of changing from heating to cooling, the residue treater recirculation flow valves to both the heater and cooler closed, blocking all recirculation flow. However, the CSB concluded that this was not causal to the runaway reaction and vessel rupture.

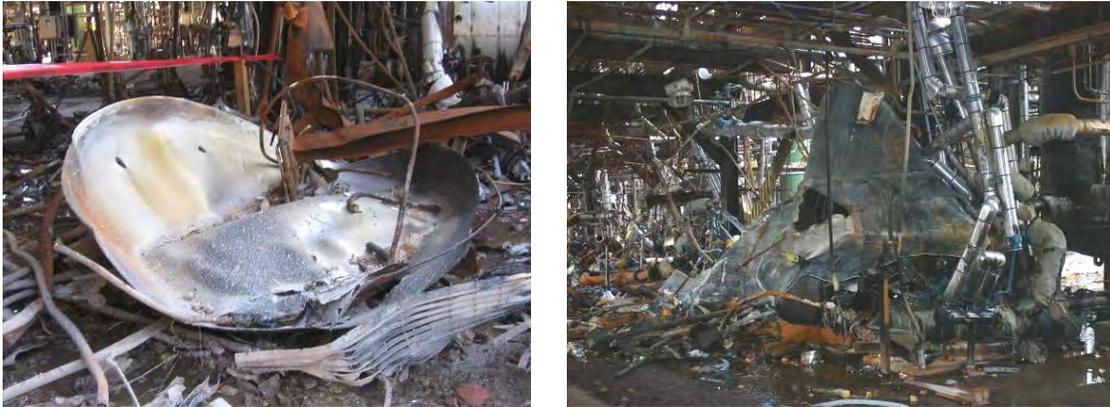
Figure 12. Residue treater bottom head (left); vessel shell and top head (right)

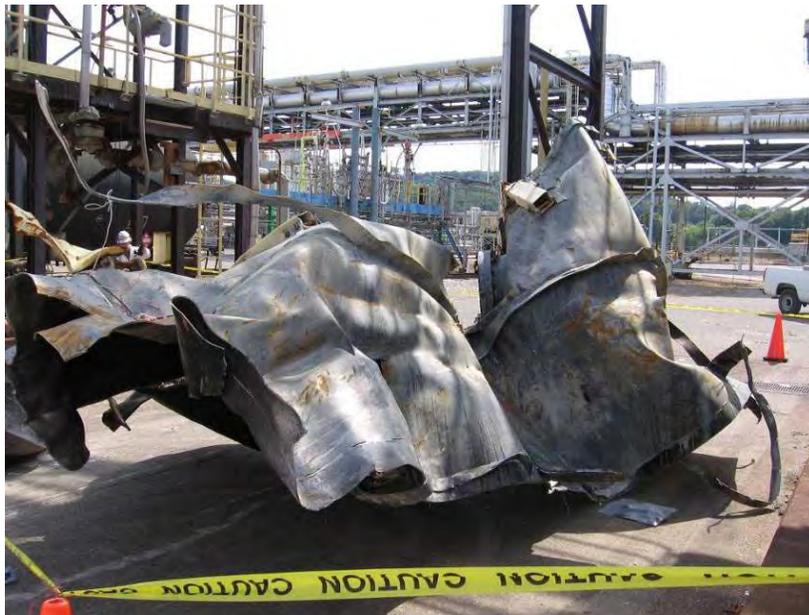
Figure 13. Residue treater shell and top head recovered from inside the Methomyl-Larvin unit

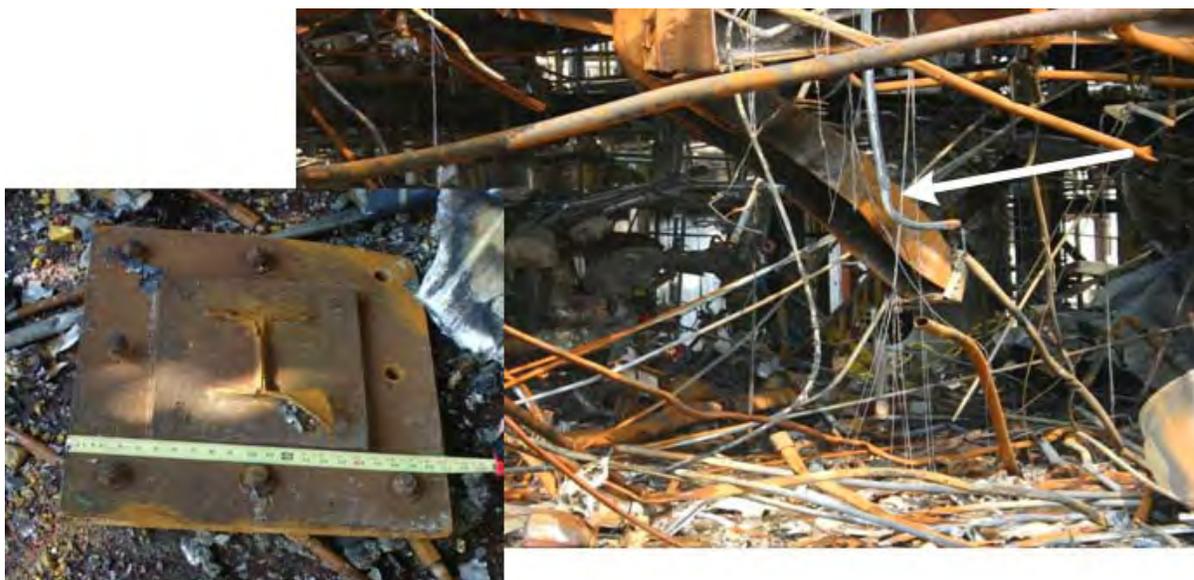
The residue treater struck a large support column on the four-story process unit structure and sheared it off the baseplate on the concrete foundation (Figure 14). Small debris, including conduit, valves, small diameter pipe segments, and insulation, was thrown in all directions, some of which struck, but did not penetrate the MIC day tank blast blanket. The blast blanket also functioned as a heat shield to protect the tank and attached piping from the intense solvent-fueled fire.

Figure 14. Structural column (arrow) ripped from the steel baseplate (left)

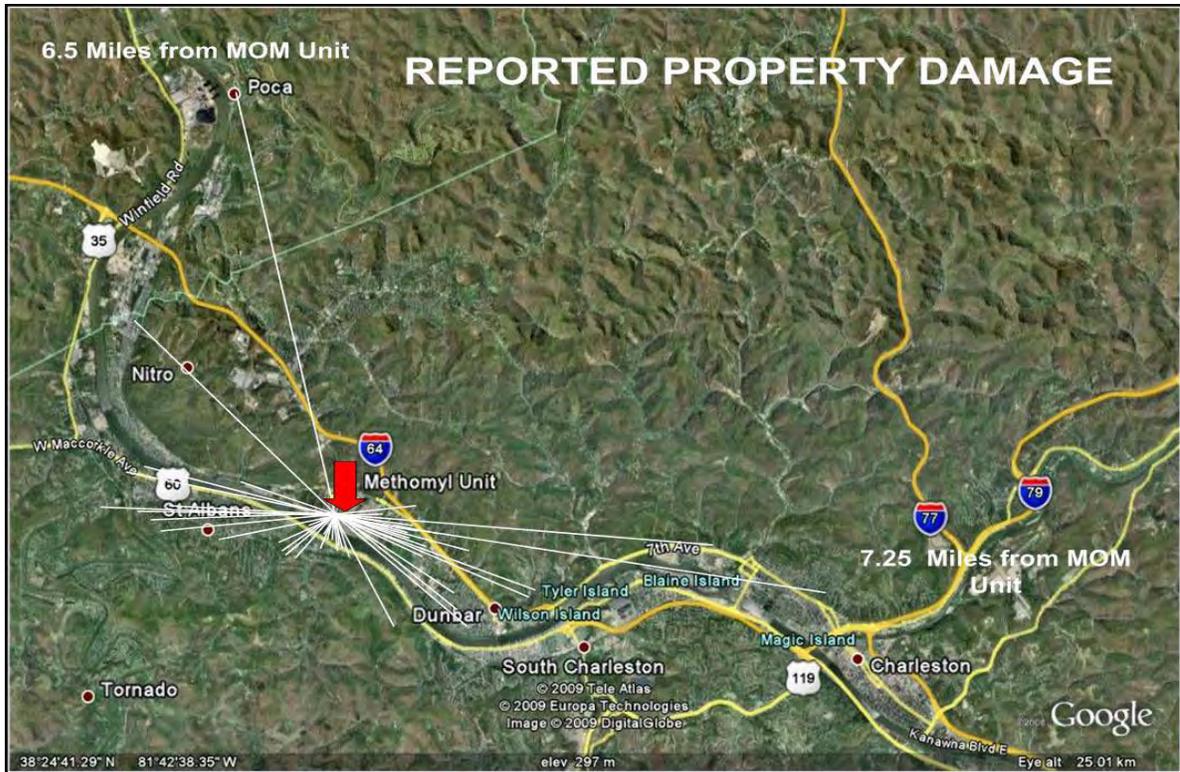
The overpressure produced by the rupturing residue treater damaged properties in the surrounding community. Mobile homes, houses, businesses, and vehicles sustained primarily window breakage and minor structural damage. The majority of the property damage reports were within 1.5 miles of the explosion epicenter; however, some damage was reported as far away as 7 miles (Figure 15). Bayer received 57 property damage claims from residences and businesses totaling about \$37,000.

Figure 15. Aerial view of locations of reported offsite property damage

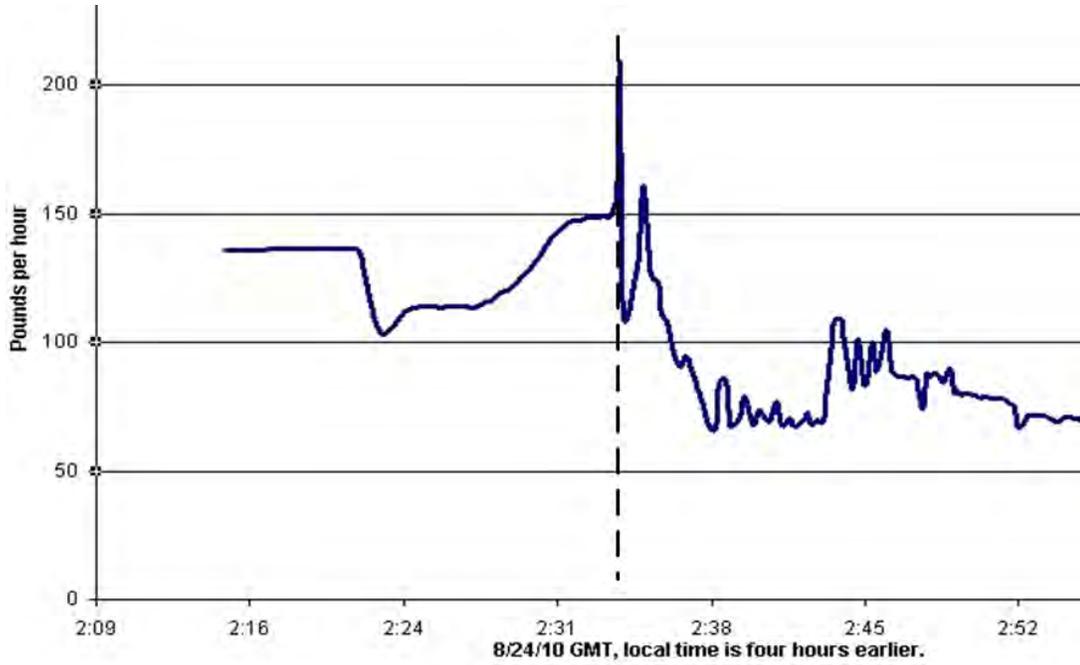
Figure 19. Indicated steam flow through the residue treater heater. Vertical dashed line shows point of vessel failure. Actual flow was zero because valve was closed

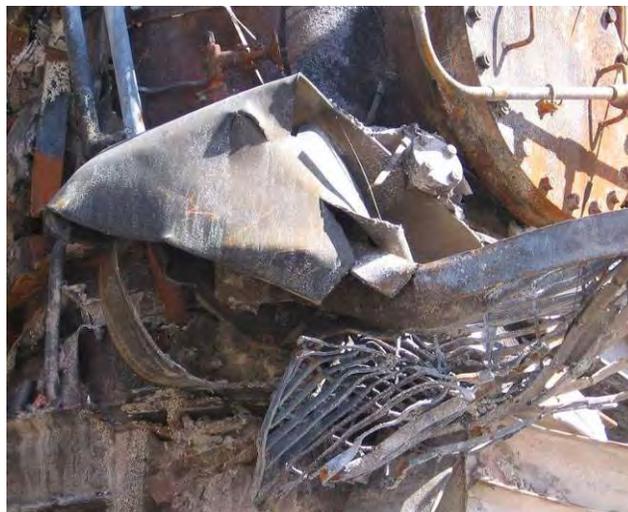
Figure C-4. Residue treater shell fragment lodged in catwalk of adjacent distillation column
