U.S. CHEMICAL SAFETY AND HAZARD INVESTIGATION BOARD

INVESTIGATION REPORT

EXPLOSION AND FIRE

FIRST CHEMICAL CORPORATION

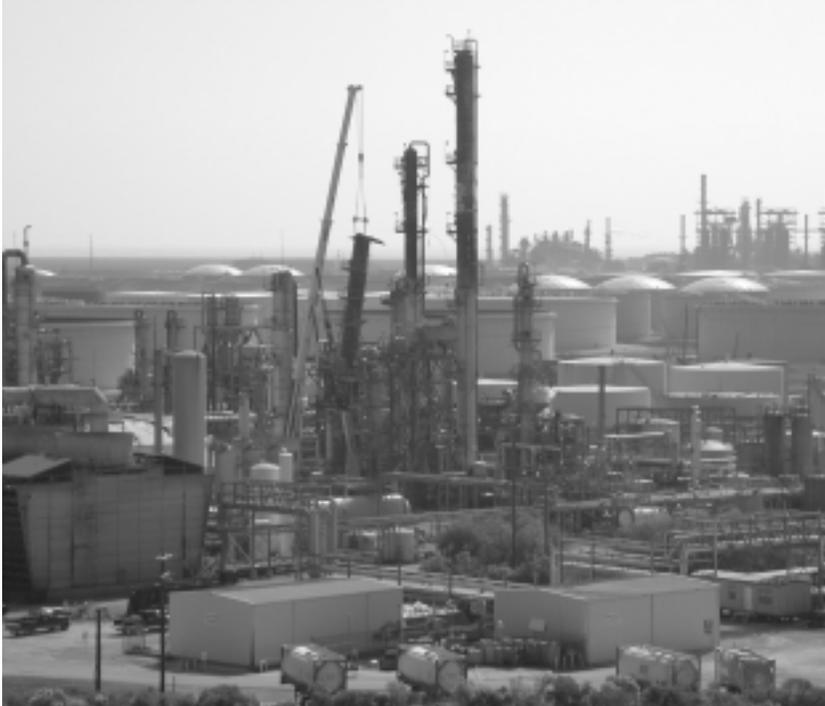
Figure 1. Facility overview.
(Note: The crane is attached to the column damaged in the explosion.)

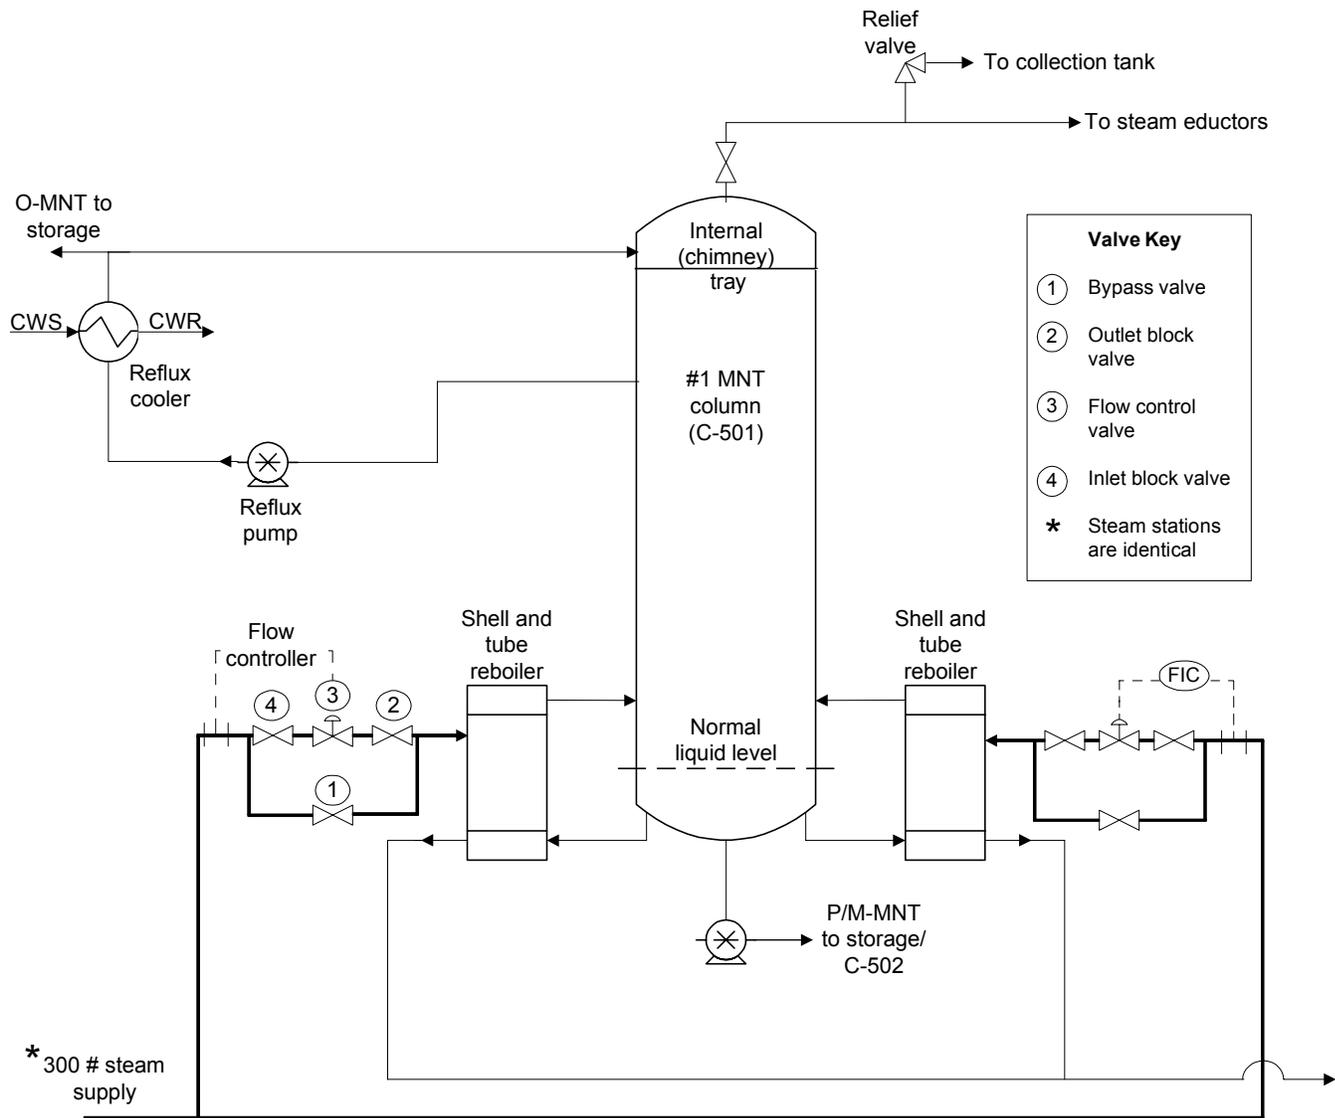
A pump removed material from the bottom of the column (predominantly para- and meta-MNT), which was sent to a second distillation column for separation of the isomers. This material might also be circulated back to C-501. A reflux pump removed liquid (predominantly ortho-MNT) from the top collector tray; the liquid flowed through a cooler and was either sent to storage or returned to the top of the column. The column was filled with stainless-steel packing material to aid in the distillation process.

Figure 2. #1 MNT distillation column (C-501) and related equipment.

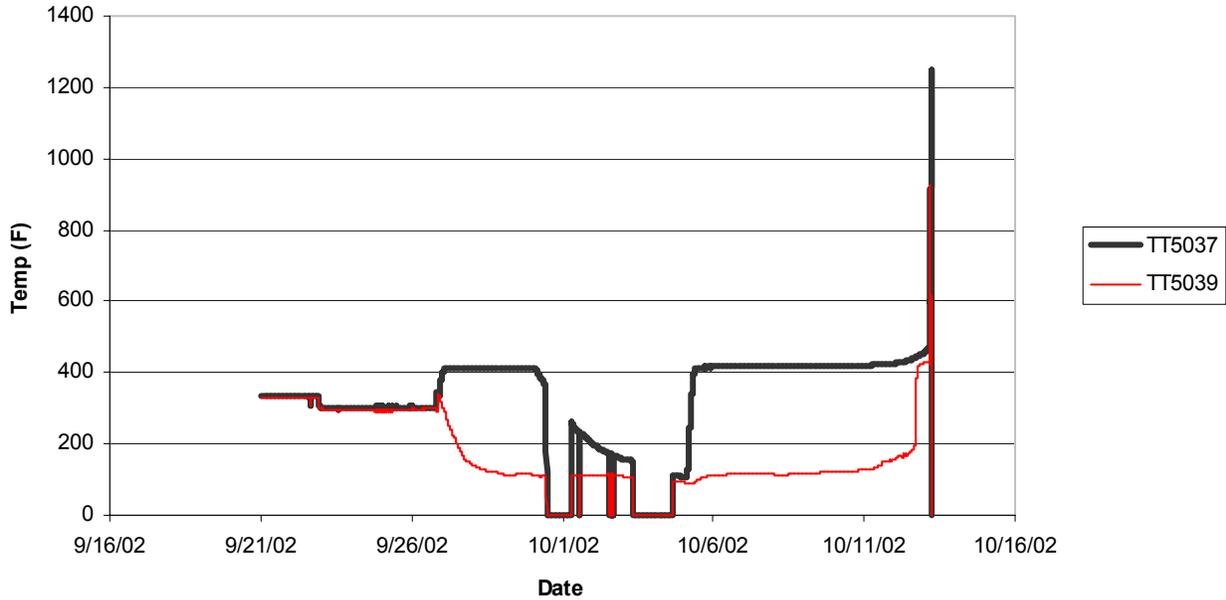
Figure 3. Temperature at column bottoms, September 21–October 13, 2002. (Note: Thermocouple TT-5037 [the top line shown for 10/11/2002] was at the bottom of the vessel, and TT-5039 was above the reboiler inlet line.)

On September 29, the plant steam boilers were shut down for scheduled maintenance. The temperature in C-501 cooled to near ambient. Power was lost to DCS on October 1 and restored the next day; the hard drive on the control system was lost on October 3 and restored the following day. No DCS data are available for these times.

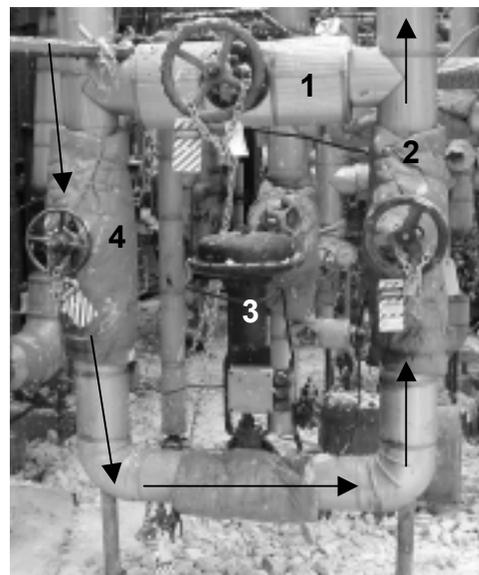
CSB examined the means by which heat could have been applied to the MNT that remained in C-501 after it was shut down. Separate supply lines carried steam to the two reboilers at the base of the column. Manual valves downstream of the control valves in both lines and both bypass lines were closed on September 22, as confirmed by log entries, interviews, and the as-found position of the valves. In addition, the flow control valves had been commanded closed from DCS. CSB tested both valve stations to determine if they had leaked and the likely cause. Each station consisted of four valves, as shown in Figure 5.

Figure 5. Steam line to reboiler.
(The numbered valves represent:
[1] manual valve in bypass line,
[2] outlet block valve, [3] automatic
flow control valve, and
[4] inlet block valve.)

Examination of the other steam station indicated that it leaked as well. Although the manual valve in the bypass line (i.e., valve 1 in Figures 2 and 5) did not appear to leak, the facing on the outlet block valve (downstream of the flow control valve) was severely scored from corrosion products and debris in the system. Because the flow control valve was not intended to be a tight shut-off valve, it is likely that steam leaked through the main branch.

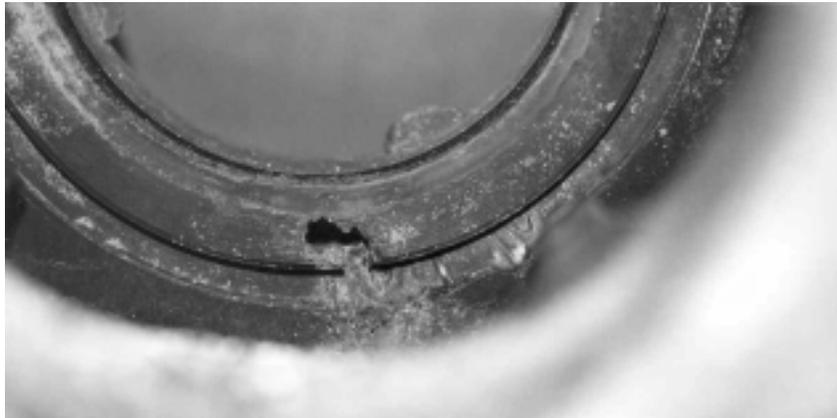
CSB contracted to have the steam stations tested in the as-found condition of the valves to determine leak rate. Test data showed that the manual valve in the bypass line for one of the stations was leaking significantly, over 180 pounds/hour. Corrosion and erosion caused a breach in the valve; and the steam flow caused holes to form in the seat of the valve, one of which is shown in Figure 6.

Figure 6. Breach in valve seat for bypass line.

Based on examination of the outlet-blocking valve for that station (i.e., valve 2), it is believed that debris and particulates may have prevented the valve from seating properly. The steam system was moist—meaning that it contained liquid as well as steam vapor, which contributed to additional erosion and corrosion of the piping system.

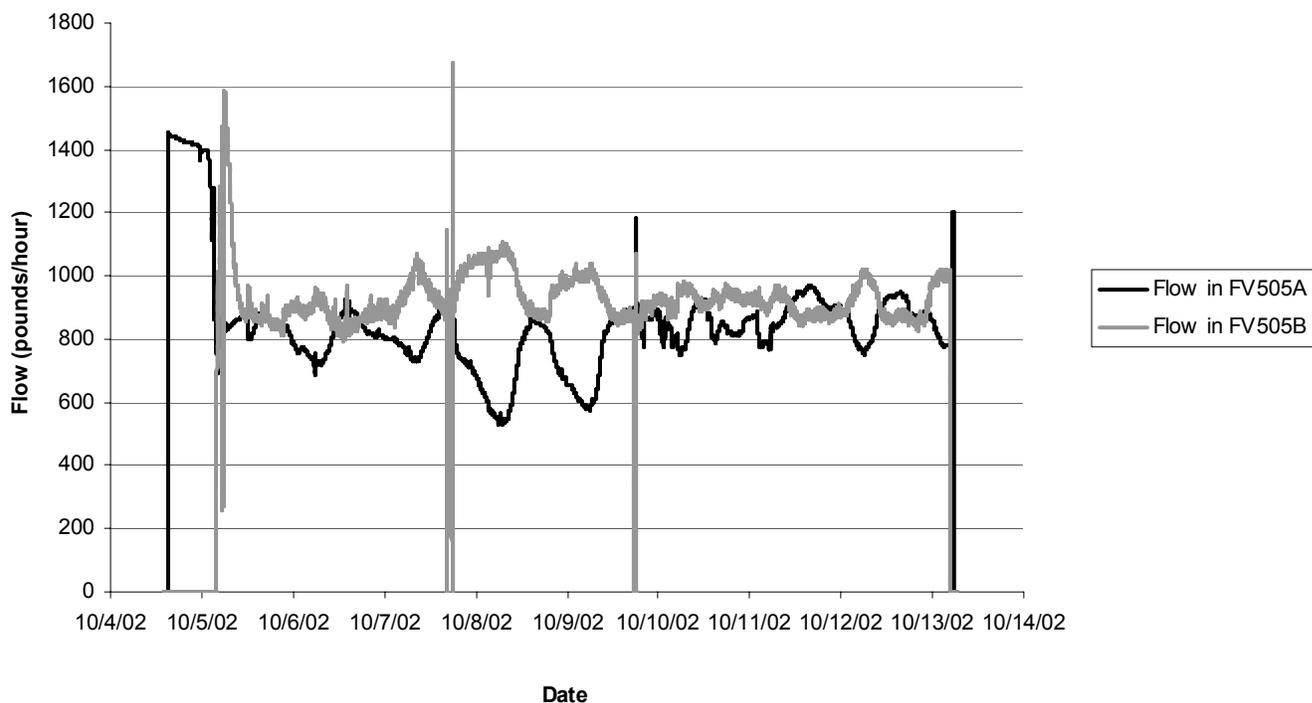
These results verify that steam likely leaked through manual valves and continued to heat material in C-501, even though the valves were in the closed position. These findings are consistent with DCS data, which indicate that there was flow through the line when the valves were closed and believed to be isolating the steam source from C-501 (Figure 7).

DCS data, though exhibiting an erratic pattern, indicate even higher flow rates than were found during CSB testing. Although the registered flow rates indicated in the DCS data may not be correct, they illustrate that flow was occurring in the system at a time when the column was believed to be isolated.

Figure 7. DCS readout of steam flow to reboiler when system was believed to be isolated.

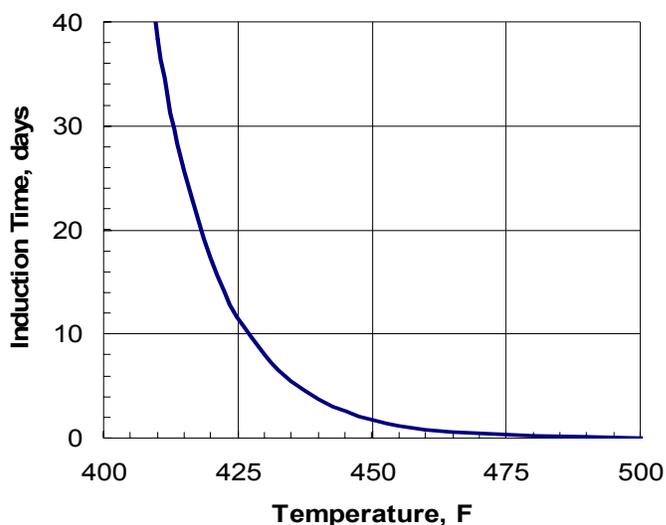
The adiabatic calorimeter was also used to perform induction time¹⁶ measurements between 240° and 265°C (464° and 509°F). The values were extrapolated to estimate the induction times under conditions similar to those at FCC.

Figure 8. Mononitrotoluene induction time–temperature data on linear scales.

These results are consistent with information found in literature concerning the decomposition of MNT. In a paper presented at an Institution of Chemical Engineers (ICChemE) symposium, the authors note that a number of incidents occurred when MNT was heated to excessively high temperatures or held at more moderate temperatures for an extended time (Harris, Harrison, and MacDermott, 1981). The latter phenomenon is referred to as the “induction effect.” For large batches of material (on the order of the amount in C-501 prior to the incident) that are exposed to temperatures between 401° and 419°F, a violent decomposition will occur within 8 to 25 days. This is consistent with conditions at FCC prior to the incident.

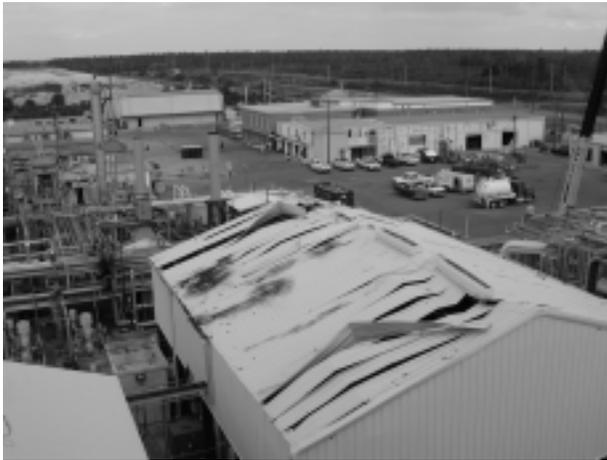
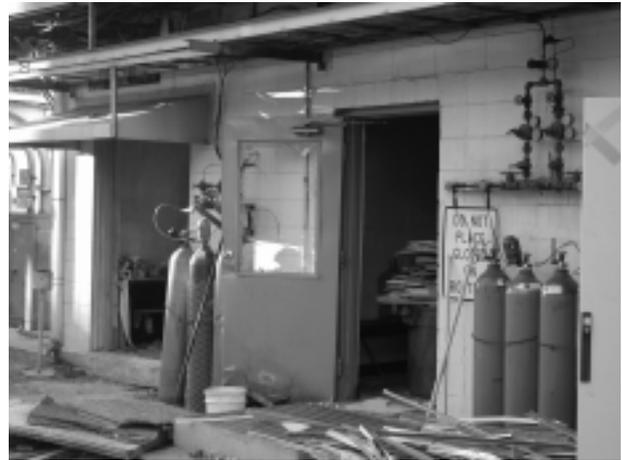
The pressure of the explosion damaged a number of buildings onsite, including the control room. Almost all of the acoustical drop ceilings in the control room and adjacent laboratories and breakrooms collapsed. The roof was extensively damaged, cinderblock walls were cracked and distorted, and the exterior doors were buckled and glass broken. An administration building located over 400 feet from C-501 was significantly damaged, including impact from a piece of shrapnel that punctured the cinderblock wall adjacent to an office. Roll-up doors and corrugated siding on a number of additional steel-frame construction buildings were damaged.

Figure 9. Damage to control room roof and door.

sides. The building was located approximately 50 feet from the #1 MNT column (C-501). The explosion resulted in structural damage to the walls of the building and the roof (Figure 9). Several other buildings onsite were damaged, including the administration building, which was located approximately 450 feet from C-501.
