U.S. CHEMICAL SAFETY AND HAZARD INVESTIGATION BOARD

OIL REFINERY FIRE AND EXPLOSION

No. 2004-08-I-NM
October 2005

GIANT INDUSTRIES' CINIZA OIL REFINERY

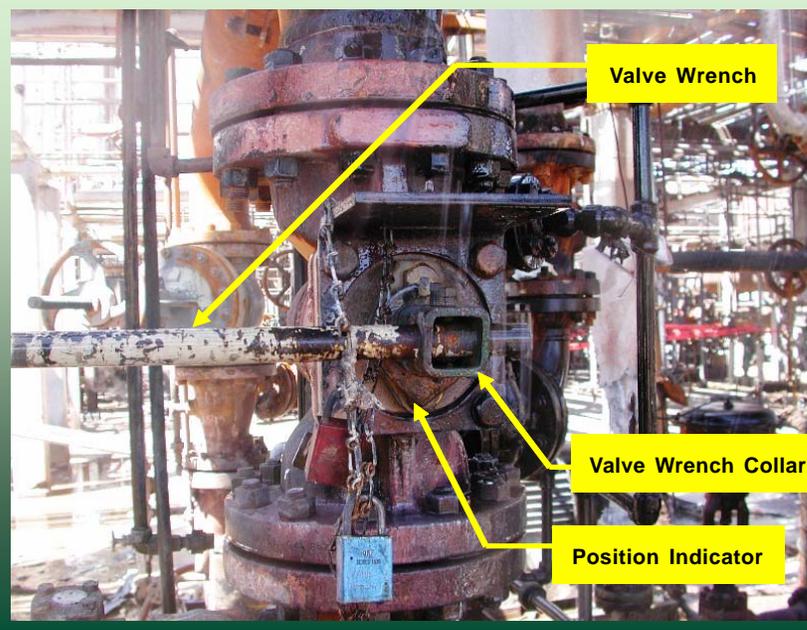
Figure 1.

the closed position with the wrench perpendicular to the flow of product. Interviews with several operators revealed that some operators used the valve wrench's position relative to the flow to determine whether the valve was open or closed, while others referred to the position indicator on the valve stem. The valve was actually open.

The pump needed to be disassembled and the rear pump housing assembly and impeller moved to the shop for repair. Before leaving the area to obtain materials needed to remove the pump, the mechanic noticed that the valve position indicator on the suction valve body showed that the valve was open (See Figure 1). He did not relate this information to his co-workers.

Suction Valve and Position Indicator as Found After Incident

Neither mechanic observed the operator closing the valve. Both mechanics believed the task had been completed because the wrench used to open and close the valve was positioned perpendicular to the flow, and the operator had affixed his tags. (See Figure 1)

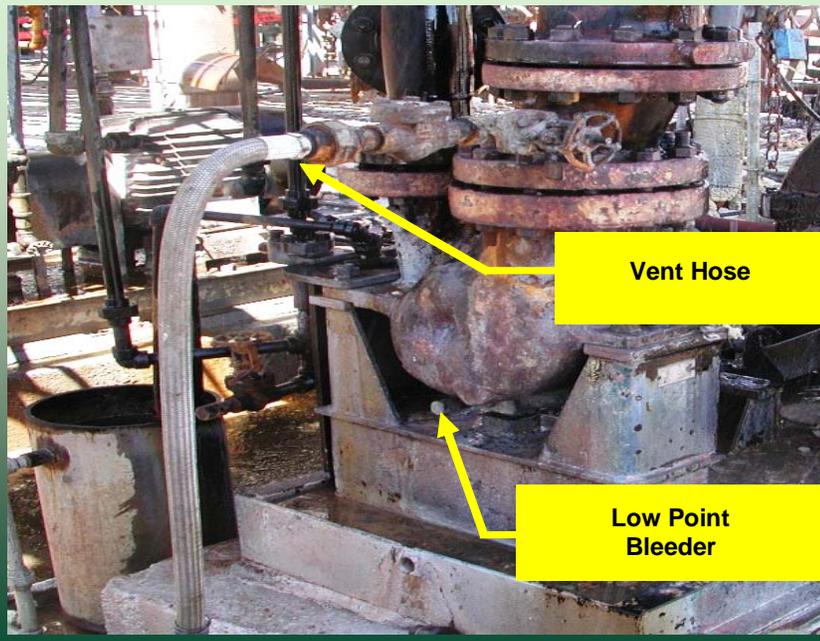
Figure 2

Depressurizing Hose

The operator then disconnected the pump's vent hose to verify that no pressure was in the pump case. The low point drain plug was not used because it was not equipped with a valve to isolate it from the line used for depressurizing the pump. (See Figure 2) Giant lockout/tagout procedures outlining operator responsibilities state:

After uncoupling the hose at the connection to the flare line, a stream of alkylate flowed from the pump housing through the hose and subsided after a few seconds. The operator and the maintenance mechanics believed the pump had been de-pressured and was ready for removal. Actually, the vent line was plugged, and the pump was not de-pressured.

locked out, the facility lacked procedures to verify that the pump had been isolated, depressurized and drained. Equipment being prepared for maintenance should be drained of all liquid at a low point drain.

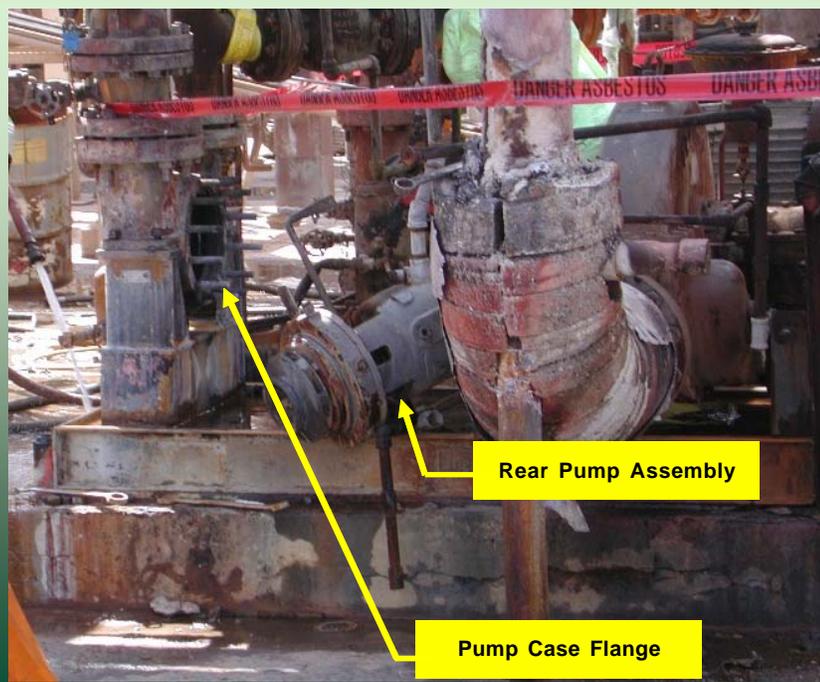
Figure 3.

Damage to Area of Pump

The pump shaft coupling and the flange connecting the pump to the pump case were unbolted. (See Figure 3) As the pump case flange was separated, alkylate was suddenly released at about 150 pounds per square inch gauge (psig) and 350 degrees Fahrenheit. The release produced a loud roaring sound that could be heard throughout the refinery.

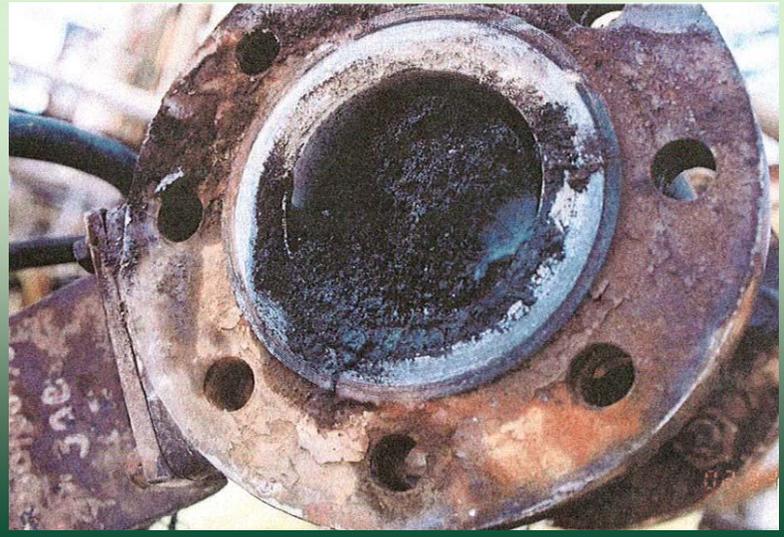
Figure 4

Giant's mechanical integrity program did not effectively prevent these repeated failures of the pump seals. After the incident occurred, plugging material was found in the pump discharge line, the depressurizing line, pump housing, and the impeller. (See Figure 4). Giant's approach to these frequent pump seal problems was an example of breakdown maintenance. In other words, pump failures were addressed when the equipment finally broke down, instead of identifying causes of breakdowns and preventing them before they occurred again.

cleanup activities. Some of this soft, water-laden scale comes off when the unit is running. The rest creates a site for extremely fast and extensive corrosion, resulting in a large amount of scale being added into the process. Scale may accumulate and settle at low points and orifices in equipment such as spare pumps.

Giant management did not investigate why excessive iron fluoride generation in the process caused the mechanical seals on the alkylate recirculation pumps to fail repeatedly.

Plugging Material Found in Discharge Valve

Mechanical integrity programs should prevent breakdown maintenance. Identifying operating conditions that could be contributing to equipment failure is a critical component of mechanical integrity.

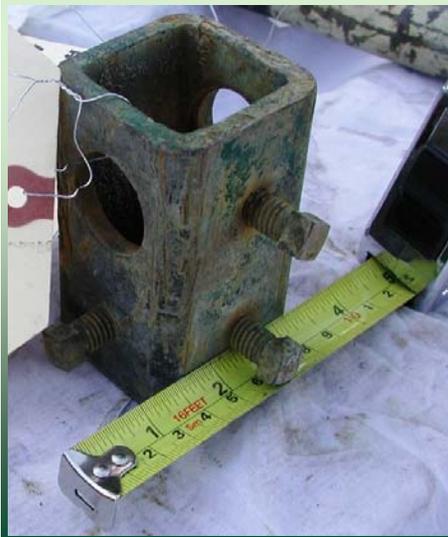
Figure 5

Examination of the 6-inch, $\frac{1}{4}$ turn, plug valve after the incident determined that it was originally designed to be opened and closed by a gear-operated actuator. The gear-driver had been removed and was replaced by a valve wrench. The wrench was a two-foot-long bar inserted into a collar. Because it had a square shape, the collar could be easily removed and repositioned on the valve stem in different directions. (See Figure 5)

Giant did not consider the design or engineering safety implications of changing from a gear-operated valve actuator to using a wrench as a valve handle.

Spare Pump Valve Wrench Collar

In some instances, set screws would be loosened, and the wrench would be removed and placed on the pump base to provide better clearance for personnel walking nearby. When the valve was to be opened or closed, the wrench would be replaced on the valve stem. In the Ciniza oil refinery incident, the valve wrench collar was installed in the wrong position.

Any valve position indication used by employees to determine the open/closed position of valves should communicate accurate information to employees. Valve modification should receive MOC analysis to determine whether new hazards or risks have been introduced.

Although the valve had a position indicator, employee practice was to sometimes use the position of the valve wrench to determine the open/closed status of the valve. The valve collar and wrench were not permanently fixed to the stem and were positioned incorrectly. When the valve was changed from a wheel and gear-driven mechanism to a wrench, the collar could be attached in the wrong position. An MOC hazard analysis was not conducted. If an MOC had been used, it could have revealed the potential for the valve wrench to be oriented in the wrong direction.

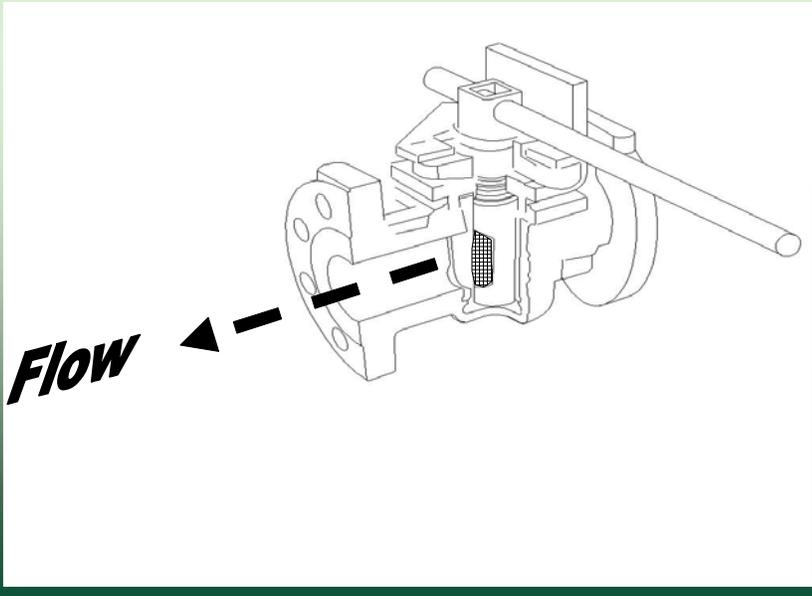
Plug Valve in the Open Position

Figure 6 is a drawing of the plug valve in the open position with the wrench in the perpendicular or perceived “closed” position.

Both the plant operator who attached the locks and the mechanics who removed the pump mistakenly believed the suction valve had been closed, in part because the valve wrench was perpendicular to the normal pipe flow. After he returned from obtaining materials needed for pump removal, the mechanic who earlier observed the position indicator in the open position began working on the opposite side of the pump, so he did not realize the valve position indicator still indicated the valve was open. From his vantage point, he observed the valve wrench in a perpendicular orientation and believed the valve was closed.

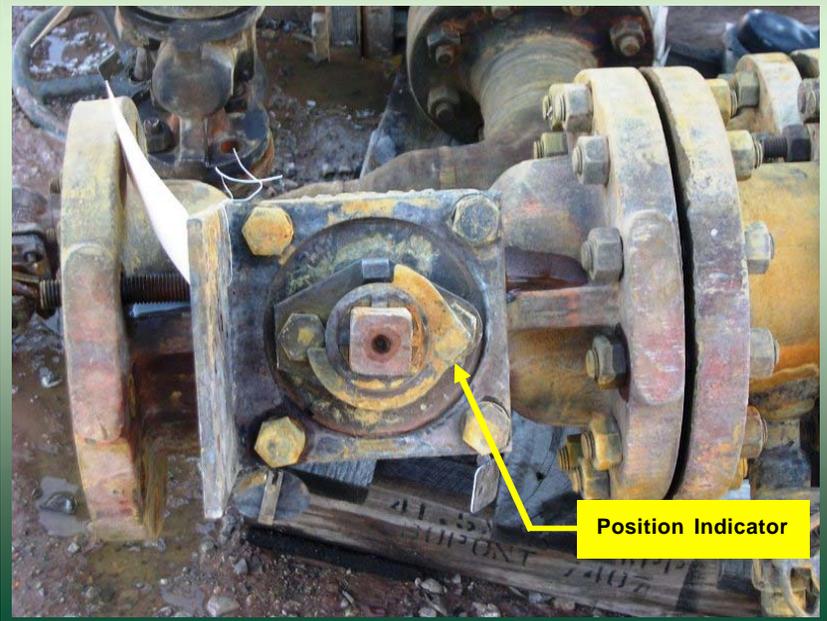
Figure 7

Technically, the wrench was not intended to indicate valve position because the valve was equipped with the position indicator, which was located on the valve stem. (See Figure 7) In practice, however, some plant employees used the wrench to determine valve position, partly because the wrench was much more visible than the actual valve position indicator.

Suction Valve & Position Indicator
