## Investigation Update

July 2024

On January 23, 2023, at 8:12 p.m., a reboiler catastrophically ruptured at the Honeywell Performance Materials and Technologies facility in Geismar, Louisiana. The rupture resulted in the release of hydrogen fluoride (HF) gas, chlorine gas, and other process fluids. Honeywell estimated that approximately \$4 million of property damage resulted from the incident. No injuries occurred as a result of the release, but a complex-wide shelter-in-place was initiated at the facility. Local officials also closed nearby highways. This document provides an update on the ongoing CSB investigation of this incident.

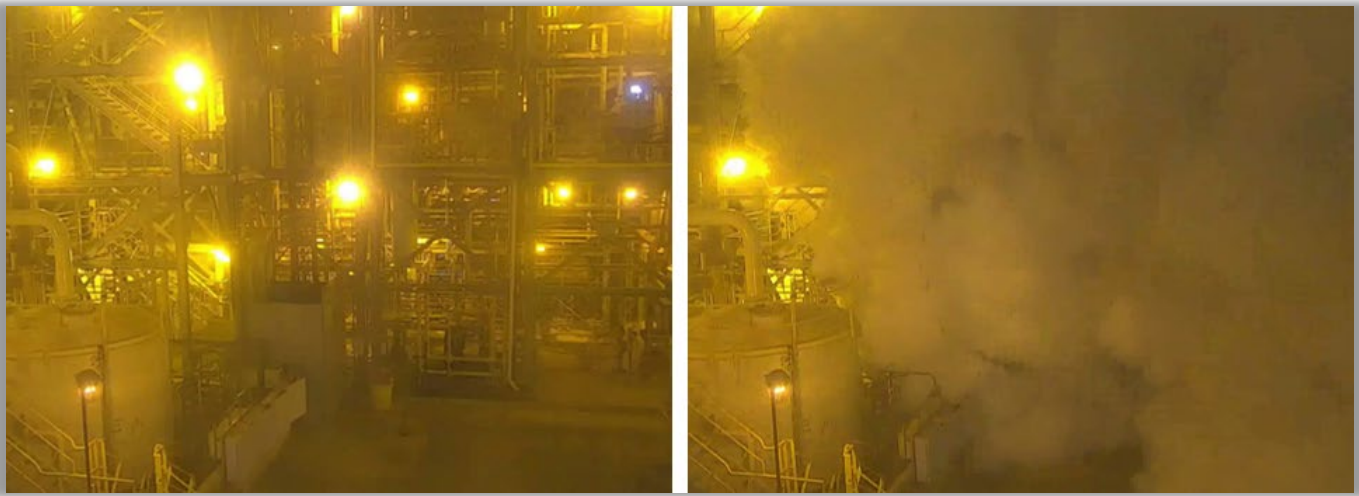
- At 7:03 p.m. on January 23, 2023, Honeywell began restarting the HFC-245fa unit after the site experienced a utility outage. Operations established feed to the distillation column at 7:16 p.m. At 8:12 p.m., the reboiler shell catastrophically ruptured (**Figure 2**).

**Figure 2.** Surveillance images immediately before (left) and four seconds after (right) the reboiler rupture. (Credit: Honeywell)

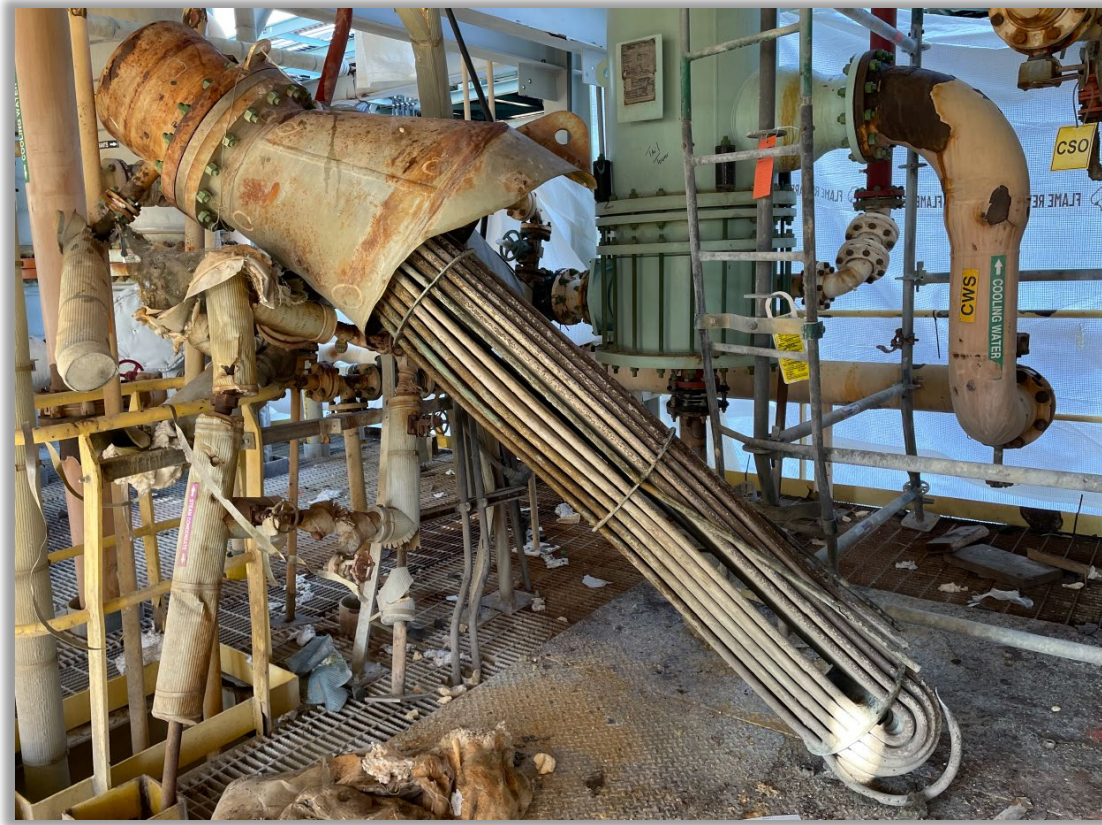
- After the incident, Honeywell contracted metallurgical testing and examination of the failed reboiler shell. The examination found that the reboiler shell had severely thinned due to HF corrosion of the carbon steel. Honeywell found at least two locations on the shell to be as thin as 0.03 inches, corresponding to a thickness loss of roughly 95 percent.<sup>a</sup>

- The reboiler shell ruptured into at least nine fragments, which were propelled up to 35 feet away. The largest fragment contained the tube side head, the complete tube bundle, and the eccentric conical section of the shell and is pictured below in **Figure 3**. This fragment was located about 35 feet from the reboiler's original location, and it was the furthest ejected fragment that Honeywell documented. The debris from the explosion was largely contained by the nearby piping and equipment collocated on the same platform as the reboiler.

<sup>a</sup> The  $T_{min}$  for both locations was 0.156 inches

Figure 3. Post-incident image showing the remnants of the reboiler. (Credit: Honeywell)
