## Investigation Report

Published: December 2023

## U.S. Chemical Safety and Hazard Investigation Board

The April 2, 2019, explosion and fire at the KMCO facility in Crosby, Texas, fatally injured James Mangum.

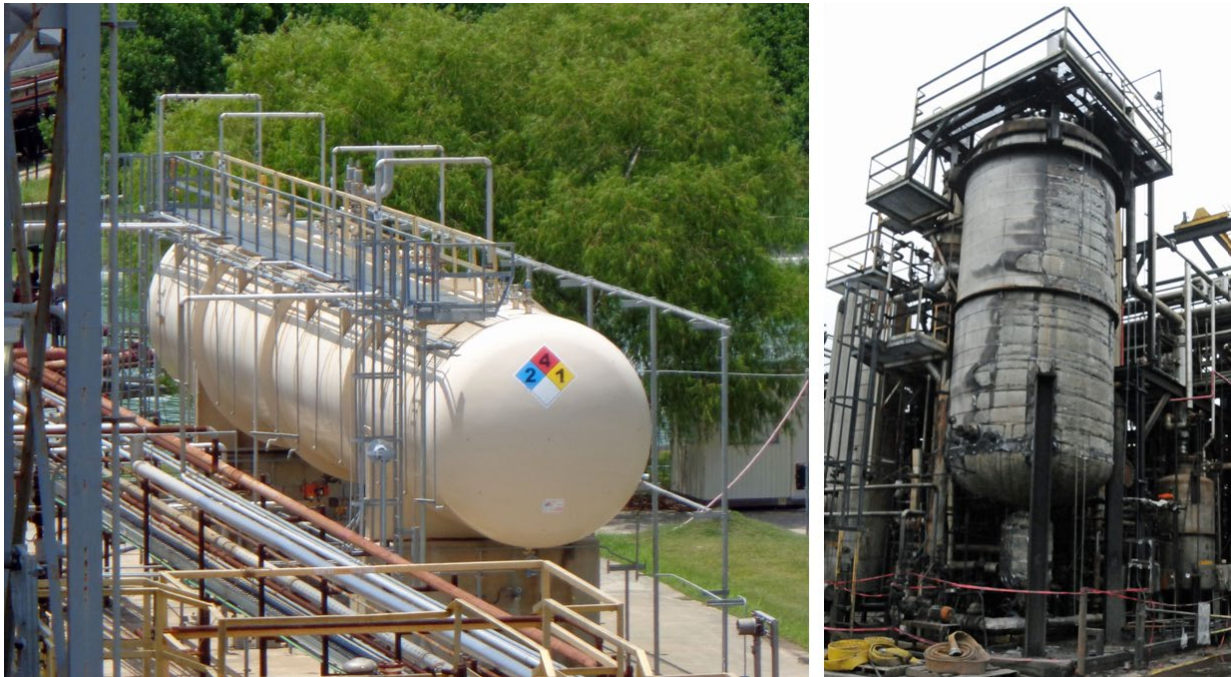
**Figure 2.** Post-Incident Photos of KMCO’s Isobutylene Storage Tank (left) and Batch Reactor System (right). (Credit: CSB)

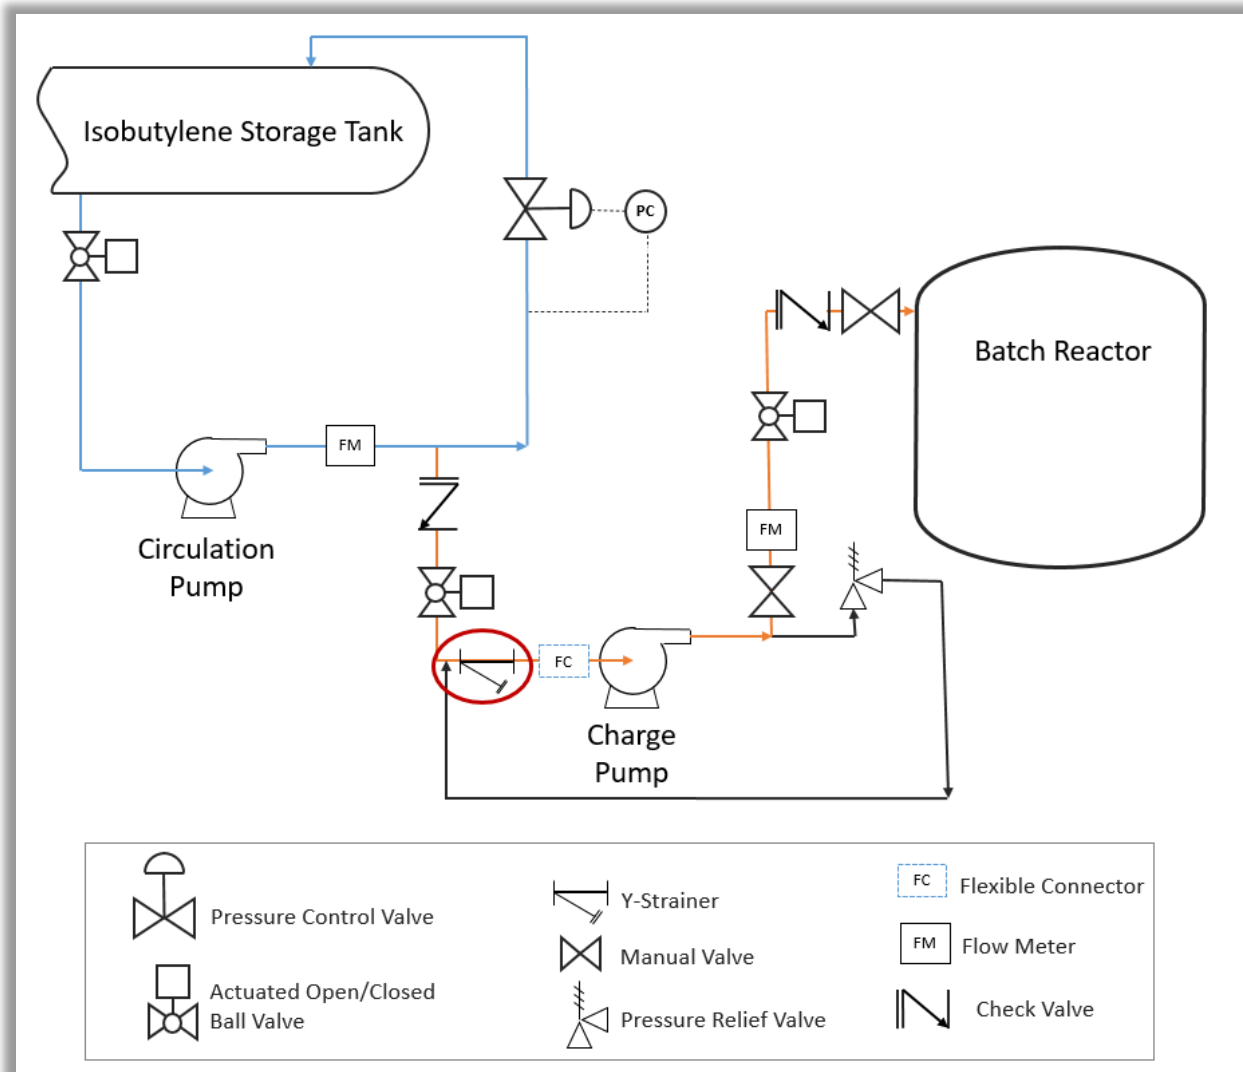
**Figure 3.** Isobutylene System. This simplified schematic shows the isobutylene system KMCO used to supply (charge) its batch reactor. The red circle shows the location of the y-strainer. (Credit: CSB)

<sup>d</sup> KMCO control system data for the flow meter on the isobutylene circulation pump (**Figure 3**) shows a significant increase in isobutylene flow shortly before 10:41 a.m., consistent with a hole developing in the y-strainer, releasing isobutylene to the atmosphere.

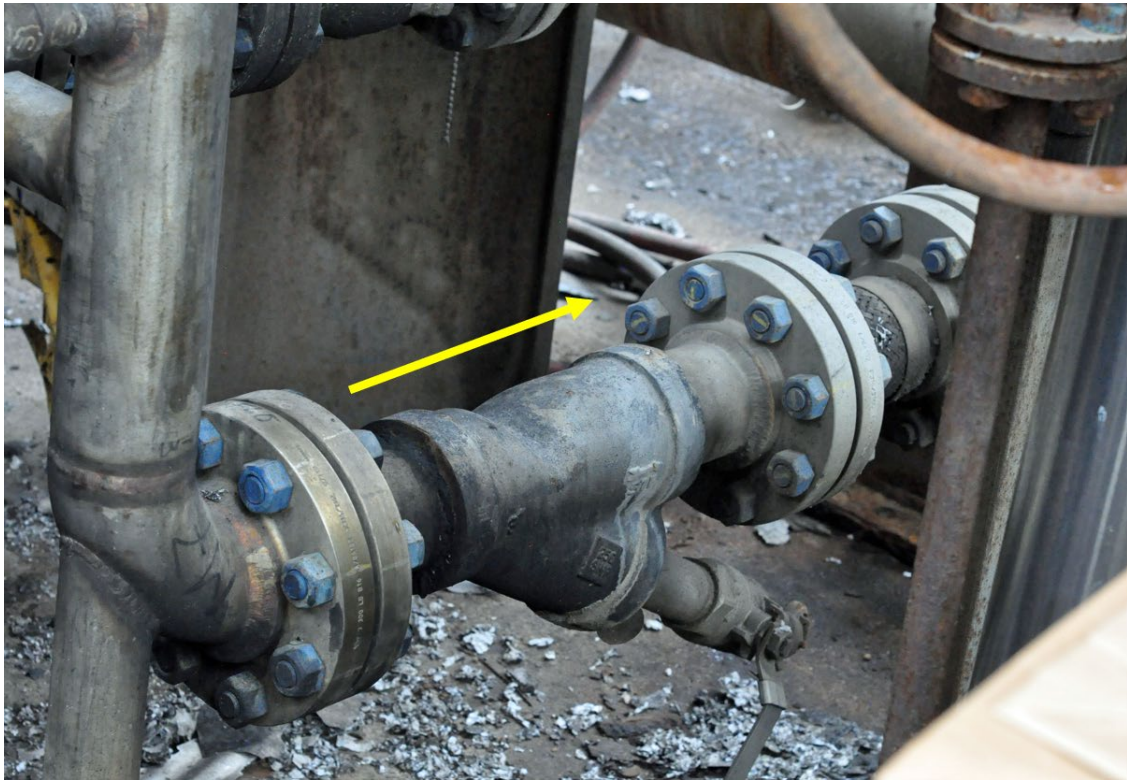
**Figure 4.** Y-Strainer (East Side). This post-incident photo shows the top and east sides of the 3-inch y-strainer in the inlet piping to the isobutylene charge pump. The orientation of the y-strainer was such that the straight-through flow was headed north. (Credit: CSB)

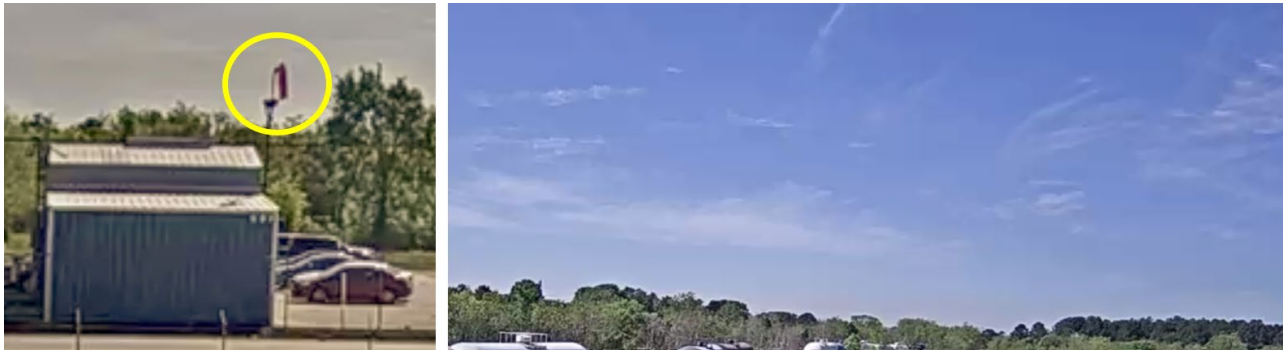
**Figure 9.** Surveillance Video Images Showing the Time of Incident Weather Conditions at KMCO. The yellow circle (left) shows a windsock under calm wind conditions. (Credit: KMCO, annotation by CSB)

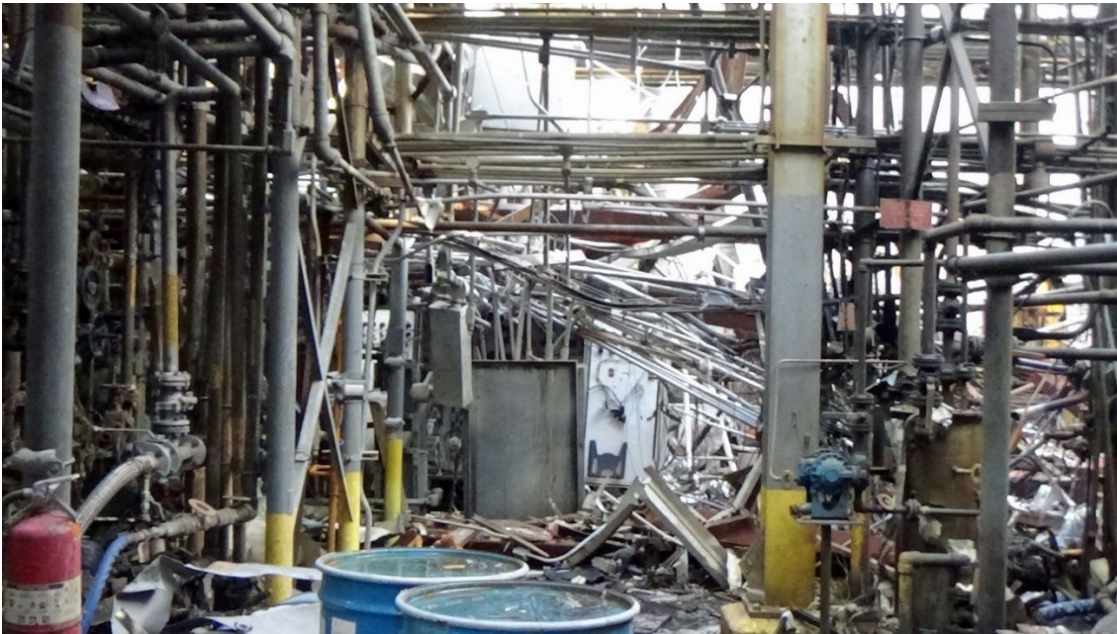
One of the responders described what the R2 Building looked like right after the incident, saying, “Shrapnel. ... There was nothing left of it. Wires, there was nothing there. There wasn’t a building there anymore” (**Figure 13**, **Figure 14**, and **Figure 15**).

**Figure 13.** R2 Building (North Side). This post-incident photo shows the path KMCO workers commonly took to enter the R2 Building. With process units on the left and right, this walkway led to the entrance on the north side of the R2 Building, where emergency responders found Board Operator 2. (Credit: CSB)

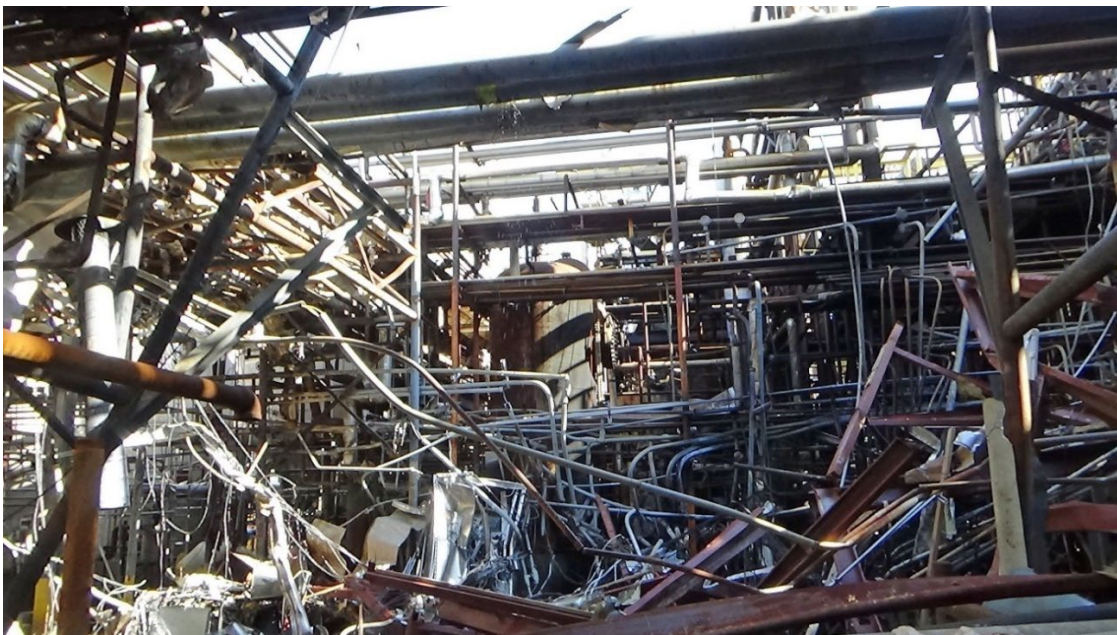
**Figure 14.** R2 Building (South Side). This post-incident photo shows the south side of the R2 Building. (Credit: CSB)

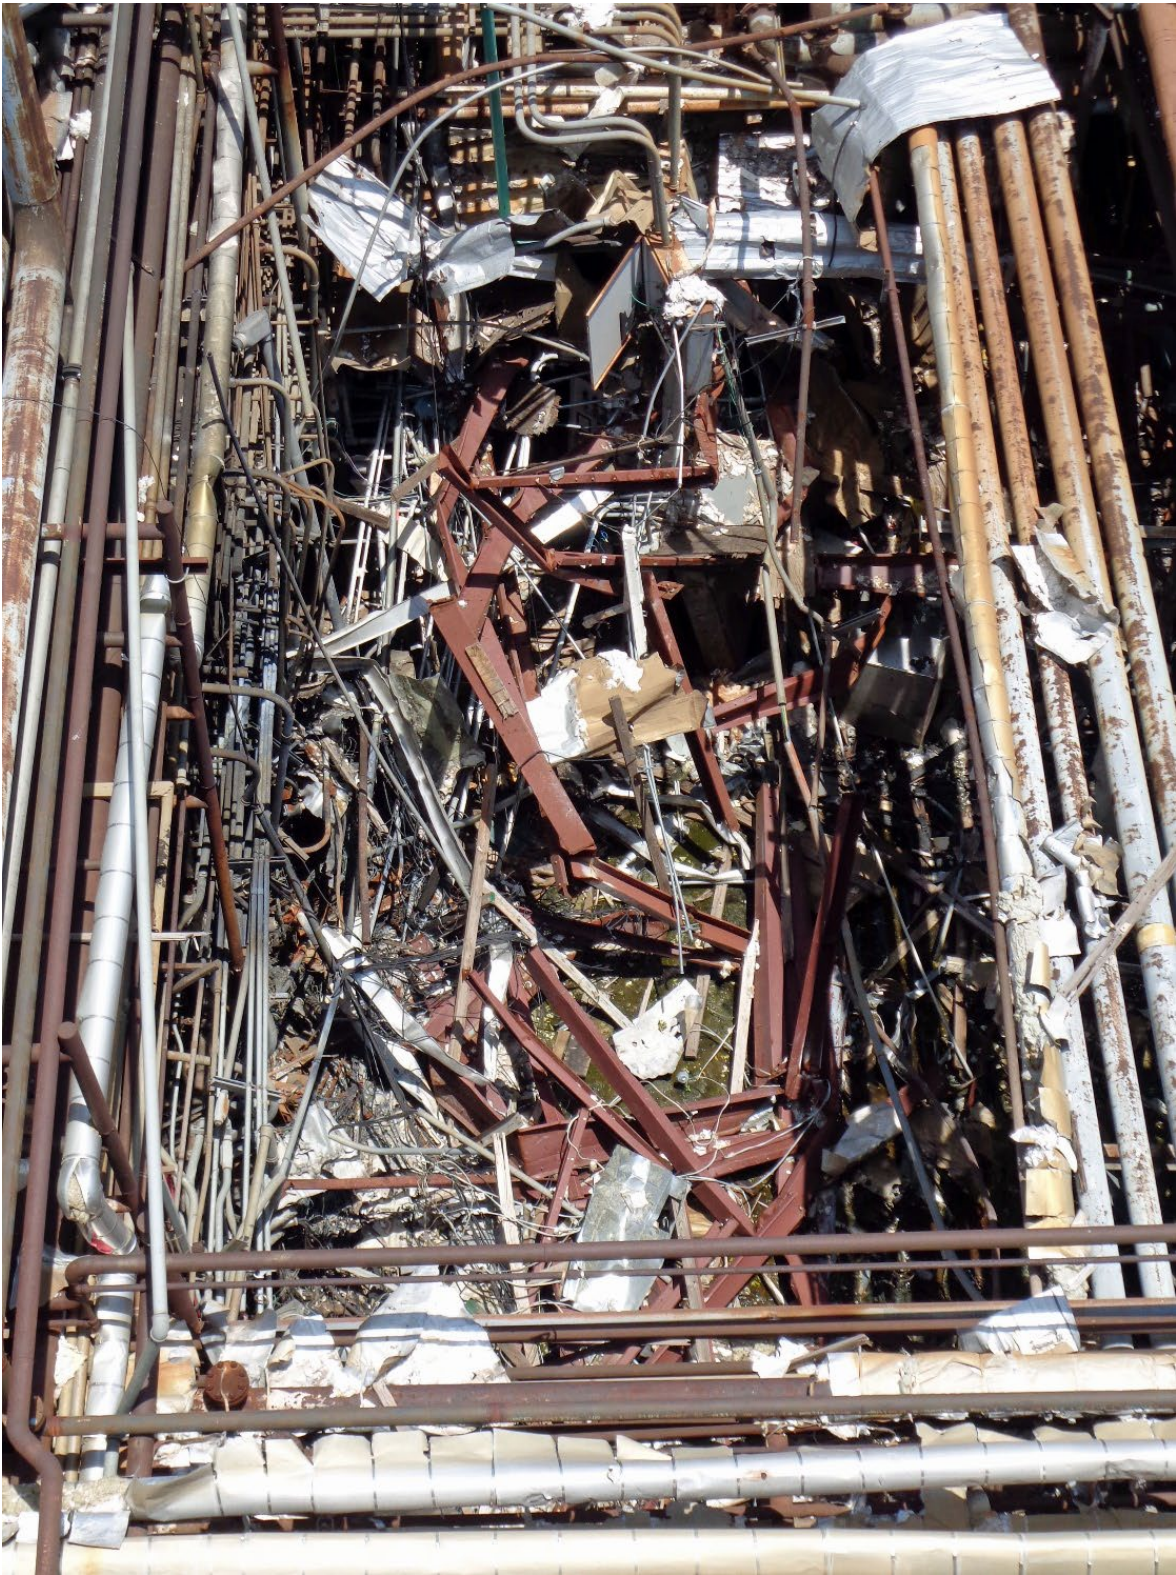
**Figure 15.** R2 Building (Top View). This photo, taken from the top of adjacent equipment, shows the post-incident condition of the R2 Building. (Credit: CSB)

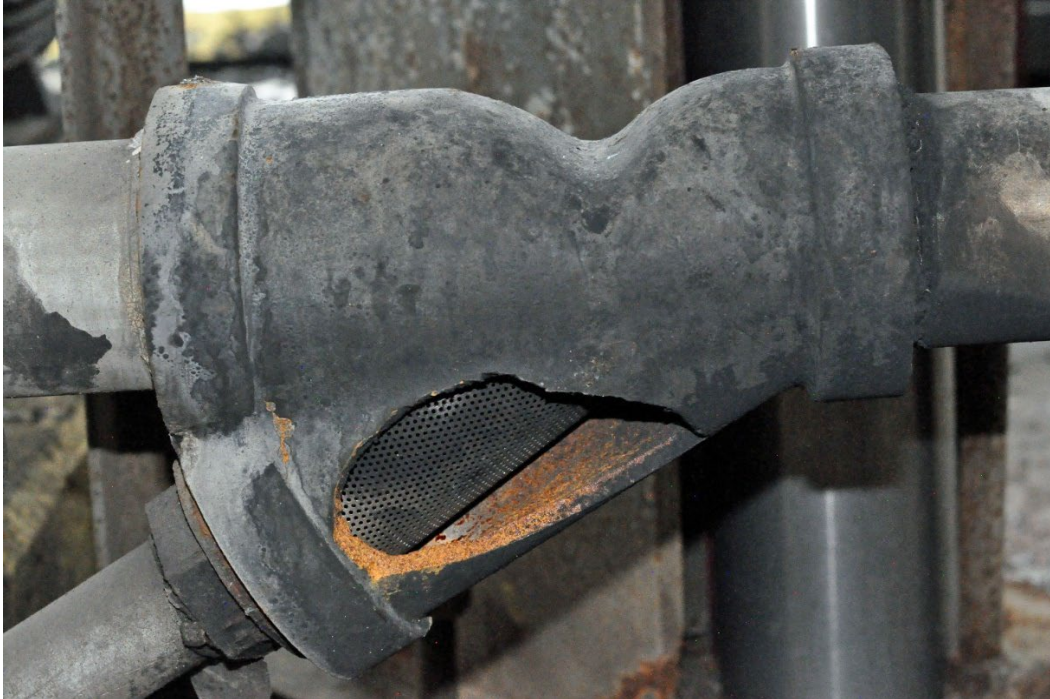
The CSB determined that the cause of the isobutylene release was a brittle overload fracture of the cast iron y-strainer driven by internal pressure. The y-strainer was installed in a segment of the isobutylene piping that was not protected from the high-pressure conditions that developed within this equipment, most likely from liquid thermal expansion. The isobutylene vapor cloud was most likely ignited by electrical equipment within a poorly sealed, nearby building.

Post-incident, the source of the isobutylene release was identified as the 3-inch y-strainer on the inlet (suction) piping to the isobutylene charge pump. The y-strainer was found with a hole, which was roughly 3 inches by 5.5 inches, on its west side (**Figure 17**). Field Operator 1 confirmed that the location of this hole was consistent with where he saw the isobutylene escaping.

**Figure 17.** Y-Strainer. This photo shows the west side of the failed y-strainer involved in the April 2, 2019, incident. (Credit: CSB)

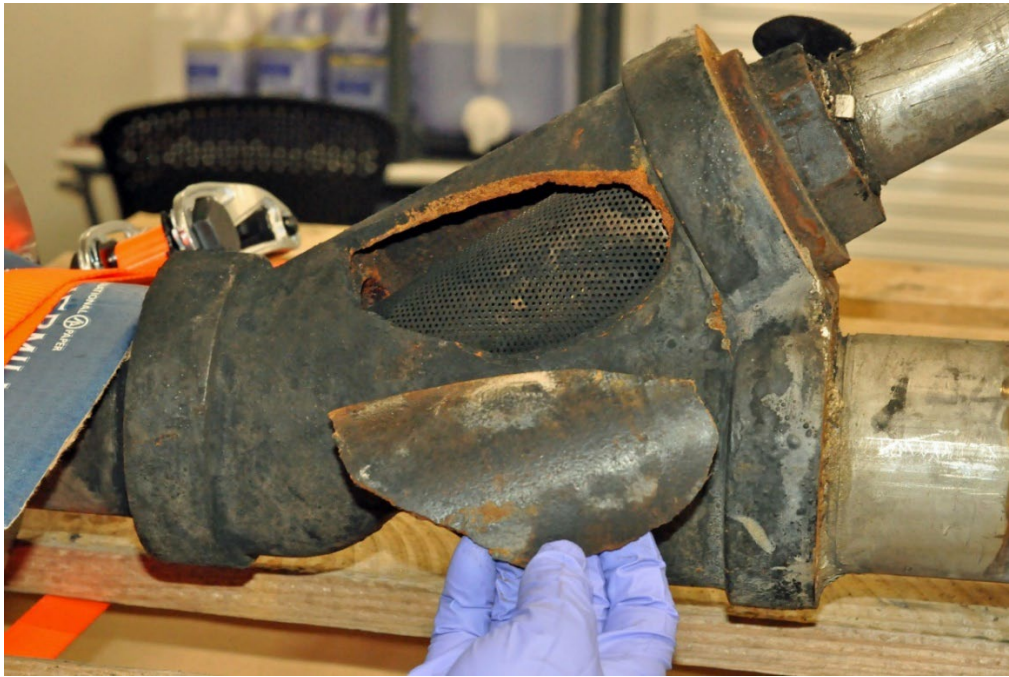
The metal fragment that broke away from the y-strainer was found on the ground, near the sulfurized isobutylene reactor and to the west of the y-strainer (**Figure 18**).

**Figure 18.** Y-Strainer Piece. This photo shows the single piece that broke away from the failed y-strainer. (Credit: CSB)

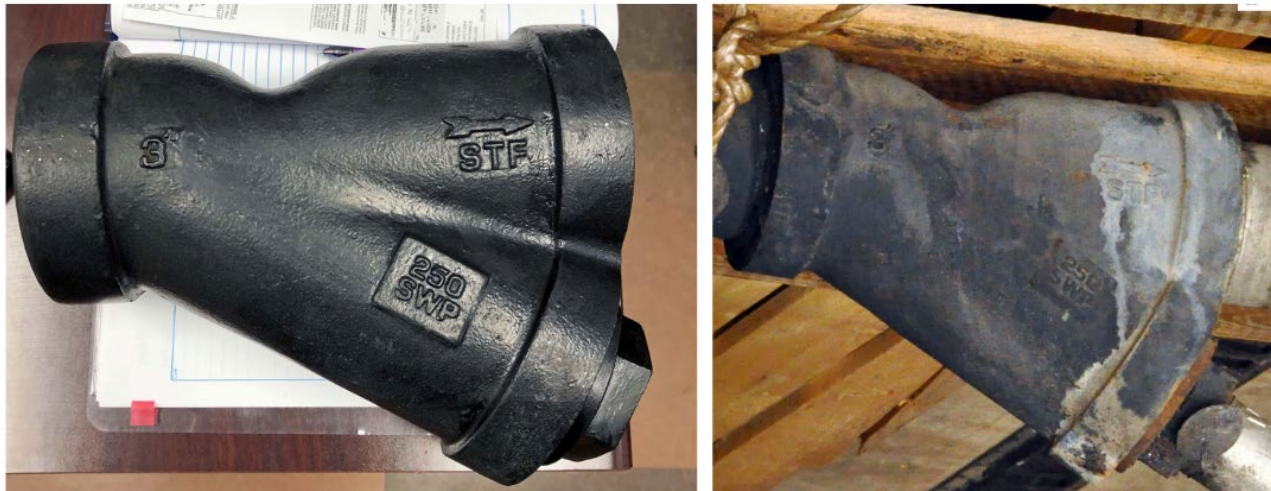
The y-strainer involved in the incident was the same make and model as the standard 3-inch gray iron y-strainer that KMCO stocked in its warehouse. Using the KMCO warehouse inventory information, the CSB purchased an exemplar y-strainer for \$171 that was the same make and model as the incident y-strainer (**Figure 19**). The CSB used this exemplar y-strainer in the metallurgical testing that determined why the incident y-strainer failed.

**Figure 19.** Exemplar Y-Strainer. The CSB purchased an exemplar y-strainer (left) using the inventory information available in KMCO’s warehouse. The image on the right shows the y-strainer involved in the incident. (Credit: CSB)

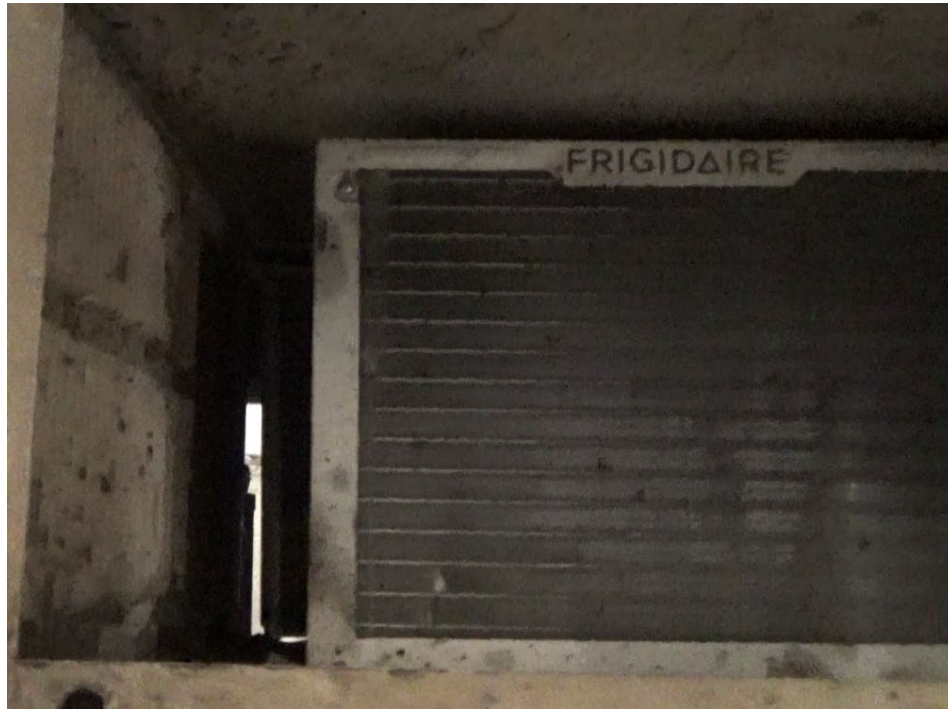
**Figure 21.** Wall-Mounted Air Conditioner. This photo, taken from outside of the PPE Room, shows an opening to the inside of the PPE Room. (Credit: CSB)

KMCO had identified the area where the R2 Building was located as a Class 1, Division 2 location, one of the hazardous classified locations under the National Fire Protection Association (NFPA) 70, *National Electric Code*, where the possibility of fire or explosion hazards may exist under abnormal conditions because of the presence of flammable material, such as isobutylene [38, p. 350]. The CSB learned that the R2 Building likely did not meet the NFPA’s requirements because it contained unclassified electrical equipment, such as motor starters, and the building was not pressurized to prevent flammable vapor from entering the building.

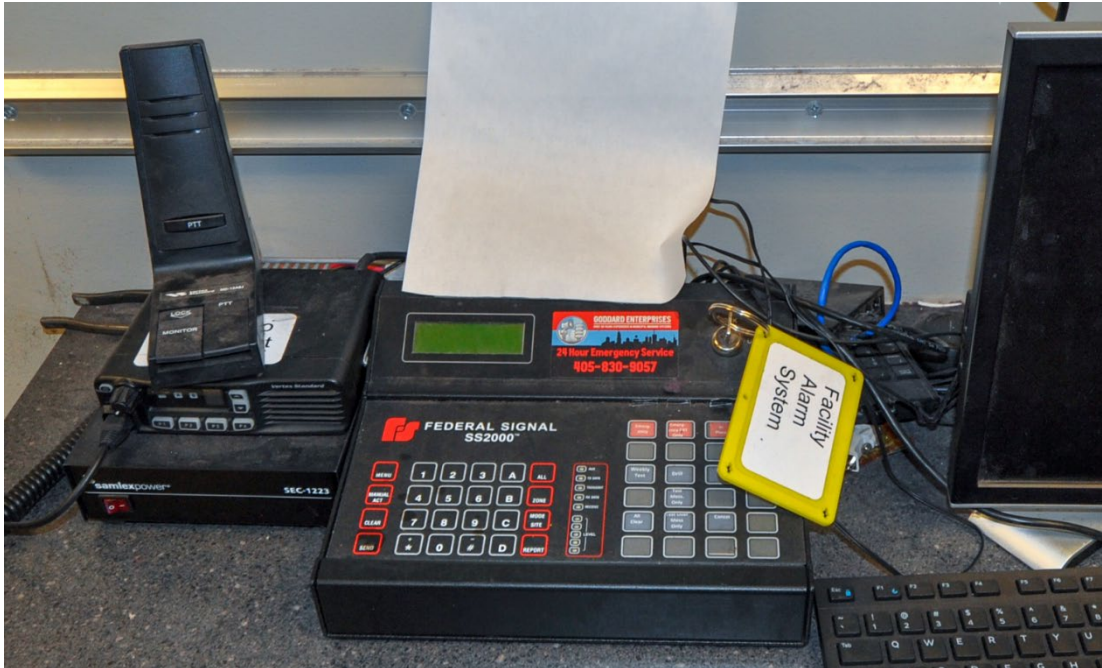
One operations supervisor stated that the old facility alarm system never worked—or at least, not during his 14 years at KMCO—and that he had never heard a facility alarm until the new system was up and running.

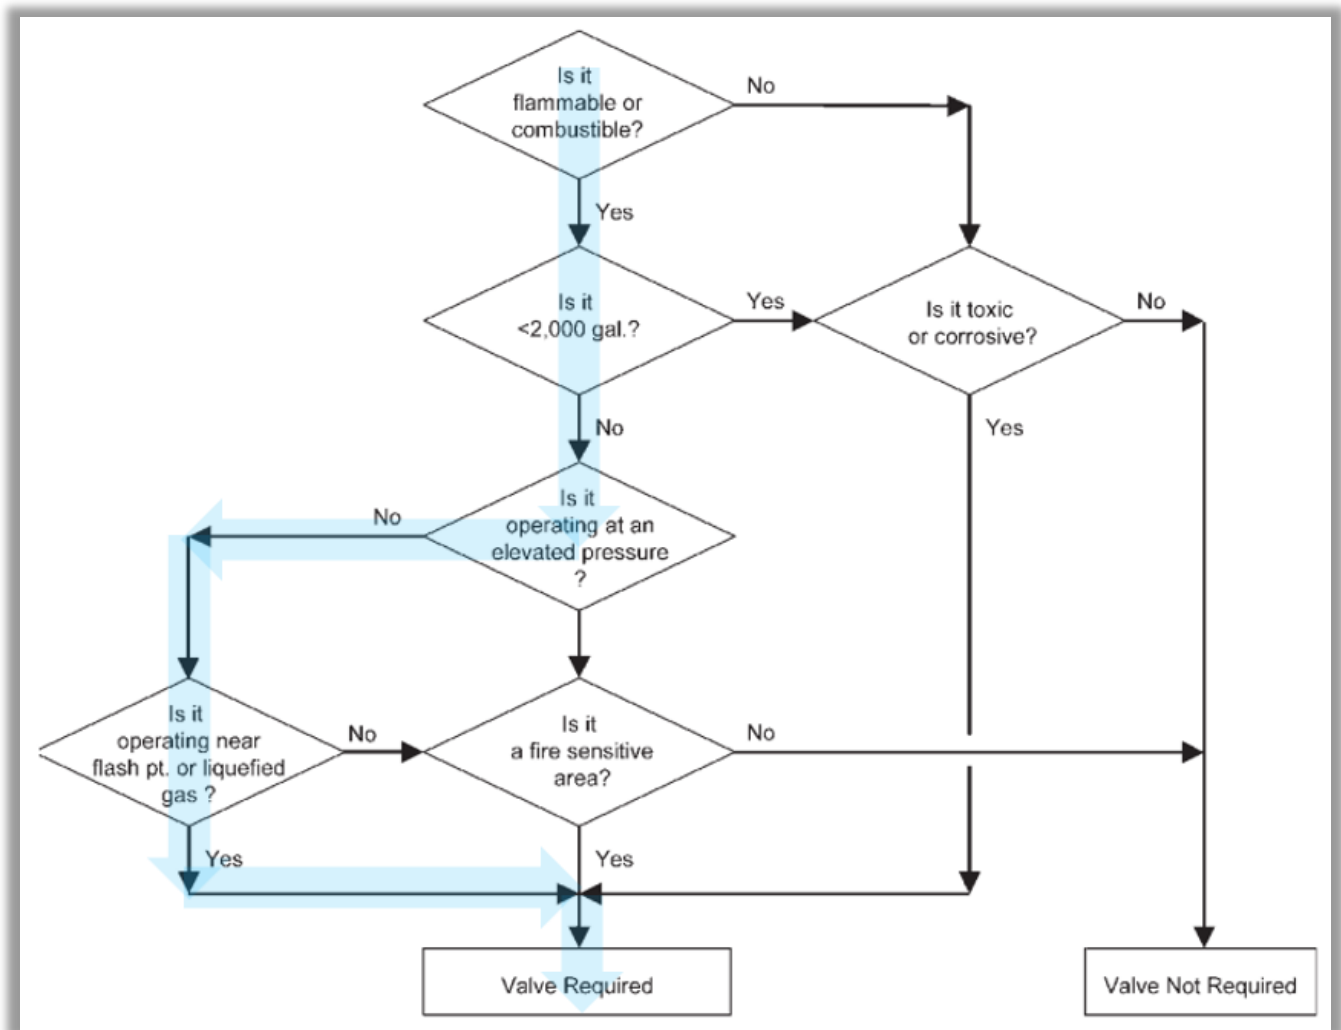
In addition, the CCPS provides a decision flowchart as an example of a tool that companies could use to decide where remote isolation equipment should be installed [55, p. 267]. As illustrated in **Figure 23**, applying this tool to KMCO's isobutylene system shows that remote isolation equipment should have been provided.

The CSB concludes that although the need to provide workers with effective remote isolation capability has been well established by existing industry standards and good practice safety guidance documents, KMCO's isobutylene system remained unprotected. As a result, when the y-strainer ruptured on April 2, 2019, KMCO workers did not stop the isobutylene release remotely, from a safe location.<sup>a</sup> KMCO could have reduced the severity of its April 2, 2019, incident if the company had provided its Board Operators with the capability to remotely isolate the isobutylene release from within the blast-resistant Reaction Control Room—a safe location.
