Investigation Update

February 2024

On November 19, 2023, at approximately 12:21 a.m., a metal tube ruptured within a reactor charge furnace during a unit startup at the Martinez Renewables facility in Martinez, California. The ruptured tube released renewable diesel and hydrogen, resulting in a fire that seriously injured one Marathon employee (**Figure 1**). This document provides an update on the ongoing CSB investigation of this incident.

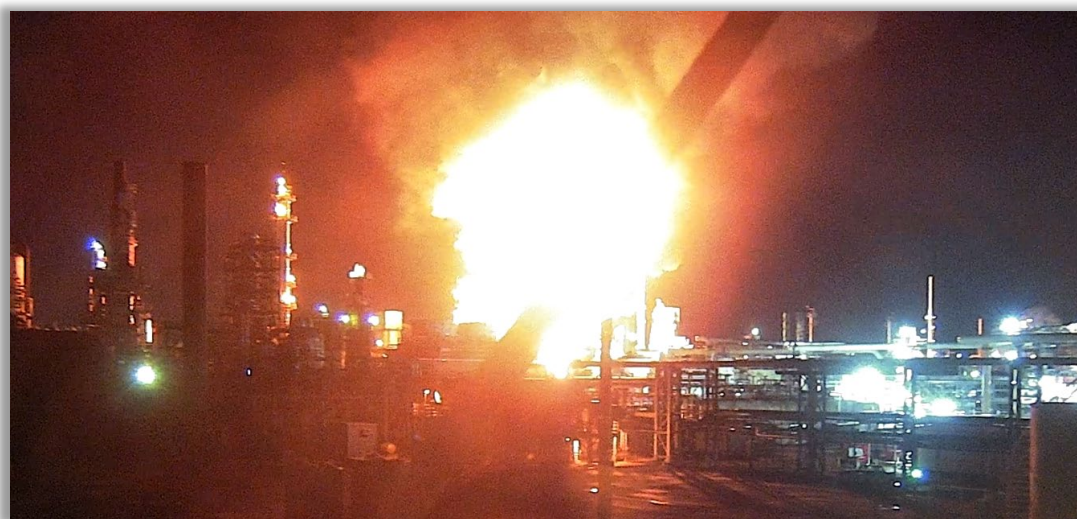
Figure 1. Surveillance footage of furnace fire. (Credit: Marathon)

- To reduce temperatures within the furnace, Marathon operations staff increased the flow of material through the furnace and directed a field operator to turn off two of the furnace burners. At the furnace, the field operator closed manual fuel gas valves to turn off two of the four burners that were lit at the time. Around 12:21 a.m., just after the field operator had completed this action, a tube ruptured within the furnace, releasing hot renewable diesel and hydrogen. The materials released from the furnace and ignited, causing a fire (**Figure 1**). The field operator was seriously injured by the release and fire, suffering third-degree burns to most of his face and body. Despite his severe injuries, he made his way approximately 80 yards from the furnace area to the field operator shelter, where he was discovered by fellow operators and air-lifted to a nearby hospital. The fire was extinguished by approximately 1:15 a.m., and an all-clear was sounded at approximately 2:00 a.m. [8].

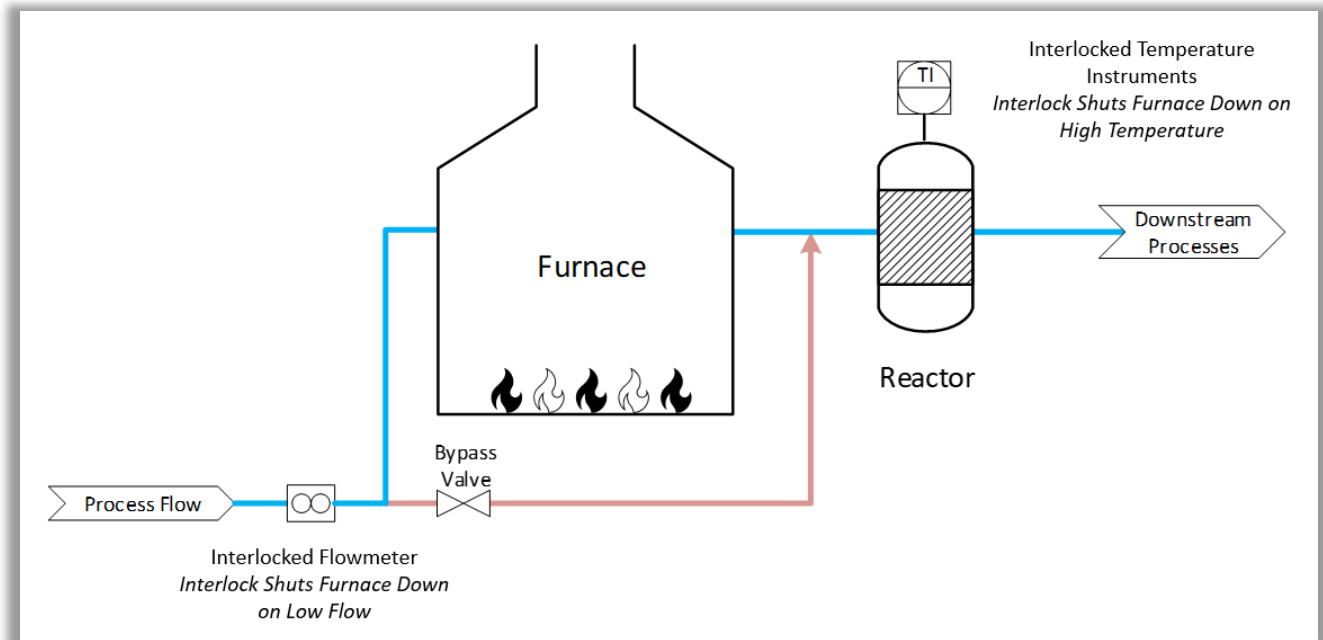
- The morning after the incident, Marathon employees discovered that a normally closed manual bypass valve upstream of the furnace was open (misaligned), which created a potential flow path around the furnace. The flowmeter intended to monitor diesel flow through the furnace was located upstream of the open bypass valve, and had been indicating flow at the time of the incident. Although safety interlocks existed to automatically shut down the furnace during low renewable diesel flow to the furnace and high temperatures downstream of the furnace, none of these conditions were detected by the instrumentation, and the interlocks did not activate (**Figure 2**). Any flow being bypassed around the furnace would have fed back into the process piping upstream of the high temperature safety interlock instrumentation.

Figure 2. Simplified process flow diagram depicting furnace safety interlock instrument configurations relative to the bypass valve found open after the incident. Note: Not all instruments and interlocks are depicted. (Credit: CSB)

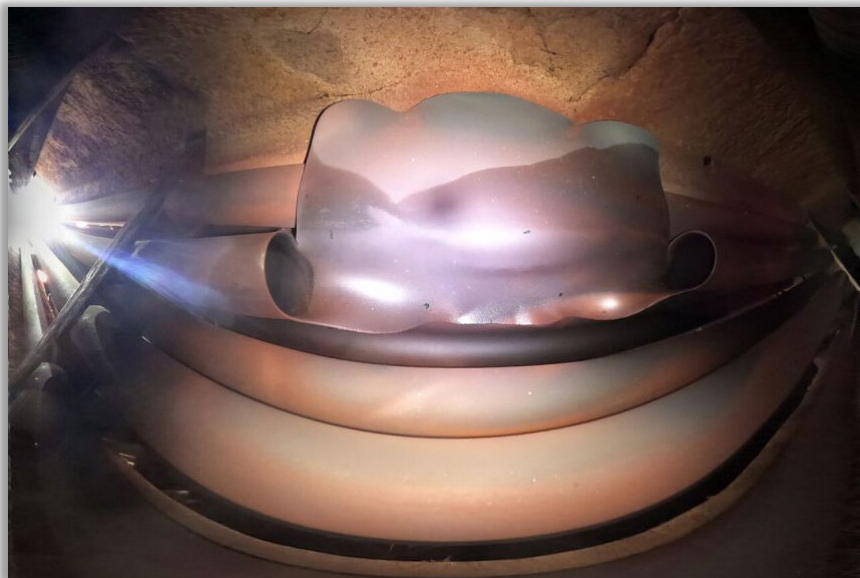
- A post-incident examination of the furnace identified the release point as a ruptured tube in the convection section of the furnace (**Figure 3** and **Figure 4**). Further investigation of the furnace tubes is ongoing.

Figure 3. Post-incident image showing the failed furnace tube from above. (Credit: Marathon)
