# E-6600E and E-6600B Heat Exchanger Metallurgical Analysis

April 2, 2010 Tesoro Refinery Incident

Anacortes, Washington

**U.S. CHEMICAL SAFETY AND HAZARD INVESTIGATION BOARD**

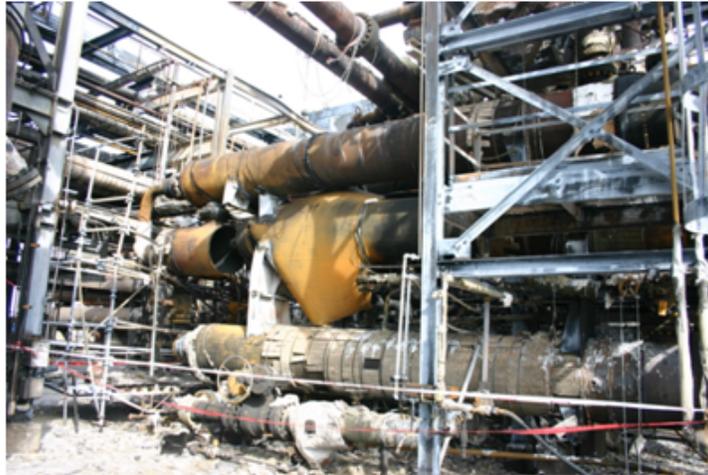
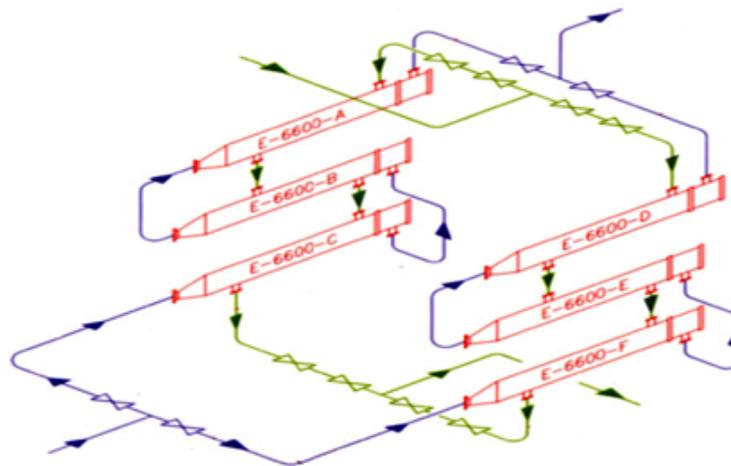
**Figure 1:** The heat exchanger that failed (E-6600-E) is between two other heat exchangers in the stack, and paired in the system with heat exchanger E-6600-B. In the photograph, the E-6600-E heat exchanger is in the front middle position and E-6600-B is not visible. In this series of heat exchangers, naphtha (a light fraction of crude oil) and hydrogen (effluent) are cooled following a reaction in which sulfur and nitrogen are removed from the naphtha by mixing it with hydrogen at a temperature of 630-700 °F and pressure of 600 psi. Flow into the shells comes in from the reaction process on the top (green). Naphtha and hydrogen are fed into the tubes (from bottom, in blue) to cool the reactor product and pre-heat the reactor charge. The top, middle, and bottom heat exchangers are pairs in the system that experience very similar conditions during processing. The highest temperature portion of the 6600-E and B heat exchangers is near the nozzle-shaped end. Inlet temperatures to 6600-A and D are estimated to be near 715 °F and outlet temperatures from 6600-C and F are expected to be near 300 °F (under ideal operating conditions).

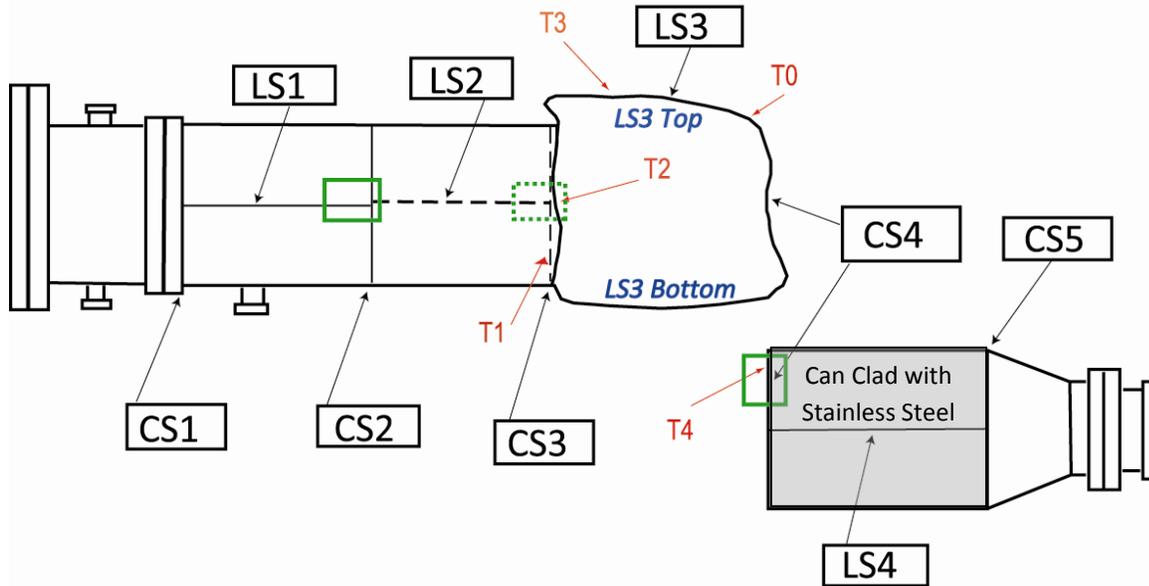
**Figure 6:** The E-6600E Heat Exchanger that failed is diagrammed here to show the identification labels (in black) for welds used in this review and the regions where cracks were identified by the Spectrum Inspection using ultrasonic techniques (labeled in red). The green boxes indicate some of the locations from which samples were removed (dotted green line indicates sample taken from back side of shell, away from fracture regions). The entire fracture regions labeled LS3 top and bottom were also removed for sampling and evaluation, as well as the CS4 fracture regions. For the welds, L represents longitudinal seam weld and C represents circumferential seam weld. From left to right there are four sections to the heat exchangers, referred to as CANs, and the welds change designations according to the section(s) they are associated with.

Spectrum Inspection detected cracking in five regions of the E-6600E (5/20/2010) heat exchanger. These regions were recommended for removal and further evaluation. The regions were identified as follows:

- TO, fractured LS3 weld had cracks on both sides (top and bottom) near CS4
- T1, cracking at CS3 (back side, dotted line) not too far from LS3 bottom section
- T2, at intersection of LS2 and CS3 (back side, dotted lines)
- T3, transverse crack along fracture of LS3 top section
- T4, cracks along CS4

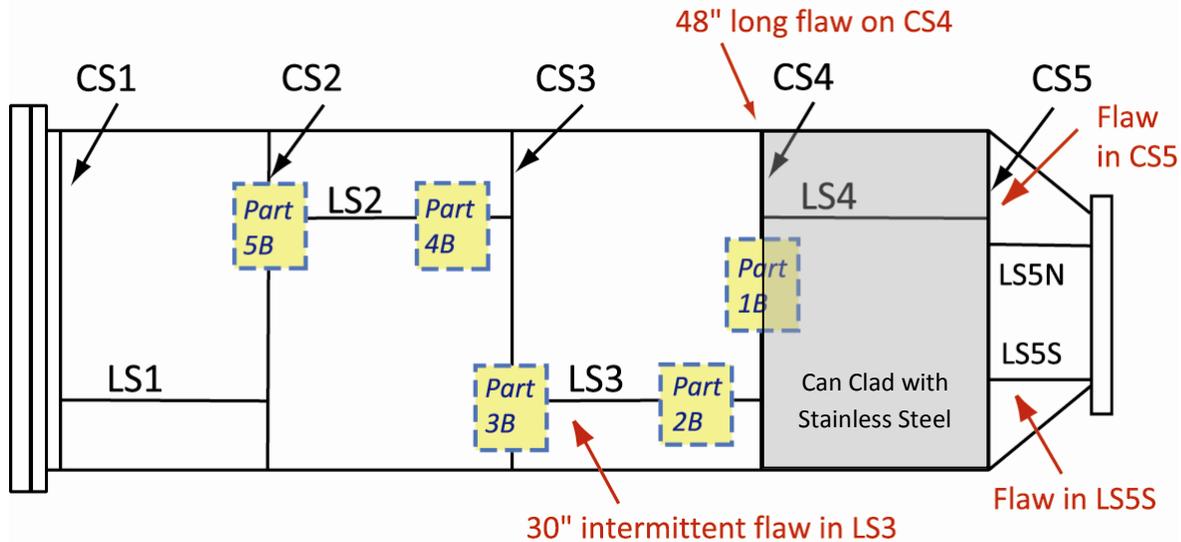
**Figure 7:** The schematic of the E-6600B exemplar heat exchanger shows weld identifications, flaw locations from the Spectrum Inspection report, and sample positions for specimens evaluated by BETA Laboratories. The positions shown for the welds are approximated for informative and semantic purposes, so differences shown for weld positions in E-6600E in Figure 3 and those shown here for E-6600B are not meaningful.

The Spectrum Inspection report identified a large crack in the E-6600B shell during the Phased Array inspections of the heat exchanger. The crack intersected the ID surface along the CS4 weld, at the edge of the stainless steel cladding. This crack was approximately 0.3 inches deep and 48 inches long (over 50 % of the weld length). Wet Fluorescent Magnetic Particle (WFMT) inspection of the ID surface by Spectrum Inspection confirmed the presence of this crack. Other evidence of flaws<sup>2</sup> was indicated in the Spectrum Inspection report on the E-6600B heat exchanger for the LS3 weld (30-inch-long intermittent mid-thickness flaw), the CS5 weld, and the LS5S weld.

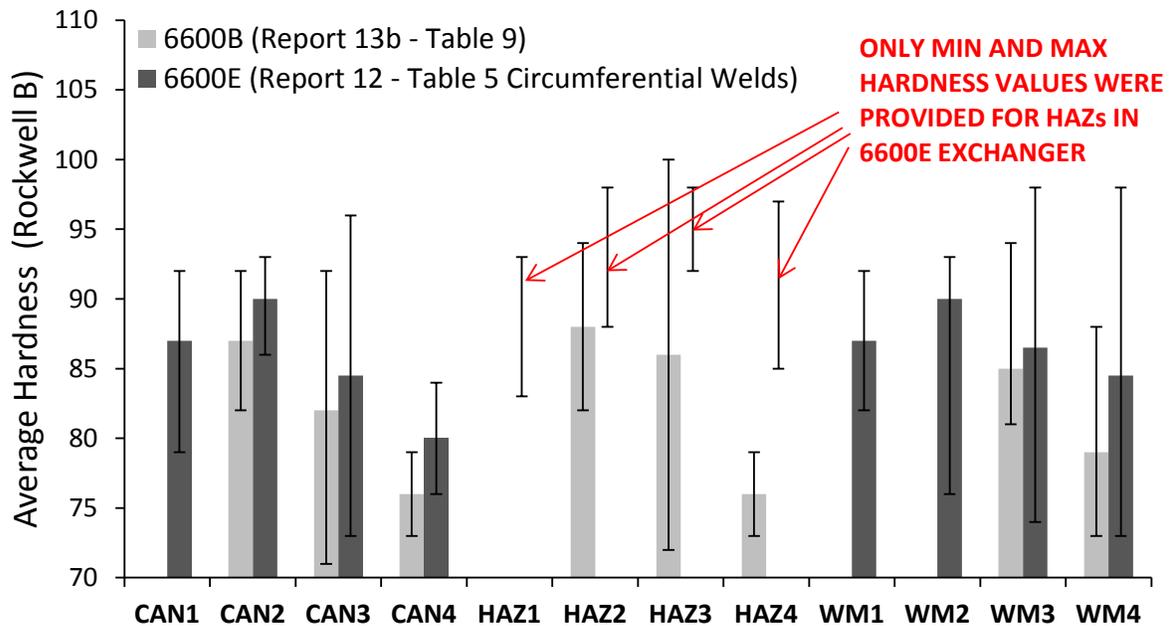
Hardness values were generally higher in the failed heat exchanger (E-6600E) compared with the exemplar (E-6600B), and in both exchangers the hardness values near CAN4 tended to be lower than those near CAN1. This variance is shown in **Table 2** and **Figure 8**. **Table 2** summarizes macro hardness values measured in each of the CAN base metals. **Figure 8** shows averaged microhardness values (converted from the Vickers scale to the Rockwell B scale) for different regions of both vessels including CAN, HAZ, and weld metal (WM) locations. In general, the CAN4 material tends to be softest, with increasing hardness towards CAN2. The CAN4 end was the hotter end of the exchanger and may have experienced a slight hardness reduction during service due to tempering or stress relief effects (that might have occurred at the vessel operating temperature). However, the heat from the fire during the accident, and the various subsequent cooling rates of the steel that might have resulted from extinguishing of the fire, could have significantly affected the hardness of the heat exchangers. This is particularly true for regions where the shell burst during the failure. If the E-6600E exchanger reached peak temperatures over approximately 730 °C (1350 °F), metallurgical transformations would be expected that could significantly alter hardness upon cooling.

**Figure 8:** Average hardness values (converted from Vickers 500 g) in different regions of E-6600B and E-6600E exchangers. Minimum and maximum hardness values in each of the regions are indicated with the error bars.

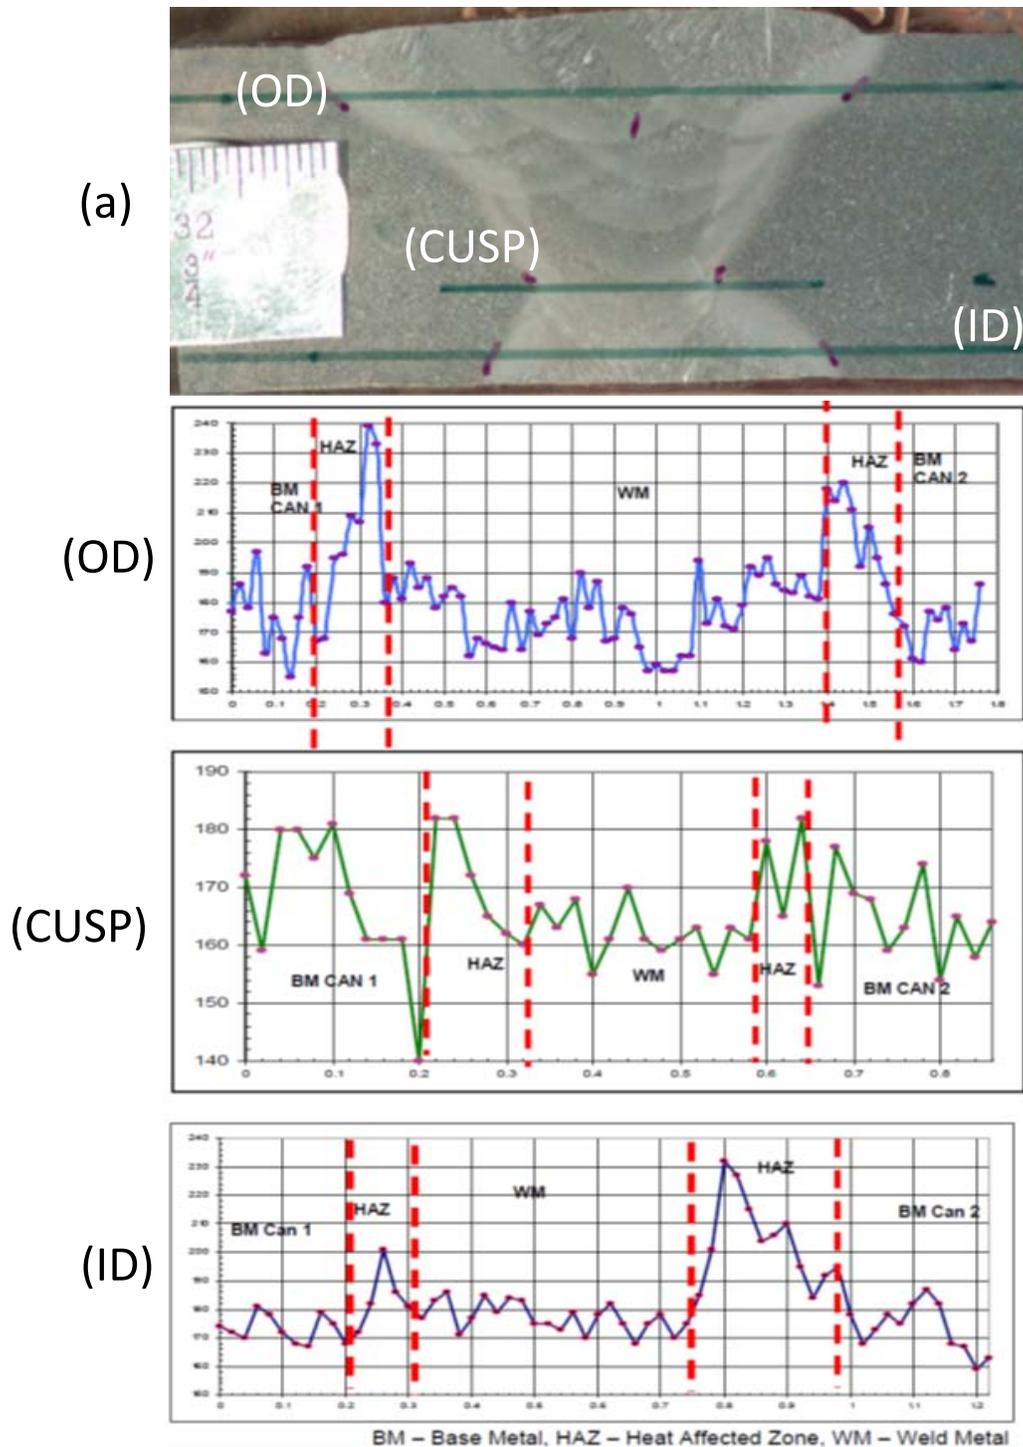
**Figure 9:** Example microhardness data collected from a cross section of the CS2 weld (CS2-A mount) on E-6600E. The green lines on the cross section in (a) indicate the location of the three hardness traces shown below it. The hardness across the OD line shows the HAZ regions of the three cap weld passes to be harder than the base metal or weld metal surrounding them (220 to 240 HV500). The base metal regions range from approximately 160 to 180 HV500, and weld metal regions have similar hardness.

The fusion line cracking (underbead cracking) occurs in the vicinity of the peak hardness values shown in microhardness traverses of the first type (**Figure 9**). The HTHA that occurs in the second type of hardness traverse (**Figure 10**) is different in that it occurs in the base metal just outside the HAZ. The differences in the toe crack and underbead crack morphologies likely reflect influences of higher stress and higher microstructural susceptibility, respectively.

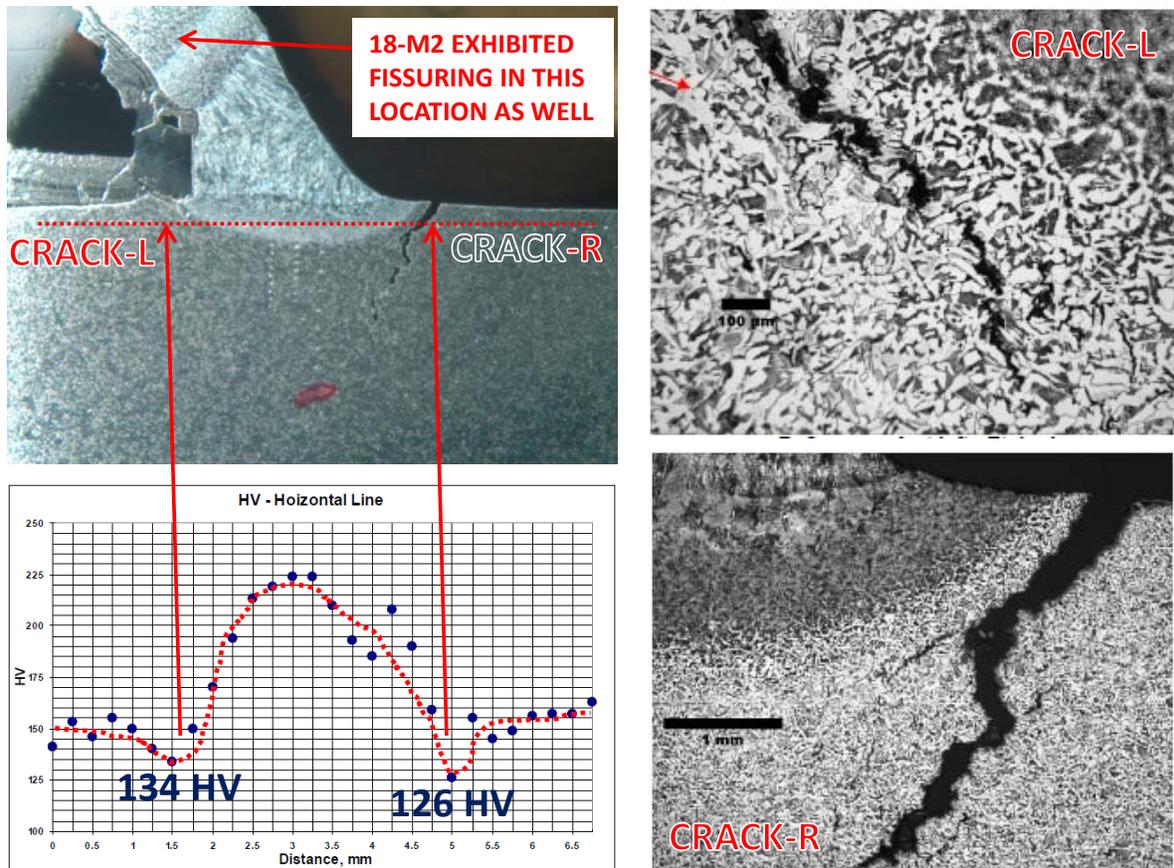
**Figure 10:** Example microhardness data collected from a cross section of the CS4 weld region (18-M1 mount) on E-6600E. Note that significant softening appears in the microhardness traverse just outside the HAZ regions of the fillet weld where fissuring is present.

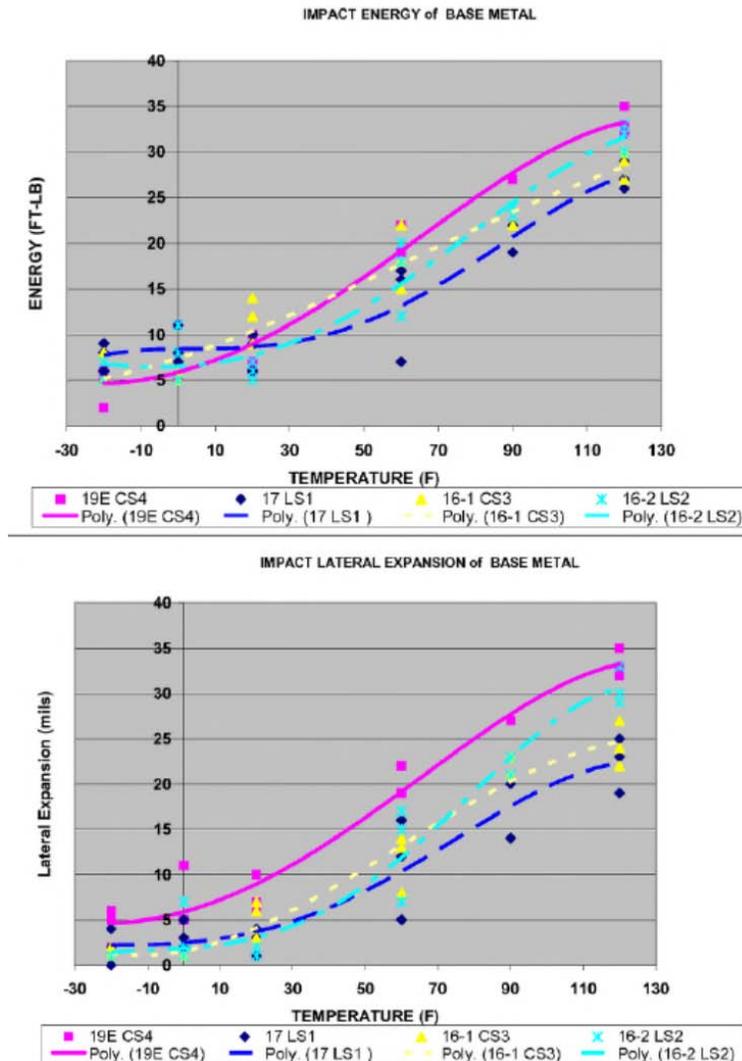
The impact properties of the heat exchangers are shown in **Figure 11**. The ductile-to-brittle-transition of the base material occurs at over 60 °F, likely closer to 100 °F (as indicated by the 50 % fracture appearance shear plot for this data, not shown here). This high transition temperature (above room temperature) at which brittle behavior can occur is expected for this coarse-grained carbon steel, as indicated by the literature data for a SA-515 Grade 70 steel shown in **Figure 12**. **Figure 12** also contains a plot of data points from the heat exchanger materials (approximate median values from **Figure 11**) for comparison. Note that the Charpy impact toughness of the exchanger material is within the typical scatter range shown in **Figure 11**, if not slightly better.

**Figure 11:** Impact energy and lateral expansion for the base metal samples.

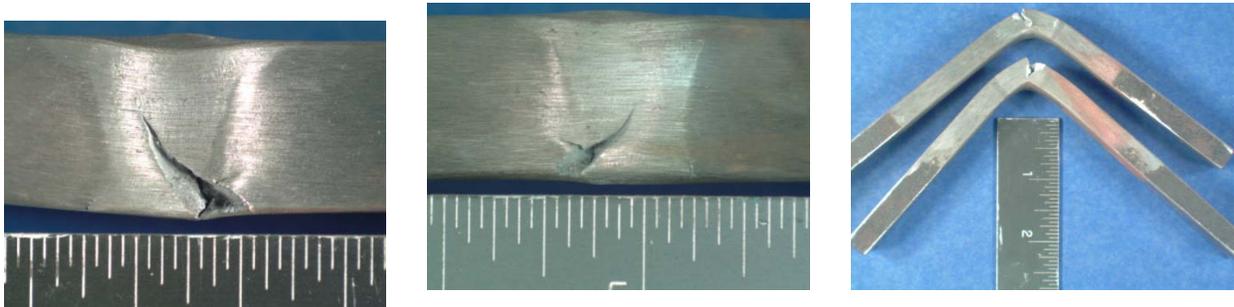
Bend tests of the CS2, LS2, and LS1 welds (from E-6600E) passed ASME acceptance criteria for qualifying welders and welding procedures (no open discontinuities), whereas the seam weld specimens (CS3) failed the test criteria. As shown in **Figure 13**, the CS3 specimens formed cracks during the bend test. The cracks initiated near the toe of the root passes in both welds, but it is not clear from the

**Figure 13:** Showing two bend specimens that cracked during testing. It is difficult to clearly see the weld position in the figures, but it appears that the failures of both specimens initiated near or at the toe of the root pass in the welds (ID). Both fractures then propagated into the weld metal, where the stress of the bend bar is expected to be highest.

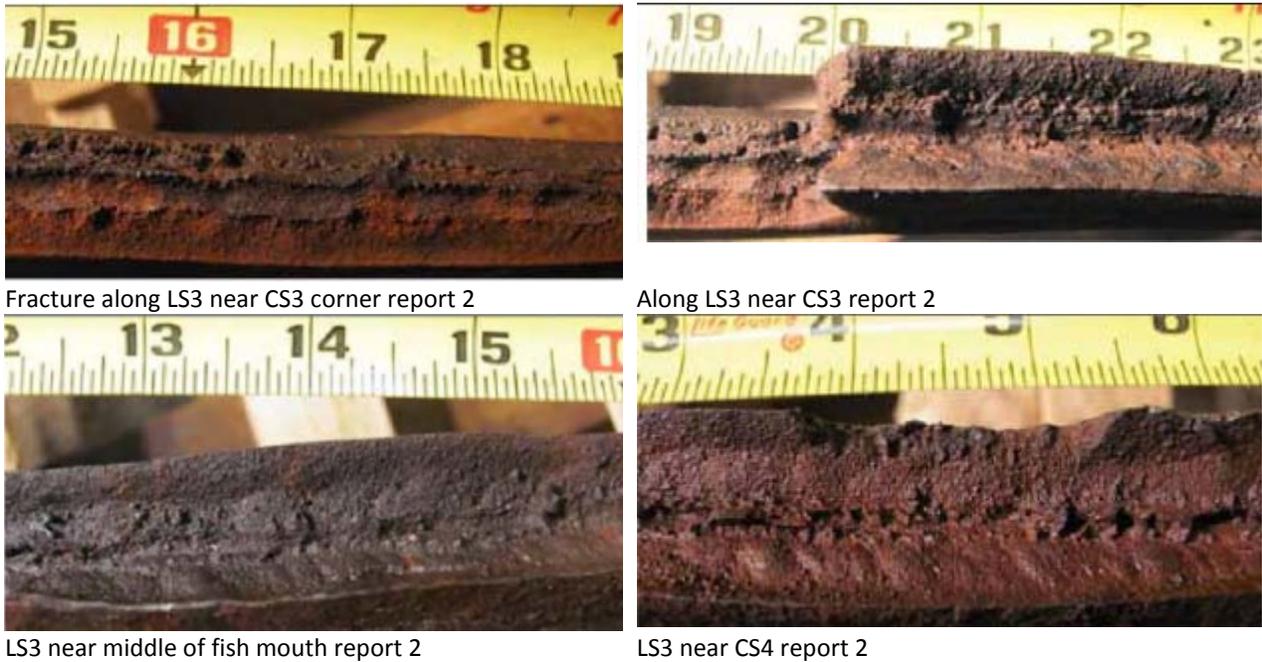
A few examples of fracture surface morphologies from the burst region along the LS3 weld are shown in **Figure 14** for general discussion. The fracture surfaces were exposed to fire and fire-fighting actions, so many features of the fracture surfaces are obscured. General morphologies of the fracture profiles do show that fracture paths followed the welds very closely in some regions. On some fracture surfaces, the contours of several weld passes are clearly recognizable.

**Figure 14:** Fractography from Beta Laboratory reports 2 and 3.

The general point taken from the fractures is that the catastrophic failure event occurred in a ductile mode. This point is evident in the general texture of the fracture surfaces, and is also shown by the plastic thinning of the shell thickness measured adjacent to the fractured surfaces.

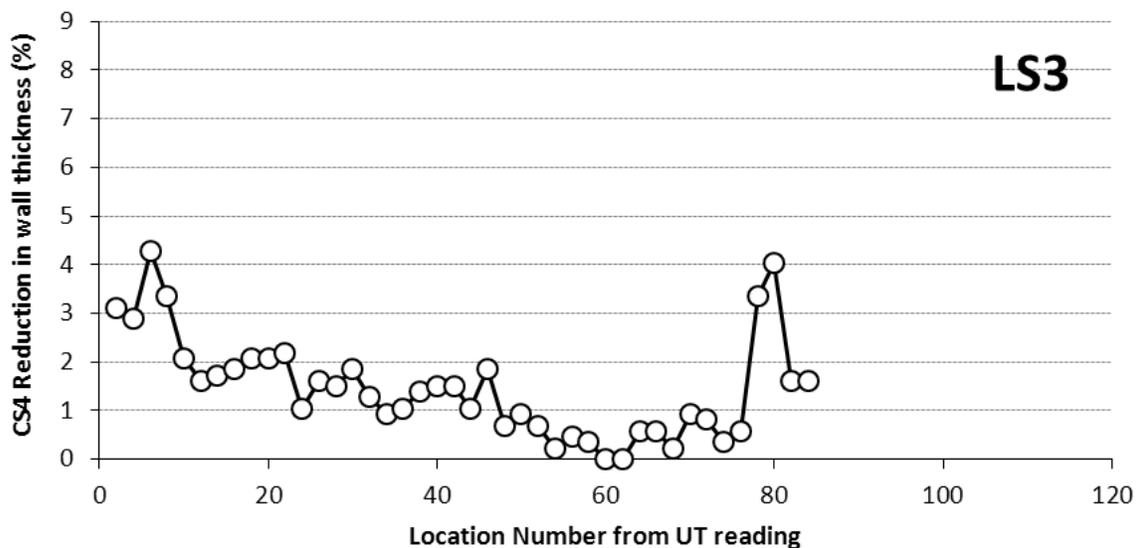
**Figure 15:** The thinning associated with the fracture along the LS3 weld is shown as percent change, with respect to the thickest region measured for the UT reading positions :  $\% \text{ Change} = \frac{(\text{thickest position} - \text{position})}{\text{thickest position}} \times 100$ . The zero UT location is near the CW3 and other end near CW4.

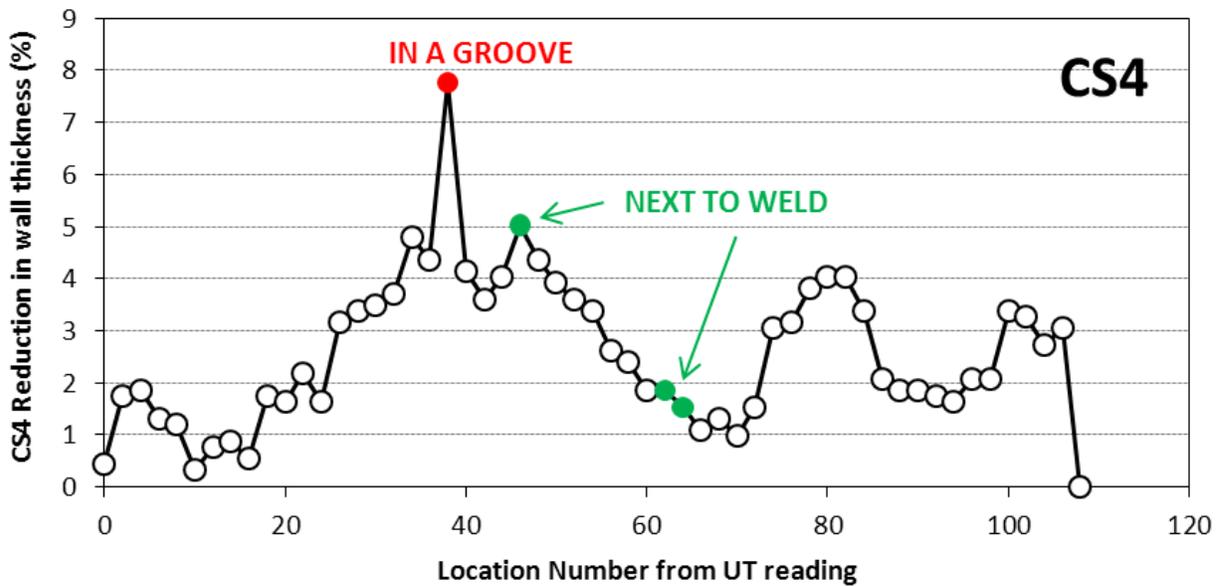
**Figure 16:** The thinning associated with the fracture along the CS4 weld is shown as percent change, with respect to the thickest region measured for the UT reading positions:  $\% \text{ Change} = \frac{[\text{thickest position} - \text{position}]}{\text{thickest position}} \times 100$ . The UT positions are around the circumference of the shell, so position 0 and position 108 are adjacent position. Position 0 is on top of the shell (12 O'clock) at the nozzle. The LS3 and LS4 welds intersect the fracture along CS3 near the 26 and 86 UT positions. The meaning of "next to weld" was not clear, but it is assumed that it means the thinning measurement position along the fracture was close to the CS3 weld in these locations.

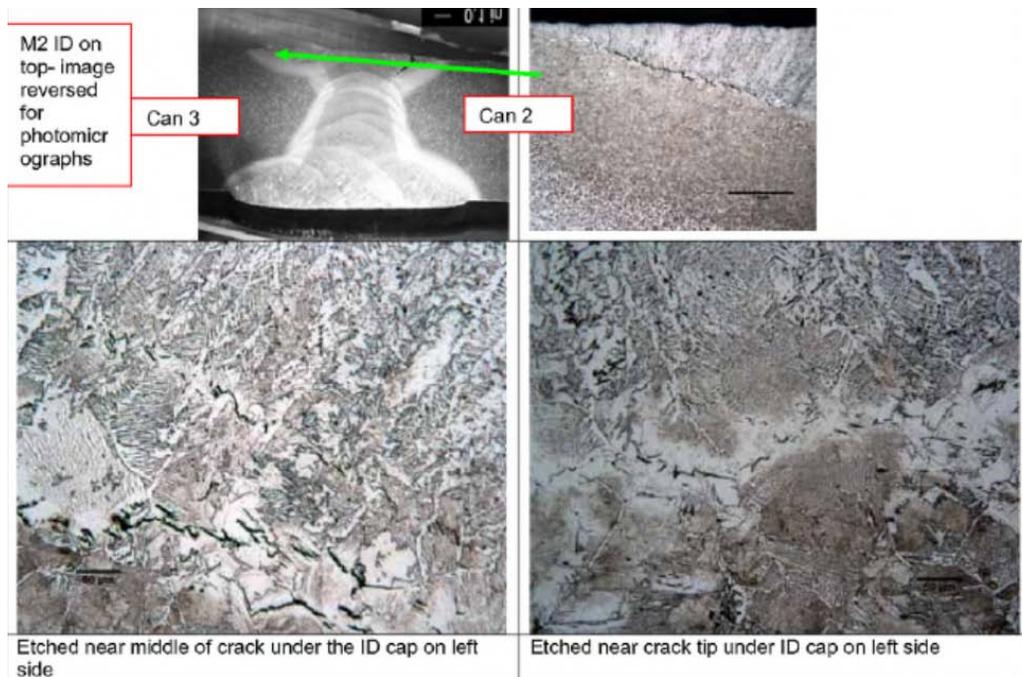
**Figure 17:** Cracks at toe of ID weld pass. Cracking occurs near the fusion line and has decarburization associated with it. Some of these cracks grew into the shell more than ¼ of the thickness (see report 4 fig 16, E-6600E). This figure was taken from report 2, Figure 27.

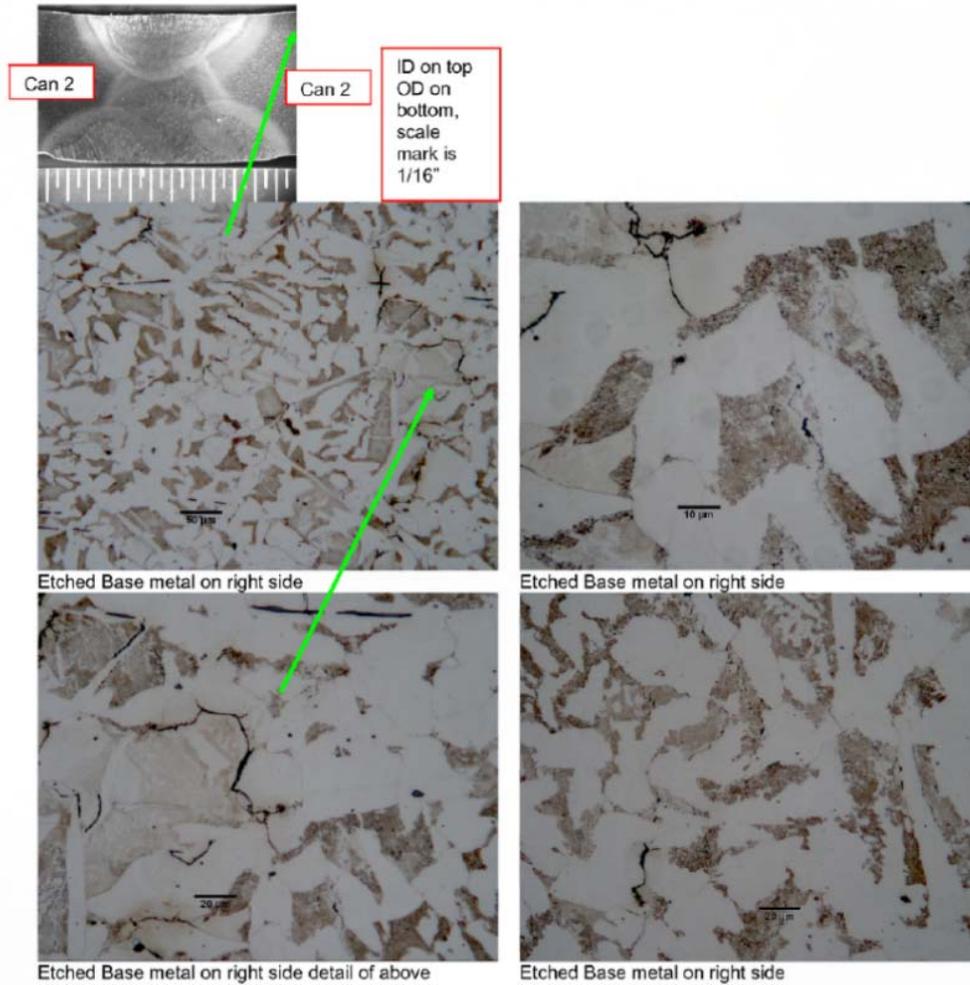
**Figure 19:** Cracking near the surface of the ID in the base metal to right of the weld shows damage morphologies typical of HTHA in carbon steel. Fissures at grain boundaries join to form cracks. The fissures are associated with decarburization of carbides in the steel. Decarburization is apparent here, because the brown pearlite phase is fading in contrast (compared with other pearlite regions) as carbides are dissolved and combined with hydrogen to form methane. This Figure is from report 4, Figure 1, E-6600E.

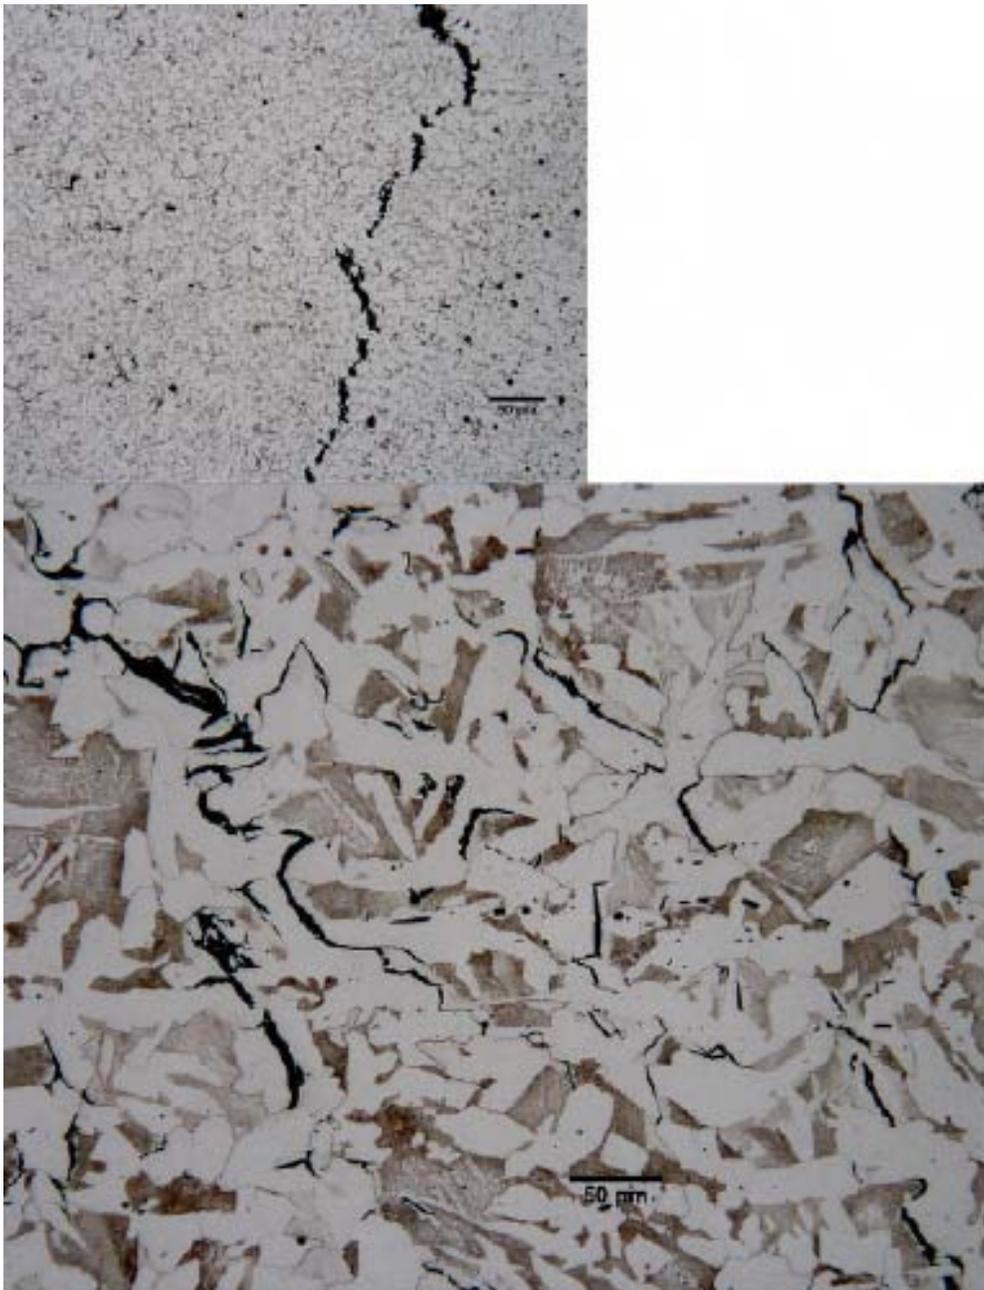
**Figure 20:** A macrocrack in the base metal in the LS2-CS3 Tee region. Details of the macrocrack above are shown below. From report 4, Figure 9, E-6600E.

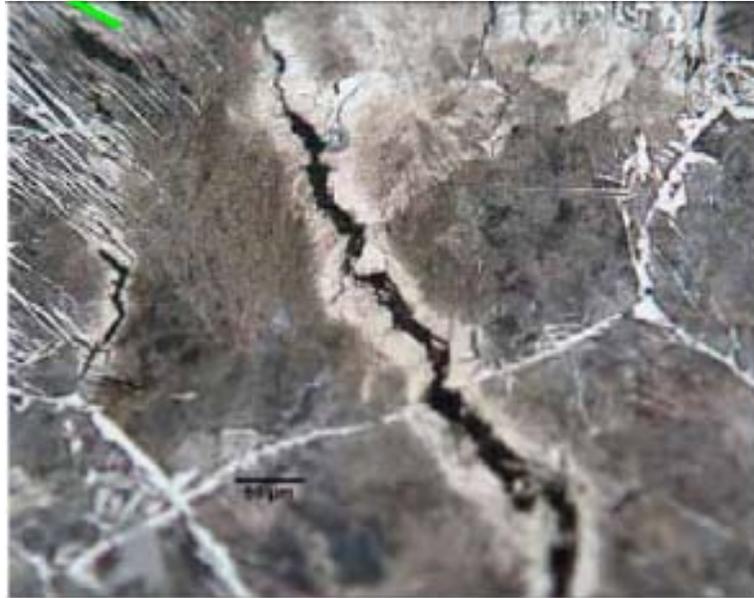
From report 2, Figure 33, LS3 HAZ region just under fracture surface on a plane parallel to ID surface.

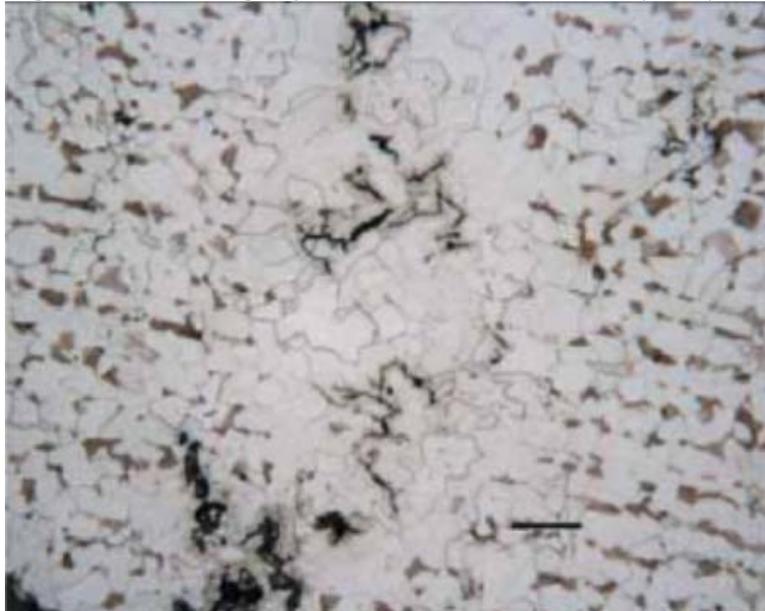
From report 2, Figure 40, base metal region adjacent to CS4 weld/fracture.

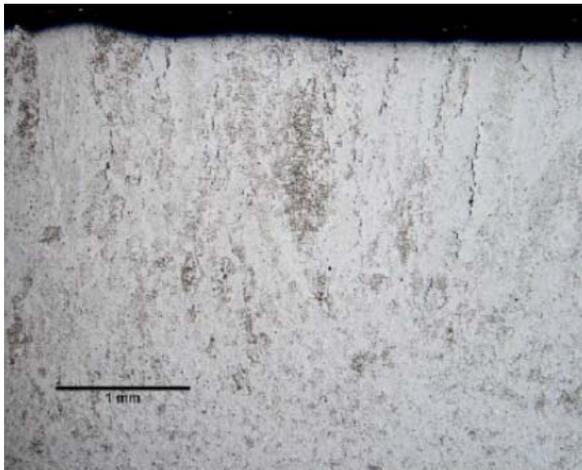
a) Report 4, Figs 10, for LS2-CS3 Tee.  
Surface of ID (top) near middle portion of weld pass.

**Figure 22:** Examples of cracks intersecting the ID surface in the E-6600E heat exchanger.

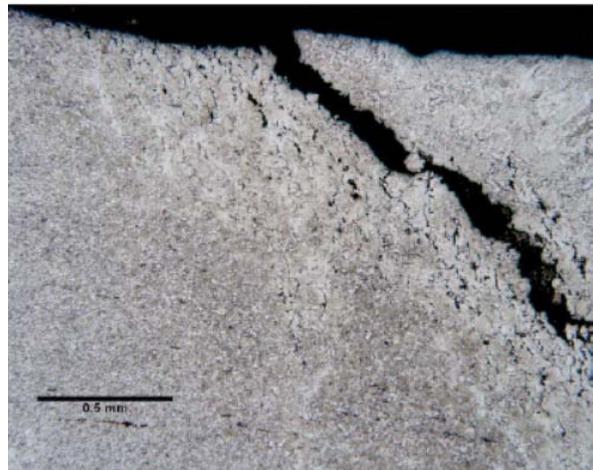
b) Report 4, Figs 13, LS2-CS3 Tee.

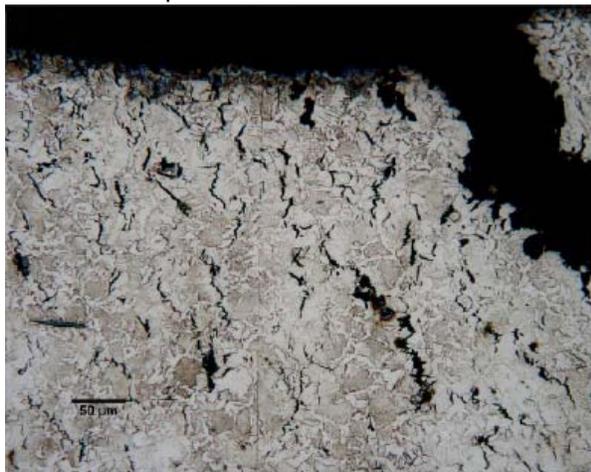
c) Report 5, fig 18, toe crack on right side of angle in 18-M2 where fracture intersects ID.

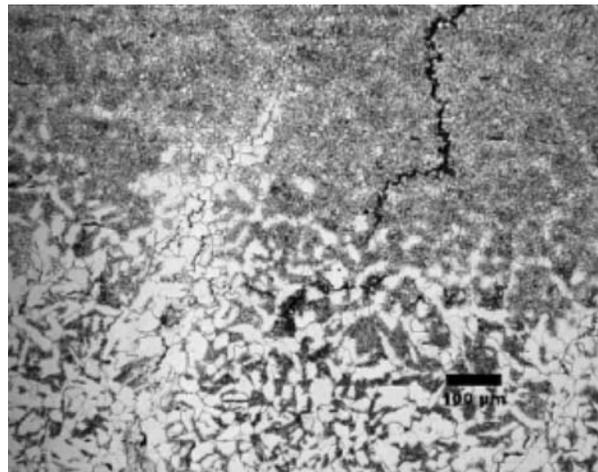
d) Report 4, Figs 14, LS2-CS3 Tee.

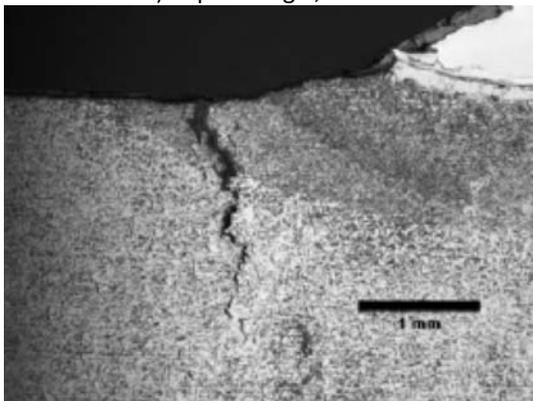
(c) Report 5, fig 14, toe crack on left side of angle.

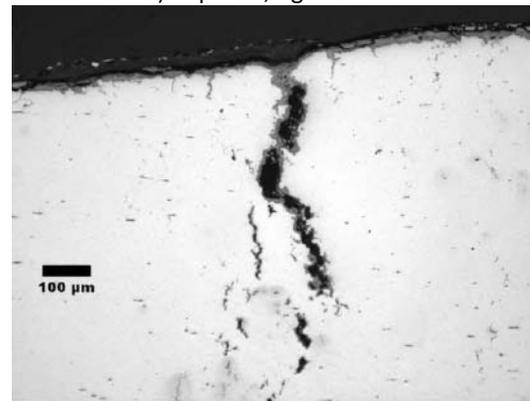
d) Report 5, fig 7, surface cracks to left of toe crack.

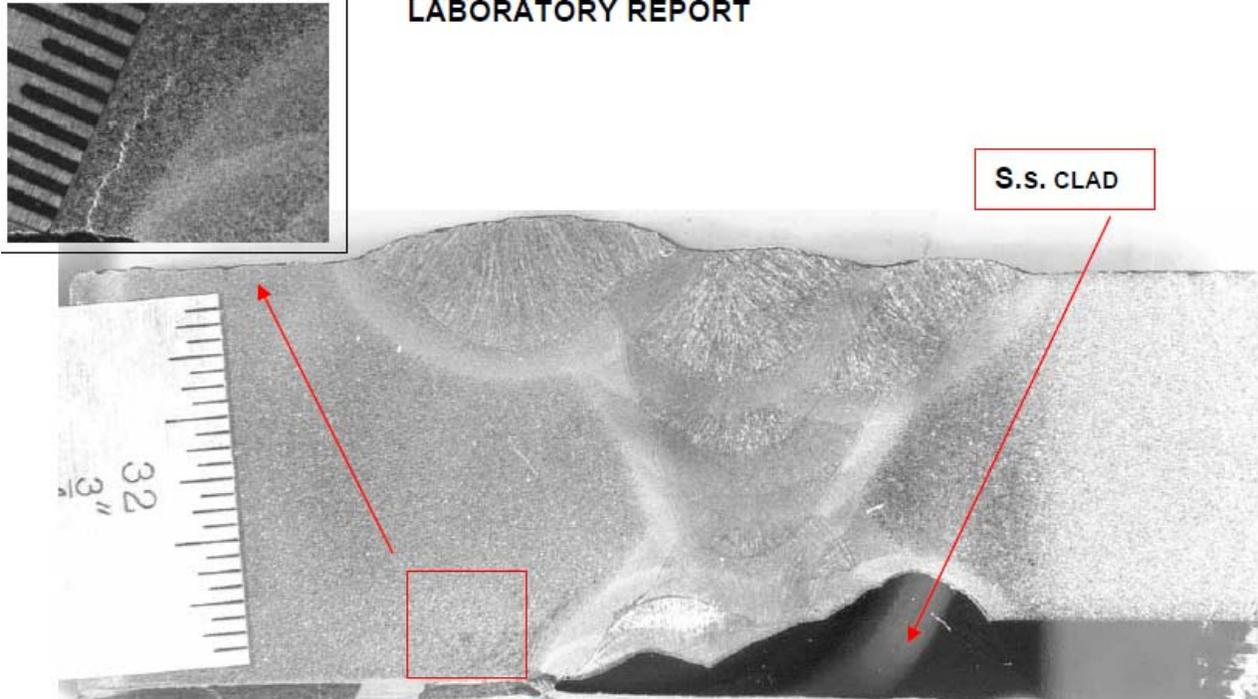
Figure 24: E-6600B exemplar heat exchanger in region where Phased Array inspections showed a 48-inch long, 0.3-inch deep continuous crack that was connected to the ID surface at the CW4 weld. The upper ruler is in 64 inch divisions, indicating a depth of about 0.15 inch for the crack at this position. The crack is barely visible in the larger cross section, but is shown to intersect the surface in the inset macrograph.

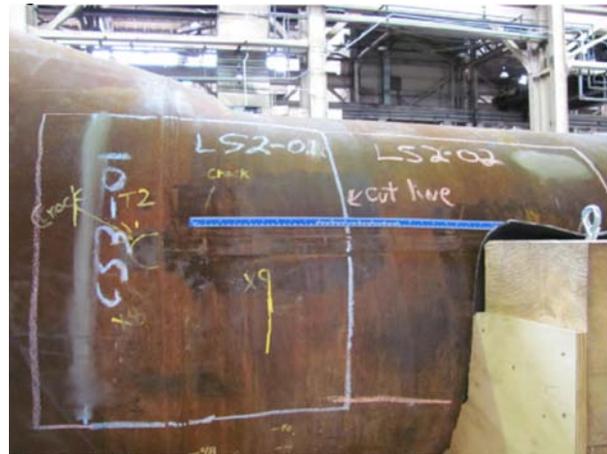
Note T-2 UT indication at CS3 and LS2 TEE

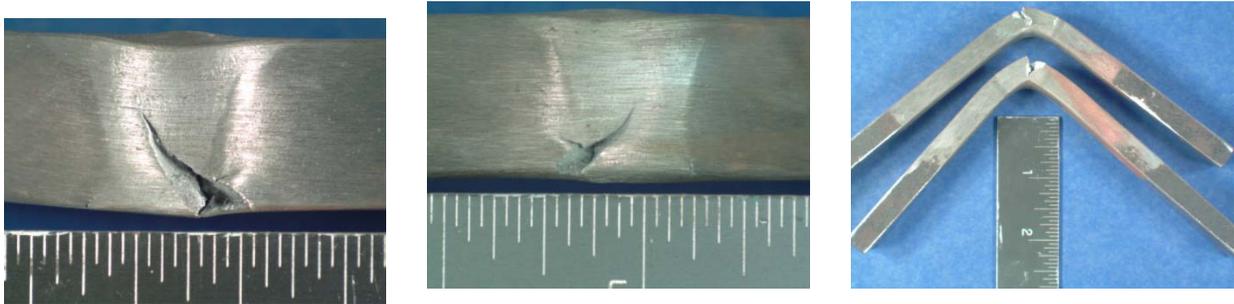
Table 8 shows bend testing results of welded joints. Two circumferential seam weld (CS3) specimens failed during bend testing. This could be from fabrication- or service-related defects. No information was provided on the failure mode other than the apparent observation that cracks were perpendicular to the bending. Upon request, images of tested bend specimens were provided to the reviewers however no significant new information could be obtained by observing the failed welds, except that it is likely that the bars contained flaws in the region near the fusion line of the root passes of the welds (ID). SEM evaluation would have given more insight into cause of cracking during bend testing.

Figure A1.5: Showing two bend specimens that cracked during testing. It is difficult to clearly see the weld position in the figures, but it appears that the failures of both specimens initiated near or at the toe of the root pass in the welds (ID). Both fractures then propagated into the weld metal, where the stress of the bend bar is expected to be highest.

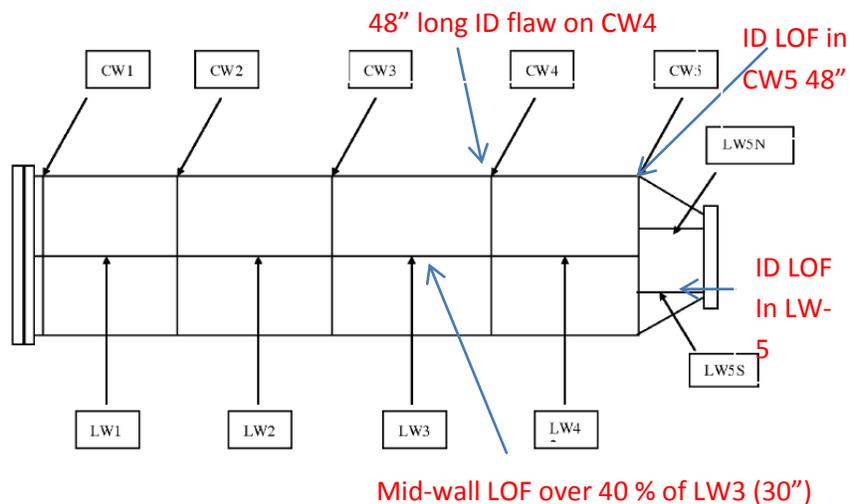
Figure AII. 1: Showing the weld identification notation used and the locations of the flaws identified in the report on the E-6600B heat exchanger.
