Investigation Update

September 2022

This document provides an update on the CSB investigation of the December 8, 2020, incident at Optima Belle LLC in Belle, West Virginia. The investigation is ongoing. Complete findings, analyses, and recommendations, if appropriate, will be detailed in the CSB's final investigation report.

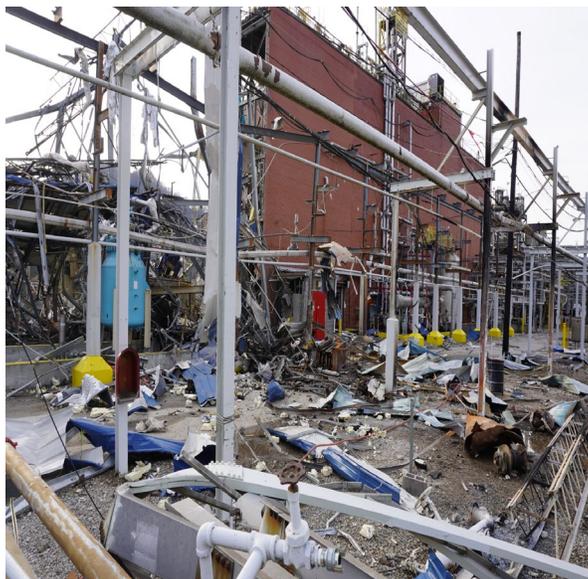
The explosion resulted in significant damage to the dryer unit (**Figure 1**). Debris from the explosion struck a methanol pipeline owned by Belle Chemical Company at a co-located facility not owned by Optima Belle,^a causing a fire. Another large fragment landed approximately 1,000 feet off-site on U.S. Route 60, causing reported damage to two vehicles. The driver of one of the vehicles, a Kanawha County resident, also reported having leg pain after hitting the large object on the road.

Figure 1. Post-incident photo of the Optima Belle process building and area where the dryer unit was installed (Credit: CSB)

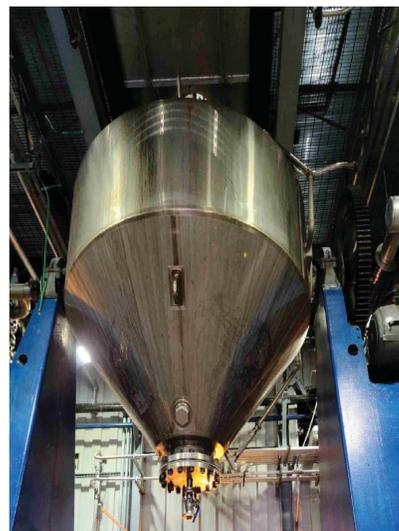
- A double cone dryer (*ASME code stamped*)^c constructed of Hastelloy C276 (**Figure 2**)^d operating under vacuum (below atmospheric pressure) was used to heat and dehydrate the CDB-56[®] in the batch operation. Other connected process equipment included a vessel configured with a condenser to collect the water leaving the dryer, a scrubber, and an eductor^e to create vacuum conditions.

Figure 2. Optima Belle's double cone dryer pre-incident (Credit: Optima Belle)

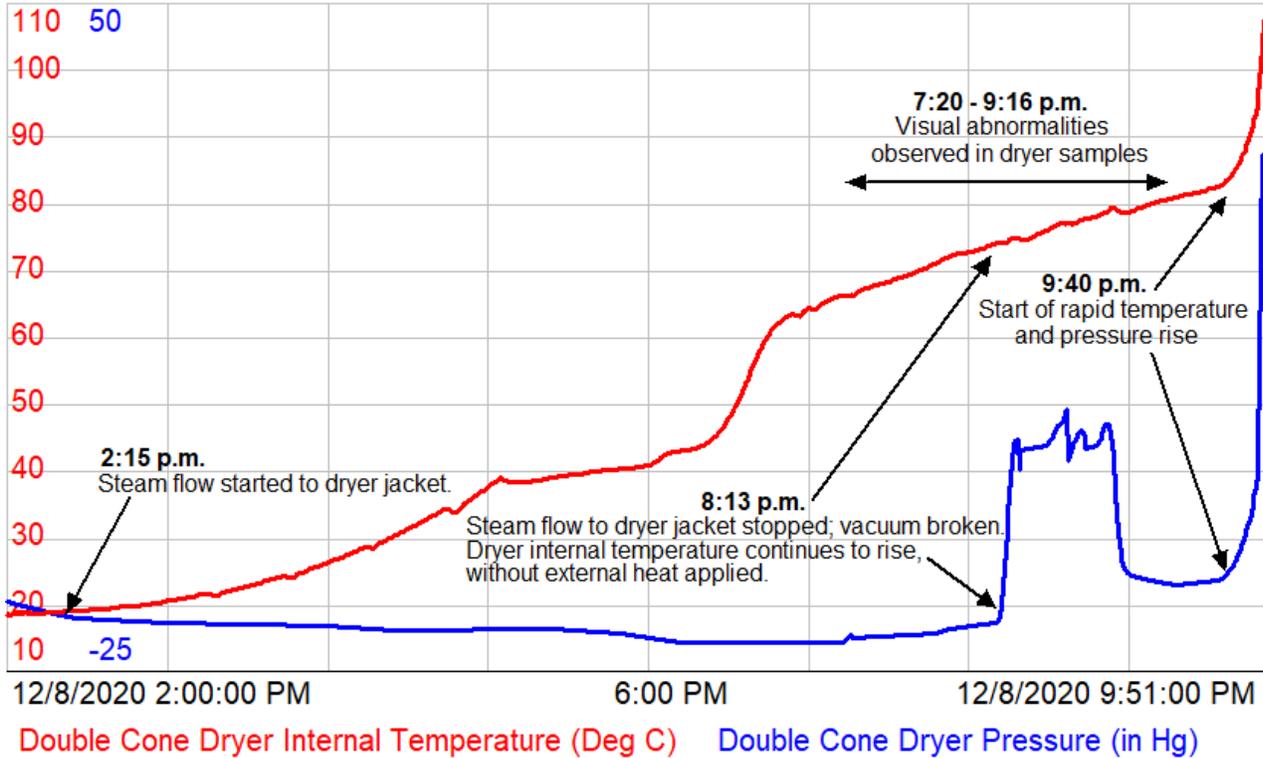
- At 9:50 p.m., the dryer’s rotation had not been re-started, and the internal temperature rapidly increased to a maximum recorded temperature of approximately 108°C (226°F) (**Figure 3**). The temperature was monitored via

- The dryer exploded shortly after this temperature measurement.

Figure 3. Dryer Operating Conditions on December 8, 2020 (Credit: CSB)
