Investigation Update

March 2025

This document provides a second update^a on the CSB’s investigation of the October 10, 2024, incident at the Deer Park Refining, Limited Partnership’s (“PEMEX Deer Park”) refinery in Deer Park, Texas.

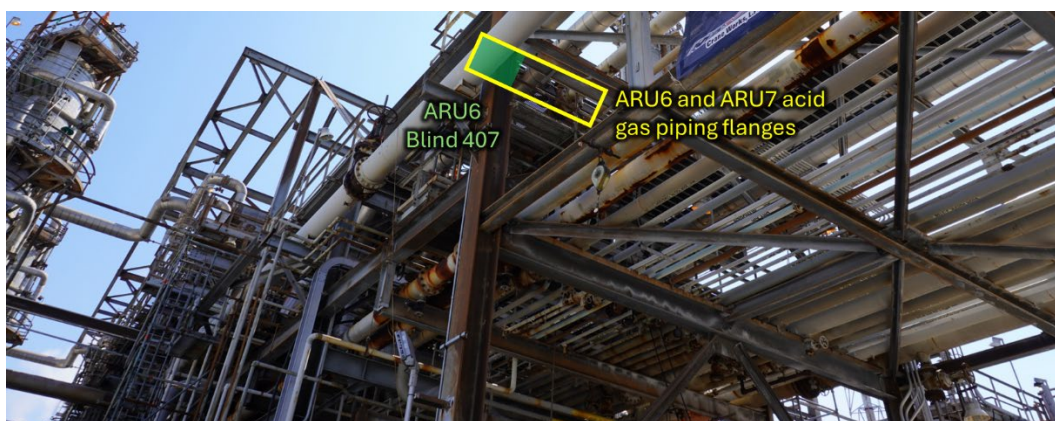
One of the blinds that the operator and Repron foreman did not visit – the 14th blind, labeled Blind 407 – was located on the acid gas piping approximately 25 feet above the ground (**Figure 4**). The operator and foreman viewed Blind 407 from the ground underneath the piping.

Figure 4. View of Blind 407 from the ground. (Credit: CSB)

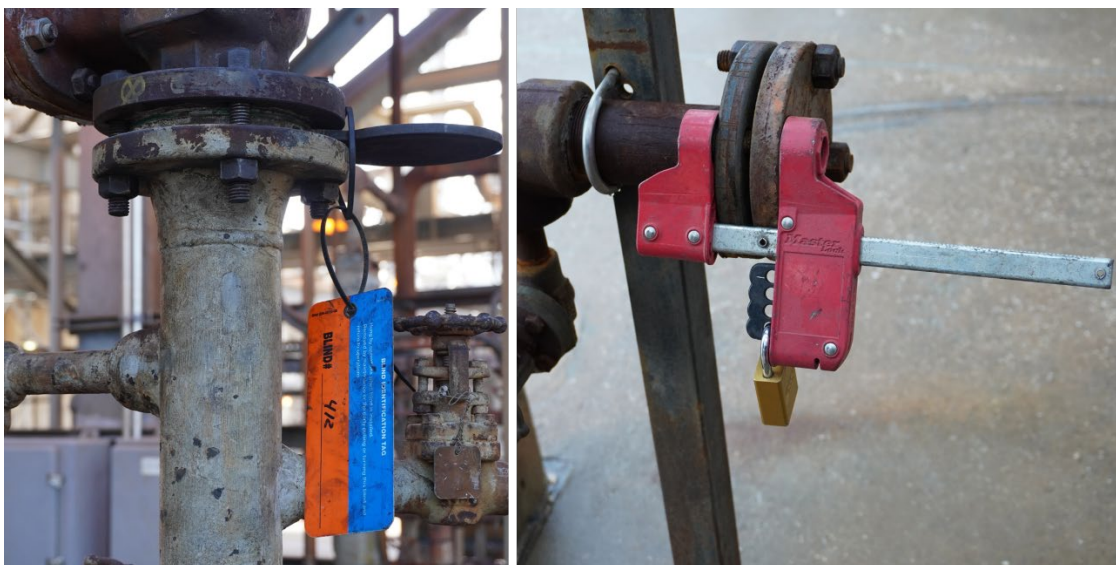
The four Repcon boilermakers worked in pairs, opening flanges and removing blinds from the ARU6 piping. The boilermakers did not have the blind list or drawing; they used visual indicators to identify the location of the blinds to be removed. The boilermakers informed the CSB that they depended on an orange-and-blue blind identification tag or an unlocked red flange locking device to locate the 15 blinds (**Figure 5**).^b

Figure 5. Blind identification tag (left) and flange locking device (right).^c (Credit: CSB)

^b PEMEX Deer Park procedures required the use of the tags and locking devices on flanges with blinds during turnaround activities, such as the work occurring at the SRU, but these are not required during non-turnaround maintenance activities, like at the ARUs. Instead, PEMEX Deer Park policy required the development of an isolation list and a drawing depicting the blind locations, which the PEMEX Deer Park operator had provided to the Repcon foreman. Although blind identification tags were not required during non-turnaround maintenance activities, PEMEX Deer Park operators hung tags at ARU blind locations prior to the ARU6 blind removal activities.

^c The photo of the red flange locking device was taken in another part of the facility and is displayed here as an example of an installed lock.

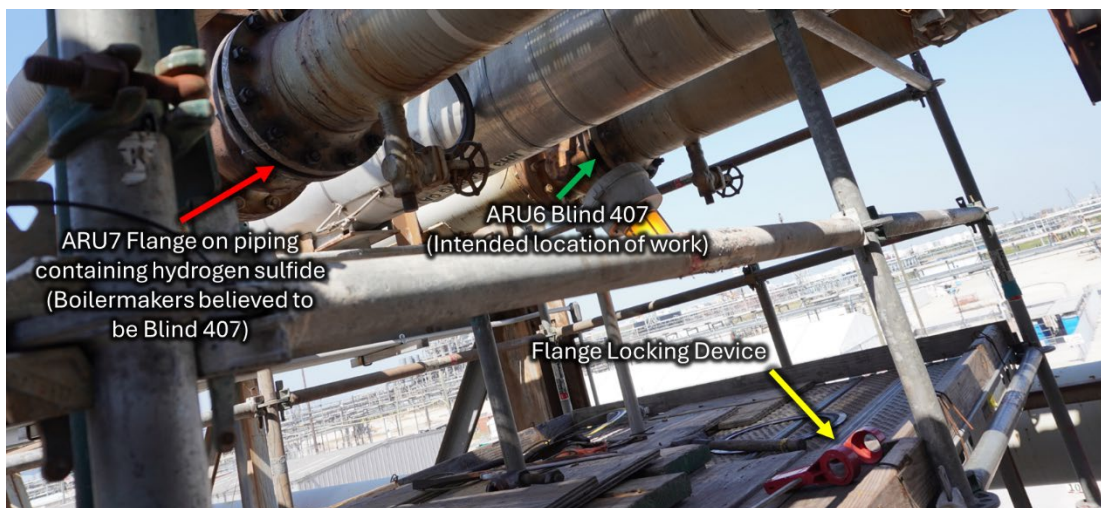
The two Repron boilermakers at the Blind 407 location encountered two identical piping segments five feet apart. The ARU6 piping, which was the intended location of the work, had previously been depressurized, purged, and isolated via a closed and locked-out upstream valve. Five feet away, the ARU7 piping segment (**Figure 6**) contained approximately 90 percent hydrogen sulfide gas at a gauge pressure of about 15 pounds per square inch.

Figure 6. Adjacent ARU6 and ARU7 acid gas piping flanges. A flange locking device was found on the work scaffold underneath the ARU7 acid gas piping flange. (Credit: CSB)

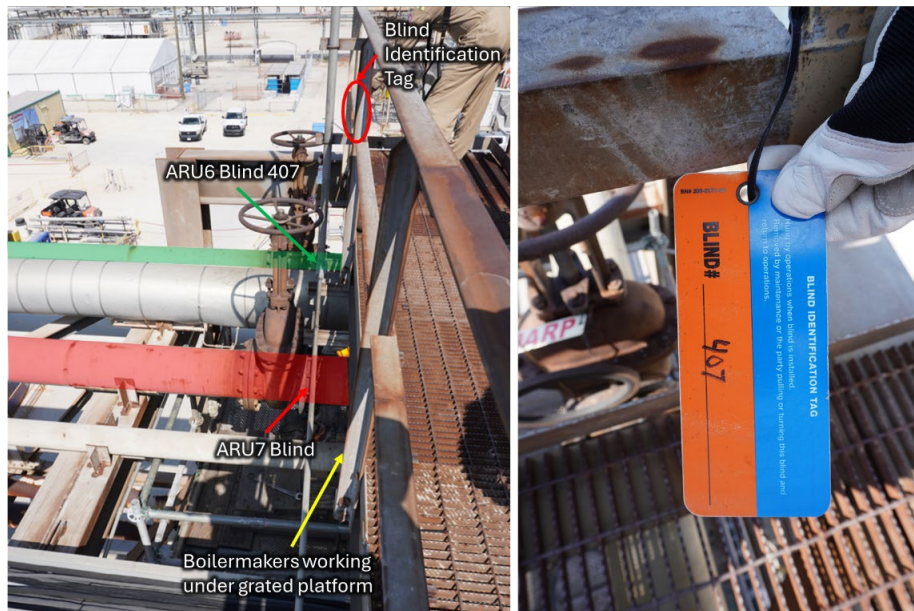
The two Repron boilermakers did not observe a blind identification tag on either of the ARU6 or ARU7 flanges. After the incident, the CSB located the Blind 407 identification tag attached to the railing on the grated platform above the piping where the boilermakers were working (**Figure 7**). The boilermakers observed a flange locking device on or near the ARU7 flange (**Figure 6**) and believed that the ARU7 flange was the intended location of the work, unaware that Blind 407 was located on the piping segment five feet away.

Figure 7. ARU6 blind identification tag location. (Credit: CSB)

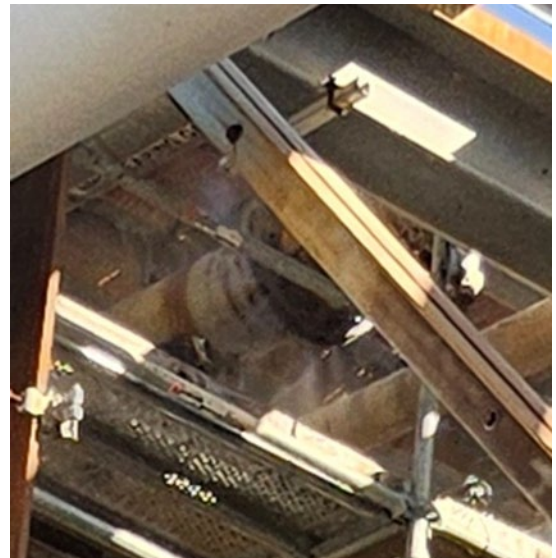
At 4:23 p.m., the connection was disassembled enough that the flange opened, forcefully releasing toxic hydrogen sulfide gas (**Figure 8**). The two boilermakers disconnected their supplied air connections to flee from the area. One boilermaker turned the valve to engage air flow from his escape cylinder and proceeded down a nearby ladder to the primary assembly point. The other boilermaker collapsed near the top of the ladder and was found by emergency responders with his respirator mask lying next to him, fatally injured from hydrogen sulfide poisoning.^a

Figure 8. Hydrogen sulfide release from the ARU7 flange. (Credit: PEMEX Deer Park)

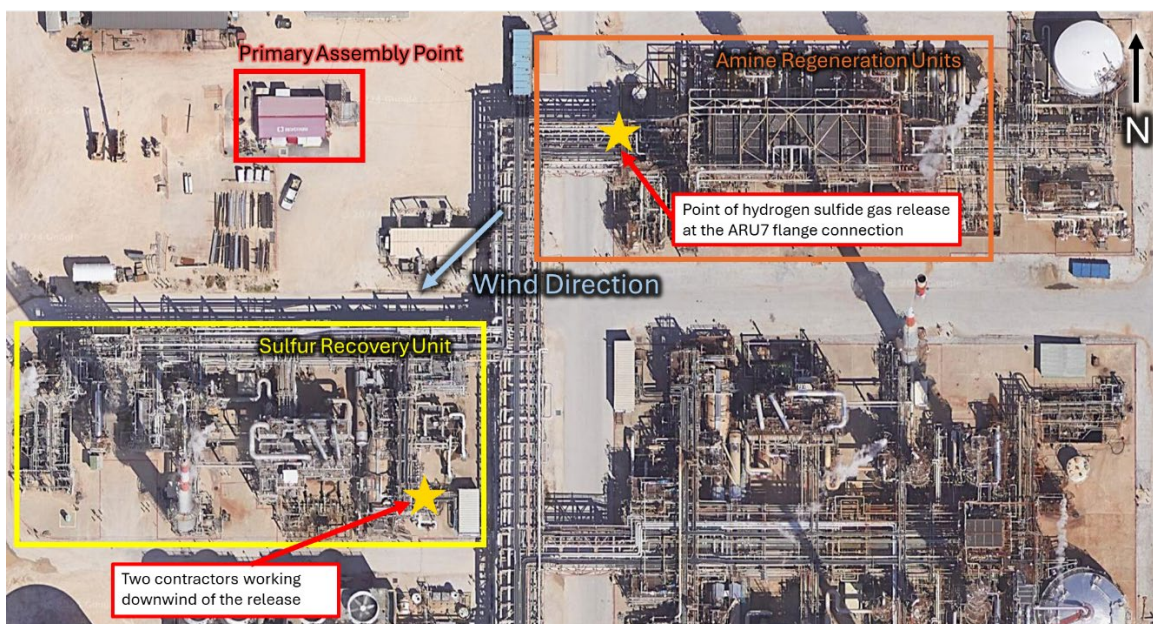
The wind^a carried the released hydrogen sulfide away from the gas detectors in the ARUs, and consequently the ARU alarms did not sound immediately. Although the wind brought the hydrogen sulfide gas through the nearby SRU (Figure 9), the SRU hydrogen sulfide detectors were disabled due to maintenance work associated with the turnaround and did not activate. The portable gas monitors, maintained by Code Red, were stationed throughout the SRU and detected hydrogen sulfide concentrations exceeding 500 ppm and reaching nearly 800 ppm in some areas.^b At 4:24 p.m., the portable gas monitors began to alarm audibly at the location of each gas detector, and a functioning, permanently mounted alarm at a shelter within the SRU also started to alarm.

Figure 9. Overhead view of hydrogen sulfide release location and adjacent units with gold stars indicating the approximate location of the fatally injured. (Credit: Google Maps, annotated by CSB)

Two ISC contract workers were working on SRU equipment about 250 feet away and downwind from the release (Figure 9). PEMEX Deer Park did not require the ISC workers to wear respiratory protection for their permitted work,
