January 21, 2018

Crew members from the Patterson-UTI Drilling Company had been drilling a gas well for over a week under the direction and supervision of Red Mountain Operating, LLC (or RMO) in Pittsburg County, Oklahoma.

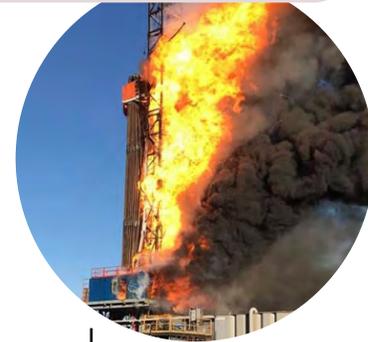
8:36 AM

A minute later, mud blew upwards out of the well. The mud and gas from the well ignited, causing a large fire.
